2013 Wetland Delineation & Monitoring Report

RUBBERT WETLAND MITIGATION SITE PHASE 2
WisDOT PROJECT I.D. 0695-12-13
WINNEBAGO COUNTY, WISCONSIN

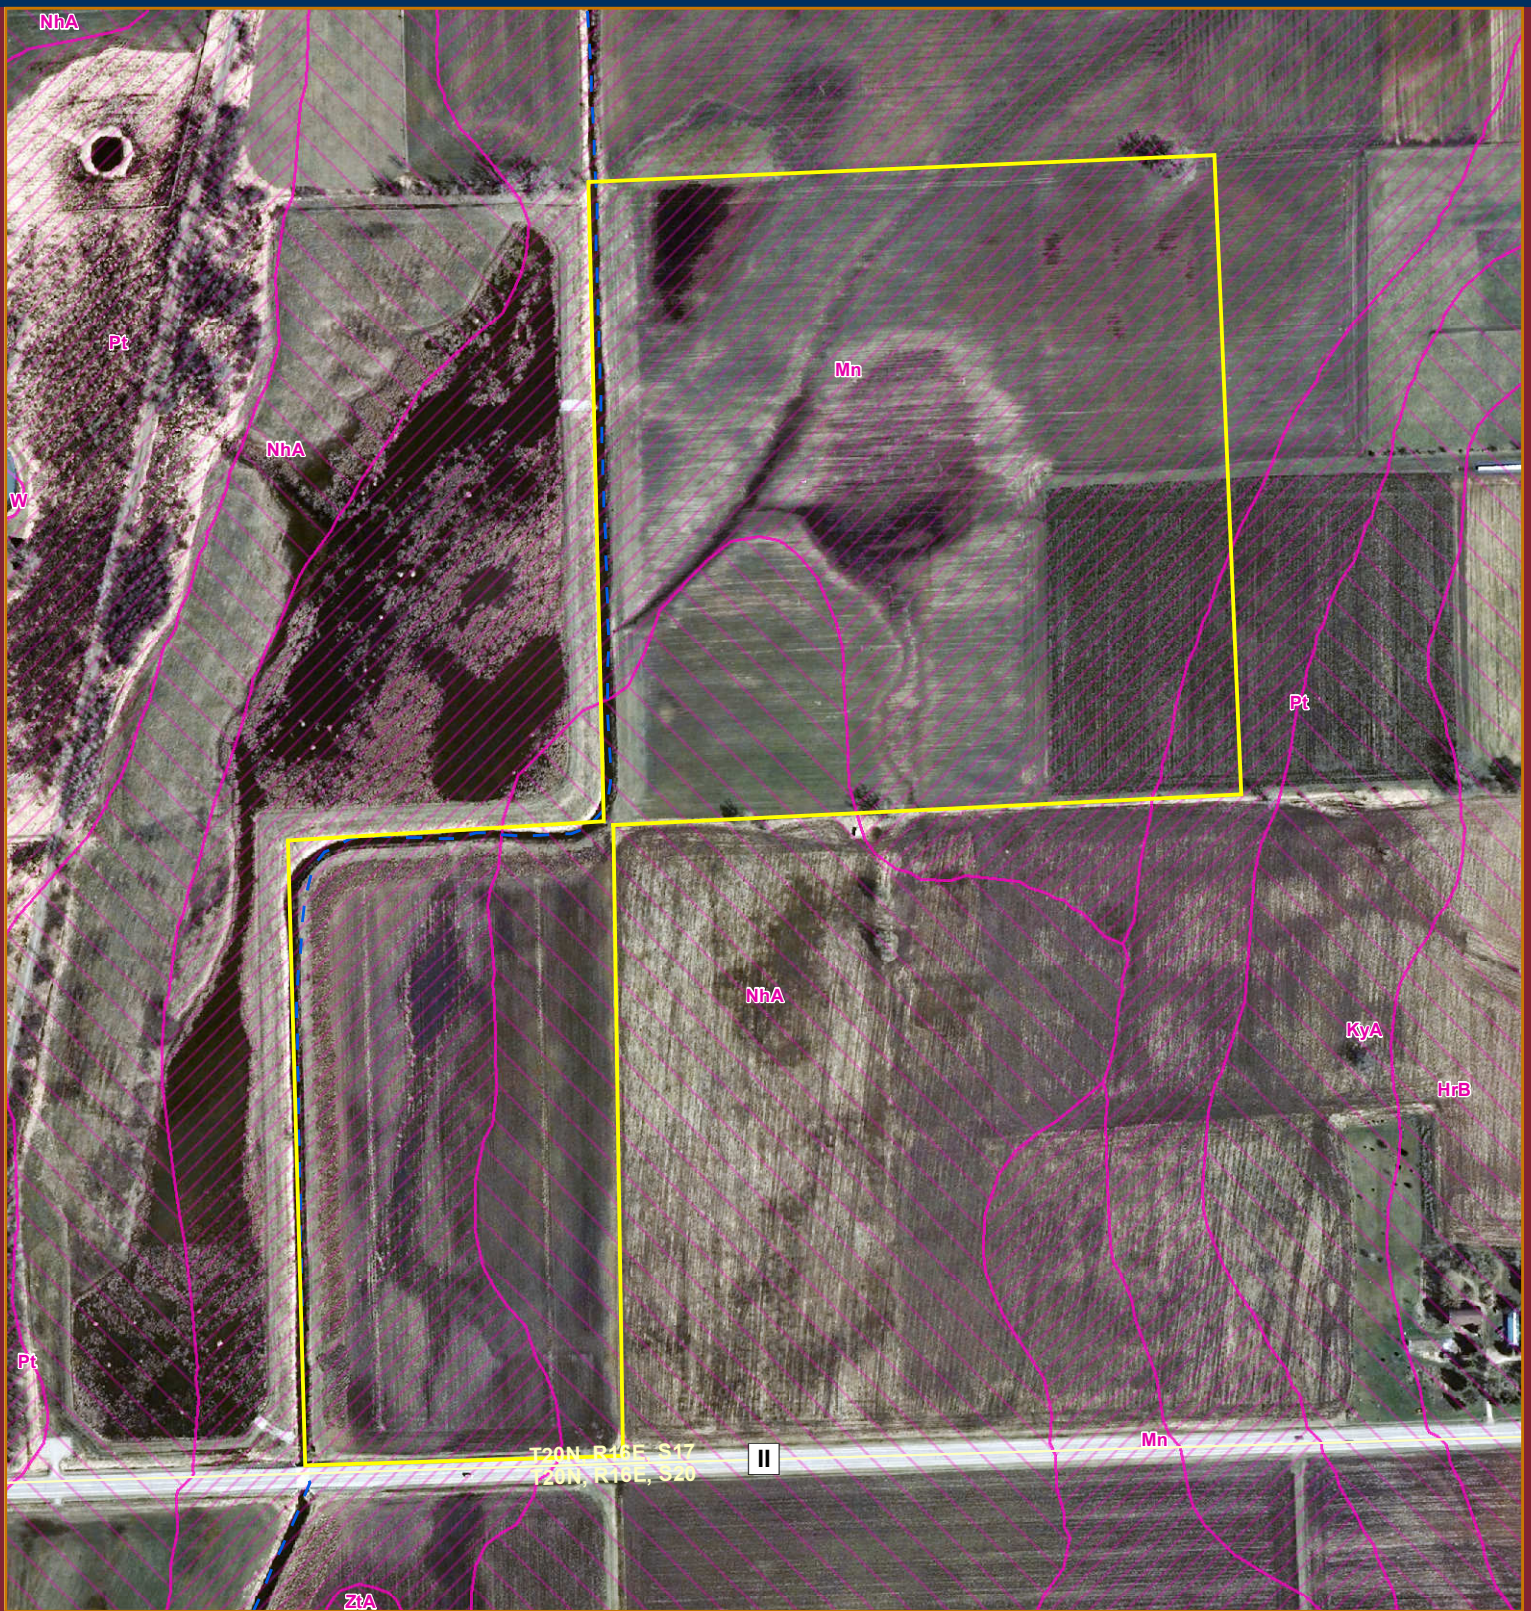
Figure 2. NRCS Soil Survey Data
Rubbert Phase II Mitigation Site Monitoring

Soils within the wetland are mostly mapped by the NRCS as Menasha clay loam (Figure 2). The soils observed at the sample points were not consistent with the Menasha series' characteristics. NRCS field indicators of hydric soil including F6 – Redox Dark Surface, F7 – Depleted Dark Surface, and TF2 – Red Parent Material were observed.

Soils within the wetland are mostly mapped by the NRCS as Menasha clay loam (Figure 2). The soils observed at the sample points were not consistent with the Menasha series' characteristics. NRCS field indicators of hydric soil including F6 – Redox Dark Surface and F7 – Depleted Dark Surface were observed.

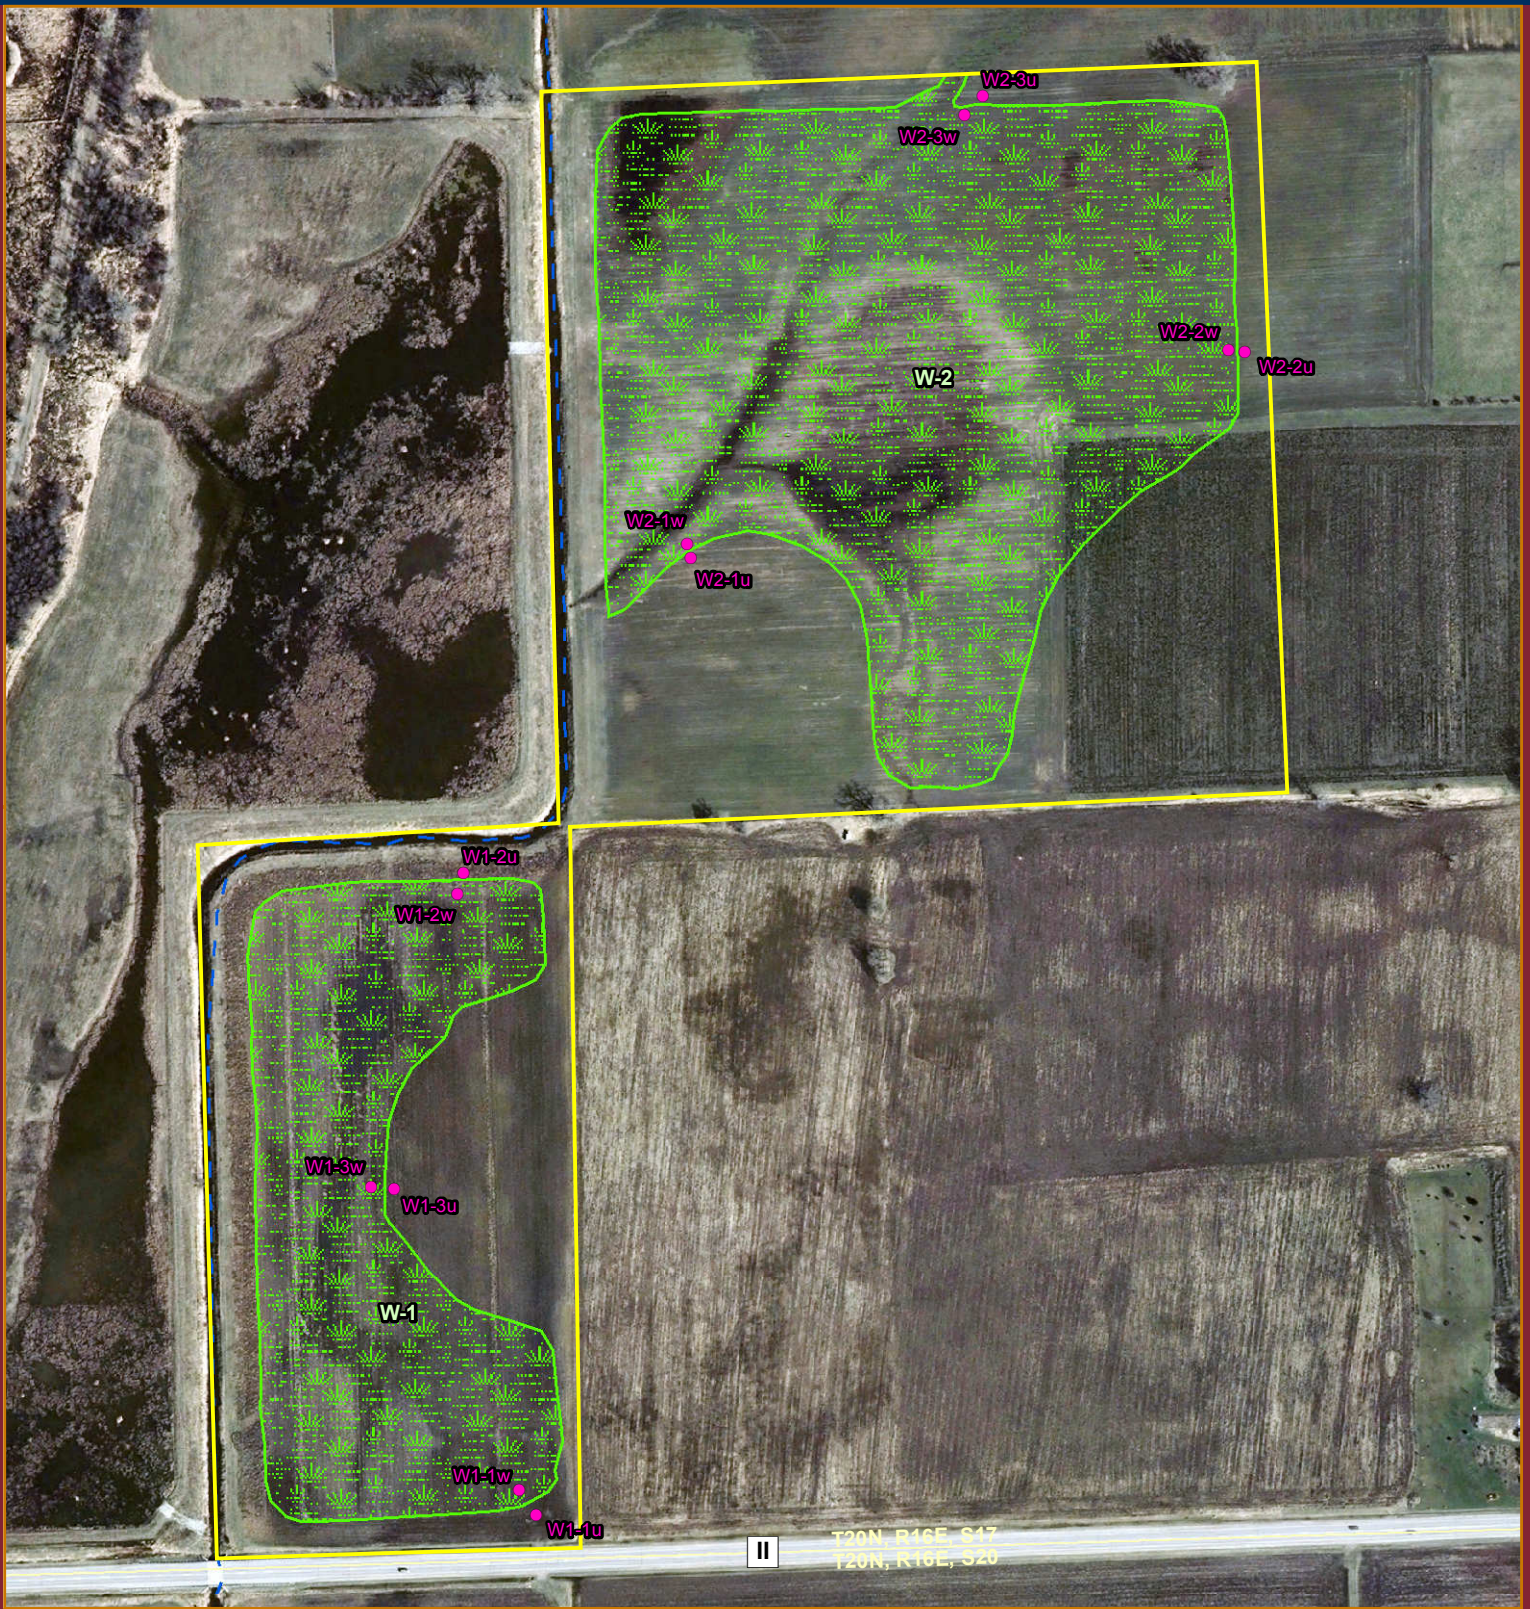
Figure 4. Field Delineated Wetland Data
Rubbert Phase II Mitigation Site Monitoring

Two wetlands (totaling 34.45 acres) were identified on the Project. Wetlands and their boundaries were surveyed and mapped. Three distinct plant communities were observed at the site: wet meadow (M), shallow marsh (SM), and upland buffer. Aggressive non-native species such as reed canary grass contribute less than 5 percent of the wetland area and purple loosestrife, black locust, buckthorns and honeysuckles were not observed. However, giant ragweed, common ragweed, sweet clover and quack grass are present throughout the site and management of these species may be required in order to meet the established vegetation success criteria.
