WETLAND DELINEATION REPORT

Rubbert Site

**RUBBERT WETLAND MITIGATION SITE
WisDOT PROJECT I.D. 6200-11-01
WINNEBAGO COUNTY, WISCONSIN**

December 21, 2012

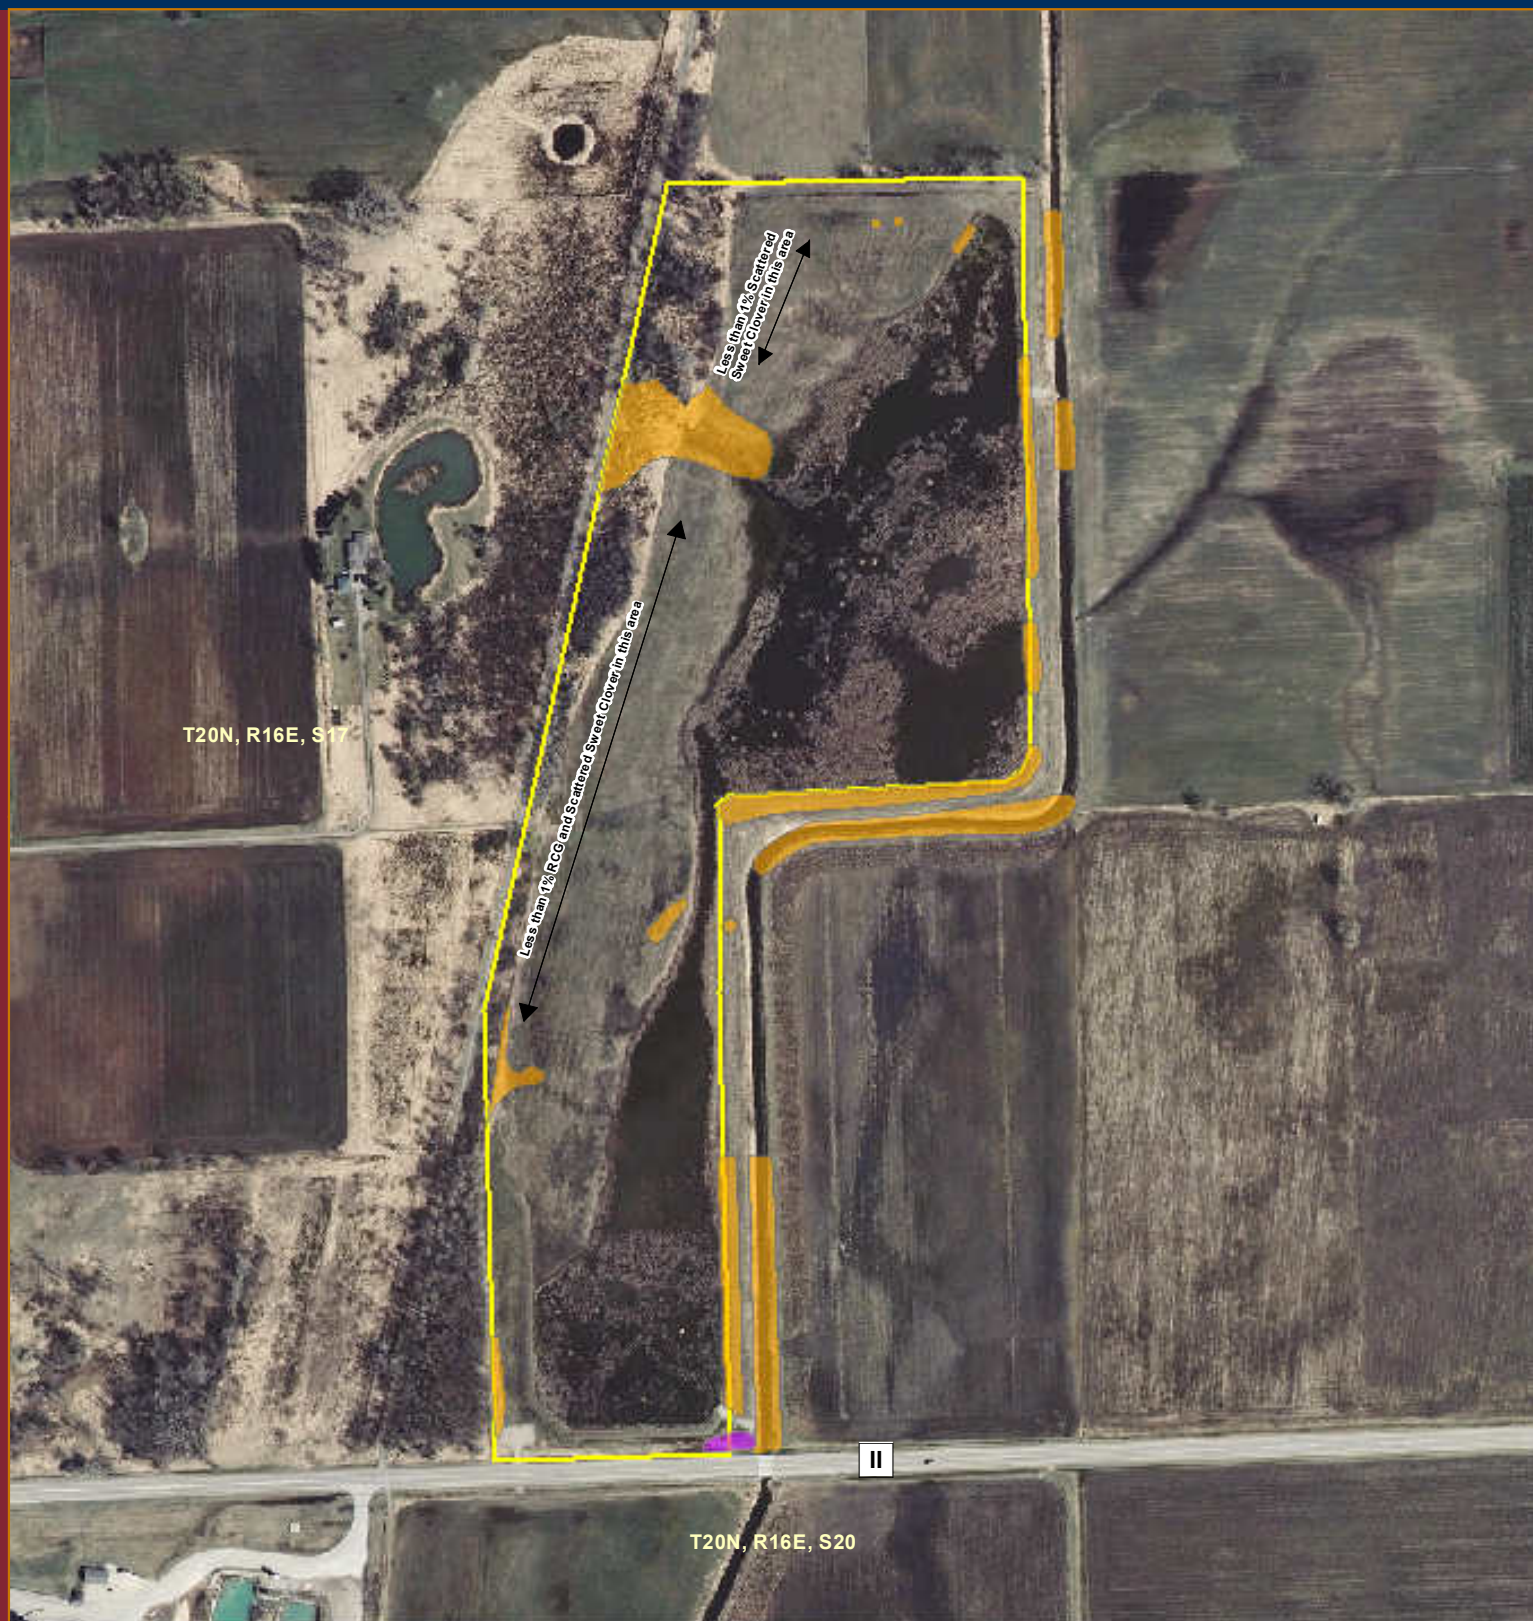
Figure 5. Invasive Species Data
WI DOT - Rubbert Site

Stantec conducted a reconnaissance of the Project to determine the presence and distribution of select non-native invasive plant species. Species targeted for evaluation included reed canary grass, purple loosestrife, and common reed grass. Results of the reconnaissance are illustrated on Figure 5 and briefly described below:

- A) Reed Canary Grass: This species was noted as scattered pockets throughout the wet meadow, shallow marsh and mesic prairie communities of the Project. Larger clones with an established localized areal coverage greater than 20 percent were located throughout the Project (Figure 5). Many of these areas had been treated with herbicide. Herbicide treatments to areas with greater than 30 percent areal coverage of reed canary grass are recommended to reduce the extent of this species within the Project. Adaptive management techniques, including a combination of mowing, herbicide treatments and re-seeding with native species, are recommended. Further monitoring is also recommended to ensure that new infestations do not occur within the Project.

- B) Purple Loosestrife: This species was not observed during the 2012 growing season.
- C) Common Reed Grass: This species was located in a dense clump along the ditch on the south portion of the project area adjacent to Winnebago County Trunk II (Figure 5). Herbicide

- D) Stantec also noted scattered clones of white sweet clover throughout the mesic prairie (Figure 5). This species can become invasive in upland areas. Eradication of this species is recommended.

treatments and continued monitoring is recommended to ensure this species does not expand its range within the project.
