REHABILITATION STRUCTURE SURVEY REPORT

IH 94 TO 40TH AVENUE (11 BRIDGES)

Inspection Report for B-18-182

USH 53 NB over HASTINGS WAY Jul 15,2015

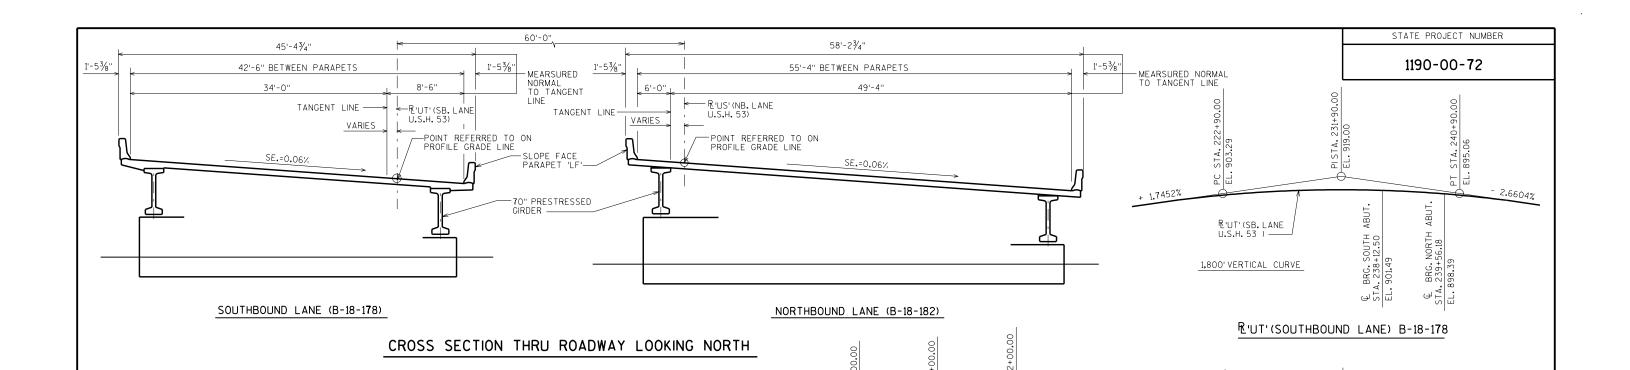
NO. DATE BY REVISION STATE OF WISCONSIN
DEPARTMENT OF TRANSPORTATION STRUCTURES DESIGN SECTION STRUCTURE B-18-182 JHG PLANS JPH SHEET 2 CROSS SECTION & QUANTITIES

PROFILE GRADE LINE R'RH' (NB. HASTINGS WAY)

R'US' (NORTHBOUND LANE) B-18-182

PROFILE GRADE LINE U.S.H. 53

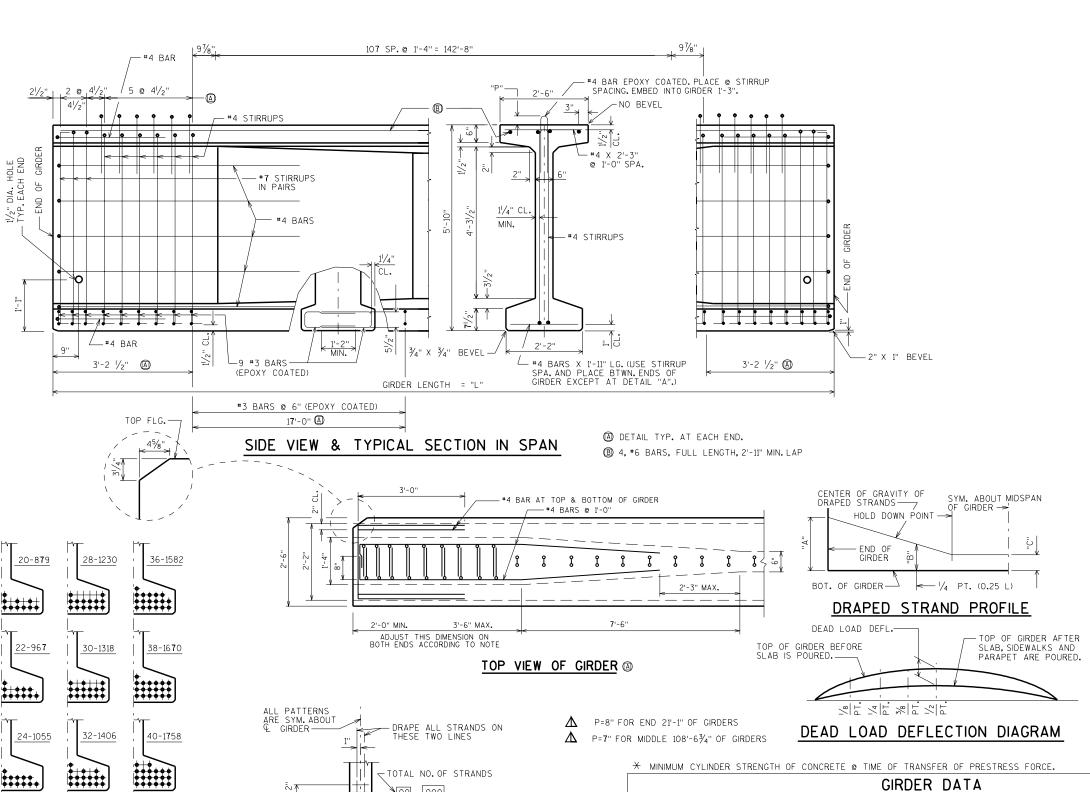
GIRDER DETAILS

SLAB HAUNCH DETAIL

- TOP OF DECK ELEV. AT FINAL GRADE TOP OF GIRDER ELEVATION
- + DEAD LOAD DEFLECTION
- SLAB THICKNESS
- = HAUNCH HEIGHT 'T

NOTE: AN AVERAGE HAUNCH ('T') OF 4" WAS USED IN THE QUANTITY "CONCRETE MASONRY BRIDGES".
