WETLAND DELINEATION REPORT

**STH 50 RECONSTRUCTION
(1300 FEET WEST OF 256th AVENUE TO
2000 FEET EAST OF 236th AVENUE)**

WisDOT ID: 1310-04-00

**Sections 1, 2, 3, 10, 11, and 12, T1N, R20E
VILLAGES OF PADDOCK LAKE AND
SALEM LAKES, KENOSHA COUNTY,
WISCONSIN**

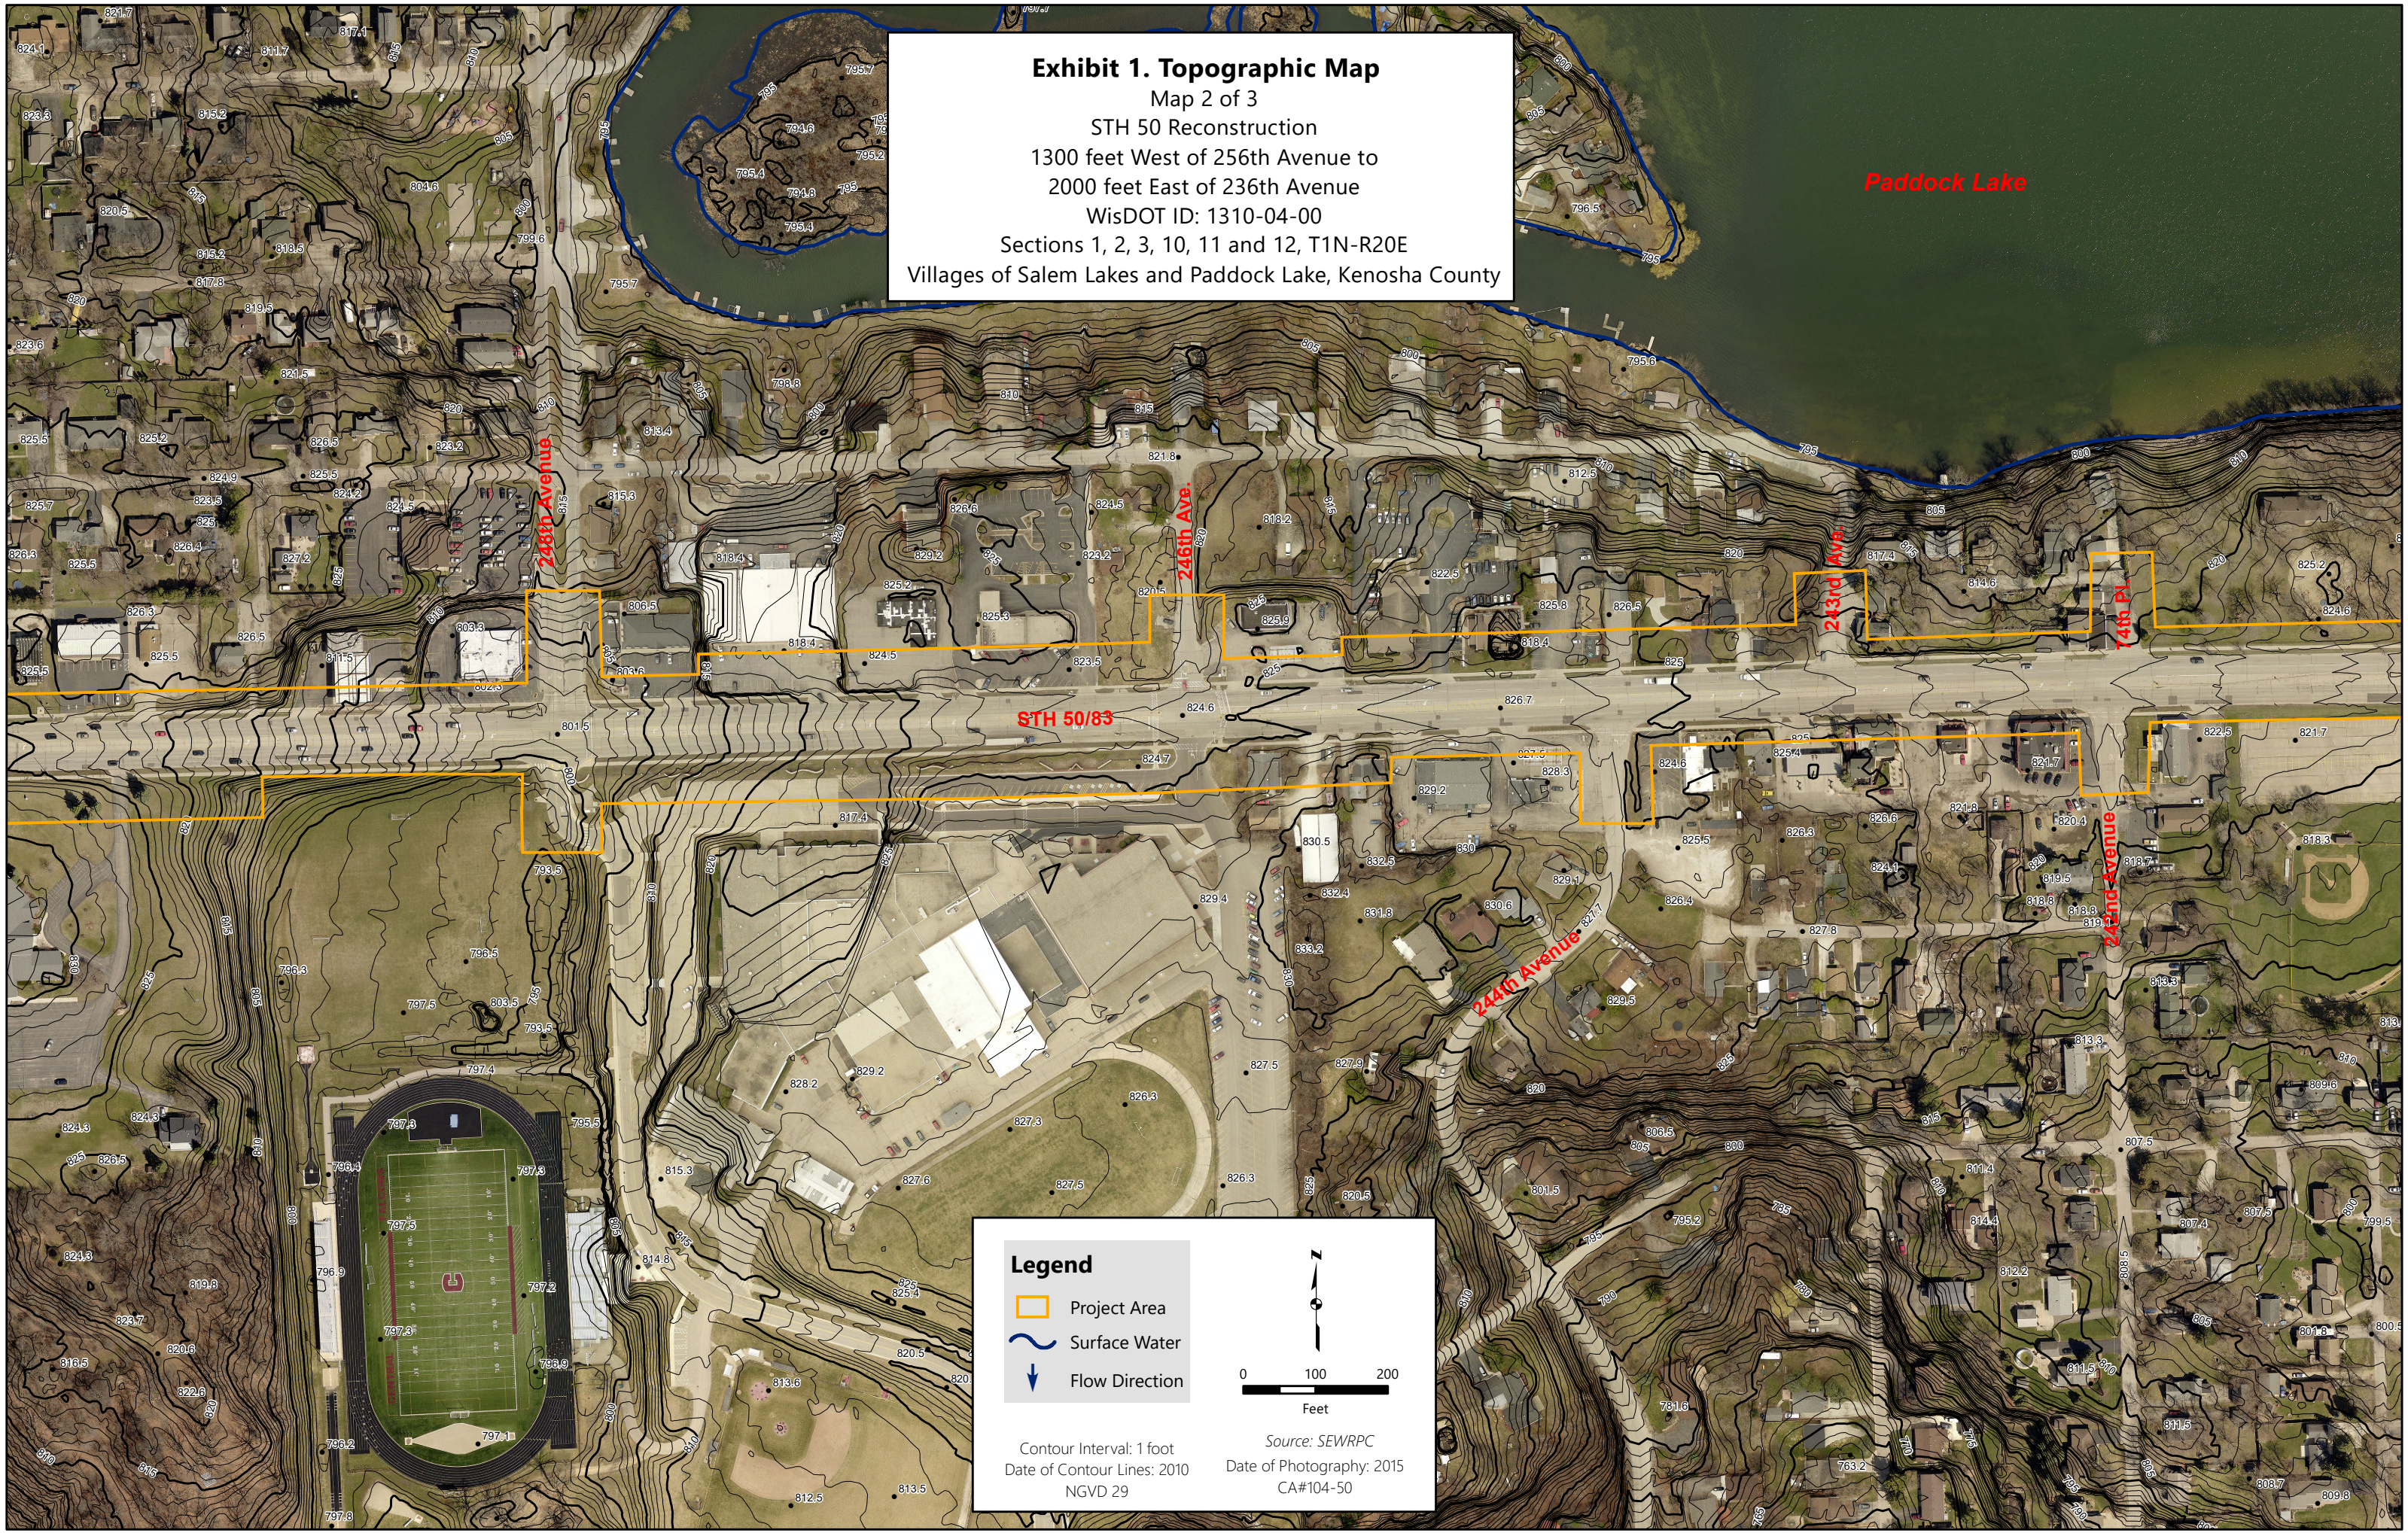
Exhibit 1. Topographic Map
Map 2 of 3
STH 50 Reconstruction
1300 feet West of 256th Avenue to
2000 feet East of 236th Avenue
WisDOT ID: 1310-04-00
Sections 1, 2, 3, 10, 11 and 12, T1N-R20E
Villages of Salem Lakes and Paddock Lake, Kenosha County

Contour Interval: 1 foot
Date of Contour Lines: 2010
NGVD 29

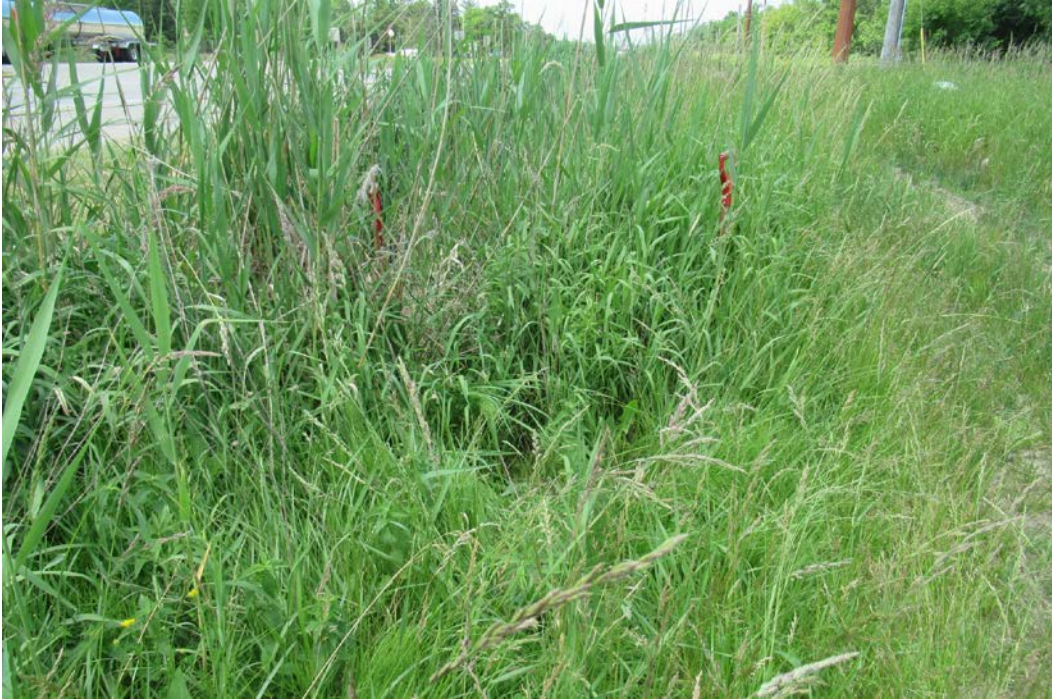
Photo 1. West view, upland sample site 1, old field (right shovel), and wetland sample site 2, PCA 1, degraded fresh (wet) meadow within a constructed roadside ditch (left shovel).

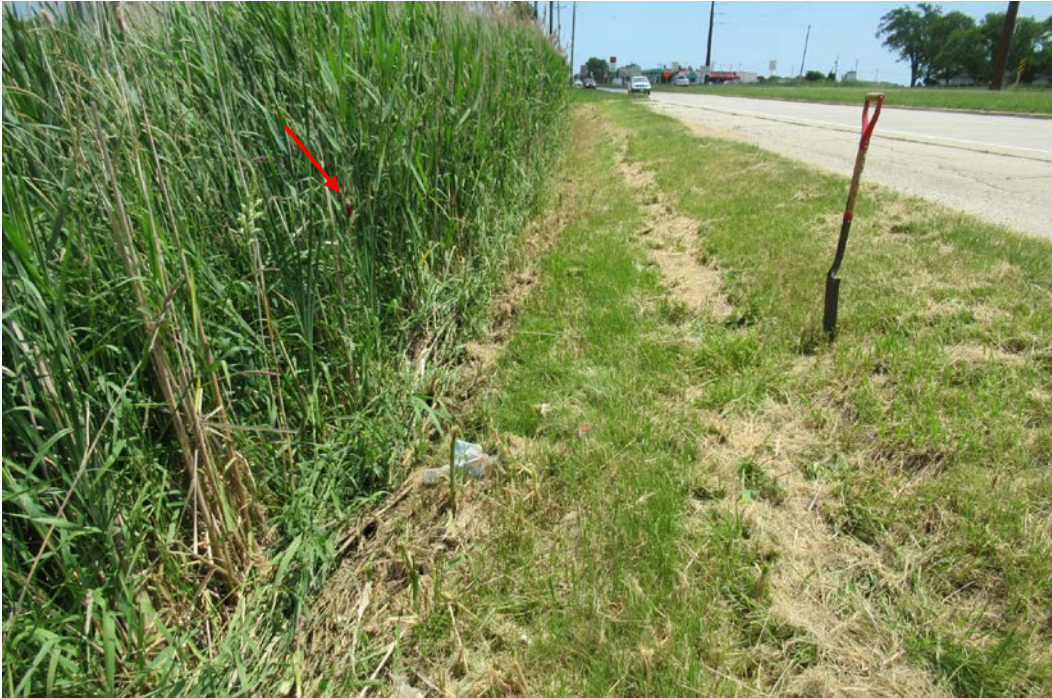
Photo 2. East view, wetland sample site 3, PCA 1, shallow marsh in a constructed roadside ditch (left shovel, as indicated by red arrow), and upland sample site 4, recently mowed old field (right shovel).

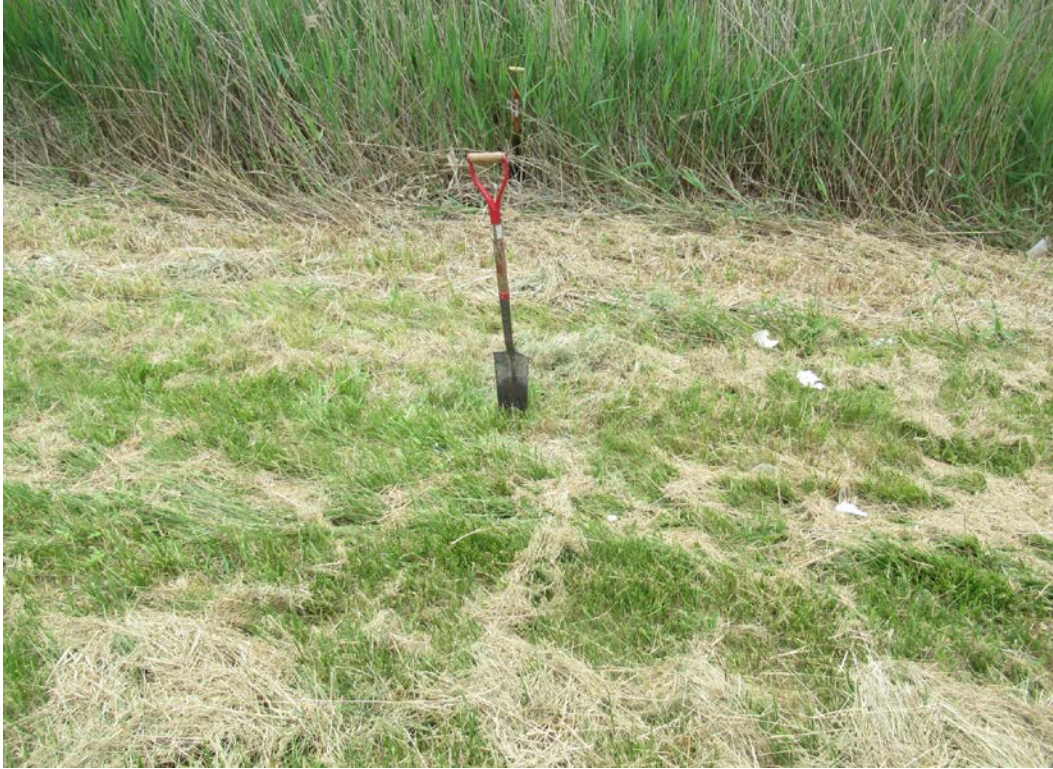
Photo 3. Upland sample site 5, mowed old field (front shovel), and wetland sample site 6, PCA 2, shallow marsh (rear shovel).

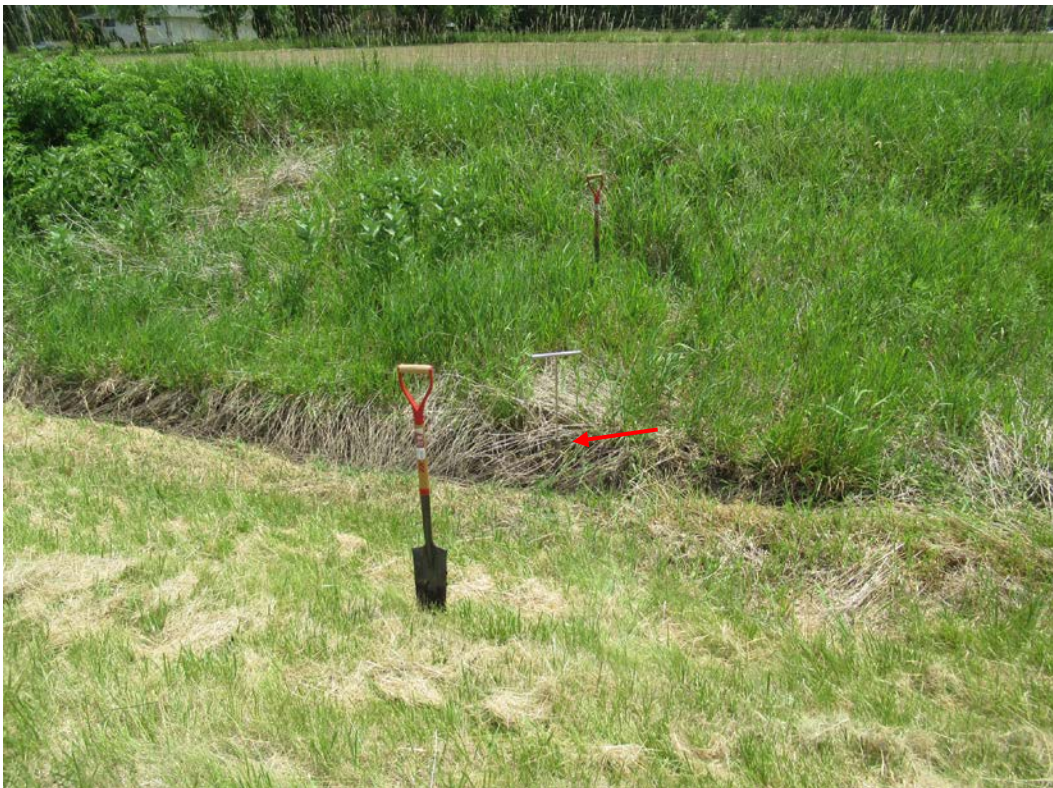
Photo 4. South view, upland sample sites 7, mowed old field, and 9, old field (front and rear shovels, respectively). Wetland sample site 8, PCA 2, degraded fresh (wet) meadow within a narrow, constructed ditch is at the soil probe in between, indicated with the red arrow.

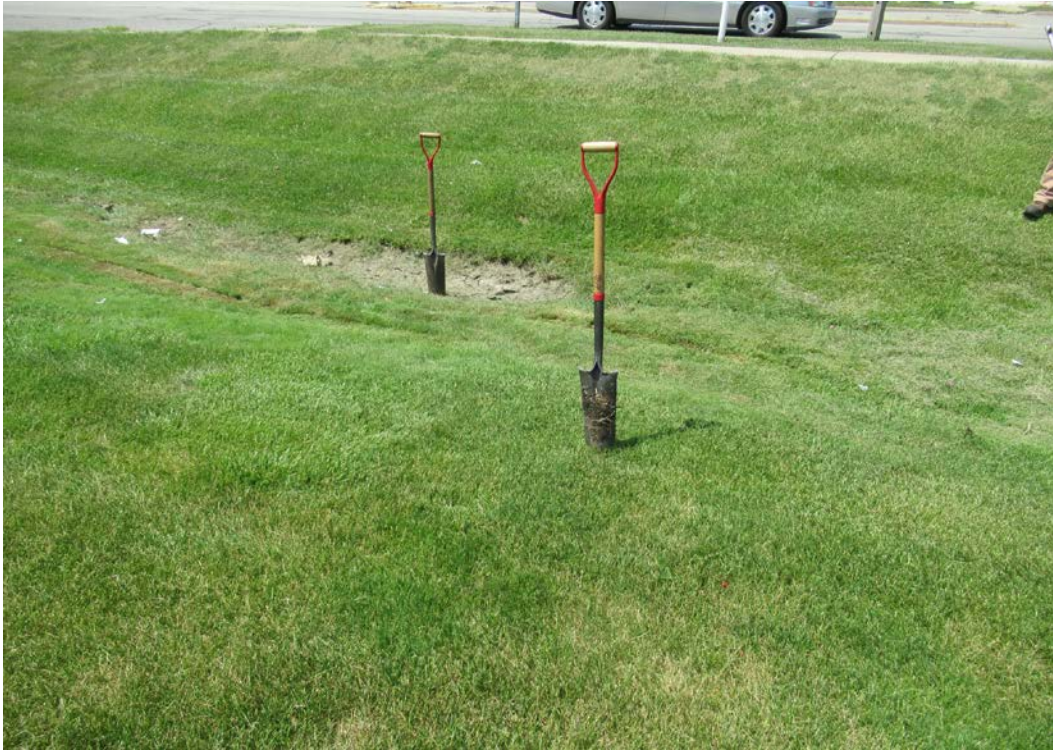
Photo 5. NW view, wetland sample site 10, PCA 3, atypical (mowed) wetland in a constructed roadside ditch (rear shovel), and upland sample site 11, mowed lawn (front shovel).

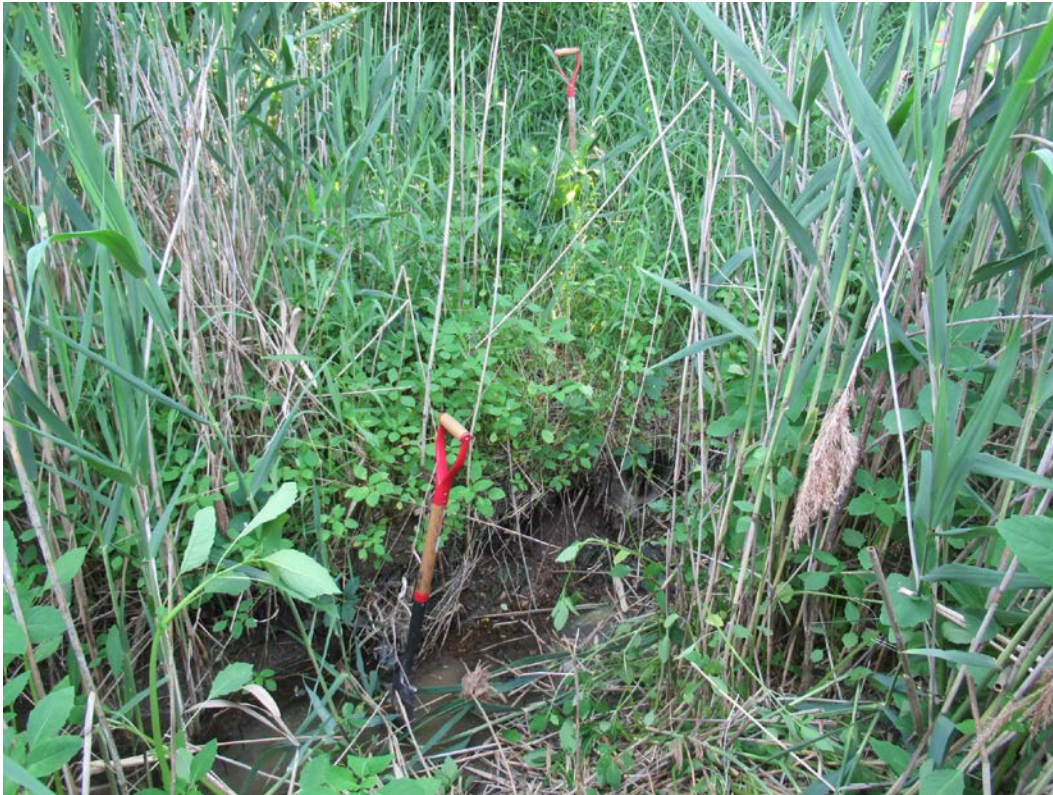
Photo 6. Wetland sample site 12, PCA 4, fresh (wet) meadow along a drainageway channel (front), and upland sample site 13, undifferentiated hardwoods (rear). Sample sites are just "downstream" of the steep rip-rapped drainageway, shown below in Photos 20 and 21.

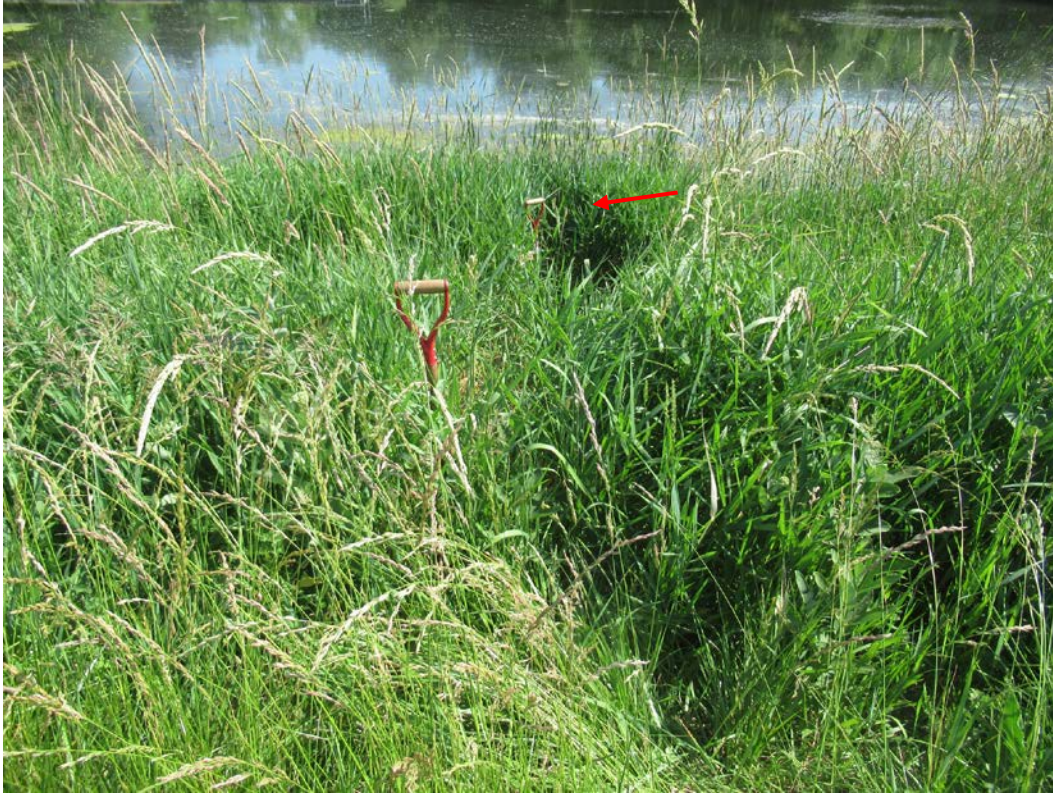
Photo 7. South view, upland sample site 14, old field (front shovel), and wetland sample site 15, PCA 5, degraded fresh (wet) meadow along the edge of a constructed pond (rear shovel, indicated by red arrow).

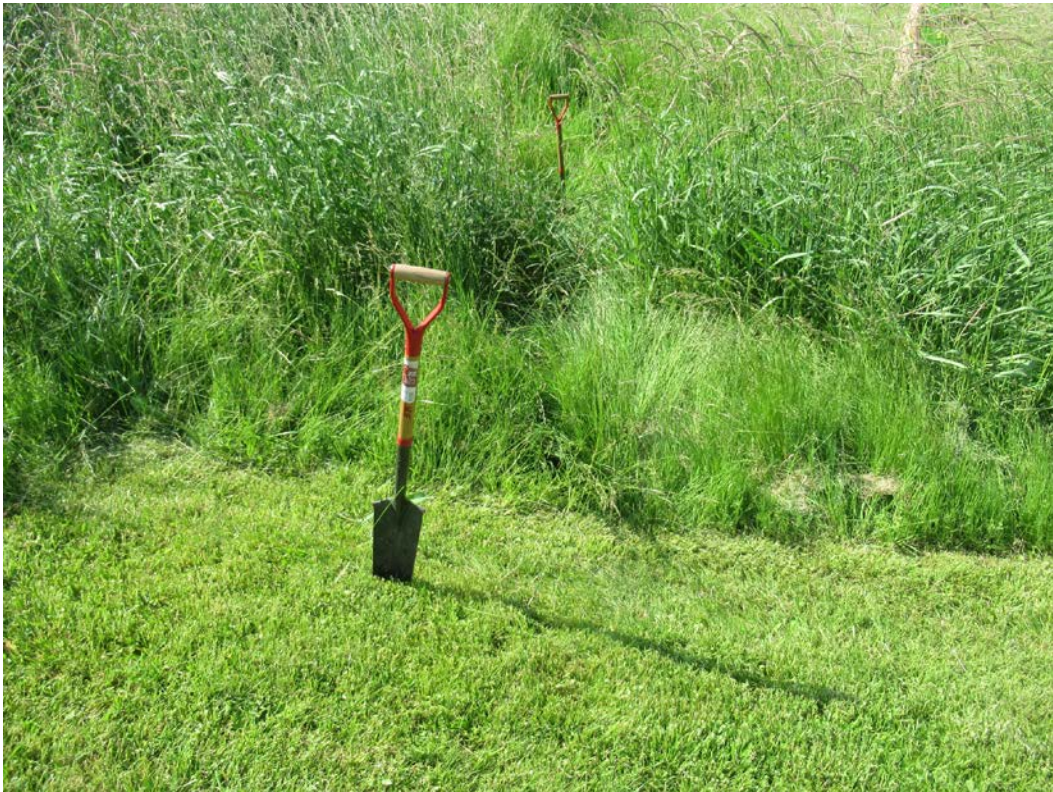
Photo 8. North view, wetland sample site 16, PCA 6, degraded fresh (wet) meadow associated with a drainageway connected to Paddock Lake (rear), and upland sample site 17, mowed lawn (front).

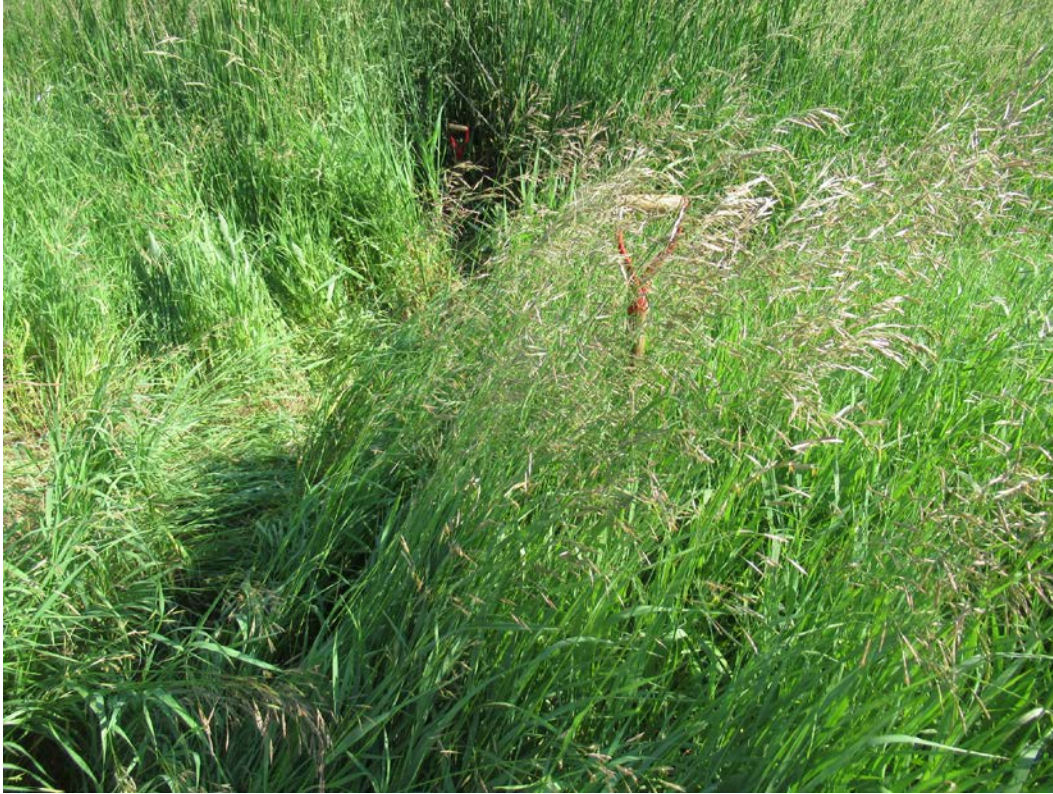
Photo 9. South view, upland sample site 18, old field (front), and wetland sample site 19, PCA 7, shallow marsh and degraded fresh (wet) meadow (rear). A storm sewer culvert discharges in between these sample sites.

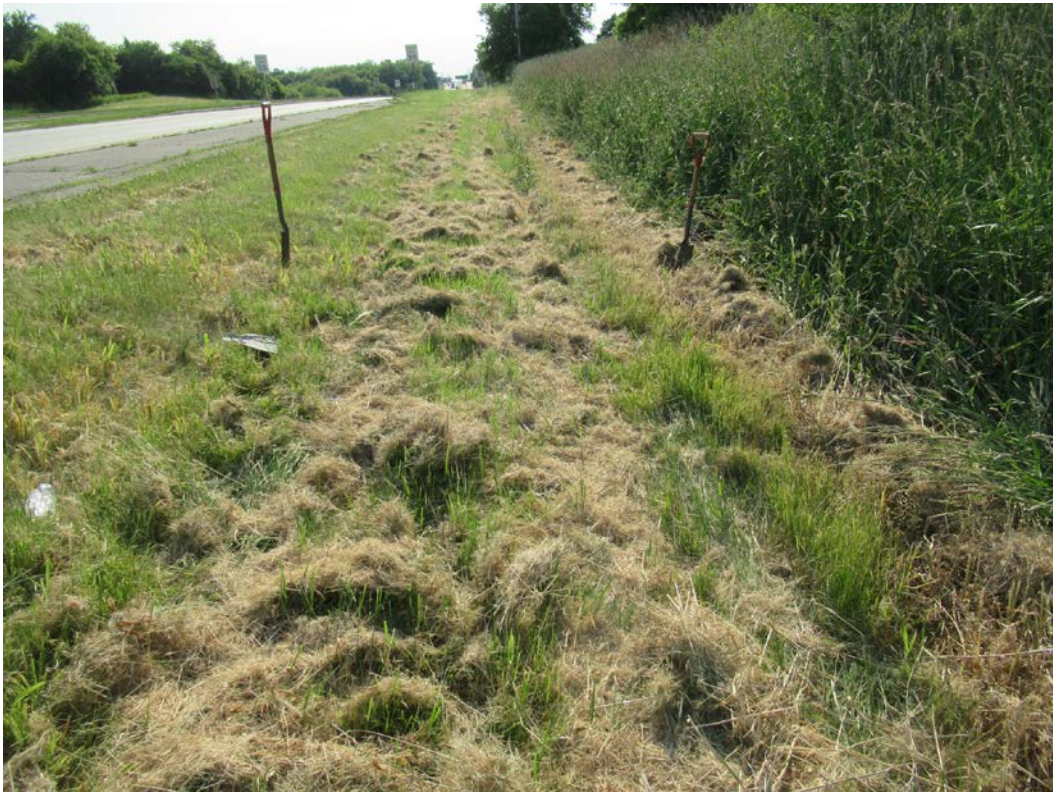
Photo 10. West view, wetland sample site 20, PCA 8, degraded fresh (wet) meadow in a constructed roadside ditch (right), and upland sample site 21, mowed old field (left).

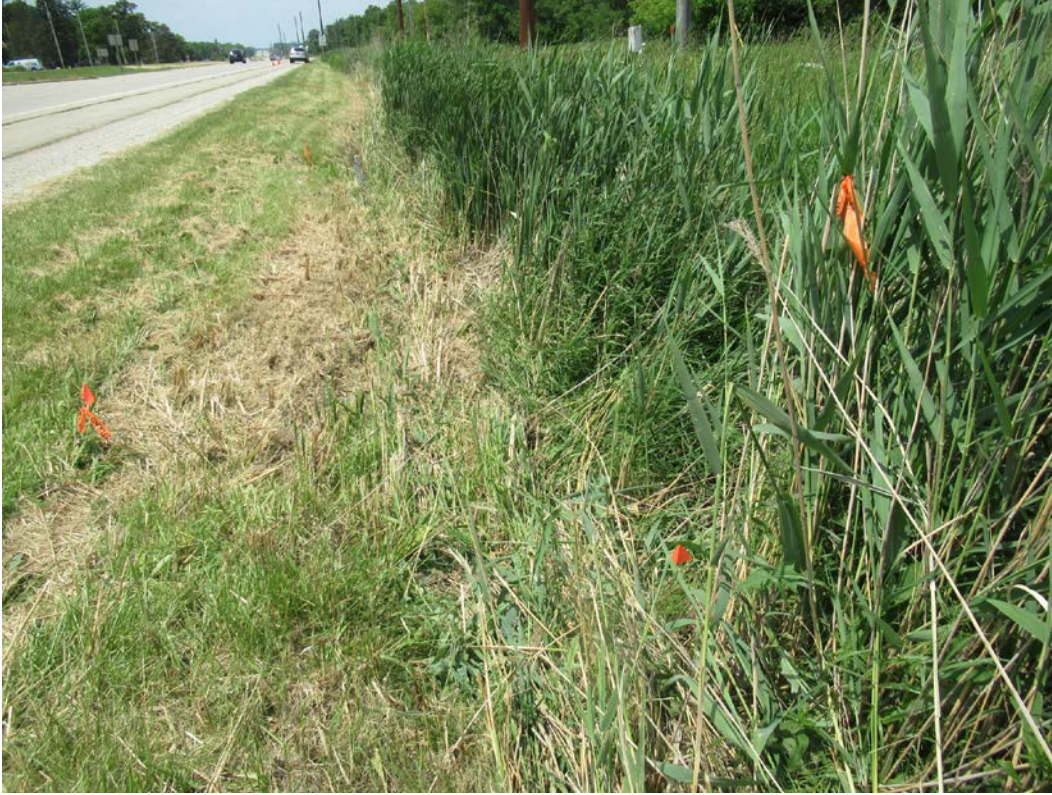
Photo 11. West view, north side of STH 50 – staked wet ditch, PCA 1, partially mowed.

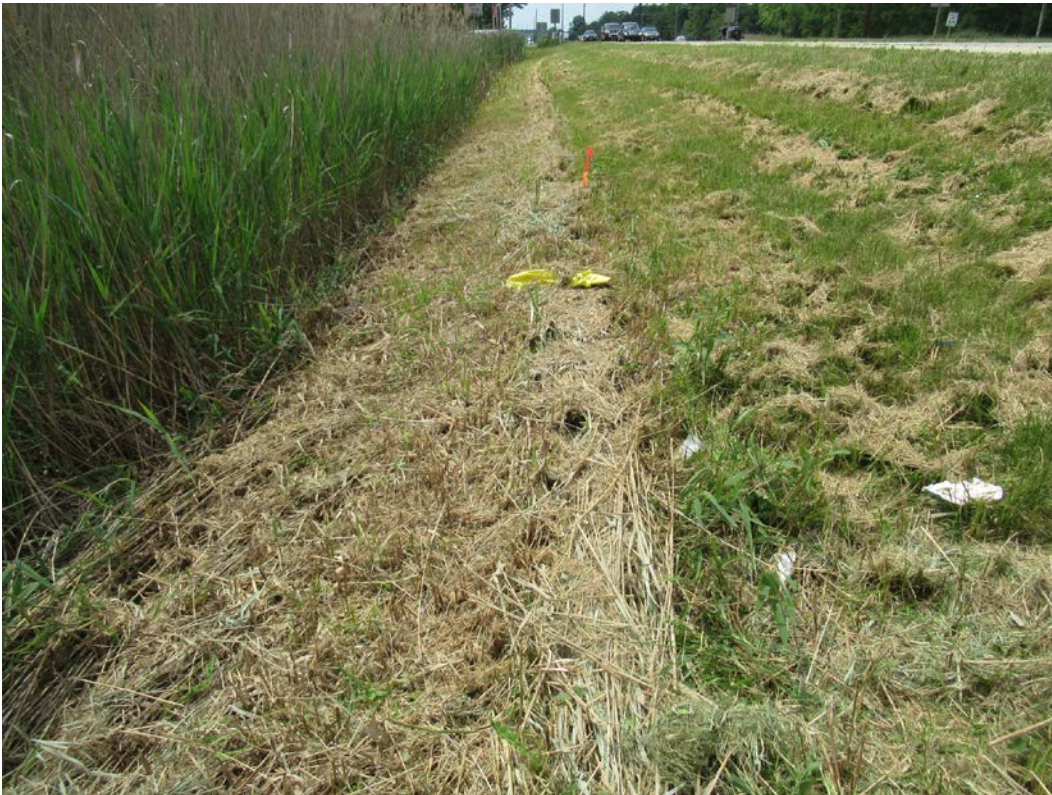
Photo 12. West view, staked wetland, PCA 2, including sample site 6. Image shows mowed fresh (wet) meadow with shallow marsh starting at the toe of the roadway embankment.

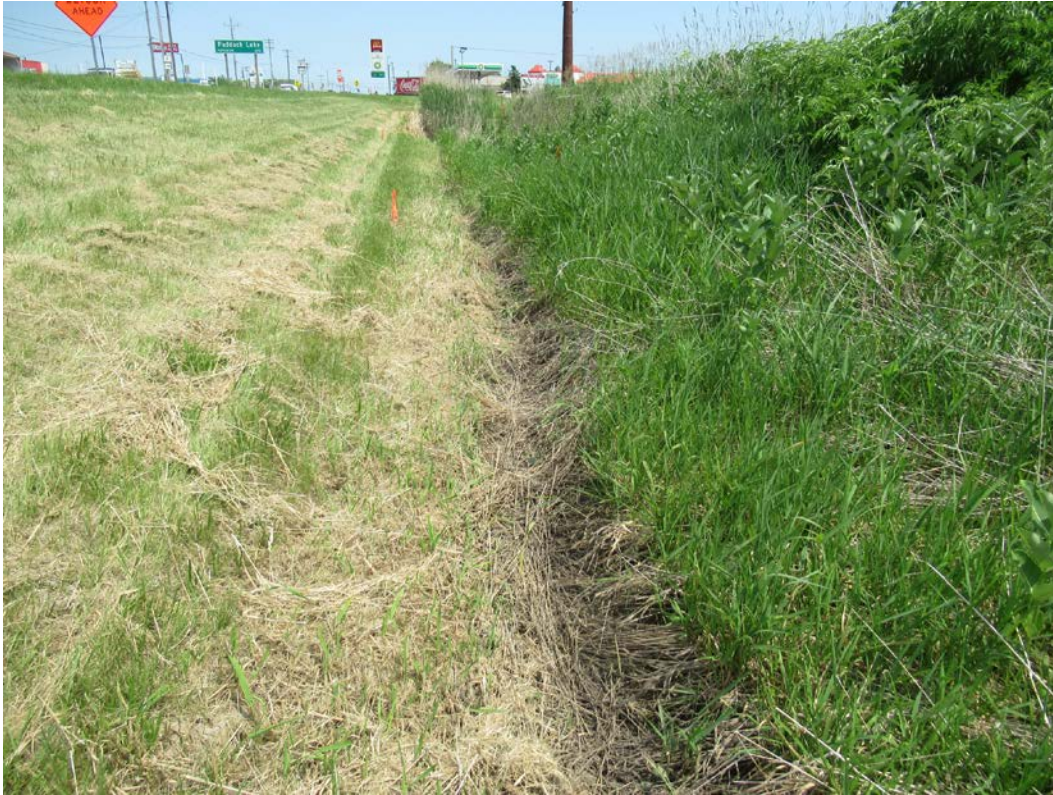
Photo 13. East view, staked narrow wet ditch portion of PCA 2, near sample site 8.

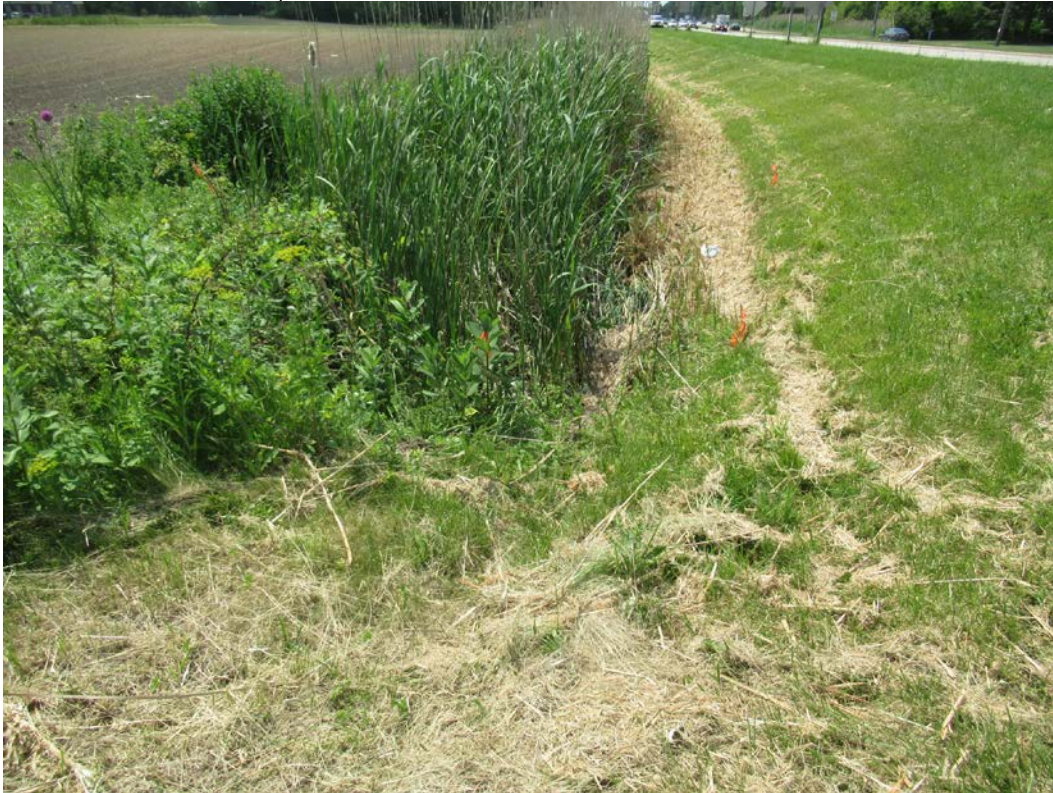
Photo 14. East view, staked portion of wetland PCA 2, at the SW corner of STH 50 and 256th Avenue.

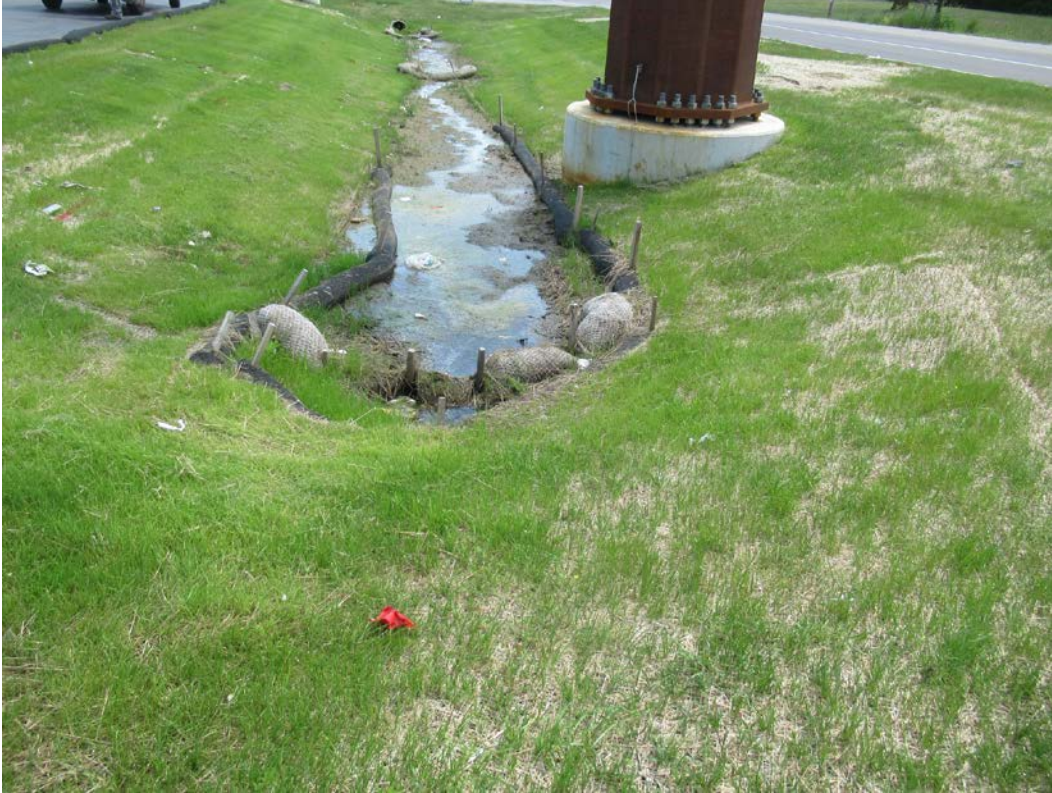
Photo 15. South view of a constructed wet ditch, PCA 3, near the SE corner of STH 50 and 256th Avenue.

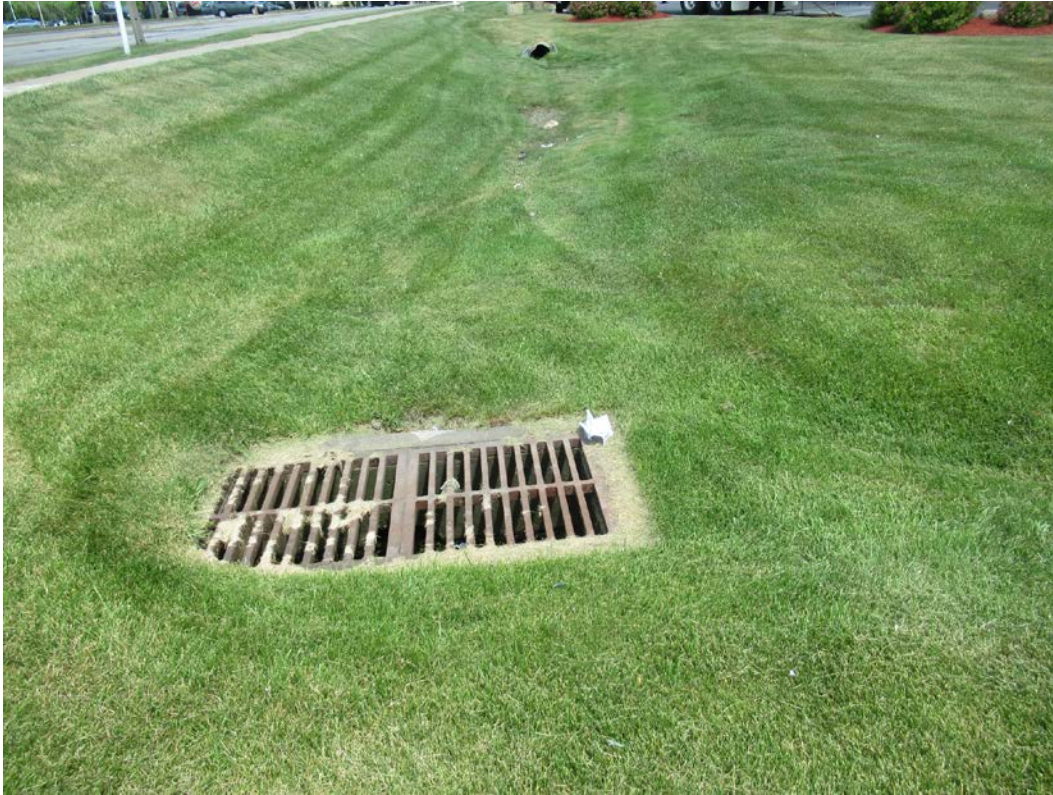
Photo 17. East view with storm sewer inlet at the SE corner of STH 50 and 256th Avenue.

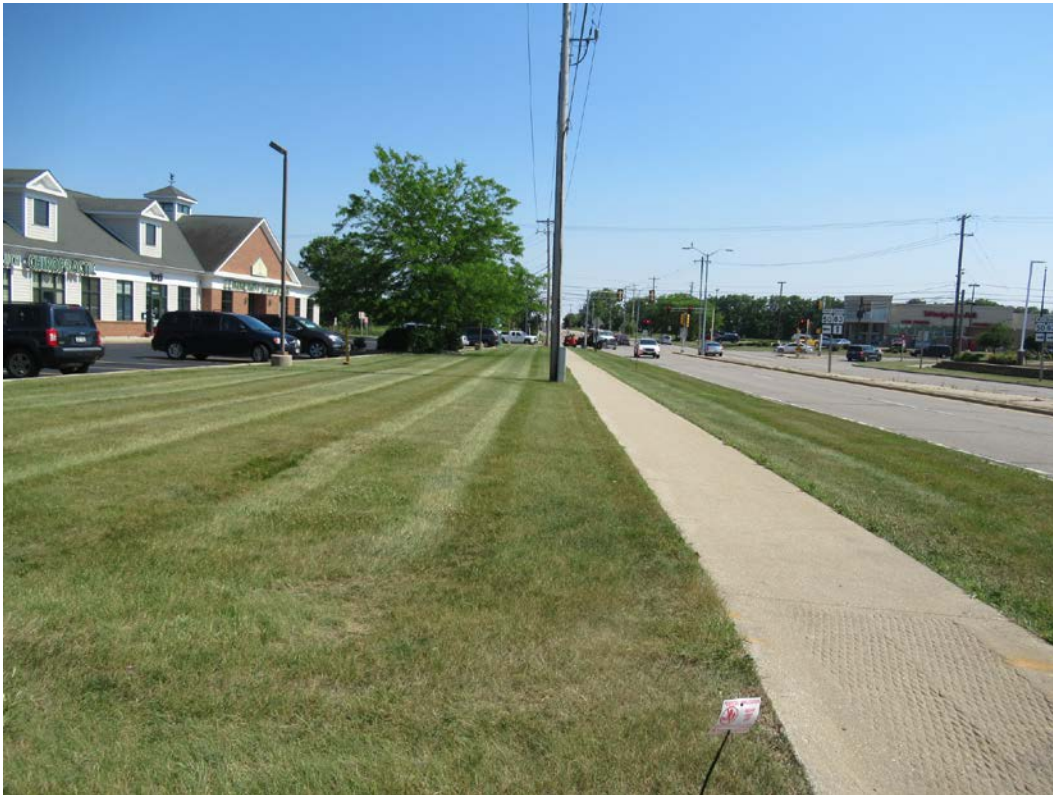
Photo 19. East view of a dry drainageway that starts near the NE corner of STH 50 and STH 75/83. The "receiving" WWI-mapped E1Hx wetland in the background lies just outside the project area.

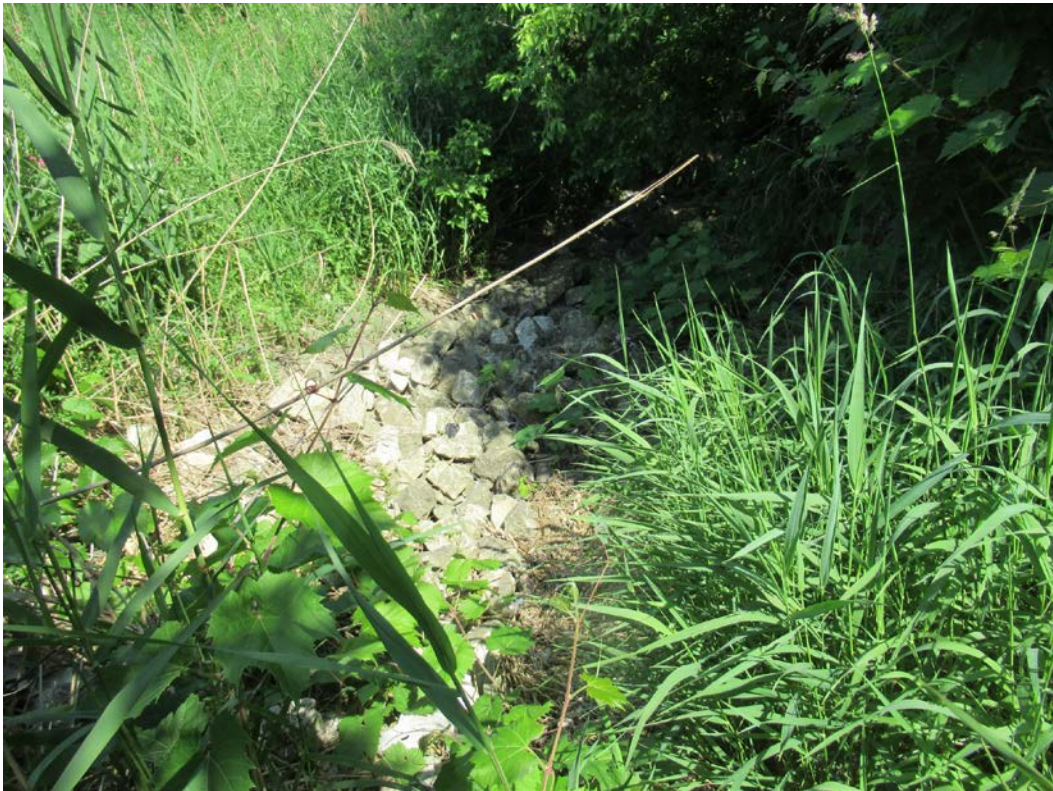
Photo 20. East view, top of steep rip-rap-lined channel near the SE corner of STH 50 and STH 75/83.

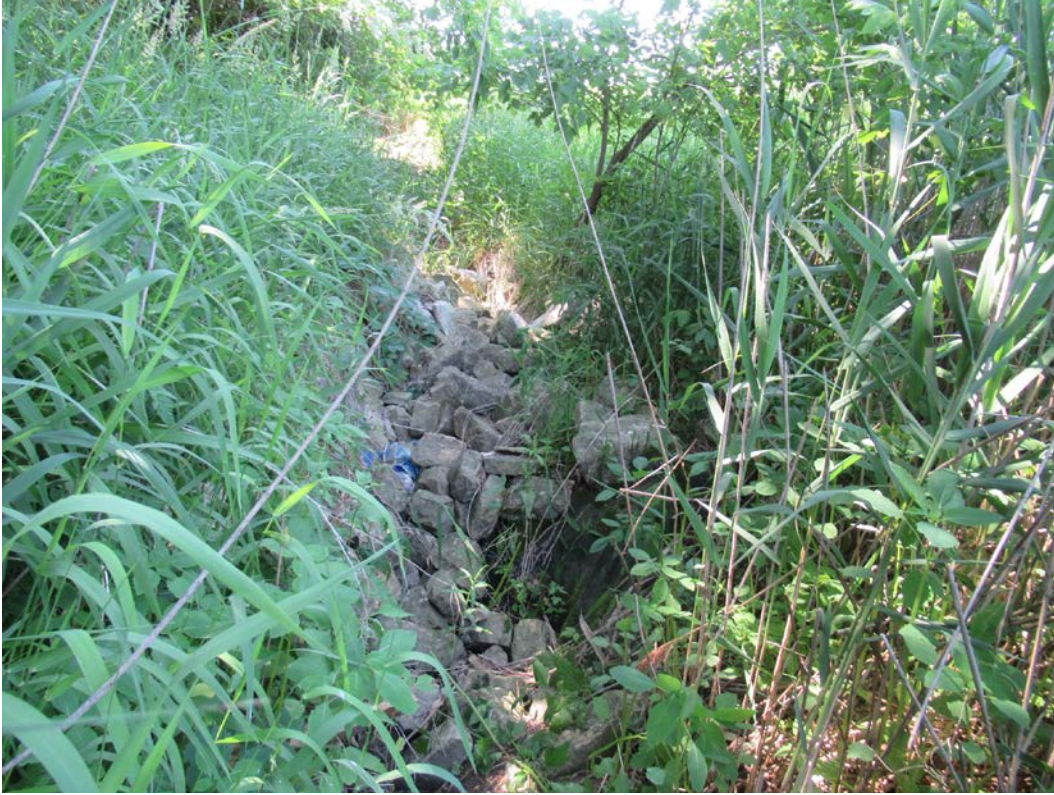
Photo 21. West/upstream view of steep rip-rap-lined drainageway channel near sample site 12, PCA 4.

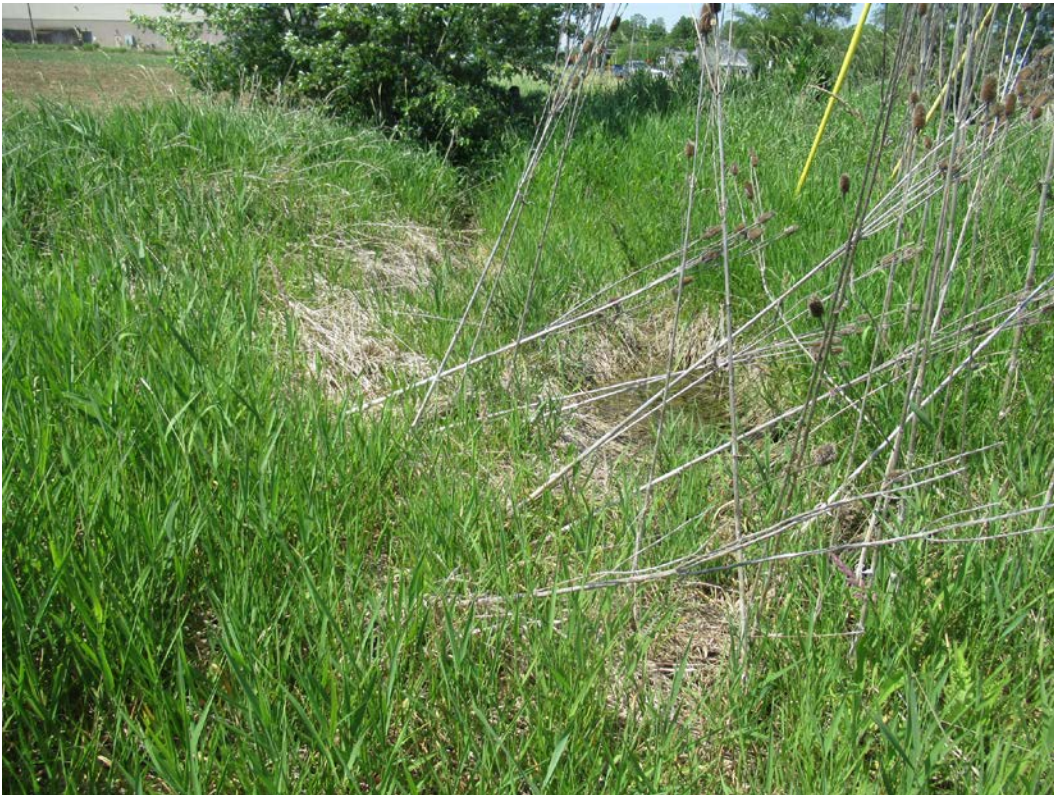
Photo 22. NW view of a dry ditch along the west side of STH 75/83 at the south end of the project area.

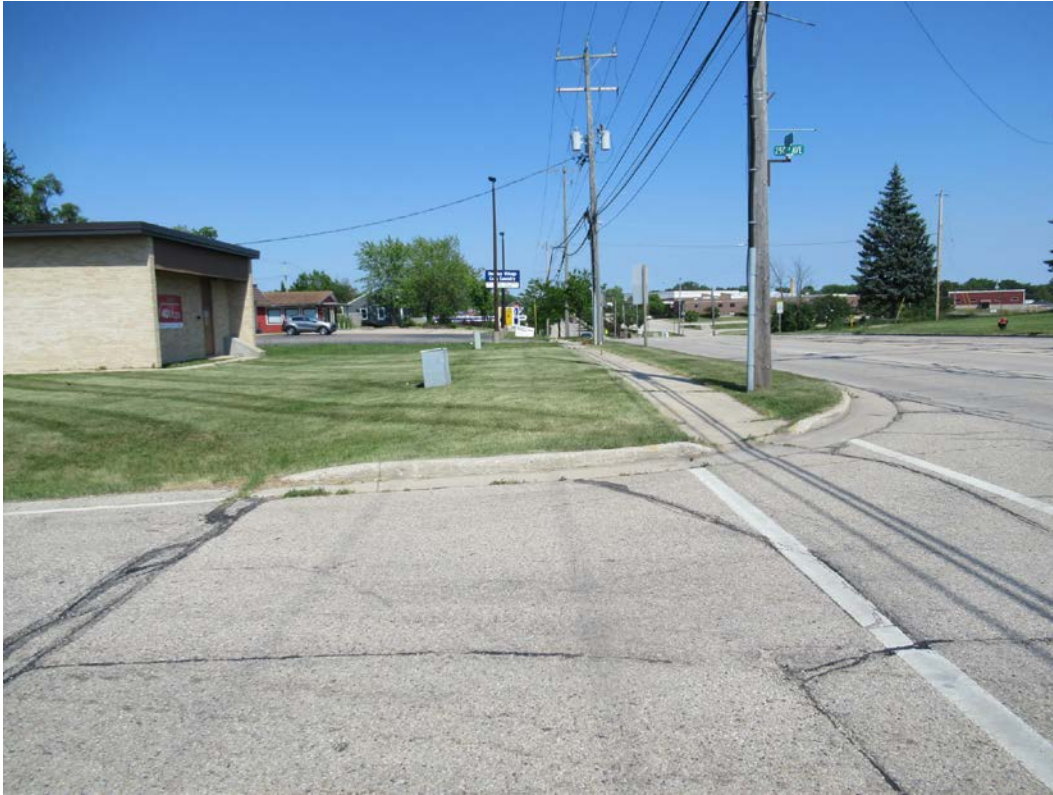
Photo 24. South view of school entry opposite 248th Avenue. The mapped depression on the right is well-drained via storm sewer.

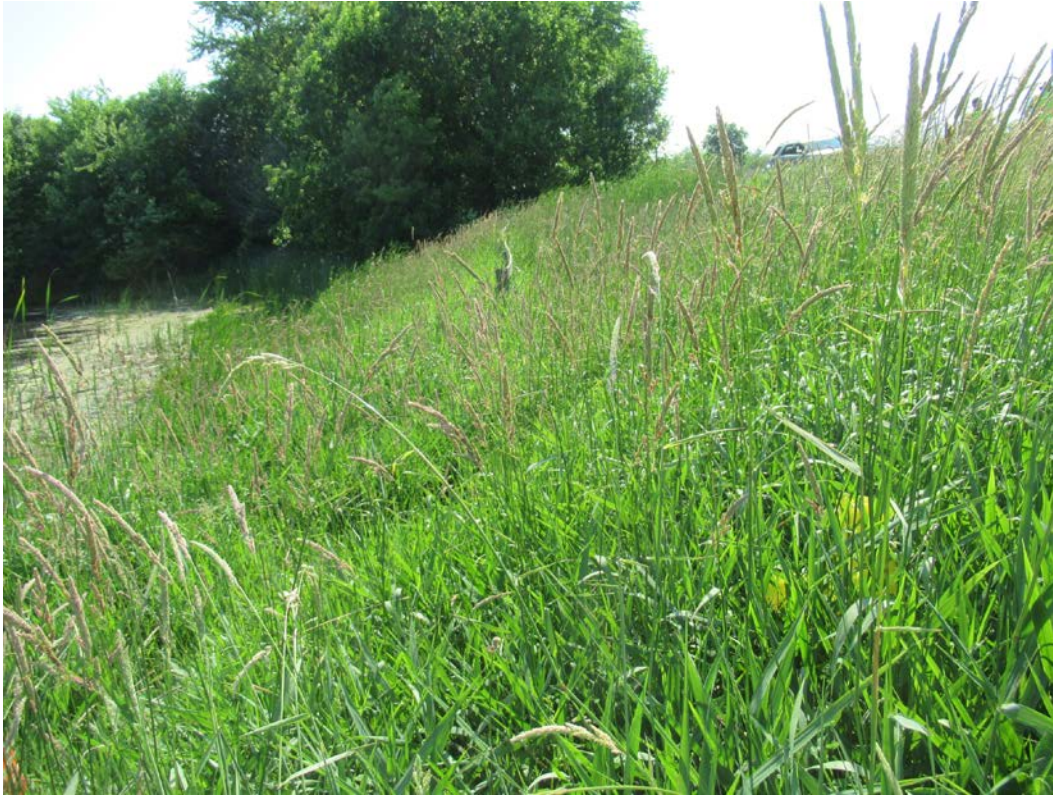
Photo 25. West view, wetland PCA 5, including sample site 15. Note the substantial rise in elevation between the pond and STH 50 in the upper right.
