WETLAND DELINEATION REPORT

**STH 50 RECONSTRUCTION
(1300 FEET WEST OF 256th AVENUE TO
2000 FEET EAST OF 236th AVENUE)**

WisDOT ID: 1310-04-00

**Sections 1, 2, 3, 10, 11, and 12, T1N, R20E
VILLAGES OF PADDOCK LAKE AND
SALEM LAKES, KENOSHA COUNTY,
WISCONSIN**

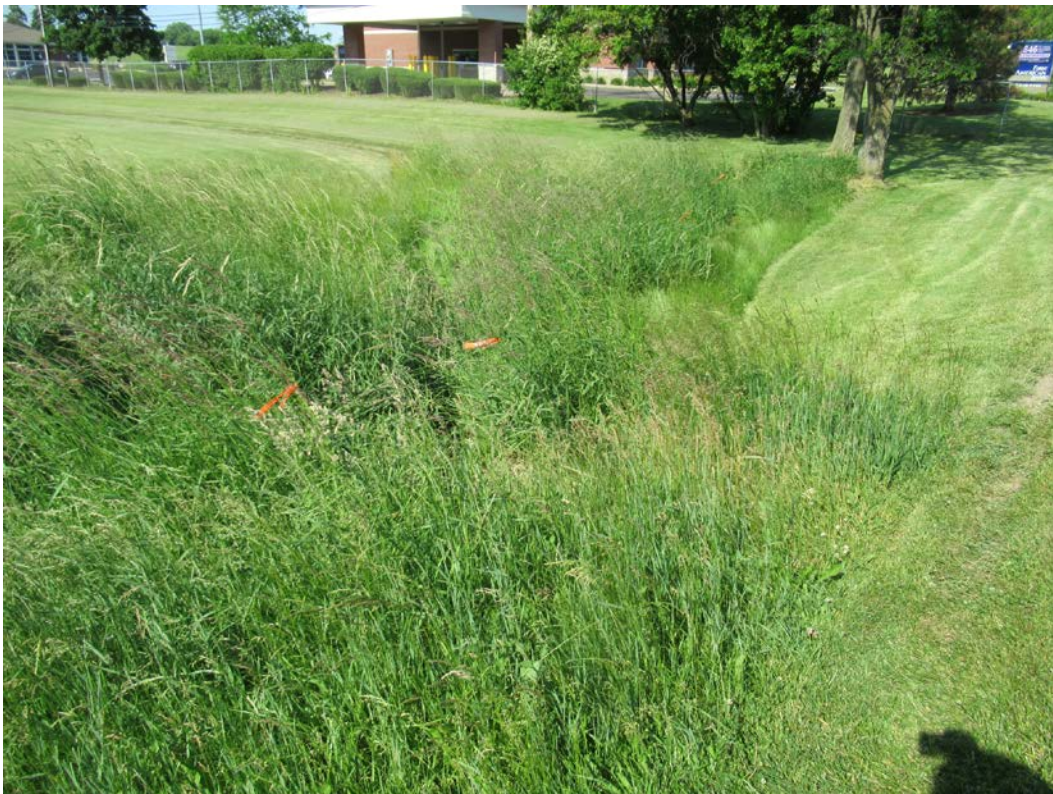
Photo 26. NE view of staked wetland, PCA 6, including sample site 16. The drainageway in the background connects to Paddock Lake. The photo was taken near the culvert that flows underneath STH 50

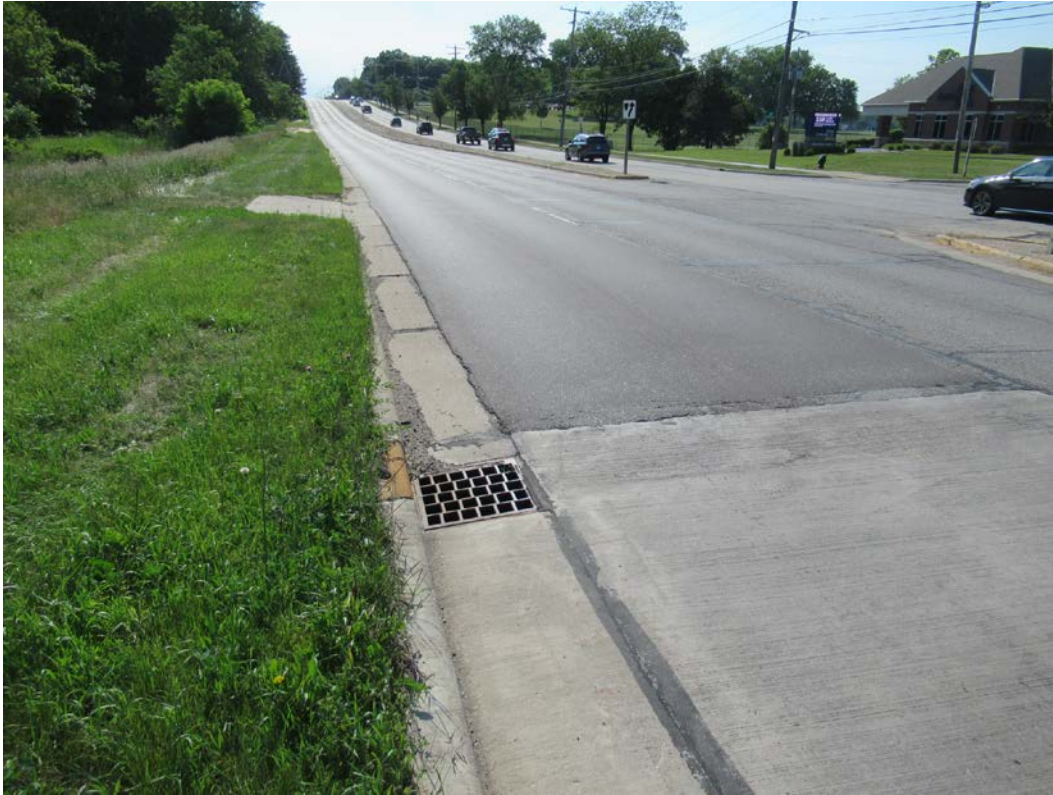
Photo 27. West view, south side of STH 50, with storm sewer inlet near sample sites 18 and 19.

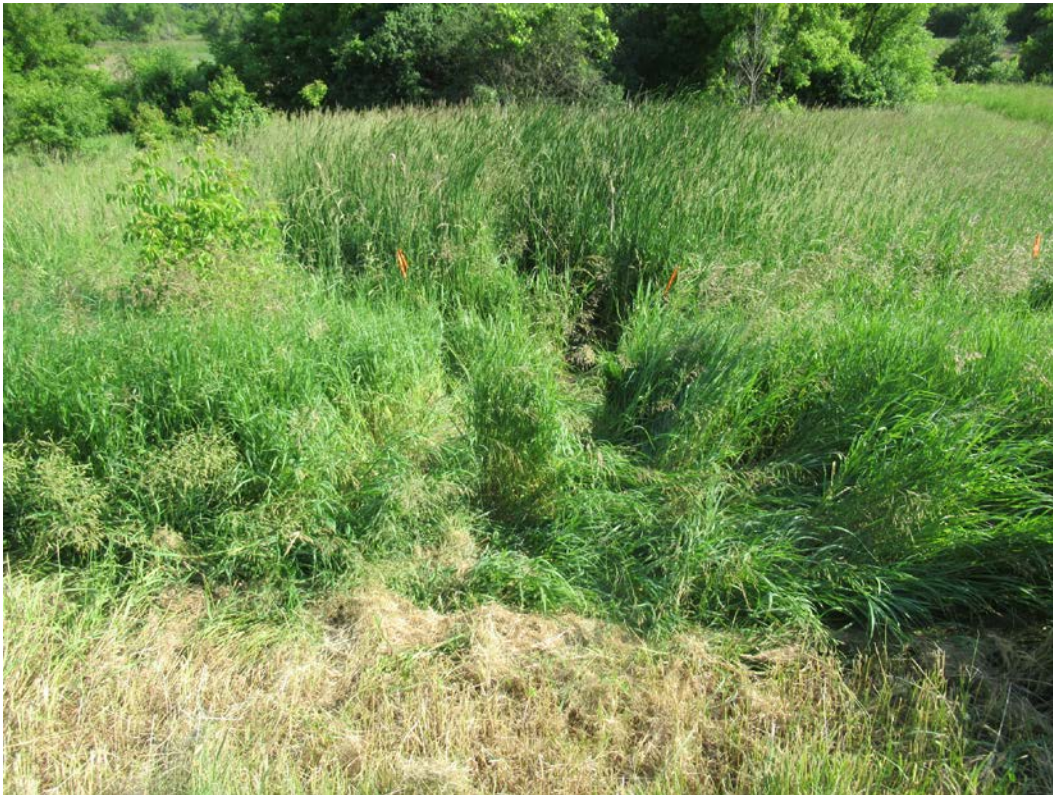
Photo 28. South view toward staked wetland, PCA 7, including sample site 19.

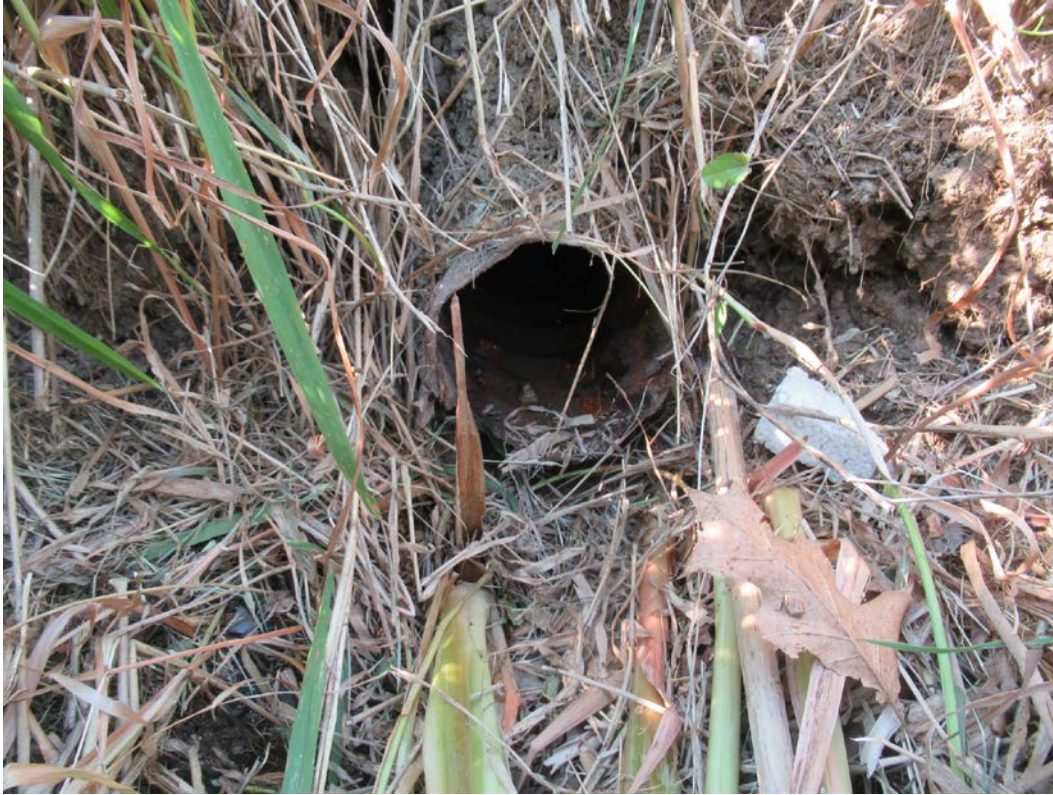
Photo 29. Smaller storm sewer discharge about 525 feet east of sample site 19. The beginning of a small drainageway wetland was staked at this location.

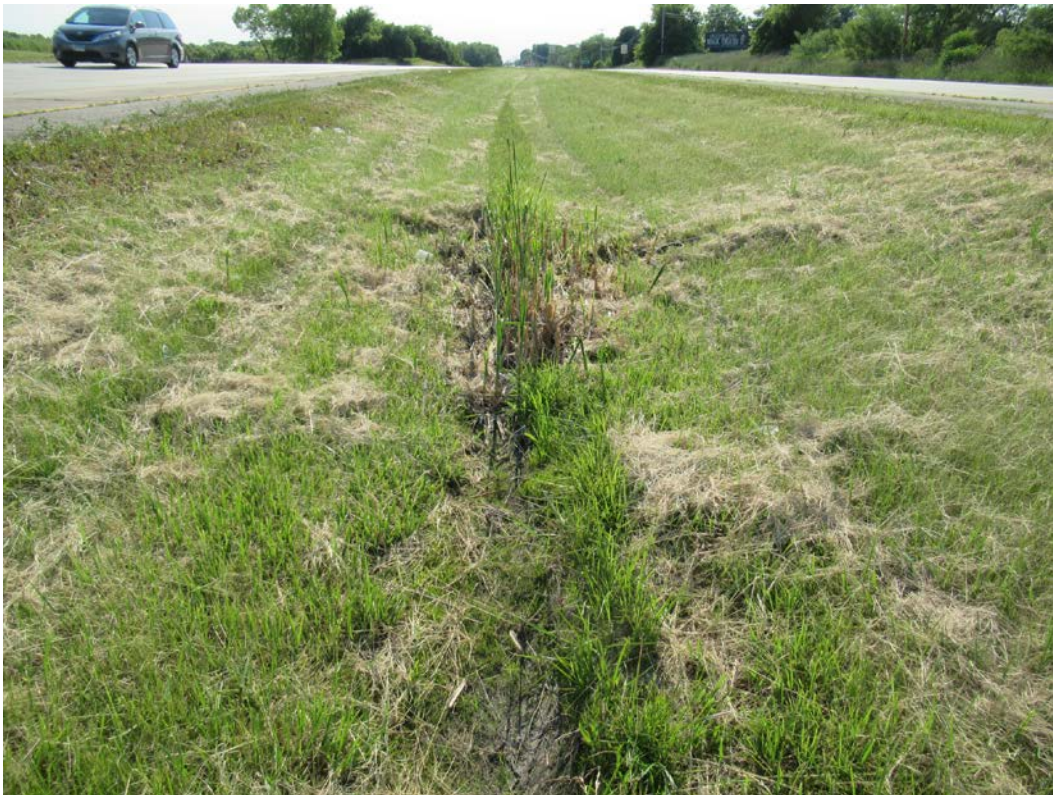
Photo 30. East view of STH 50 median near the east end of the project area. Most of the median is dry, and the wet spot shown in this image is 'too small to delineate'.
