Wisconsin Department of Transportation

CTH KR Stormwater Wetland Delineations

October 2018

Prepared for Wisconsin Department of Transportation
Project Name CTH KR Stormwater Wetland Delineations
WisDOT Project # 3763-00-04 (amended)
Cardno Project # J177001M24
Project Manager Eric Englund, Cardno
Date October 2018

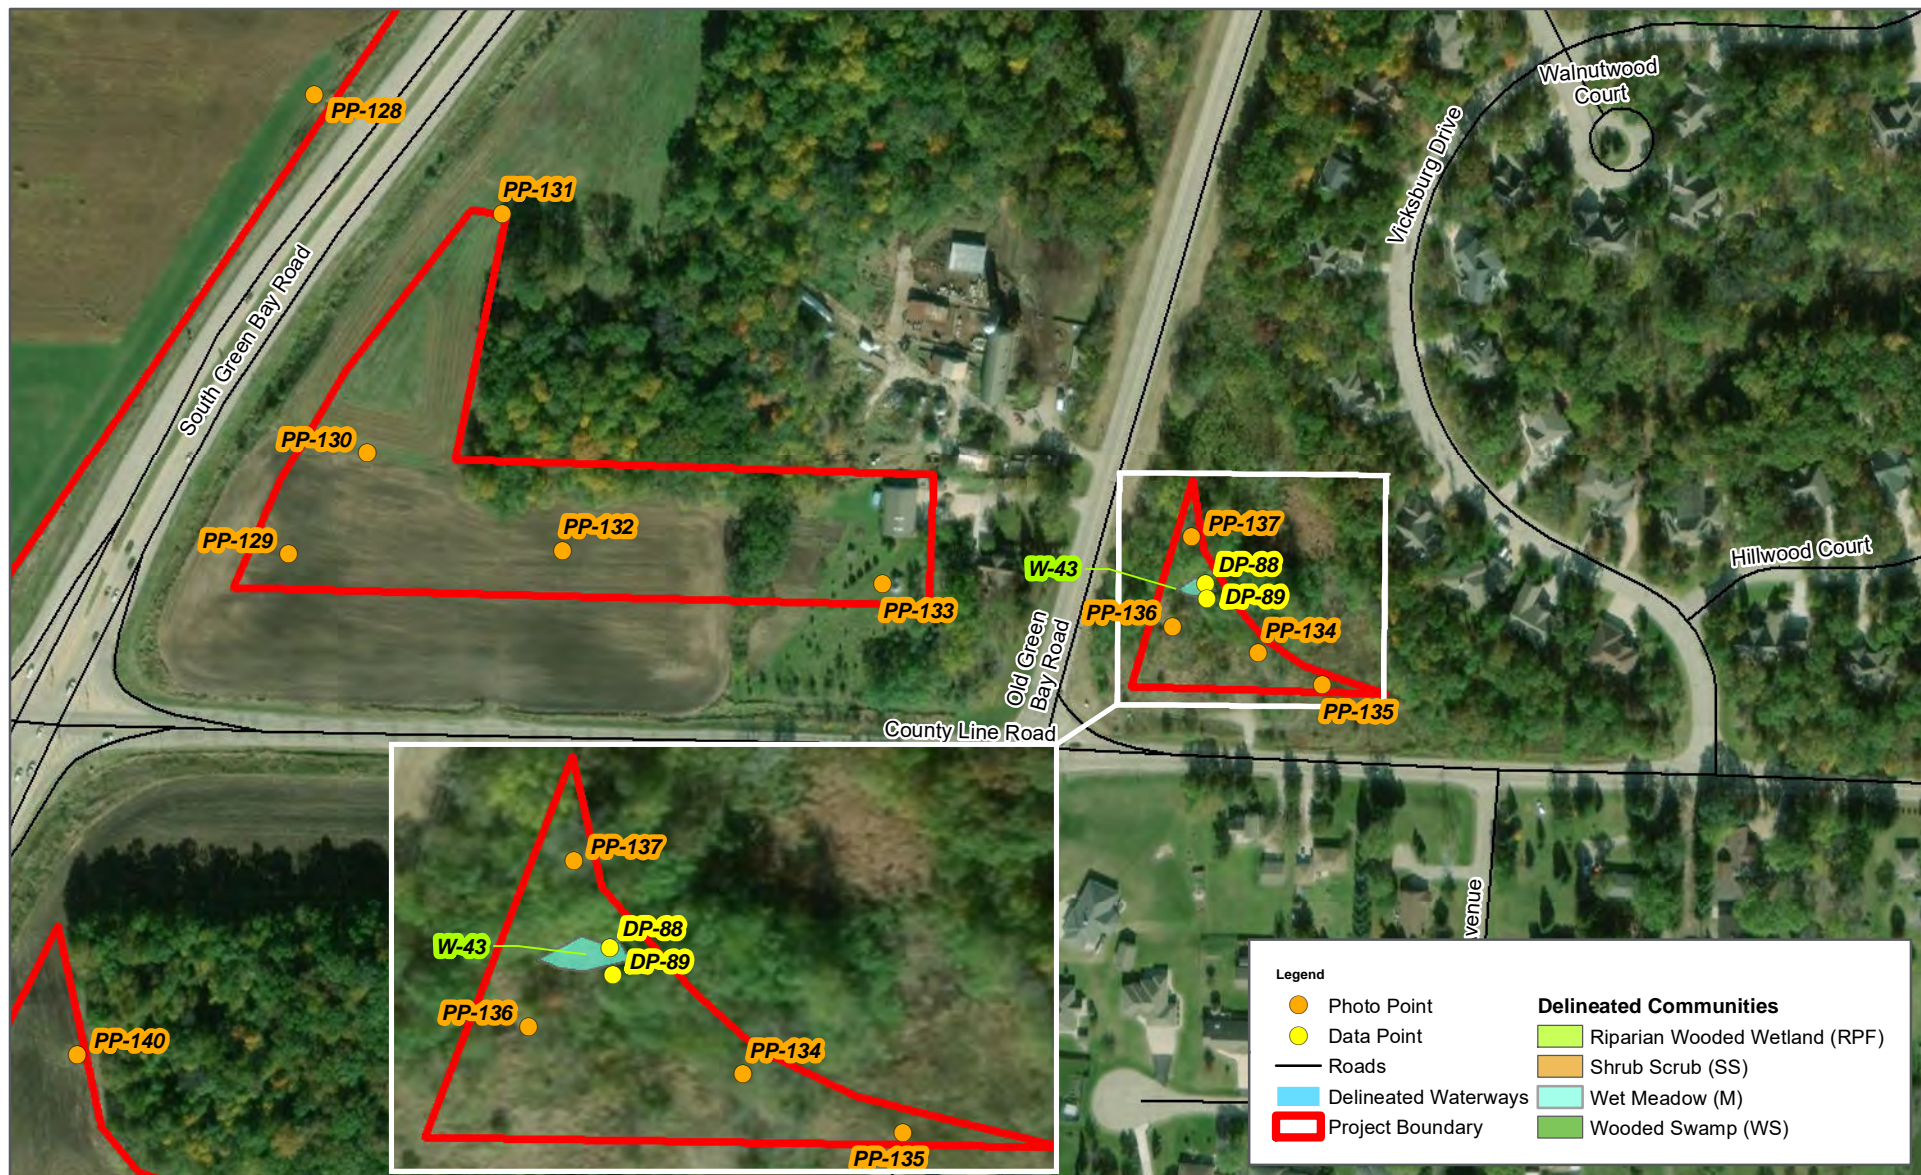
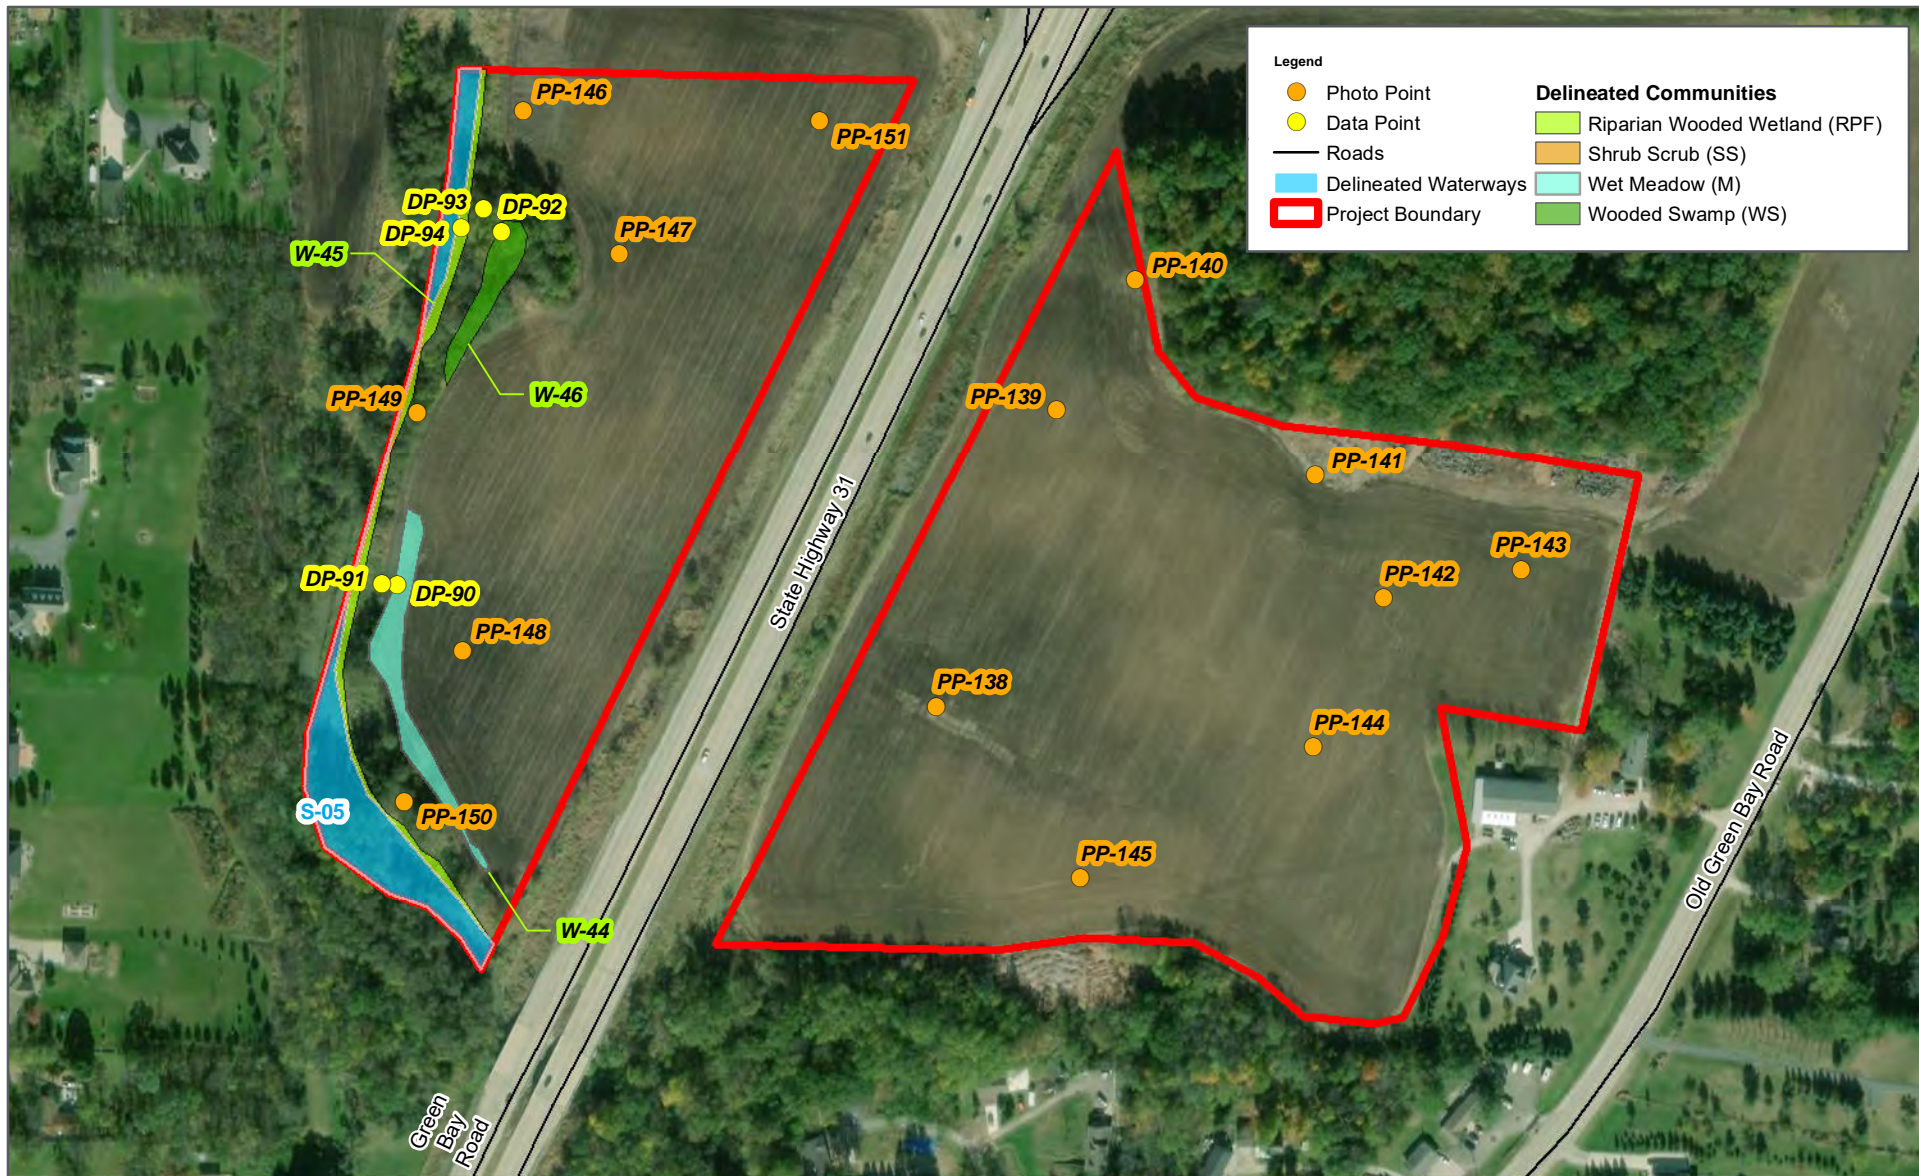
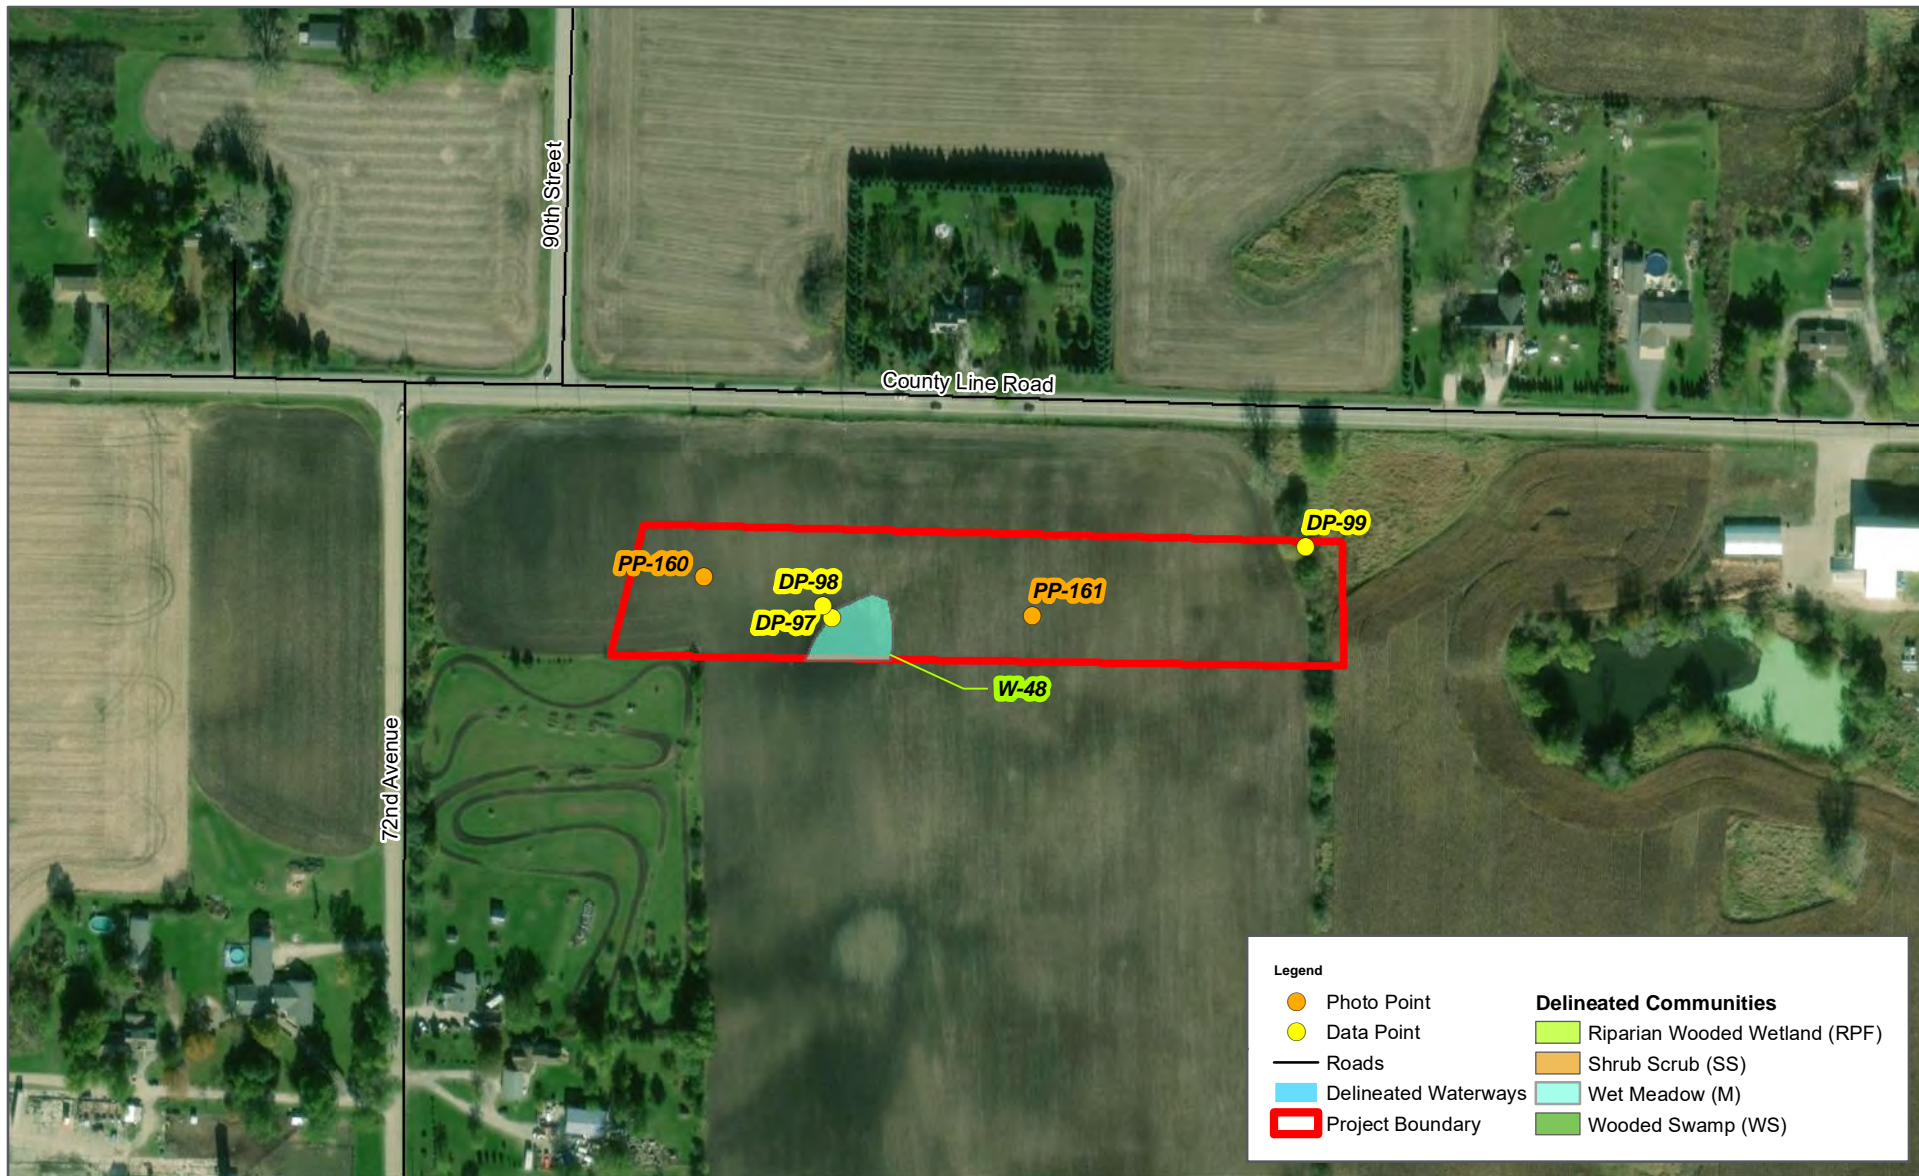
Wetland Delineation

A total of ten wetland communities were identified within the parcel boundaries (Figure 5) and were assigned community types according to WisDOT classification (Appendix C). The wetlands that were identified were generally located in lowland areas where water tends to collect and drain more slowly, such as in roadside ditches. Factors in determining wetland boundaries included topography of the landscape, dominant vegetation, soil, and hydrology observation. Documentation of these features, including wetland community type, associated data points, observed hydrology and hydric soil indicators, and dominant vegetation may be found in the wetland determination forms found in Appendix B, while general descriptions for observed wetland communities are found in Table 3-3 below.
