The PIARC TC D.3 Bridges Technical Committee is publishing a worldwide compilation of case studies as examples for bridge owners in making critical decisions to ensure the safety of the traveling public during a bridge incident caused by damage and deterioration. This case study compilation has 28 worldwide case studies received from 15 unique countries.

These case studies provide examples of incidents where owners discovered damage or deterioration under two main circumstances. Firstly, damage or deterioration resulting over longer periods of time, and secondly damage or deterioration appearing instantaneously. “Triggers” or causes of this damage or deterioration include environmental impacts, increased live loads, deicing applications, poor detailing in the design phase, poor construction materials and specifications, severe loading events, natural disasters, impacts, construction defects or by human error. At times, this discovery of damage and deterioration may lead to a bridge closure, traffic restriction, or weight restriction. This should result in damage assessment techniques, load carrying capacity calculations, and subsequent remedial works to return the bridge into serv

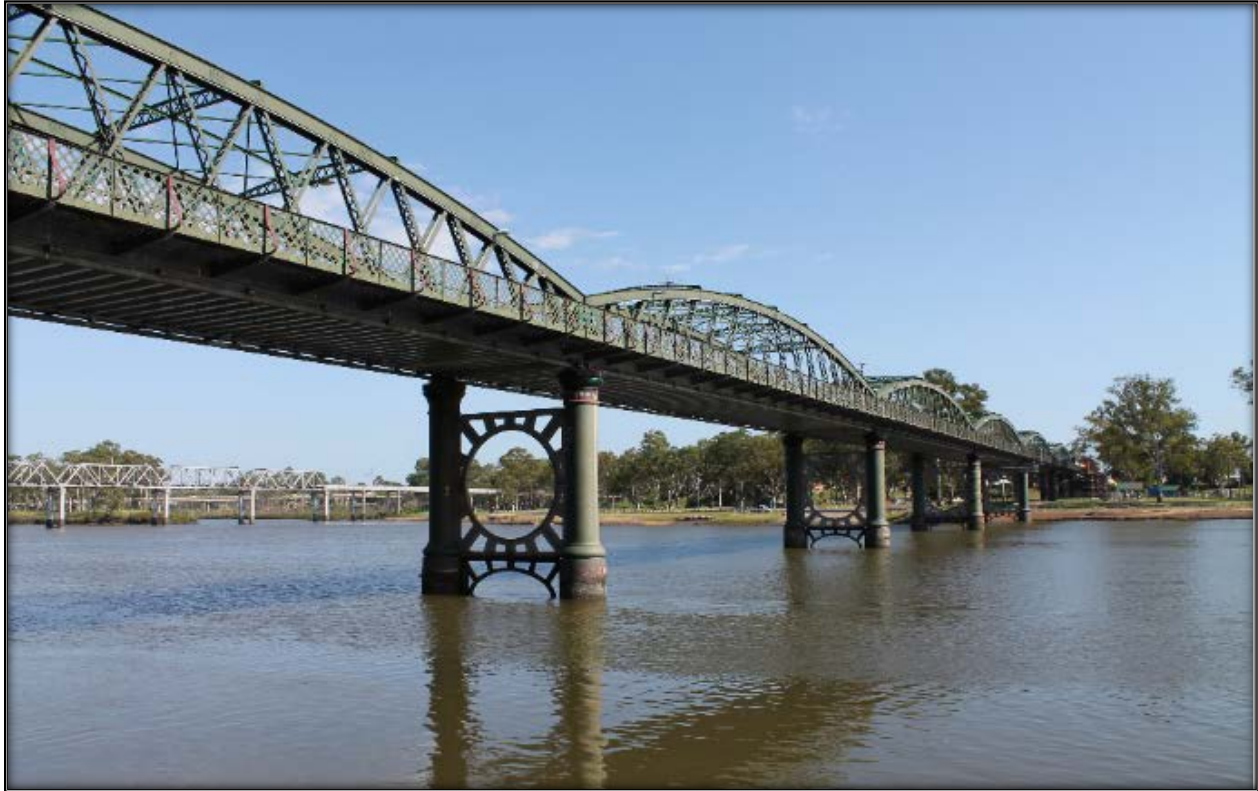
<u>Event Date</u>	Trigger Category: Bridge Impact			
March 2017	Vehicle impact with one of the diagonal steel components in the truss			
Bridge Type	Immediate Reaction	Special Assessment	Construction Year	Total Length (m)
Steel Arch -Tied Truss	No Immediate Reaction	No	1900	416

Description: A vehicle impacted one of the diagonal steel components in the truss. The member fractured at the rivet level and deformed. A rehabilitation project was under way, so the FEA analysis model was used to determine the impacts to the capacity. After evaluation, a 30-ton posting sign was installed. The member was replaced and the sign removed in approximately one month.

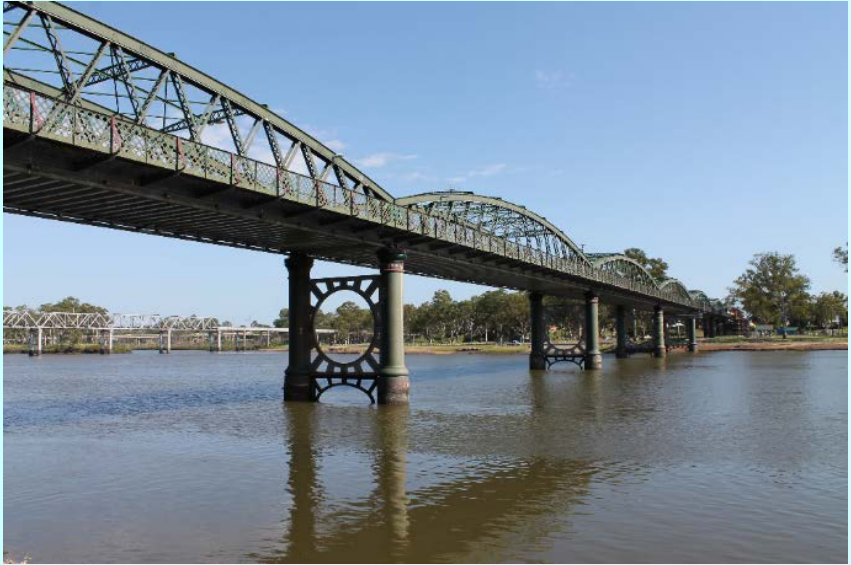
Excerpts from original plans.

Issue: D3.3 – Special inspections and Damage Assessment Techniques	
Country	Australia
Prepared by	Suzanne Brown
Date Prepared	27 April 2017
1.0	Description of Event / Incident
Description of Bridge	<p>Eight span steel bridge constructed in 1900. The Annual Average Daily Traffic is 16,900 with 7% Heavy Vehicles. Each span is approximately 52m long. The superstructure has a hog-back lattice truss either side of the 7.3m wide roadway. The piers are pairs of two cylindrical cast iron piles filled with concrete. It has a steel trough deck that spans between the bottom chords of the trusses. The bridge has been load limited to 42.5t since 2002 due to the corrosion of critical steel components. The bridge is over salt water and is very prone to corrosion.</p>
Picture of Bridge

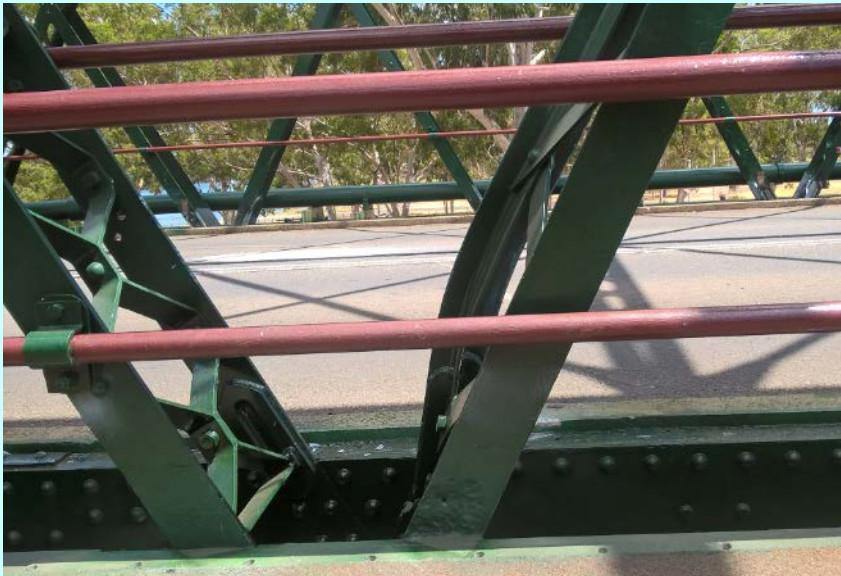
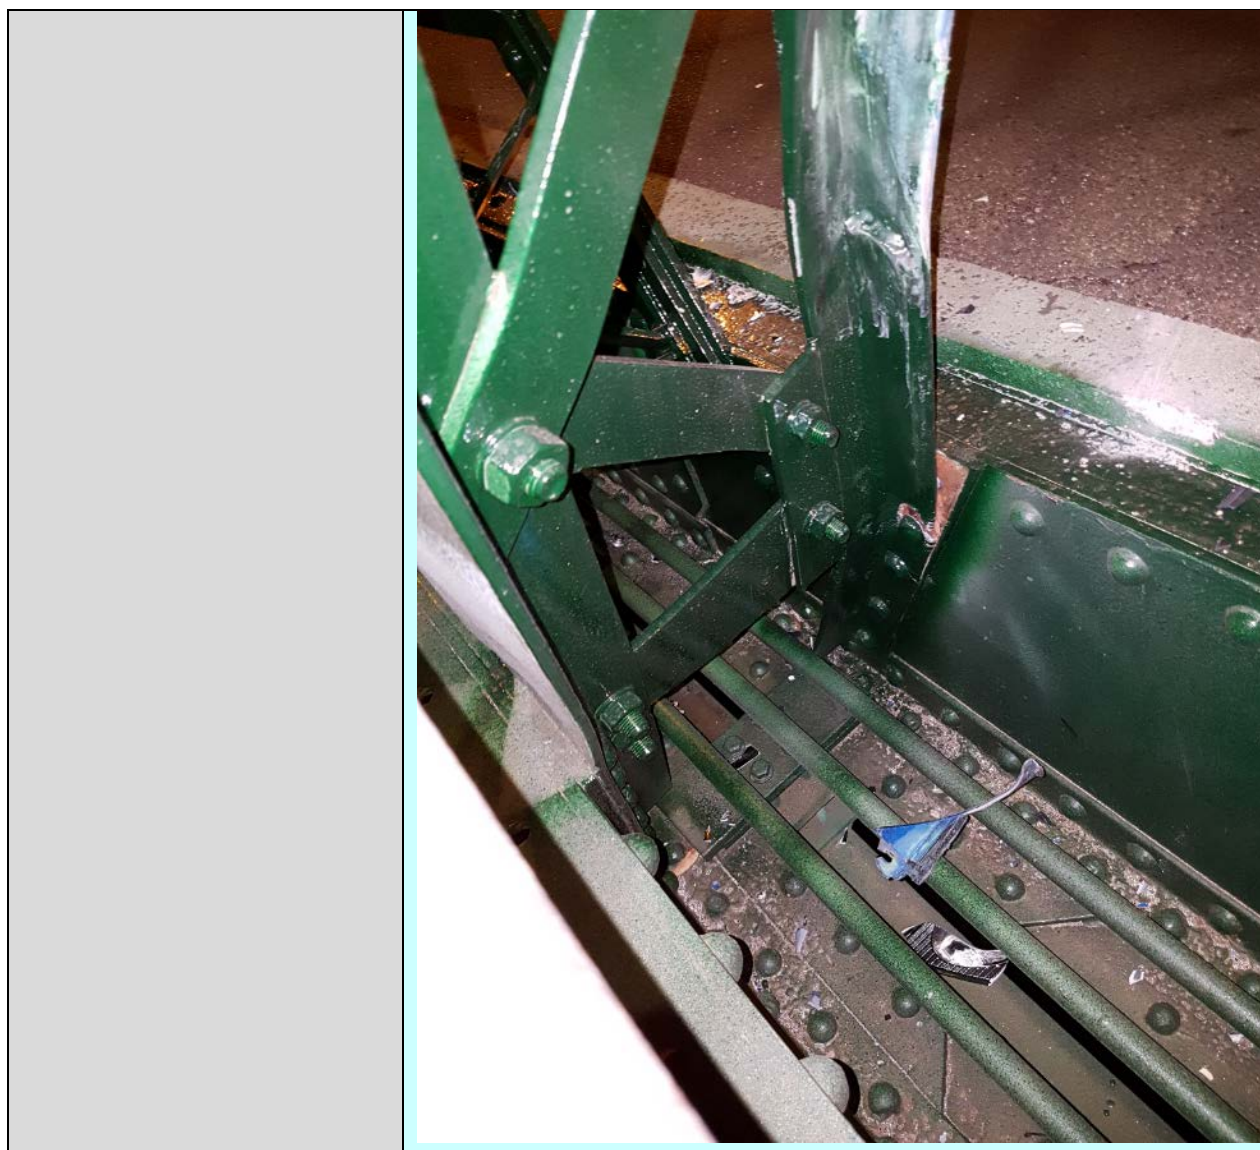
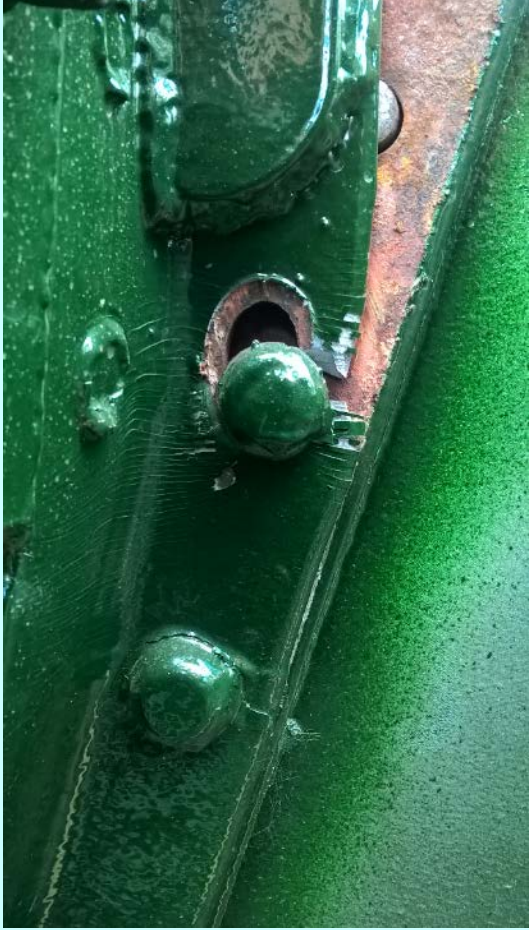
Description of the event and the trigger that caused the assessment	Examples: bridge hit, excessive deterioration, flood, scour, Routine Inspection resulting in critical finding, emergency, moving super load, etc
Answer	<p>Answer:</p> <p>Vehicle impact with one of the diagonal steel components in the truss. The diagonal steel component adjacent to the roadway has fractured at the rivet just below the road level. The component has been deformed for approximately half its height.</p>

<p>A 9.5mm thick steel section fractured around the rivet. Just above the fracture is a welded piece of steel that was added as part of the ongoing bridge repairs to compensate for section loss due to corrosion.</p>
Date of initial event	12 March 2017
Describe your immediate reactions to this event	Examples: close bridge, reduce traffic lanes, and determine the need for special assessments, investigations, or special inspections. These initial assessments would lead to follow up actions

Answer	Answer: To simplify the analysis for the crash damage a linear elastic FEA model was used with the lower portion of the damaged component removed. The 3D SpaceGass model was also checked. A diagonal component of the truss that is adjacent to the damaged component was found to be the critical member of the truss both before and after the damage. The stress level in this member was checked for various vehicle loads. It was found to be overstressed with vehicles above 30t.
Date event resolved or concluded	10 April 2017
Describe the results and outcome and any lessons learned including other factors that may have influenced your decisions	Examples: prestress bridge girder struck by vehicle, closed lane of traffic on bridge, removed loose concrete, added FRP patched bridge, and opened bridge. Other factors may include contracting mechanisms, procurement of materials, and familiarity with repair. This took five days to complete, learned of new process for application of FRP

Answer	Answer: A new works procedure was developed and recorded for replacement of the diagonal steel components of the bridge.

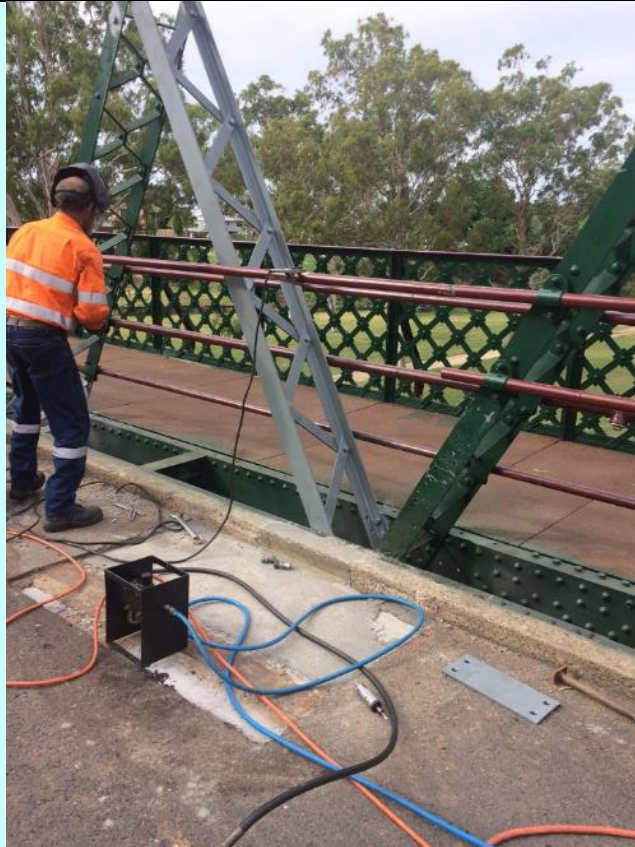
This picture shows the newly installed diagonal steel member (in grey). The picture is taken from the roadway looking toward the walkway on the outside of the truss. The bridge was closed to traffic several times in order to complete the repair. The roadway needed to be excavated to get access to where the diagonal steel member was attached to the steel chords that form the base of the truss.

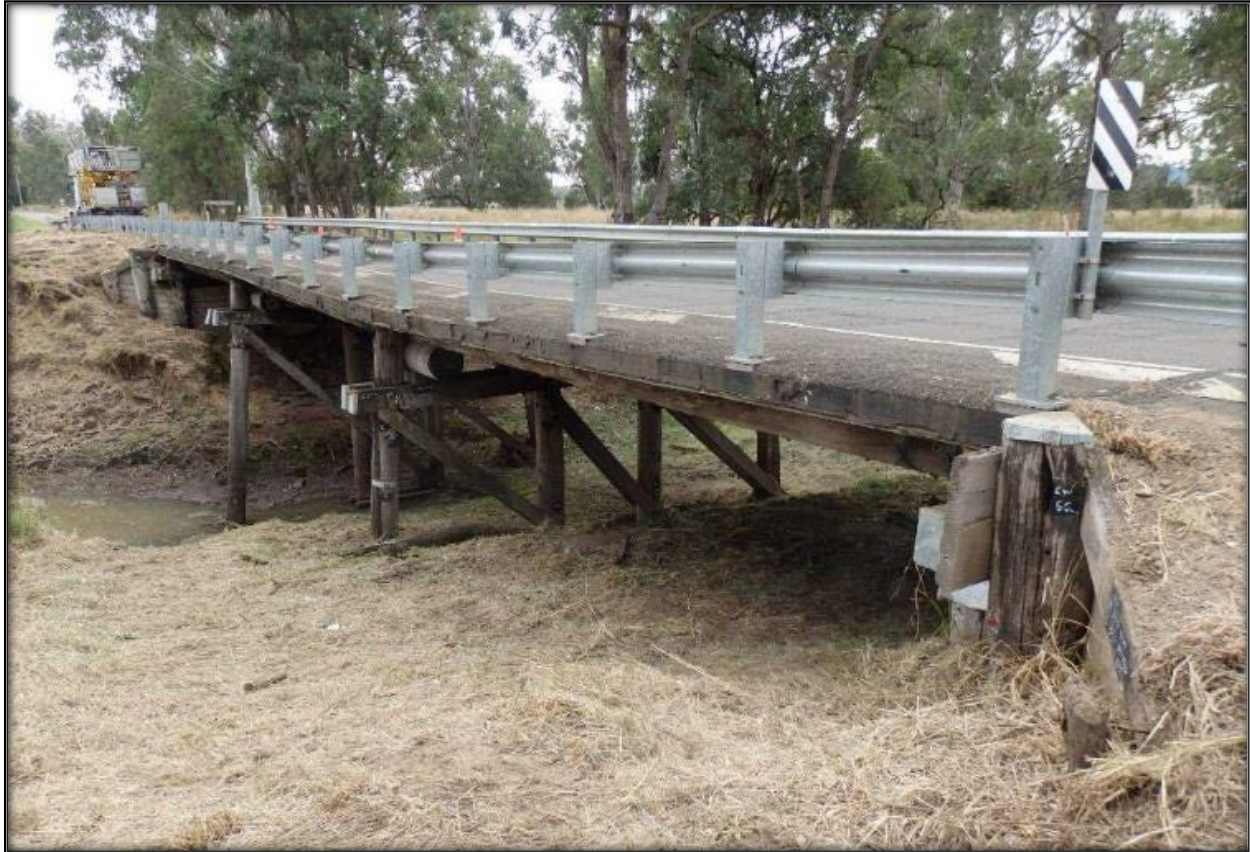
#2 AUSTRALIA (2)

<u>Event Date</u>		Trigger Category: Inspection		
September 2010		Inspection after soil washed away discovered rotten timber piles		
Bridge Type	Immediate Reaction	Special Assessment	Construction Year	Total Length (m)
Timber Girder	Restricting Heavy Trucks, and a lane	Yes	1961	27

Description: During an inspection after soil had washed away, a decayed timber pile was discovered. In addition, the part of the bridge deck had sunk. The Bridge was restricted to over legal heavy vehicles, one lane, and put on a 3-month inspection monitoring program. The permanent solution was completed in 2016.

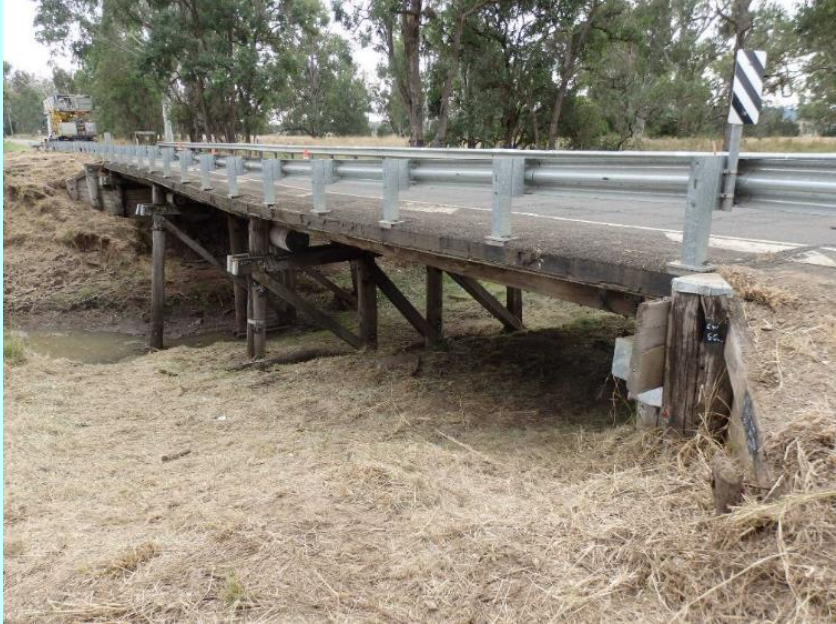
Issue: D3.3 – Special inspections and Damage Assessment Techniques	
Country	Australia
Prepared by	Suzanne Brown
Date Prepared	13 February 2017
1.0	Description of Event / Incident
Description of Bridge	<p>Three Span timber bridge originally built in 1961. The bridge was re-decked in 2003 replacing the transverse hardwood timber planks with bridge plywood. The bridge is on a low order road with a low Average Annual Daily Traffic Volume of 210 vehicles with 17% Heavy Vehicles. Each span is 9m long, so the bridge is only a total of 27m long.</p> <p>Each pier and abutment has four driven timber piles supporting two headstocks (cross beams). The superstructure consists of five round timber corbels and girders per span supporting the plywood deck with asphalt wearing surface.</p>
Picture of Bridge

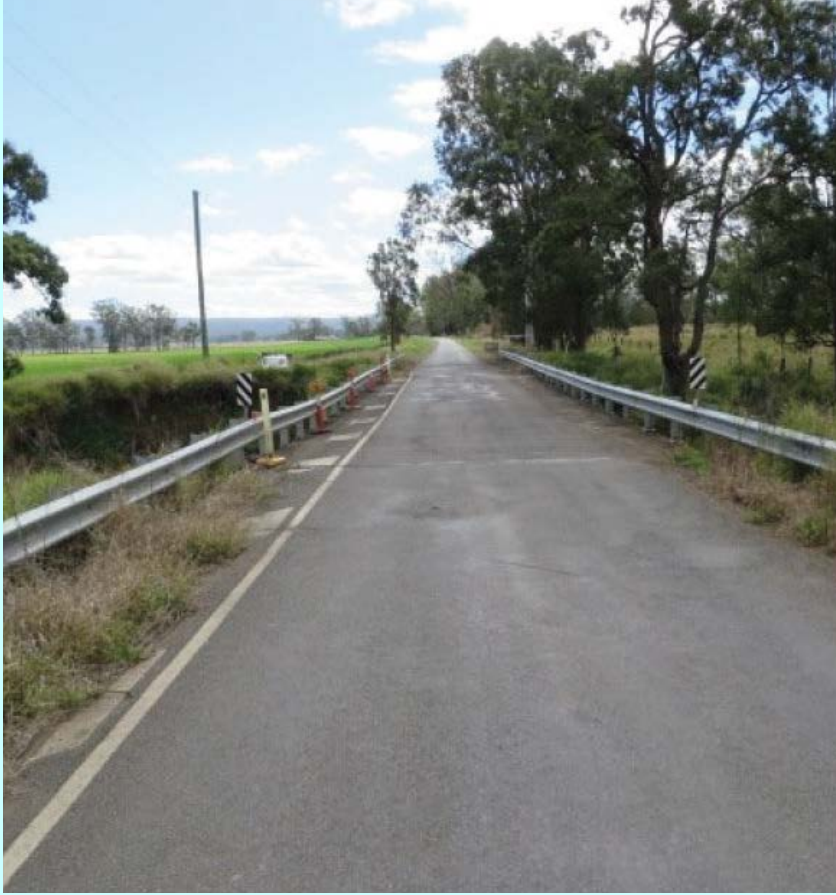
Answer	<p>Answer:</p> <p>Timber pile gradually rotted beneath the ground, defect discovered after some soil washed away. Then the bridge inspectors dug around the pile to uncover the full extent of the defect.</p> <p>The pile with the most severe rot was in Abutment 2. The bridge deck was also out of shape (sinking) at Pier 1 which added to the issues. This can be seen in the first picture above.</p>  
Date of initial event	September 2010
Describe your immediate reactions to this event	Examples: close bridge, reduce traffic lanes, and determine the need for special assessments, investigations, or special inspections. These initial assessments would lead to follow up actions

<ul style="list-style-type: none"> • The bridge was restricted to regulation mass vehicles (42.5T) by banning excess mass vehicles requiring a permit to travel. • The bridge was put onto the monitoring program to be inspected every 3 months • The bridge was restricted to one lane operation. Vehicles travelling in one direction had to give way to vehicles travelling in the opposite direction. This was practical due to the low volume of traffic using the road and the short length of the bridge (27m). Traffic was moved on the right hand side of the bridge so that the live load was carried by the other three timber piles. The other three piles in the Abutment were in good condition. Converting the bridge to single lane also prevented the event where two vehicles would be on the bridge at the same time.

Answer	<p>Answer:</p> <p>Timber bridges are good at re-distributing load.</p> <p>The final solution involved replacing the timber sub-structure with steel. Many of the timber piles were showing signs of rot and deterioration below ground level. After completing geotechnical investigations it was revealed that the bearing capacity of the ground was low and the piles had to be driven to a depth of at least 20m. It is assumed the ground conditions were the reason for Pier 1 sinking and distorting the deck.</p> <p>Funding was not available for replacement of the bridge in concrete due to other priorities on higher order roads. It was decided to keep the bridge operating as single lane as no issues had arisen since this was implemented in 2010.</p> <p>For the sub-structure replacement, the bridge was sidetracked, the timber components unbolted and stockpiled, old piles cut off at ground level, new steel piles driven and the bridge re-assembled.</p>

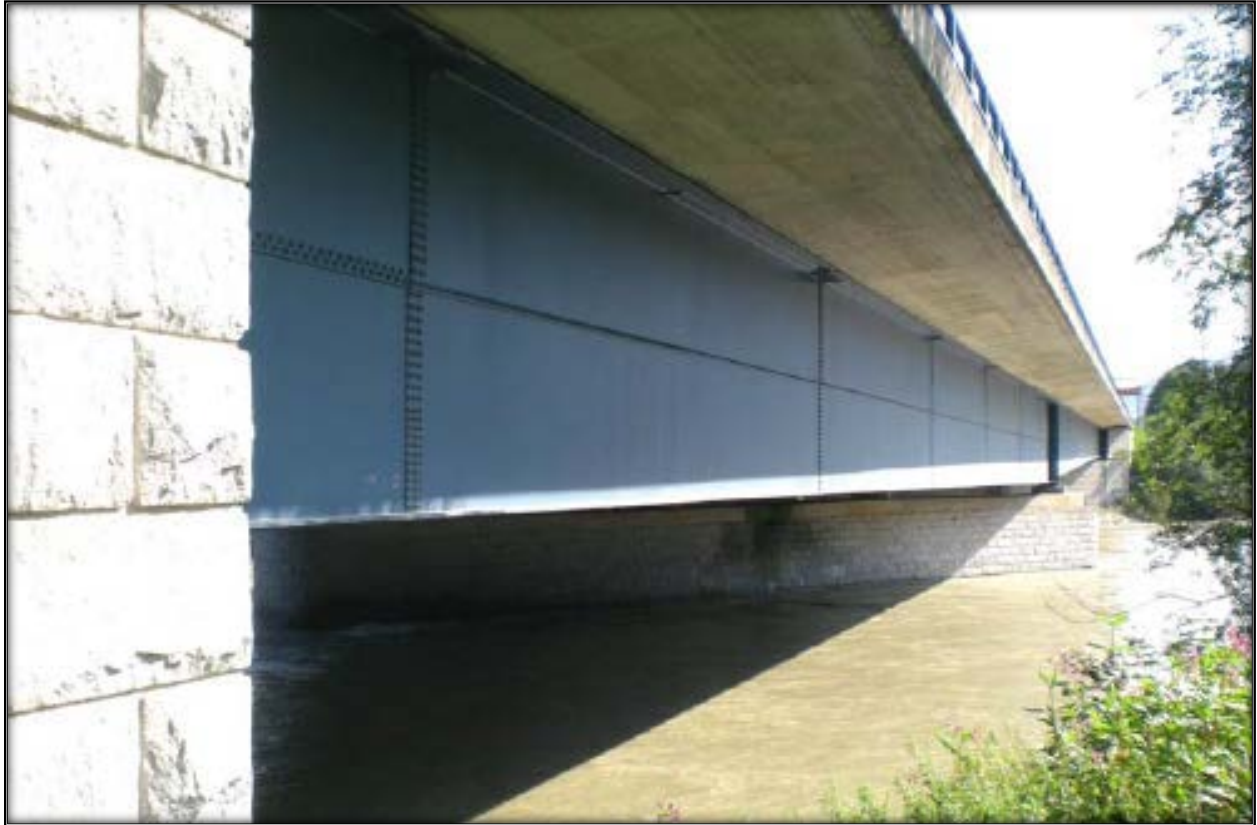
#3 AUSTRIA (1)

<u>Event Date</u>	Trigger Category: Inspection			
2009	Floor panel plate buckling			
Bridge Type	Immediate Reaction	Special Assessment	Construction Year	Total Length (m)
Steel Plate girder	Lane Closed	Yes	1969	13290

Description: A main bridge inspection identified floor panel plate buckling. The security lane was closed immediately. The decision was made to replace the bridge in a future year and leave the security lane closed.

This took 5 days to complete, learned of new process for application of FRP
Answer	We closed the security lane on the bridge – we had the same number of traffic lanes and no problem with the traffic. Due to the massive problems with the bridge it will be removed and reconstructed in the next years.

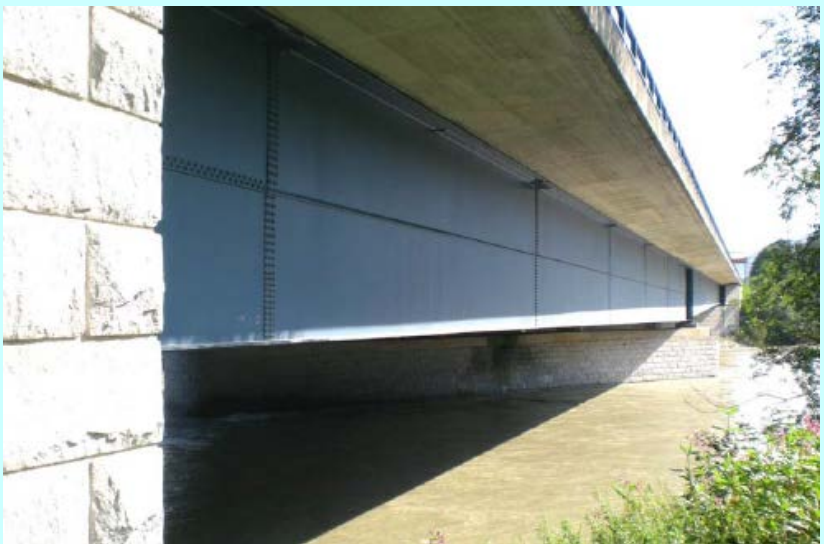
<p>Flußbrücke</p> <p>SCHNITT b-b 1:100</p>

Issue: D3.3 – Special inspections and Damage Assessment Techniques	
Country	Austria
Prepared by	Martin Kirchmair
Date Prepared	July 2016
1.0	Description of Event / Incident
Description of Bridge	<p>Name of the bridge: B74 Terfener Innbrücke</p> <p>The existing structure of the B74 Terfener Innbrücke at the A12 Inntal Motorway in Tirol / Austria spans the Inn river with 52,90 and 80,00 m. The bridge is existing of the main structure with an concrete-steel-composite structure and the secondary structures with a reinforced concrete deck.</p> <p>The bridge was built in the years 1969 and 1970. In 1973 occurred the first problems in the floor panel in terms of plate buckling.</p>
Picture of Bridge

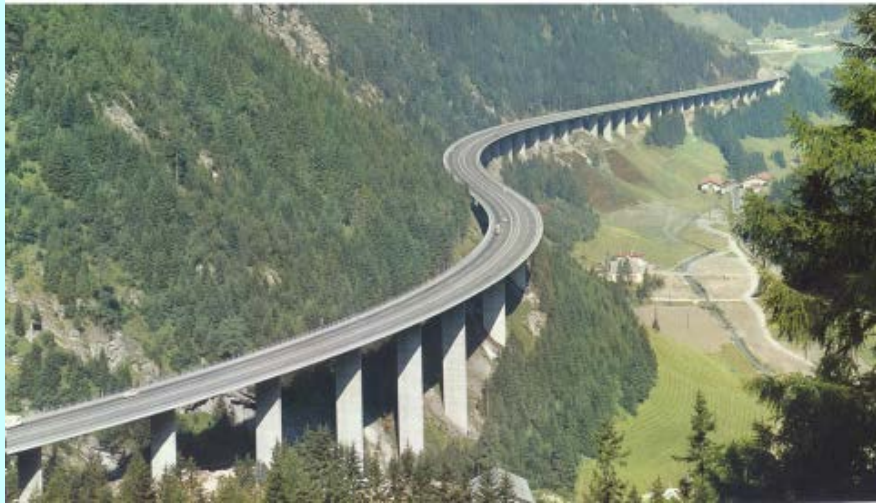
Issue: D3.3 – Special inspections and Damage Assessment Techniques	
Country	Austria
Prepared by	Martin Kirchmair
Date Prepared	July 2016
1.0	Description of Event / Incident
Description of Bridge	<p>Name of the bridge: BB57 Luegbrücke</p> <p>The existing structure of the BB57 Luegbrücke at the A13 Brenner Motorway in Tirol / Austria is a hillside bridge with a total length of 1.800m. It is subdivided into 5 frames. Four frames have a cross section of T-girders and are pre-stressed. The frame number 4 is a steel bridge with a concrete deck.</p> <p>The bridge was built in the years 1966 to 1968.</p>
Picture of Bridge

<div data-bbox="641 216 1372 829"> <p>Lageplan</p> <p>Längsschnitt</p> </div> <div data-bbox="641 913 1201 1501"> <p>Querschnitte</p> <p>Spannbetontragwerk (Rahmen I-III u. V)</p> <p>Stahltragwerk (Rahmen IV)</p> </div>
<p>Description of the event and the trigger that caused the assessment</p>	<p>Examples: bridge hit, excessive deterioration, flood, scour, Routine Inspection resulting in critical finding, emergency, moving super load, etc</p>
<p>Answer</p>	<p>In the course of the main inspection some open gaps at the location, where the pre-stressed cables are coupled have been discovered. Thereafter we initiated some special assessments.</p>

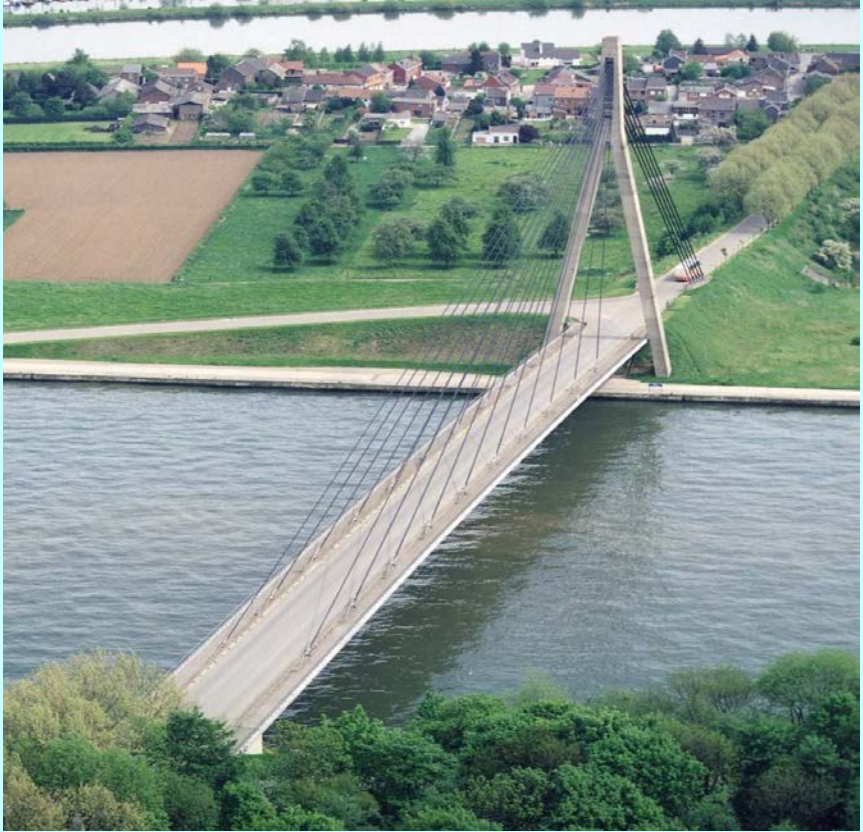
Picture of Bridge

Issue: D3.3 – Special inspections and Damage Assessment Techniques	
Country	Belgium
Prepared by	Pierre Gilles
Date Prepared	3.03.2017
1.0	Description of Event / Incident
Description of Bridge	<p>Lanaye bridge, with a total length of 232 m, crosses the Albert canal before it reaches the Dutch border. It connects the areas of Lanaye and Eben-Emael.</p> <p>It is an asymmetrical cable-stayed bridge with a single reinforced concrete pylon at the base. It is equipped with 2 layers of 5 stays anchored into the counterweighting abutment (Lanaye side) and 2 layers of 10 stays anchored to the deck (Eben-Emael side).</p> <p>The deck, in the form of a box, consists of two principal metal girders and reinforced concrete slabs (light aggregates).</p> <p>The main section, which crosses over the Albert canal, is 177 m long and 13.3 m wide and the stays, made from between 104 and 325 parallel galvanised wires (Ø 7 mm), are between 49.25 and 165.79 m long.</p> <p>The wires are protected by HDPE covers which have been injected with bray epoxy resin.</p>

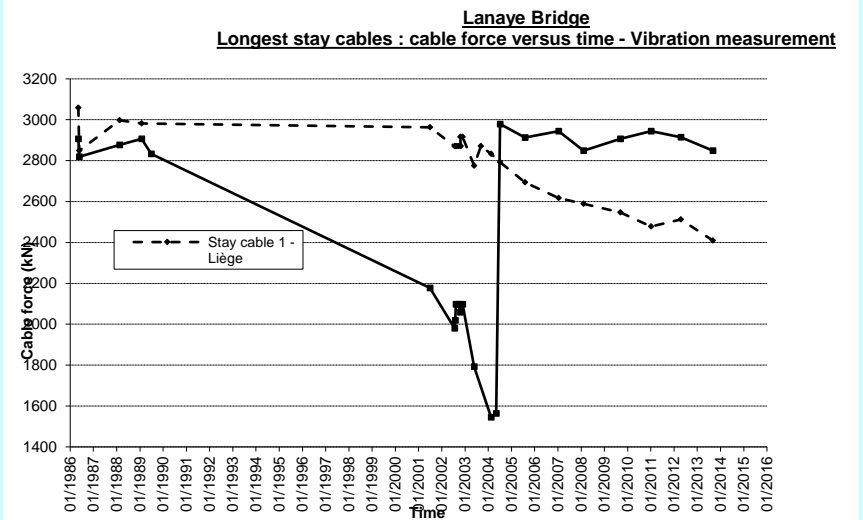
Description of the event and the trigger that caused the assessment																																																																																																	
Answer	<p>All the cable-stayed bridges managed by the Public Services of Wallonia are checked periodically to record the cable force in the stays. The measurements on the Lanaye bridge were taken in this context.</p> <p>Lanaye Bridge Longest stay cables : cable force versus time - Vibration measurement</p>

<table><tr><th>Time</th><th>Stay cable 1 - Liège (kN)</th><th>Other cables (kN)</th></tr></table>

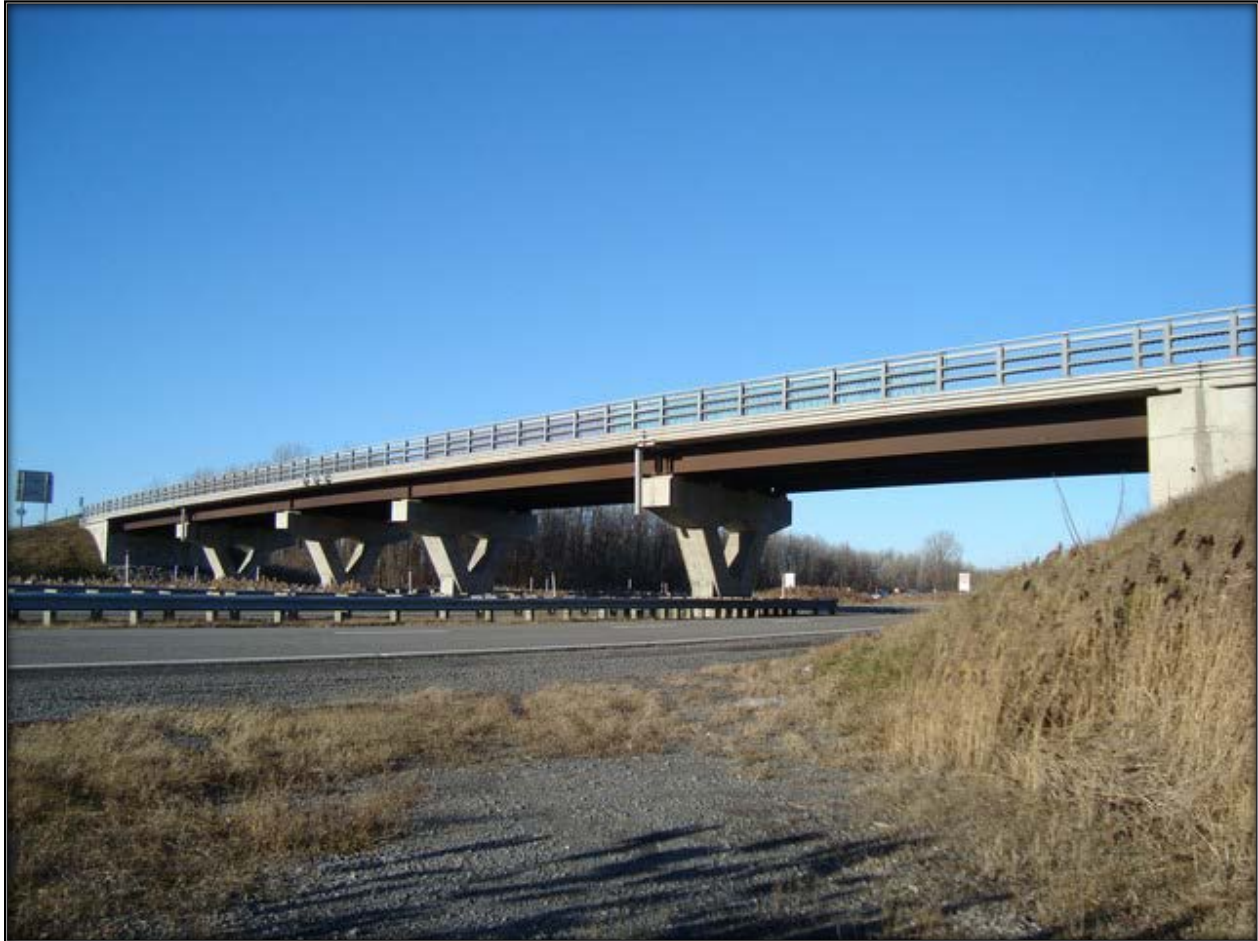
#6 CANADA 1(S)

<u>Event Date</u>	Trigger Category: Inspection			
July 2016	The impact damaged both exterior girders			
Bridge Type	Immediate Reaction	Special Assessment	Construction Year	Total Length (m)
Steel Girder	Closed Bridge	No	1965

Description: The bridge girders was impacted by an over height vehicle. The bridge was closed immediately by law enforcement. After an inspection, the bridge was open with one lane running in the center portion. A normal repair of the girders was completed in November.

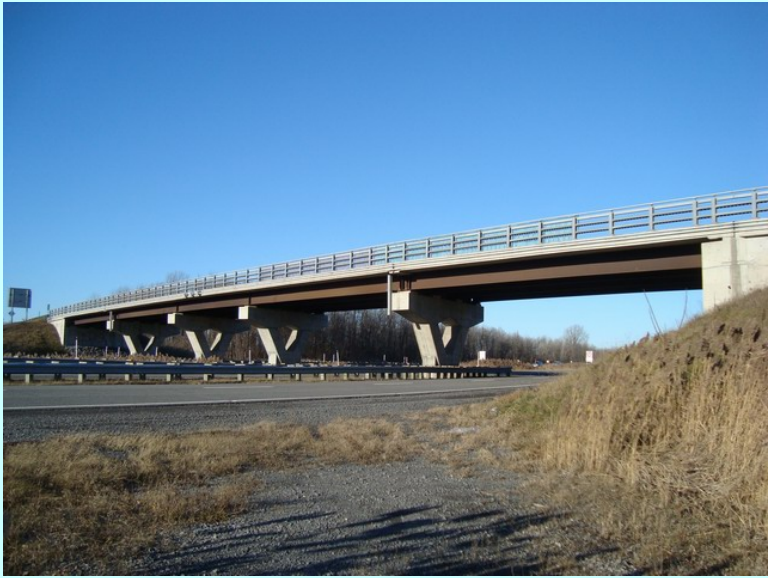
Issue: D3.3 – Special inspections and Damage Assessment Techniques	
Country	Canada
Prepared by	Bernard Pilon
Date Prepared	January 2017
1.0	Description of Event / Incident
Description of Bridge	<p>Bridge located on highway 343 over autoroute 40 in St-Sulpice (outskirts of Montreal). Consists of four continuous steel beams. Constructed in 1965 and extensively renovated in 2006 (new girders and slab)</p> <p>20 000 ADT with 4% trucks.</p> <p>The bridge is used to access the City of l'Assomption and St-Sulpice from autoroute 40 and receives a fair amount of traffic during rush hours.</p>
Picture of Bridge

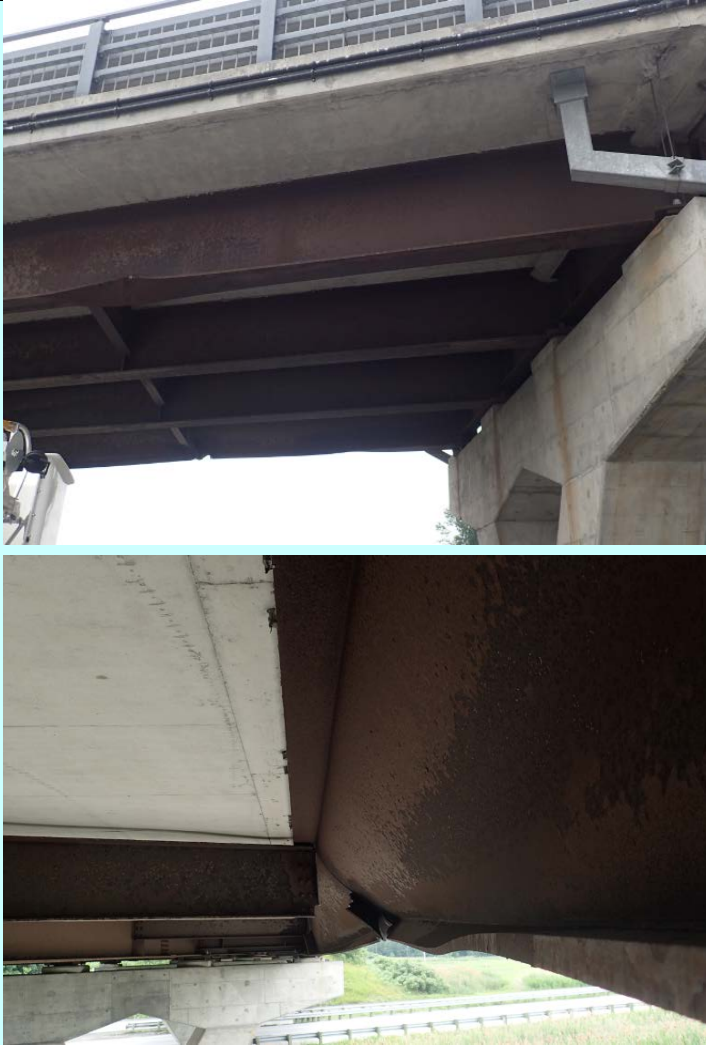
Answer	<p>Bridge was hit by boom truck and both exterior girders were damaged. Worst hit was the last one (west exterior, westbound)</p> <p>Below are pictures of both damaged girders</p>

Answer	<p>Bridge was initially closed to all traffic by law enforcement, so was the autoroute underneath. Traffic was diverted through the exit ramps. In the following hours, a bridge inspection engineer from our local office on Montreal's North shore inspected the bridge from the ground (see following answer). Decision was made to resume traffic normally on both directions of the autoroute underneath (six to 8 hours after impact) and to open one lane of the bridge in the center portion of the deck over the two intact girders. Lane on the bridge was opened approximately 10 to 12 hours after impact.</p>

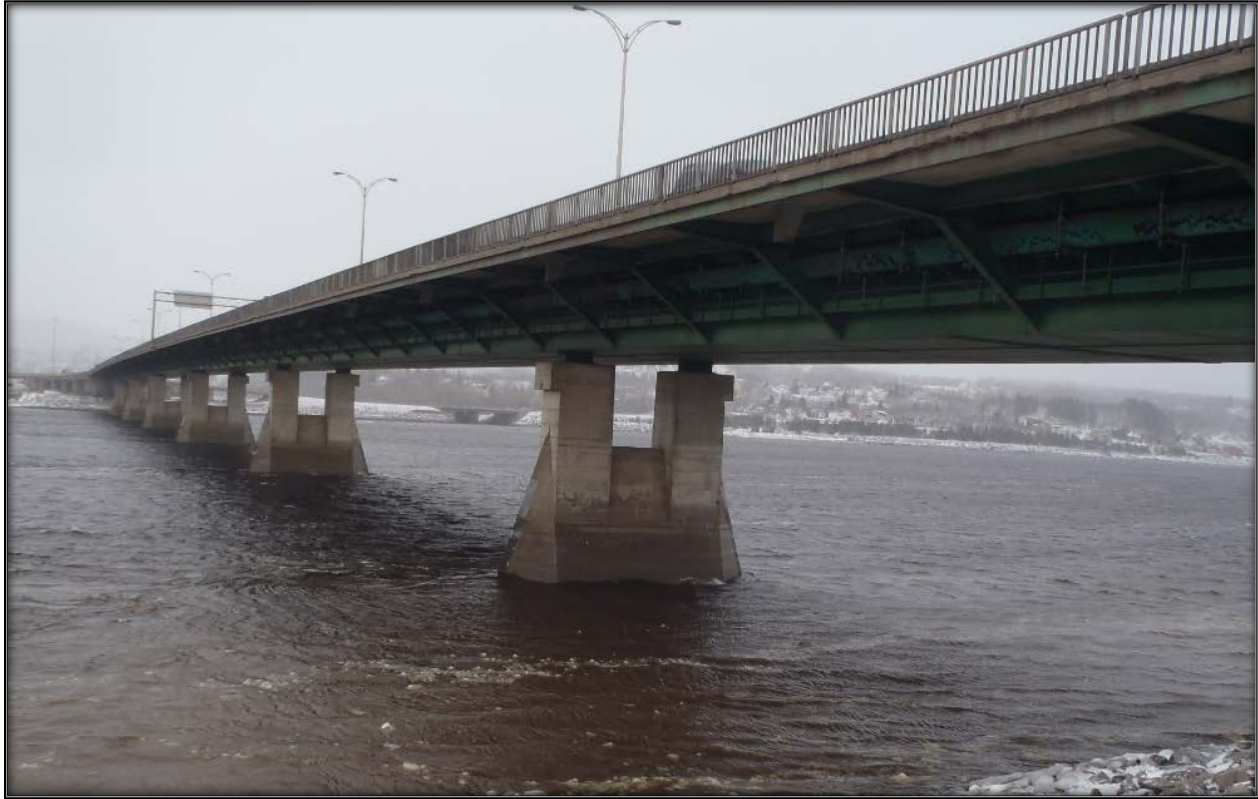
#7 CANADA 2(C)

<u>Event Date</u>		Trigger Category: Inspection		
December 2013		fire reached the girders		
Bridge Type	Immediate Reaction	Special Assessment	Construction Year	Total Length (m)
Steel Plate Girder	Closed Bridge	Yes	1972	483

Description: During a repair project, a fire started on the temporary works that reached the girders. The bridge was closed immediately by law enforcement. A inspection was performed and resulting in leaving the bridge closed. A repair and reinforcement of the girders was completed in 14 days.

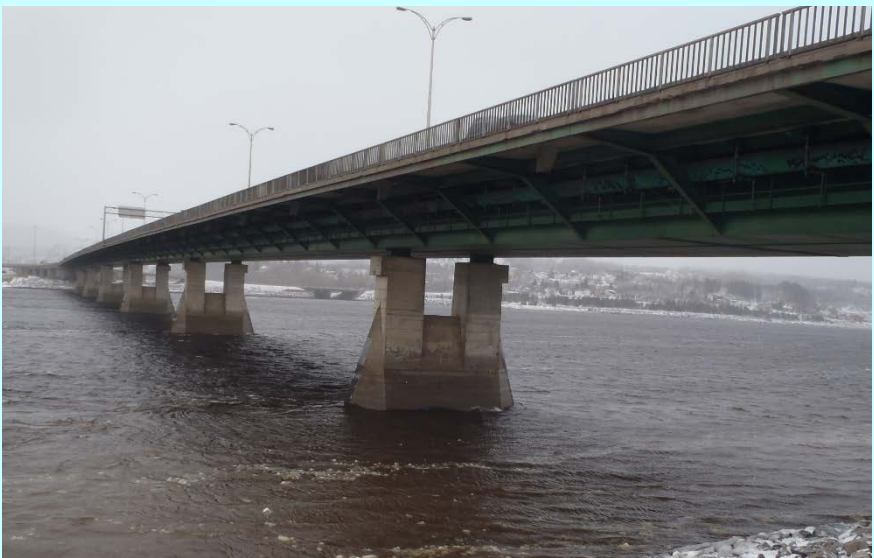
Issue: D3.3 – Special inspections and Damage Assessment Techniques	
Country	Canada
Prepared by	Bernard Pilon
Date Prepared	Week of February 6 2017
1.0	Description of Event / Incident
Description of Bridge	<p>Bridge located on highway 175 over the Saguenay river in Chicoutimi. Seven spans, continuous steel caisson beam with four webs supporting a concrete slab. Total length of bridge, 483 meters Constructed in 1972</p> <p>46 000 ADT with 10% trucks.</p> <p>The bridge is an important regional link between the city of Chicoutimi and the surrounding municipalities. It is particularly used during the morning and afternoon rush hours</p>
Picture of Bridge

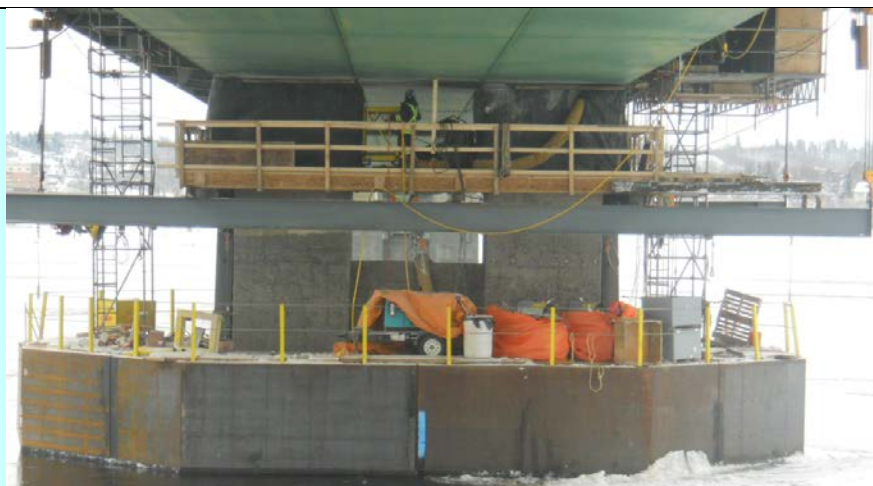
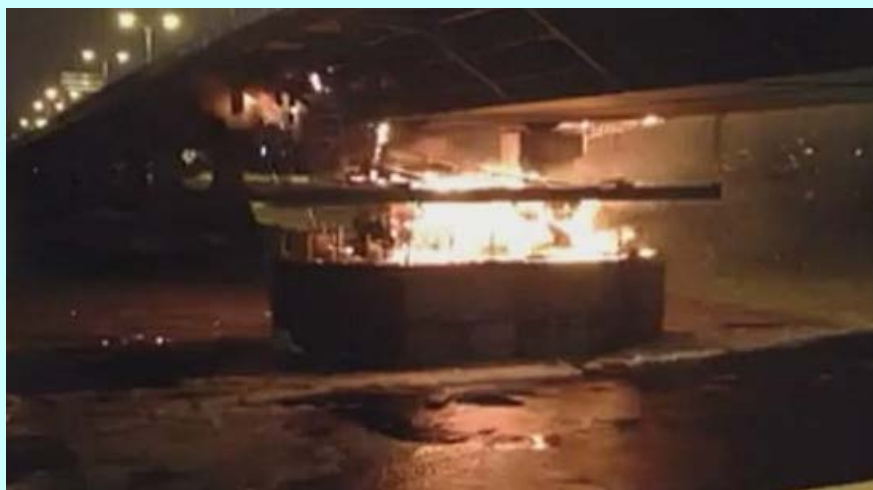
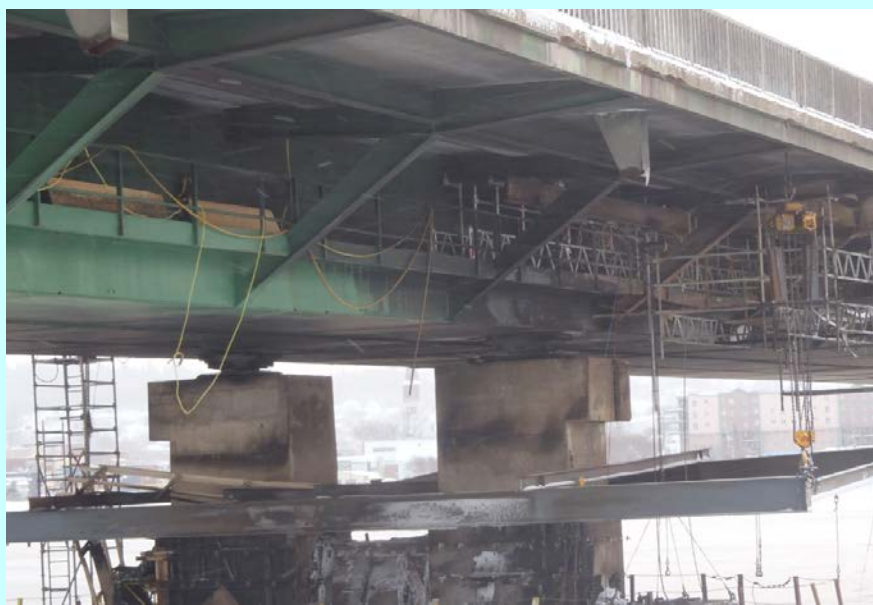
Answer	<p>While repair work was being done on one of the concrete piers (in winter), a fire started in the temporary heated enclosure and burned a wooden access structure and formworks. The flames reached the steel caisson overhead.</p> <p>Below are pictures prior, during and after the fire</p>

Answer	<p>Bridge was initially closed to all traffic by law enforcement and the local fire department. Once the fire was extinguished, a bridge engineer from our local office decided to maintain the closure and contacted an expert engineer from the central office (in Quebec City)</p> <p>Since a bridge collapse we had in 2006, we put in place a telephone number where expert bridge engineers can always be reached by all of the ministry's personnel to make quick assessments in case of events on bridges.</p> <p>By the description of the event and the aspect of the defaults seen from the embankment (15 meters distance), this expert engineer concluded that the bridge must remain closed until further inspection. He then proceeded with a colleague (also a bridge engineer) to the site (approx. 2hr drive) for this inspection.</p> <p>Both engineers, with personnel from our local office, inspected the caissons from the interior and from the exterior (summary inspection using climbing ropes) and noted significant buckling of the bottom plate of the caisson had occurred. Deformation of the webs and stiffeners was also visible. Some welds were also cracked. This led to a prolonged closure of the bridge and need for further analysis</p>

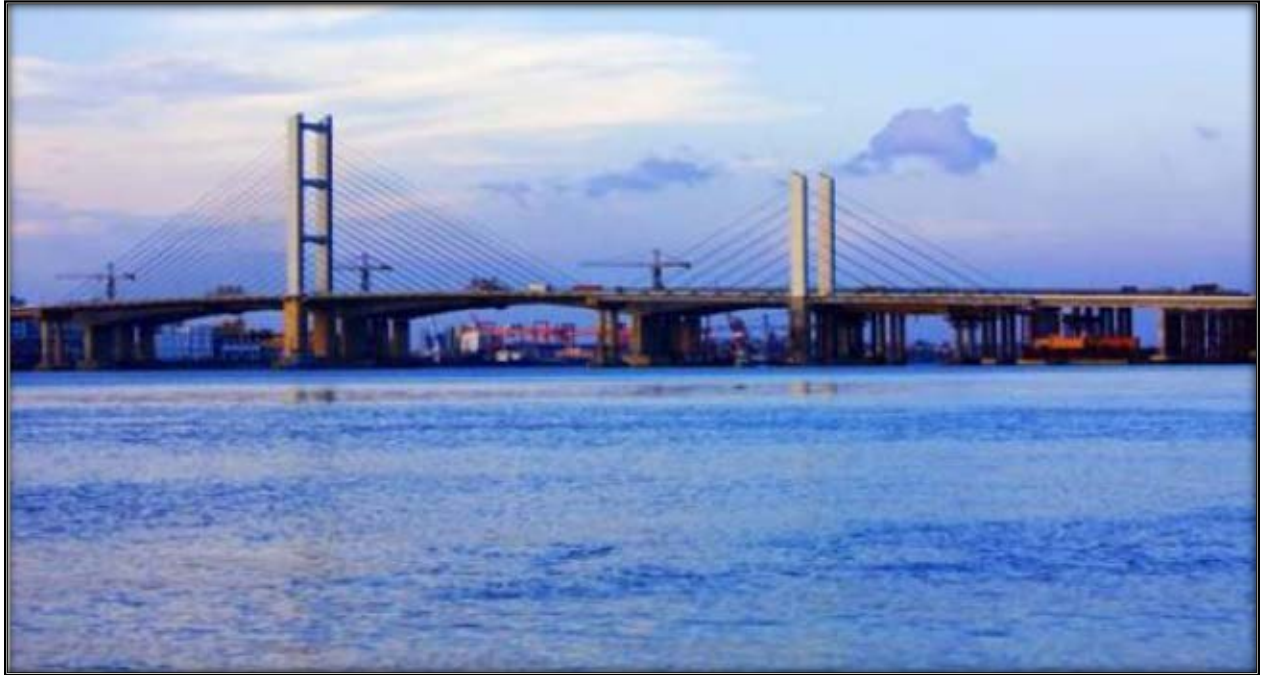
#8 CHINA

<u>Event Date</u>		Trigger Category: Bridge Impact		
June 2007		Vessel Collision with a Pier		
Bridge Type	Immediate Reaction	Special Assessment	Construction Year	Total Length (m)
Cable Stay	Closed Portion	Yes	1988	1675

Description: A vessel collided with a pier and caused a portion of the bridge to collapse. The bridge was closed and a damage inspection was performed. This was a major event and a rehabilitation project was completed in three steps. The steps included removing the sunken ship and collapsed portion of the bridge, followed by the final repair and rehabilitation. This was completed by August 2008.

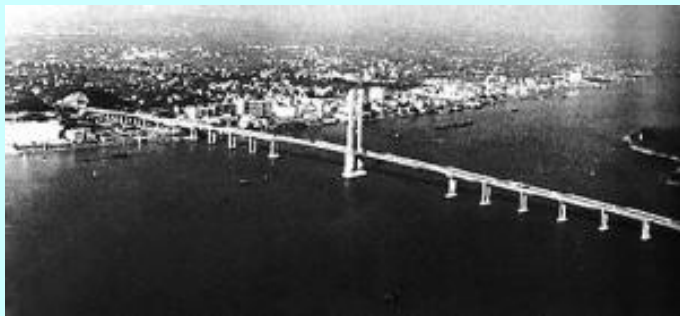
<p>The Original Bridge completed in 1988</p>

Issue: D3.3 – Special inspections and Damage Assessment Techniques	
Country	China
Prepared by	Liu Bo
Date Prepared	July 2016
1.0	Description of Event / Incident
Description of Bridge	<ul style="list-style-type: none"> ○ The Jiujiang Bridge of National Highway No.325 over the Xijiang River(Part of the Pearl River), Guangdong Province,China ○ Total length 1675.2m, bridge deck width of 16m ○ Main span--2x160m single tower cable stayed bridge ○ Approach span--21X50m Prestressed concrete box girder +20X16m concrete slab ○ Open to traffic in June 1988,Repair in 2009 and reopen to traffic in Jun 2009
Picture of Bridge

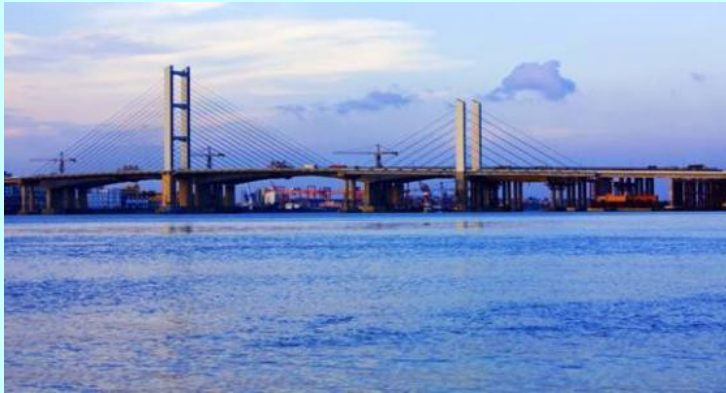
<p>The Repaired Bridge completed in 1988</p>
Description of the event and the trigger that caused the assessment	<p>Examples: bridge hit, excessive deterioration, flood, scour, Routine Inspection resulting in critical finding, emergency, moving super load, etc</p>

Answer	Due to the misty weather, a ship loaded with sand deviated from the designated channel, collided with the pier of non-navigable span, and caused a portion 200m of bridge collapse.
Date of initial event	5:00 am, 15 th June 2007
Describe your immediate reactions to this event	Examples: close bridge, reduce traffic lanes, and determine the need for special assessments, investigations, or special inspections. These initial assessments would lead to follow up actions

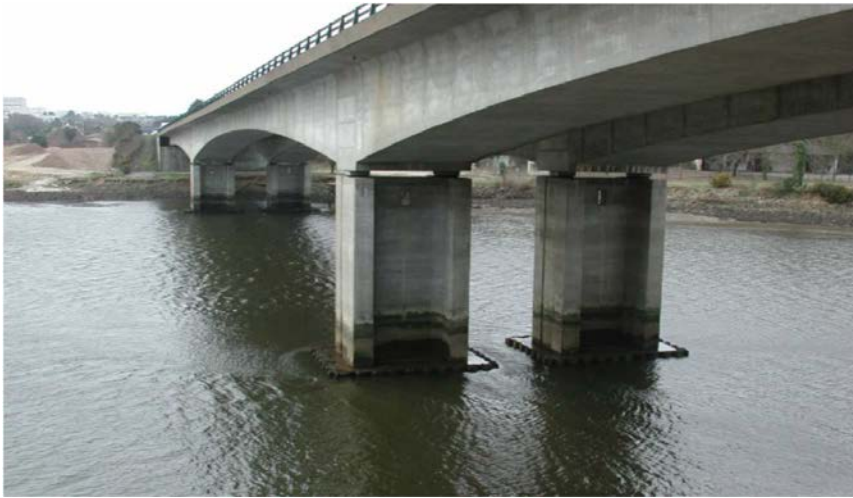
Issue: D3.3 – Special inspections and Damage Assessment Techniques	
Country	France
Prepared by	Laurent Llop
Date Prepared	13 April 2017
1.0	Description of Event / Incident
Description of Bridge	<p>Sach's Queven bridges. Bending cracks.</p> <p>Sach's Queven bridges carry the national road 165 between Nantes and Brest. There are 2 straight and independent bridges, 3 spans, prestressed concrete box girders. These bridges were built in 1976.</p> <p>Length : 204,50 meters</p>
Picture of Bridge
