The PIARC TC D.3 Bridges Technical Committee is publishing a worldwide compilation of case studies as examples for bridge owners in making critical decisions to ensure the safety of the traveling public during a bridge incident caused by damage and deterioration. This case study compilation has 28 worldwide case studies received from 15 unique countries.

These case studies provide examples of incidents where owners discovered damage or deterioration under two main circumstances. Firstly, damage or deterioration resulting over longer periods of time, and secondly damage or deterioration appearing instantaneously. “Triggers” or causes of this damage or deterioration include environmental impacts, increased live loads, deicing applications, poor detailing in the design phase, poor construction materials and specifications, severe loading events, natural disasters, impacts, construction defects or by human error. At times, this discovery of damage and deterioration may lead to a bridge closure, traffic restriction, or weight restriction. This should result in damage assessment techniques, load carrying capacity calculations, and subsequent remedial works to return the bridge into serv

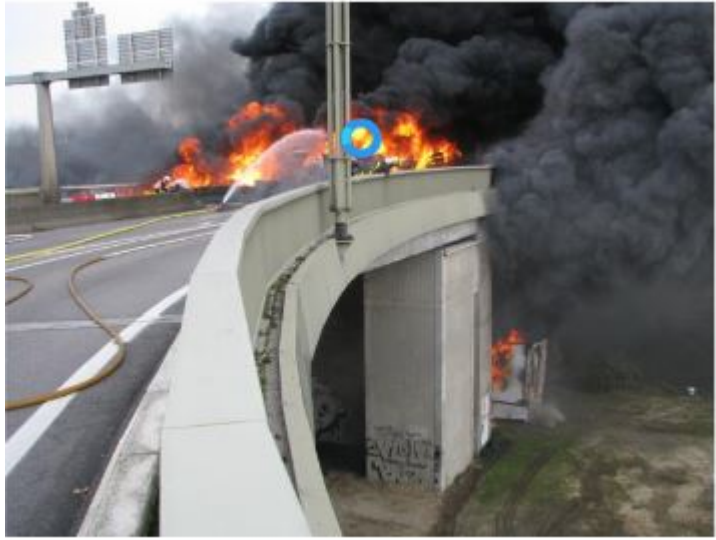
Picture of Bridge

Issue: D3.3 – Special inspections and Damage Assessment Techniques	
Country	France
Prepared by	Laurent Llop
Date Prepared	13 April 2017
1.0	Description of Event / Incident
Description of Bridge	<p>Mathilde bridge. Fire on the bridge in 2012.</p> <p>Burned zone was metallic bridge, this bridge was built in 1979. Length : 585 m, multi span, one span is metallic, others are concrete box girders.</p> <p>This bridge is in Rouen. It's not managed by the State but by the department of Seine Maritime (regional organization of France).</p>

Answer	An accident has occurred : A truck carrying hydrocarbons overturned on the bridge and fire began. Then the burning liquid flew under the bridge and several parked vehicles took fire.
Date of initial event	29 October 2012
Describe your immediate reactions to this event	Examples: close bridge, reduce traffic lanes, and determine the need for special assessments, investigations, or special inspections. These initial assessments would lead to follow up actions

<p>The temporary fix was to close the bridge for vehicles and boats, then only for vehicles in a second time.</p> <p>The permanent fix were :</p> <ul style="list-style-type: none"> - solution 1 – partial replacement of the metallic span, after entire removal, - solution 2 - partial replacement of the metallic span, in situ. <p>Solution 1 was the chosen solution, because the second need to built a temporary pier which was a problem for the boat traffic under the bridge.</p>

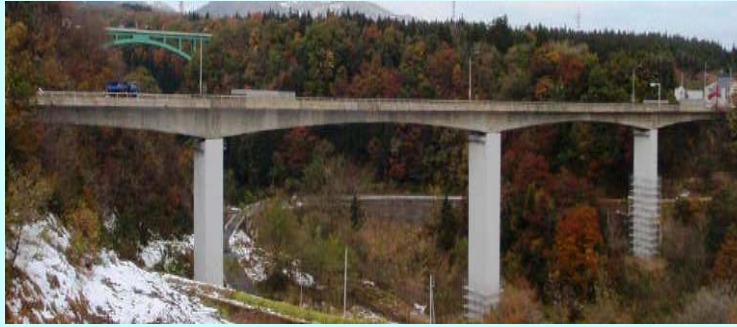
Issue: D3.3 – Special inspections and Damage Assessment Techniques	
Country	Japan
Prepared by	
Date Prepared	
1.0	Description of Event / Incident
Description of Bridge	Myoko Bridge on National Highway 18 is located in Myoko city, Niigata prefecture. The bridge is a 4-spanned continuous PC box-girder bridge, and spans over the Ohtagiri River with a total length of 300m. The bridge is comprised of pre-cast blocks. The cantilever election was used when the bridge was built. The construction was completed in 1972. The bridge serves as a major link between Hokuriku and Kanto regions or Hokuriku and Chukyo regions. The bridge carries approximately 15,000 vehicles per day, and among these, the amount of heavy vehicles is 2,400 per day with a share of heave vehicles in the total traffic volume is about 16%.
Picture of Bridge

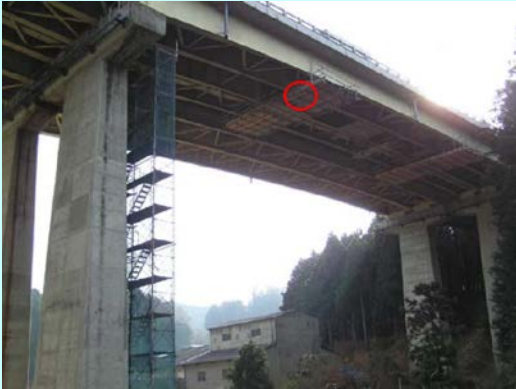
Issue: D3.3 – Special inspections and Damage Assessment Techniques	
Country	Japan
Prepared by	
Date Prepared	January 24, 2017
1.0	Description of Event / Incident
Description of Bridge	<p>Route : National Route 25, Meihan Expressway</p> <p>Type of Road : Motorway</p> <p>Type of Bridge : 3-spanned continuous steel girder bridge</p> <p>Bridge Length : 128m</p> <p>Bridge Deck : Reinforced Concrete Deck</p> <p>Completion : 1971</p> <p>Traffic Amount : Approx. 60,000 vehicles per day (45% of heavy vehicles)</p>
Picture of Bridge

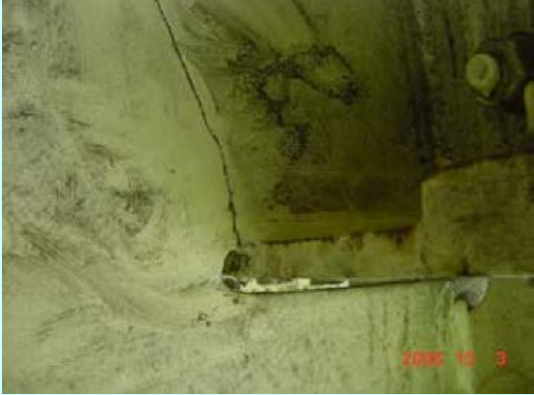
Answer	<p>During a periodic inspection, the inspector found a crack with a length of 1m developing from the welding connection around the slit between main girder and transverse girder to the girder web. (picture below)</p>

<p>Answer</p>	<p>- Fatigue crack is regarded as a major cause. The bridge had carried heavy traffic for more than 30 years, and the bridge had vulnerable substandard details of welding connection. to. And, they concluded that the defect was fatigue crack.</p> <p>- To find other defects in all similar connections, magnetic-particle testing was carried out as well as close visual inspection.</p> <p>- Stop hole with adding splices on the both side of the web. This emergency measure was carried out under the traffic closure because the stress intensity at the tip of the crack had to be reduced as much as possible.</p> <p>- Moreover the lower flange was stiffened by setting an H-shaped steel across over the cracked cross section for the purpose of backup of unforeseeable and</p>

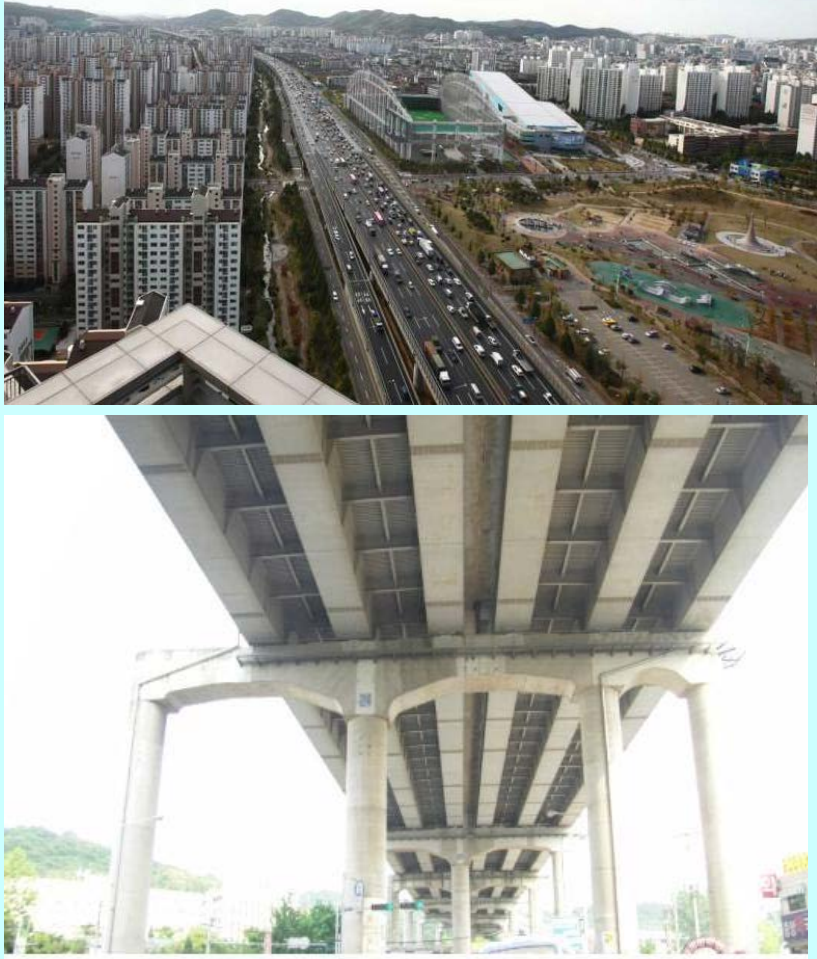
<p>Picture of Bridge</p>

<p>Description of the event and the trigger that caused the assessment</p>	<p>Examples: bridge hit, excessive deterioration, flood, scour, Routine Inspection resulting in critical finding, emergency, moving super load, etc</p>
<p>Answer</p>	<p>The tanker truck, which was illegally parked underneath the bridge between 72 pier (P72) and 73 pier (P73), caught fire. The fire lasted for about an hour and caused severe damages. The high temperature flames substantially reduced stiffness and strength of steel box girders. This lead to the breakage of the girders and sagging of bridge.</p>

Answer	<p>The main priority was quick recovery. While recovery plan was devised, the damaged portion of the bridge was removed. The superstructure, concrete deck and steel box girder, was first cut using a diamond saw cutting method.</p> <p>To reduce time, factory made precast deck as well as steel box girders were employed.</p>

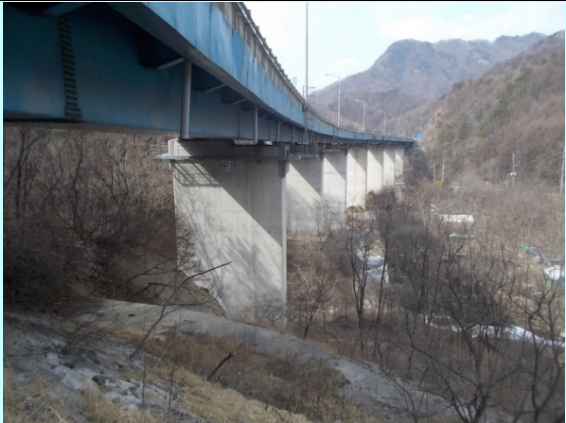
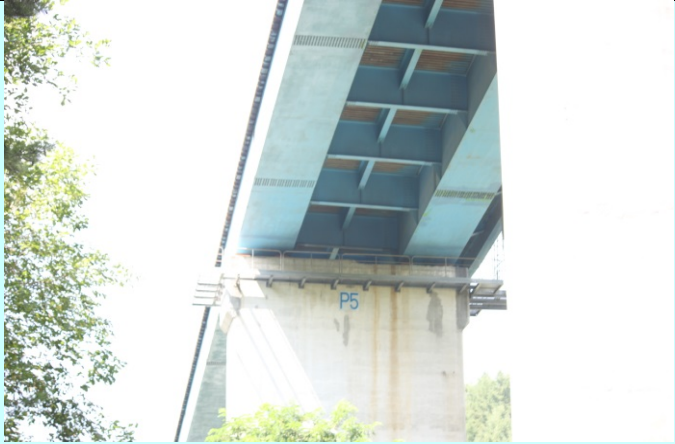
Picture of Bridge

Description: Severe corrosion in the box girders were discovered during an initial inspection. An expansion joint leaked de-icing agents into large areas of the box girders. Traffic was not restricted. A special inspection and model were built. It was concluded to plate the lower members where there was severe section loss.

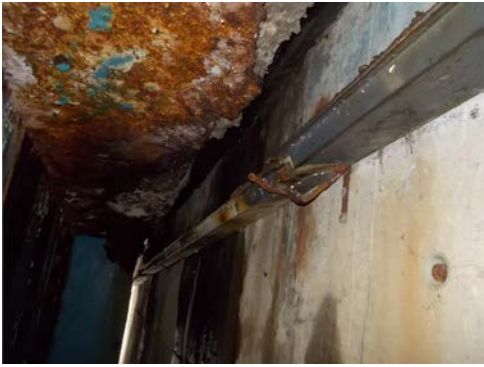
<p>< Expansion Joint ></p> </div>

<p>Description of the event and the trigger that caused the assessment</p>	<p>Examples: bridge hit, excessive deterioration, flood, scour, Routine Inspection resulting in critical finding, emergency, moving super load, etc</p>
<p>Answer</p>	<p>The inspection initially showed the following problems:</p> <ul style="list-style-type: none"> - The coating for the bottom flanges of the steel box girders was severely damaged over a large area - The bottom flanges were significantly corroded, with section loss. - The top flanges of the box girder under expansion joints were also severely damaged <p>Water and de-icing agent introduced into the inside of the box girder through leaky expansion joints caused these damages.</p> <div data-bbox="592 1203 1360 1633">

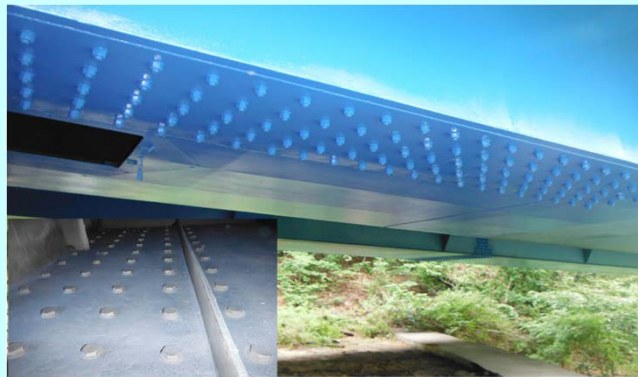
Answer - What were the potential temporary / permanent fixes considered at the time of the decision?	<p>The corrosion and section loss of the bottom flange was mainly occurred at the ends of the box girders with the lower tensile stress. Therefore, it was decided to retrofit the corroded bottom flange with an 8mm thick steel plate. As shown in following figures, the plate was attached with closely</p>

<p>spaced high strength bolts.</p>

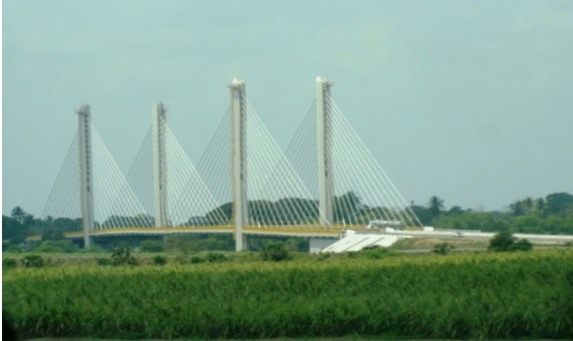
Issue: D3.3 – Special inspections and Damage Assessment Techniques	
Country	Mexico
Prepared by	Francisco J. Carrion
Date Prepared	February 20, 2017
1.0	Description of Event / Incident
Description of Bridge	The Río Papaloapan Bridge is a cable stayed structure with 203 m span length and 422.37 m total length, and it is located in the state of Veracruz in México. It has 8 semi-harps with 14 cables each; semi-harps.
Picture of Bridge

Description of the event and the trigger that caused the assessment	Defective weld in the upper anchoring element of one cable, with initial cracks that evolved due to fatigue. Failure took place on June 10 th , 2015.

Answer	Failed element was programmed for repair and, since other welds could have the same problems, a general inspection was programmed with acoustic emissions technique, while welds are embedded in concrete pylons. To calibrate the inspection to the defect size in the welds, two welds would be selected with different acoustic emission level (high and medium), then opened for penetrant and ultrasonic inspections and then repaired.
Date of initial event	June 10 th , 2015
Describe your immediate reactions to this event	Visit to the bridge and recovery of monitoring data for analysis. The bridge has a SHM permanent system.

Answer	To prevent critical conditions, it was proposed to limit traffic only on the left line on the side where failure occurred, this to prevent load concentrations, and also, at low speed only to reduce dynamic effects. A temporary support system was proposed

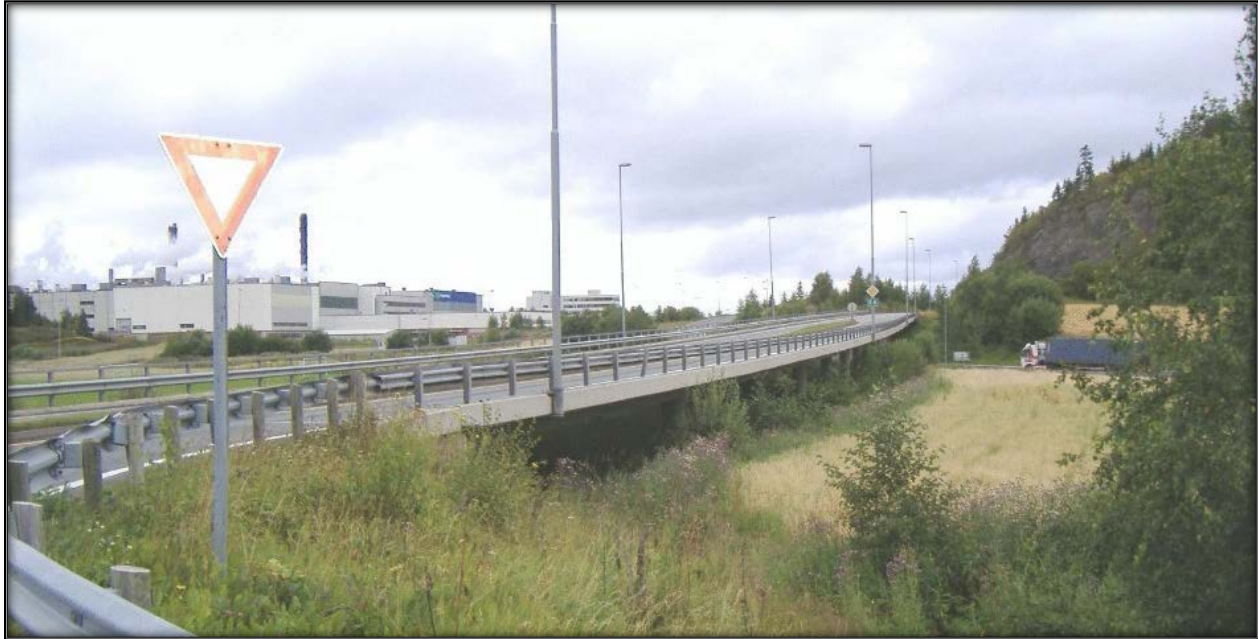
#16 NORWAY

<u>Event Date</u>		Trigger Category: Inspection		
2015		Expansion joint failure damaging side wall of abutments		
Bridge Type	Immediate Reaction	Special Assessment	Construction Year	Total Length (m)
Concrete Slab	Special Inspection	Yes	1975	214

Description: During a simple inspection in 2015 it was found that the bridge deck had no more expansion room at the joints and that the concrete was damaged along the side walls of the abutments (spalling). The immediate reaction was to remove the back wall and build one 10 cm behind the original one. Traffic was removed during work and special investigations. The permanent fix will include many more repairs and remediation. This work is ongoing.

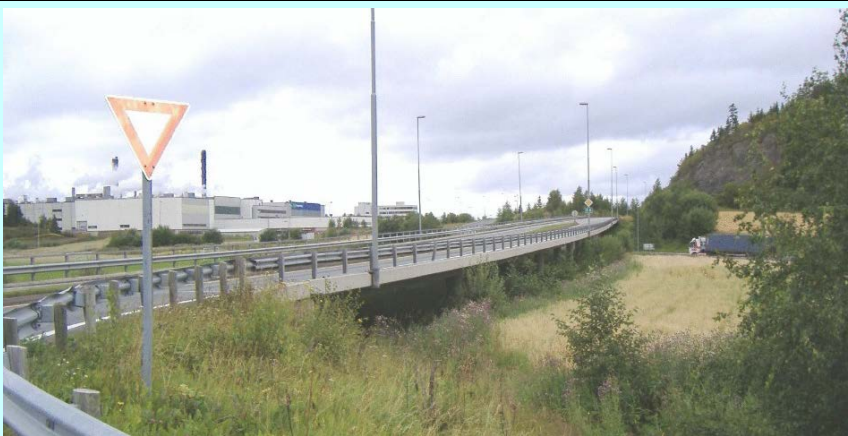
<p>Picture of Fiborg bridge</p>

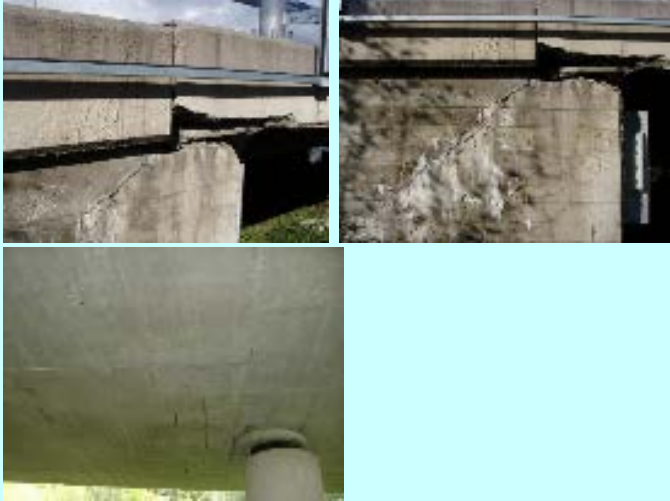
<p>Damage on kerbs of bearing</p> <p>Displacement</p>
Date of initial event	Simple inspection in 2015
Describe your immediate reactions to this event	The immediate reaction was to make it possible for the bridge to expand by removing the back wall of the abutment and reconstruct a new one appr. 10 cm behind the original one. Additionally, it was decided to reduce the asphalt thickness on the deck to reduce the weight on the bridge. Removing the asphalt revealed considerable and severe damage to the deck. The reaction to this was to perform further investigations.

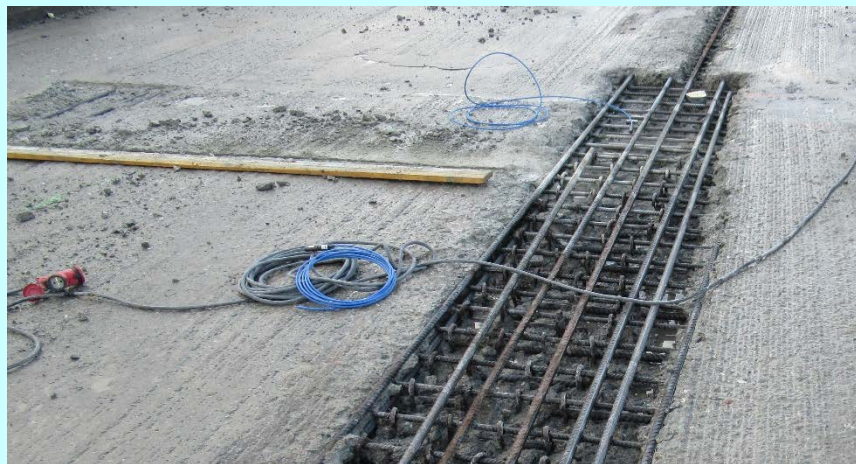
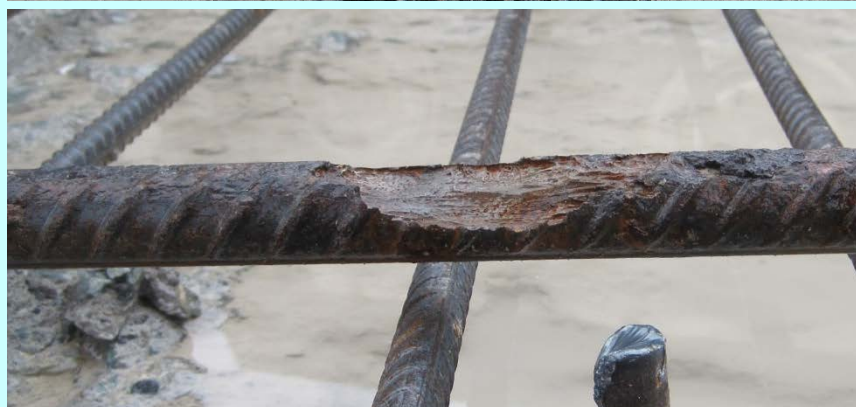
- Lifting up the superstructure by jacking to move the bearings on axis 12, 13 and 14 back to the centre of the columns. The supporting area underneath the deck for the bearings and the jack was expanded.
- Replacement of the bearings on the abutment on axis 15.
- Cleaning the deck after removal of the asphalt revealed big areas with disintegrated concrete caused by frost, bad construction joints and some corrosion of the reinforcement especially on spots where there earlier has been a central reserve.
- The water chiselling revealed severe corrosion on the top bars of the reinforcement across the entire bridge deck. It was decided to take 10 core samples and install five reference electrodes to monitor the corrosion speed. The cores were sent to a laboratory for analysis.
- The water-chiselled area of 115 m² was repaired. The deck was given a waterproof layer and a new asphalt layer.

It was decided to postpone the repairs on the corroded reinforcement of the kerbs until the complete assessment of the bridge was finished.

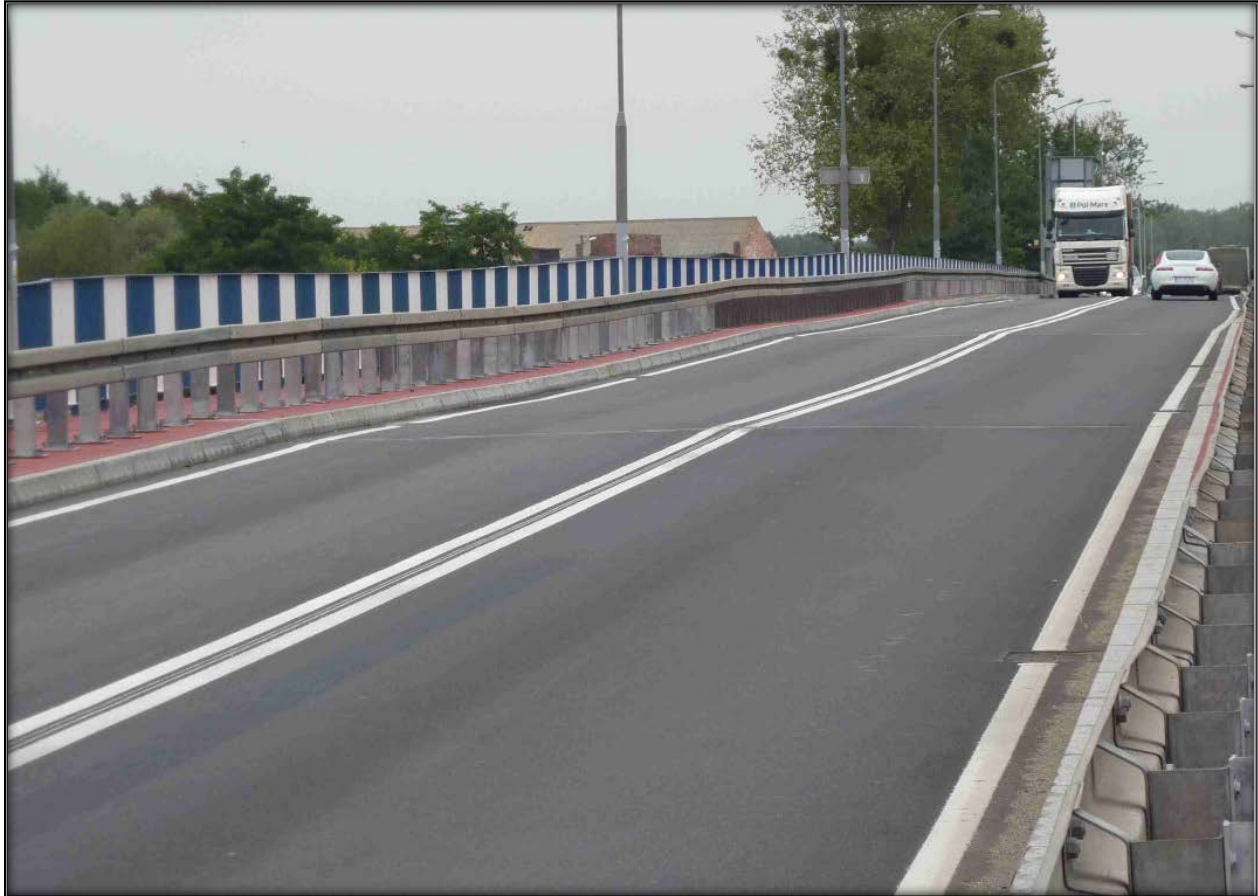
#17 POLAND

<u>Event Date</u>		Trigger Category: Inspection		
September 2014		Part of bridge portion appeared to have sank		
Bridge Type	Immediate Reaction	Special Assessment	Construction Year	Total Length (m)
Double T Post Tension Girders	Restricting Heavy Trucks	Yes	1970	233

Description: During a routine inspection, an observation of the barriers and edge beam showed the portion of the bridge was sinking. The owner restricted heavy trucks immediately. It was determined a default in the girders and the bridge stabilized. Proof testing was performed and no repairs were made. Heavy truck traffic remains restricted.

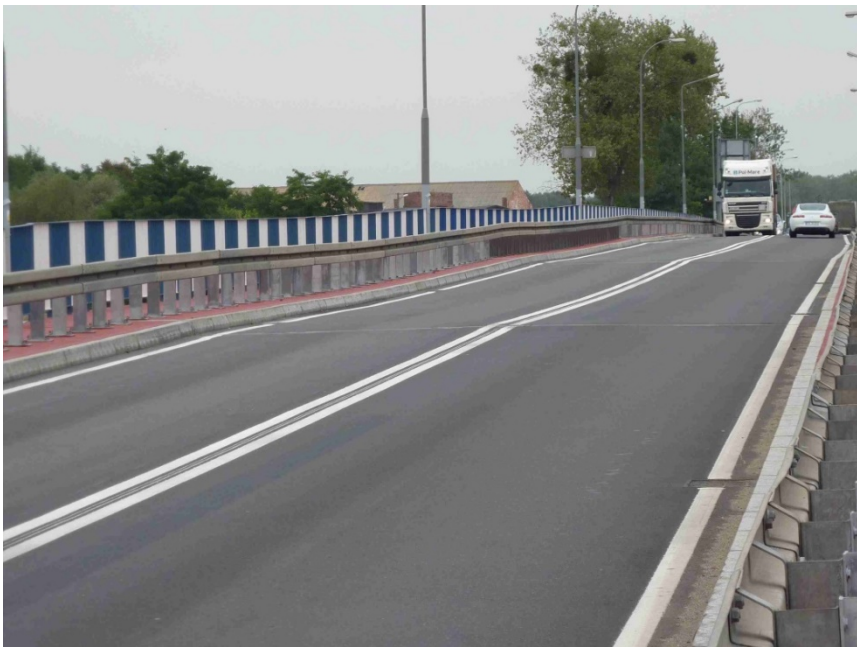
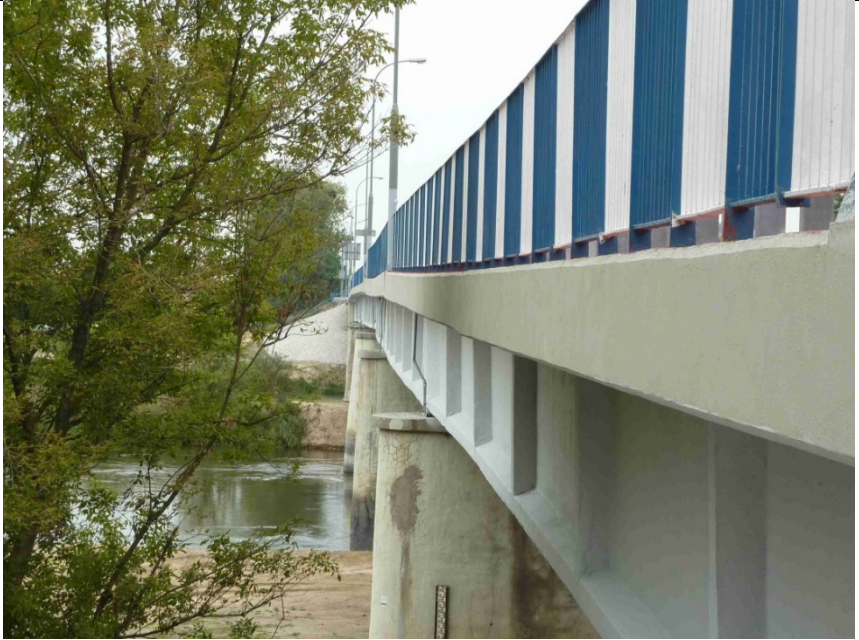
Picture of Bridge

Issue: D3.3 – Special inspections and Damage Assessment Techniques	
Country	POLAND
Prepared by	ARTUR ROSIAK
Date Prepared	12.11.2016
1.0	Description of Event / Incident
Description of Bridge	<p>The bridge was built in the early 70s of the twentieth century. Six span bridge, static diagram - a simply supported beam. Theoretical span length is 38,75m. In cross-section, there are five post-tensioning girders (double T) combine with reinforced concrete slab by prestressed cables. The nominal spacing between beams is 2.16 m.</p> <p>Beams was made using concrete with compressive strength 40 MPa. The nominal height of the girders, including slab is 229cm. Nominal thickness of the concrete slab - 12cm. Slab was made using concrete with compressive strength 25 MPa and reinforced by steel bars with a diameter of 8.3 mm, placed every 9 cm. Pillars are transmural (massive), made from concrete with compressive strength 40.0 MPa founded on piles Francs.</p> <p>In 2014, due to an emergency condition of the bridge deck was completed its replacement works. Compared to the primary solution the designer increased thickness of concrete plate and bridge concrete class.</p>

Answer	After opened bridge and putting it into exploitation during routine inspection visual observation revealed deflection of protective barriers and edge beam. Detailed observation show progressive changes in the bridge grade line.
Date of initial event	September 2014
Describe your immediate reactions to this event	Examples: close bridge, reduce traffic lanes, and determine the need for special assessments, investigations, or special inspections. These initial assessments would lead to follow up actions

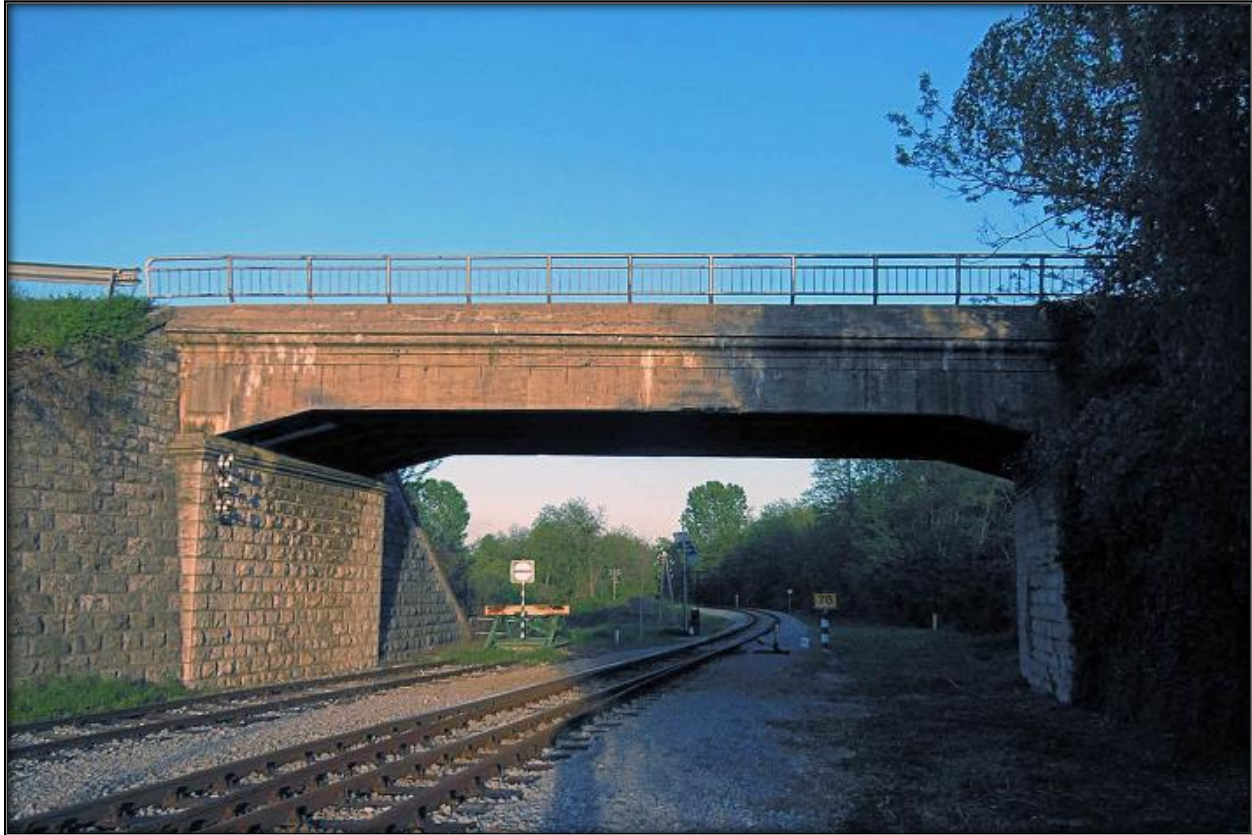
#18 SLOVENIA 1

<u>Event Date</u>		Trigger Category: Rating		
		200 older bridges designed and deteriorated assessed for safety		
Bridge Type	Immediate Reaction	Special Assessment	Construction Year	Total Length (m)
Reinforced Concrete Beams	No Immediate Reaction	Yes	1960	0

Description: Over 200 older bridges were assessed for structural safety. A program of different analysis and assessment techniques was used to determine what bridges would need posting or strengthening. Load posting of the bridges was to be mitigated based on the program assessment techniques. Of the 200 bridges that were evaluated 13 needed actions in form of strengthening or load posting.

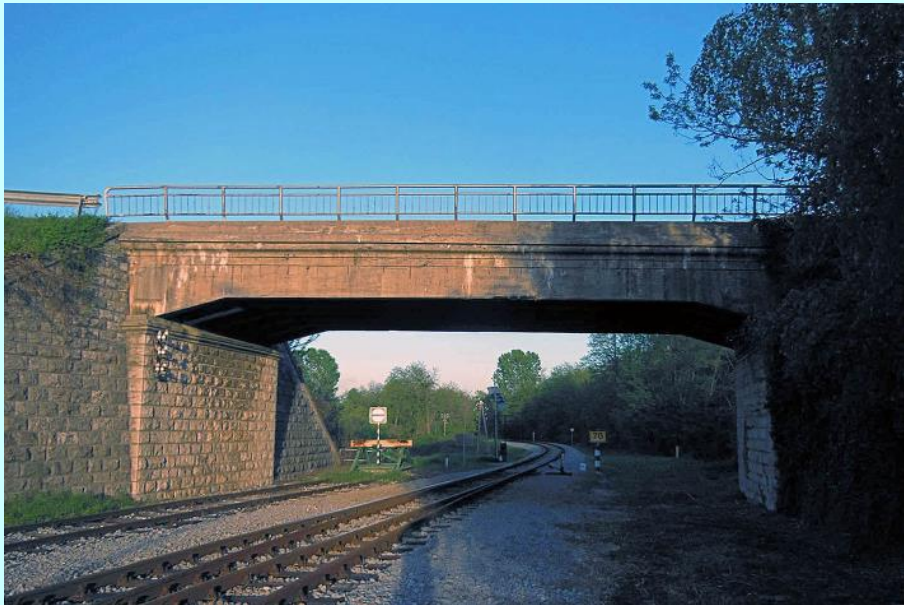
<p>Fig.1</p>

Issue: D3.3 – Special inspections and Damage Assessment Techniques	
Country	SLOVENIA
Prepared by	Aleš Žnidarič
Date Prepared	22 th March, 2017
1.1	Description of Event / Incident
Description of Bridge	Typical bridge constructed before 1975, many before 1960 or even WW II. They were in majority of cases constructed of reinforced concrete beams with cast in place RC slab. They were designed as simply supported, but have no or have non-functional expansion joints and bearings. For most pre- WW II bridges the designs or drawings do not exist.
Picture of Bridge

Answer	Due to the old design codes these bridges are by definition under-designed. Many of them are deteriorated, they are built with lower strength concrete (below 25 MPa), many have corroded reinforcement. Most are situated on low volume roads with limited heavy traffic.
Date of initial event	Nor relevant
Describe your immediate reactions to this event	Examples: close bridge, reduce traffic lanes, and determine the need for special assessments, investigations, or special inspections. These initial assessments would lead to follow up actions

Answer	<p>Usually the level 1 assessment involves 2D FE analysis. The model is updated to match as closely as possible the girder factors and the influence lines measured with the B-WIM system. For example, the figure below presents the results of measured influence lines on a 25-m long bridge that by design should be simply supported. The average bending moment influence line, obtained from the individual ones calculated for every vehicle that crosses the bridge, is far from a simply-supported one. Savings can be from a few percent on new bridges to over 100% on bridges like the one on Fig.1. Those bridges in reality behave like integral (frame-type) bridges.</p>

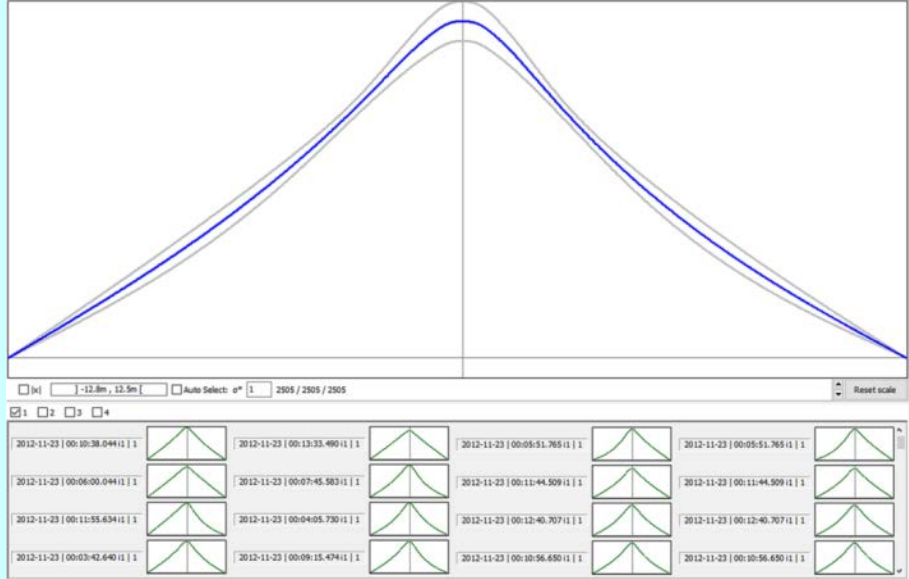
<p>Fig 3 – B-WIM software evaluating the influence lines of all vehicles</p> <p>In a similar way, the B-WIM evaluates, for every crossing of the vehicle, the load distribution over the measured structural members.</p>

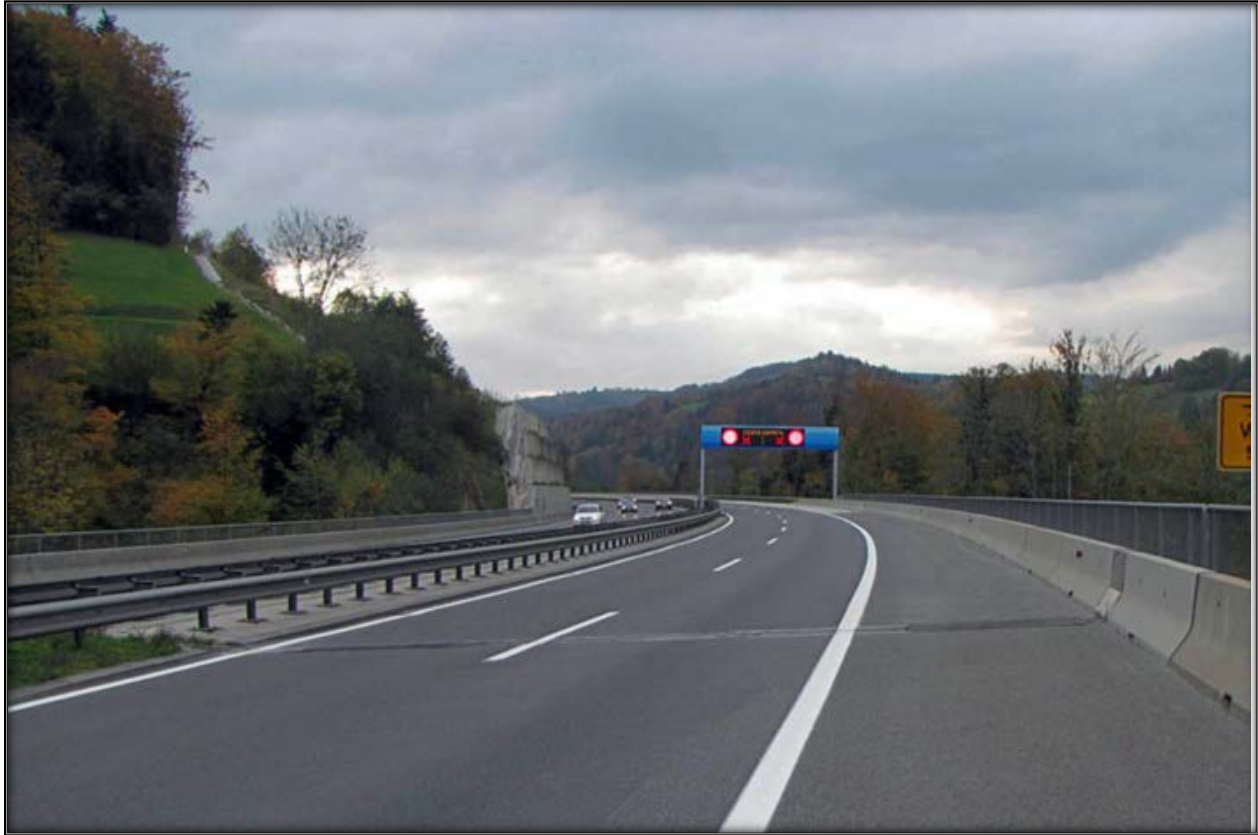
#19 SLOVENIA 2

<u>Event Date</u>		Trigger Category: Bridge Element Failure		
2009		An element of the expansion joint failed		
Bridge Type	Immediate Reaction	Special Assessment	Construction Year	Total Length (m)
Concrete Box Girder	Lane Closed	Yes	2009	91

Description: An element of an expansion joint failed. The driving and emergency lanes were closed immediately. An expansion joint expert was called in to evaluate all other elements and expansion joints. As an element was not in stock the replacement took four weeks.

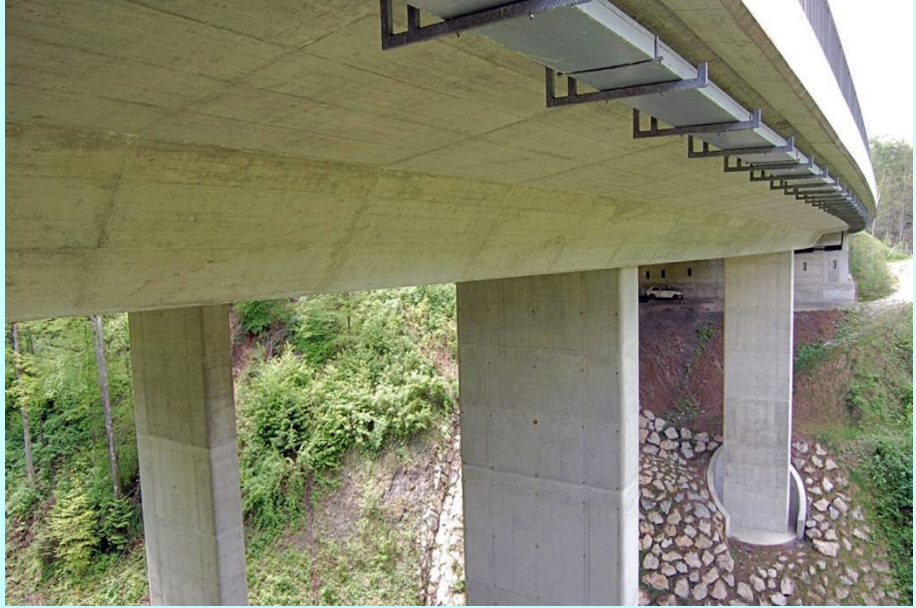
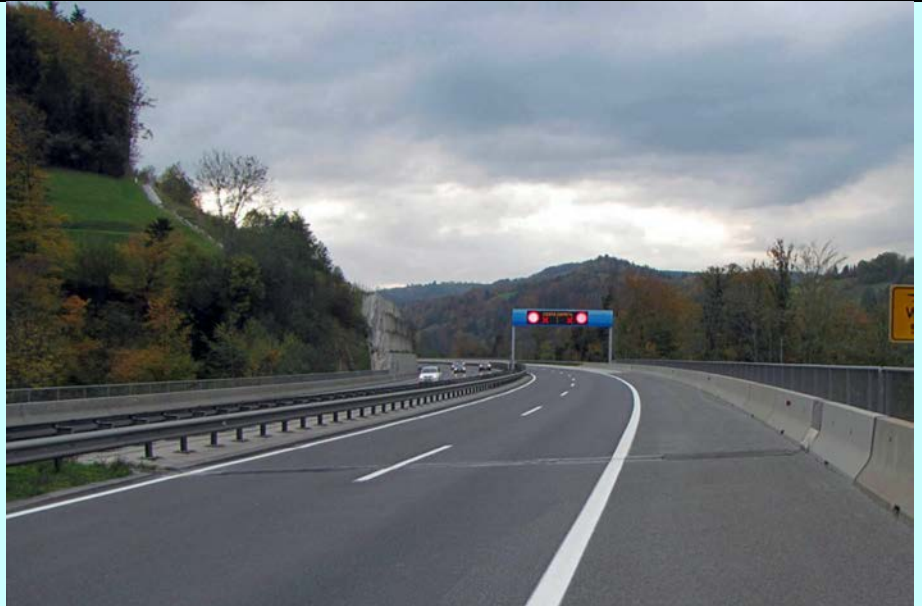
Issue: D3.3 – Special inspections and Damage Assessment Techniques	
Country	SLOVENIA
Prepared by	Aleš Žnidarič
Date Prepared	11 th May, 2017
1.1	Description of Event / Incident
Description of Bridge	<p>A continuous box girder bridge over three spans. Total length 91 m. Width 12 m. On light slope and in curve. Located on a motorway and carries 2 driving lanes and the emergency lane. At the time of the event the bridge was only 8 years old.</p> <p>Bridge is located in the area with relatively harsh climate conditions, with a lot of snow during winters, and consequent snow ploughs and salting.</p>
Picture of Bridge

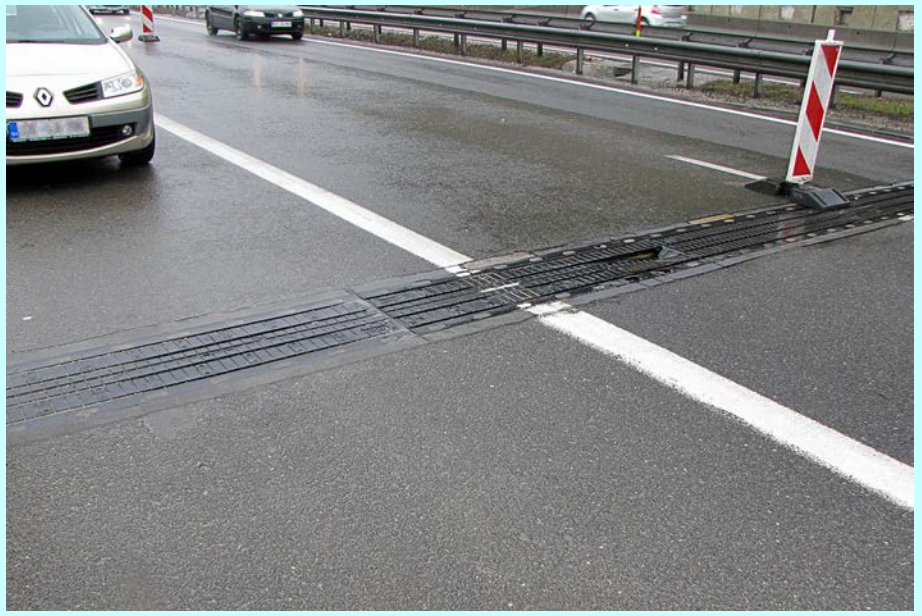
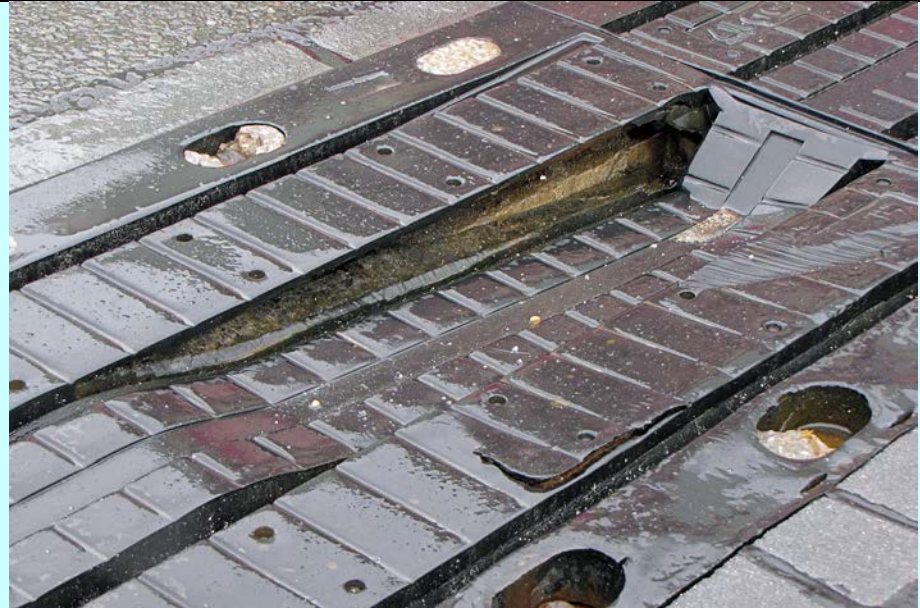
Fig.2

<p>Description of the event and the trigger that caused the assessment</p>	<p>Examples: bridge hit, excessive deterioration, flood, scour, Routine Inspection resulting in critical finding, emergency, moving super load, etc</p>
<p>Answer</p>	<p>An element of the expansion joint failed</p>

Answer	The lesson learned was that the owner should keep in stock some typical (standard and easy-to-replace) expansion joint elements, to avoid delays due to the rigid procurement rules, which were the main reason for long-lasting rehabilitation. Also, at the time of construction, the type of expansion joint was changed from steel to rubber, which was an important reason for accelerated deterioration that could have been avoided.

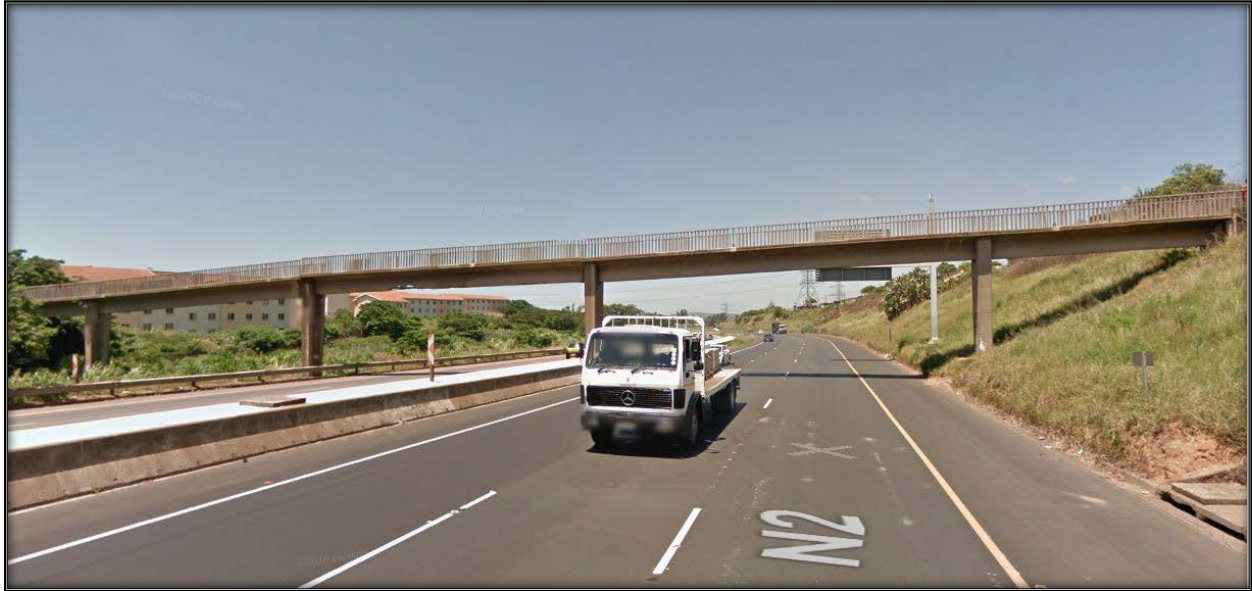
#20 SOUTH AFRICA

<u>Event Date</u>	Trigger Category: Bridge Impact			
November 2014	Pedestrian bridge hit above freeway			
Bridge Type	Immediate Reaction	Special Assessment	Construction Year	Total Length (m)
Post Tension T Beam	No Immediate Reaction	No	1979	95

Description: A pedestrian bridge was struck by a vehicle. The owner decided to jack up the bridge by .5 meters as a temporary solution before making a permanent repair. The jacking of the bridge was completed in December of 2015 and the permanent repairs of the damaged area was completed in October 2015.

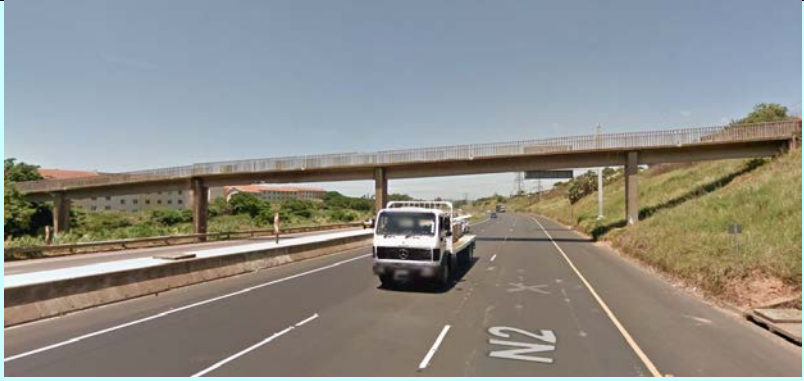
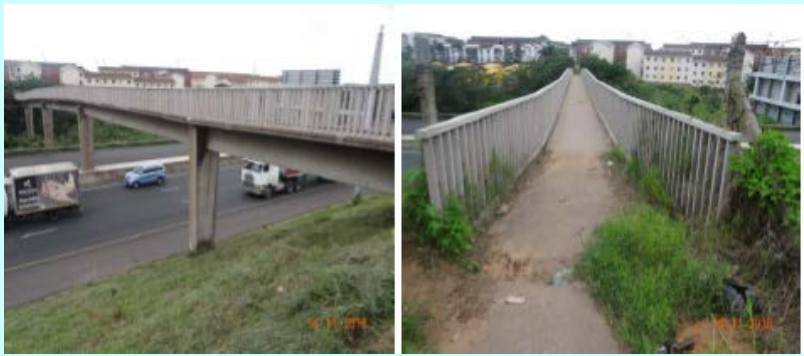
Picture of Bridge

Description of the event and the trigger that caused the assessment	Examples: bridge hit, excessive deterioration, flood, scour, Routine Inspection resulting in critical finding, emergency, moving super load, etc
Answer	<p>Bridge deck hit by vehicle in excess of legal height limit of 4.7m on the southbound carriageway. The minimum clearance of the bridge was 5.03m. Resulting damage was loss of concrete section in the web of the deck with exposure of post-tension tendons.</p>

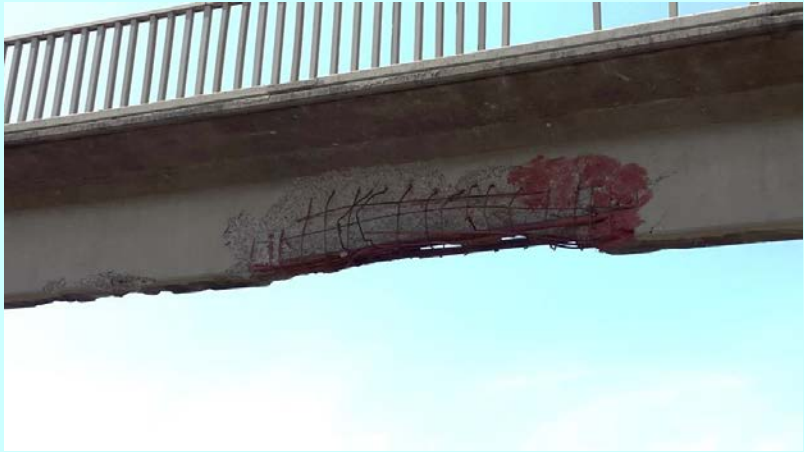
Answer	The immediate concern was the exposed post-tensioning ducts. Should the ducts be severed by an over height vehicle, this will cause the collapse of the span onto the freeway.
Who in your organization and made the immediate assessment and what qualifications did they have?	Examples: Bridge inspector, maintenance crew, law enforcement, structural engineer, field personal, etc.

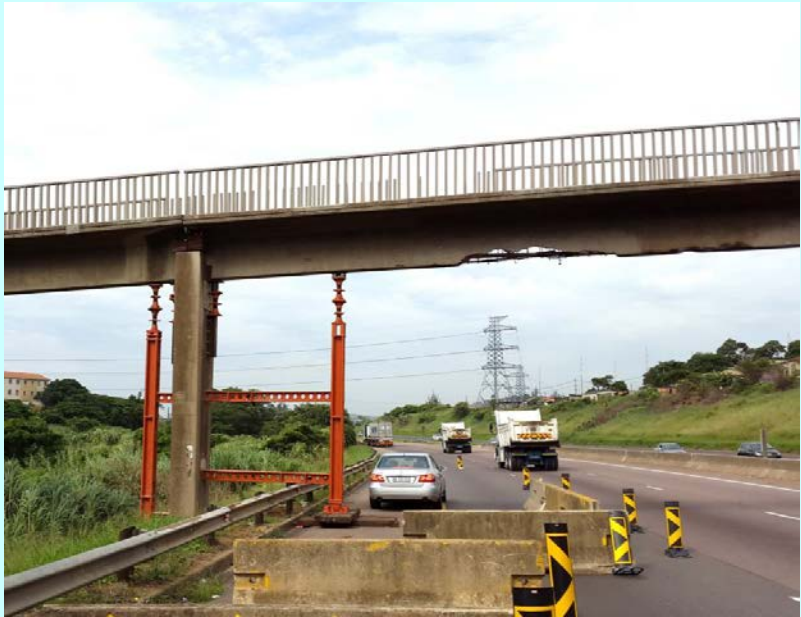
<p>Jacking of the bridge.</p> <p>The decision to raise the bridge to protect the bridge's exposed post-tension ducts proved to be the correct decision as the bridge was impacted again on 18 February 2015. Had the bridge clearance been lower, the end result may have</p>

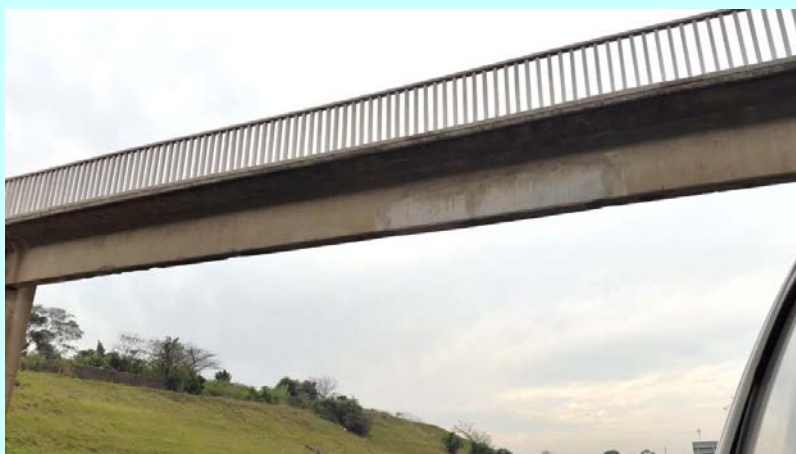
Completed Repairs

been the collapse of the bridge span. The minimum clearance now is 5.550m.

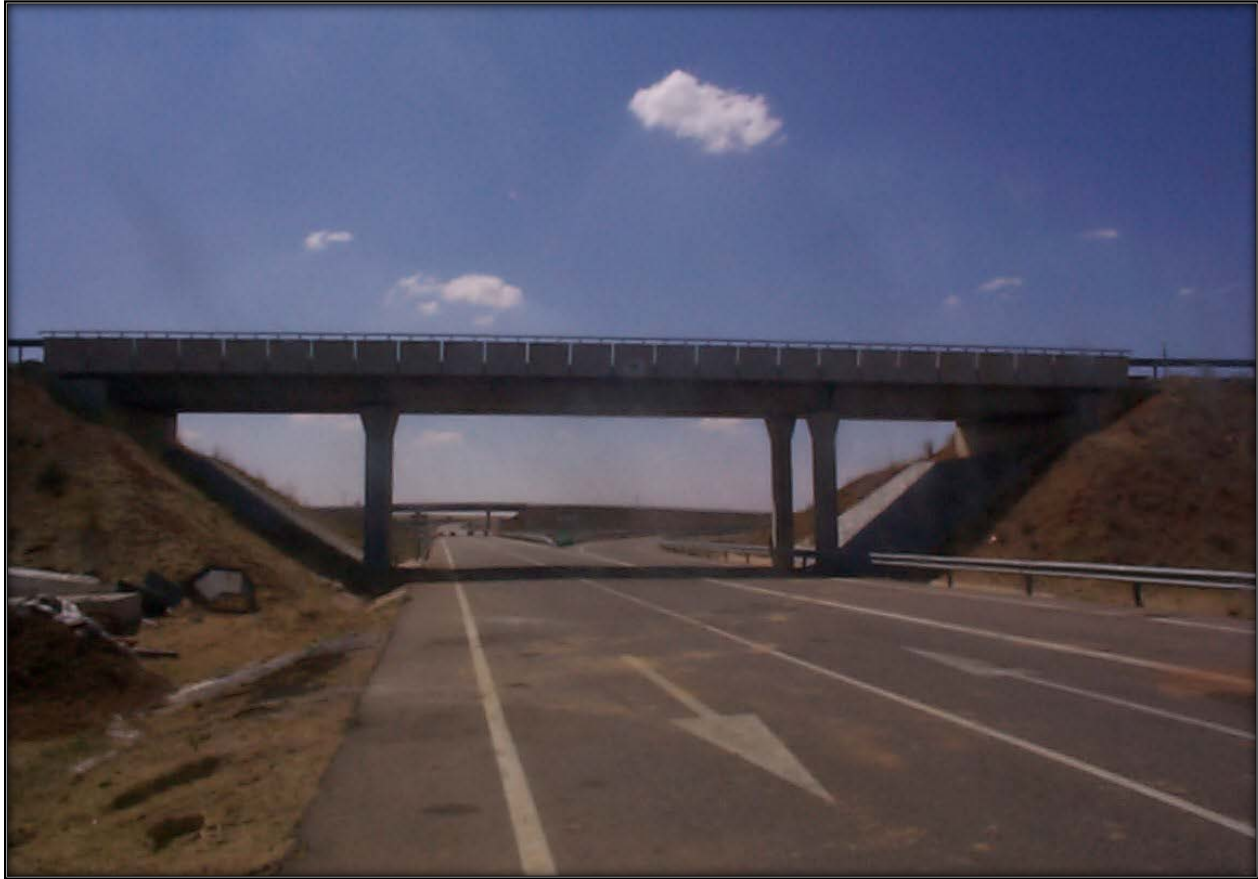
#21 SPAIN 1

<u>Event Date</u>	Trigger Category: Bridge Impact			
July 2002	Bridge hit by a vehicle knocking out a column			
Bridge Type	Immediate Reaction	Special Assessment	Construction Year	Total Length (m)
Prestress Concrete Box Girder	Closed Bridge	Yes	1995	60

Description: A heavy vehicle hit one of the columns of the pier, causing the collapse of it. The girders supported by this column were hanging on the deck. The bridge was closed and traffic was restricted underneath. Big hydraulic jacks were installed to replace the collapsed column as a temporary fix. A new column was formed and installed and tests were performed for the deck to ensure adequate serviceability. The work was completed in 42 days.
