The PIARC TC D.3 Bridges Technical Committee is publishing a worldwide compilation of case studies as examples for bridge owners in making critical decisions to ensure the safety of the traveling public during a bridge incident caused by damage and deterioration. This case study compilation has 28 worldwide case studies received from 15 unique countries.

These case studies provide examples of incidents where owners discovered damage or deterioration under two main circumstances. Firstly, damage or deterioration resulting over longer periods of time, and secondly damage or deterioration appearing instantaneously. “Triggers” or causes of this damage or deterioration include environmental impacts, increased live loads, deicing applications, poor detailing in the design phase, poor construction materials and specifications, severe loading events, natural disasters, impacts, construction defects or by human error. At times, this discovery of damage and deterioration may lead to a bridge closure, traffic restriction, or weight restriction. This should result in damage assessment techniques, load carrying capacity calculations, and subsequent remedial works to return the bridge into serv

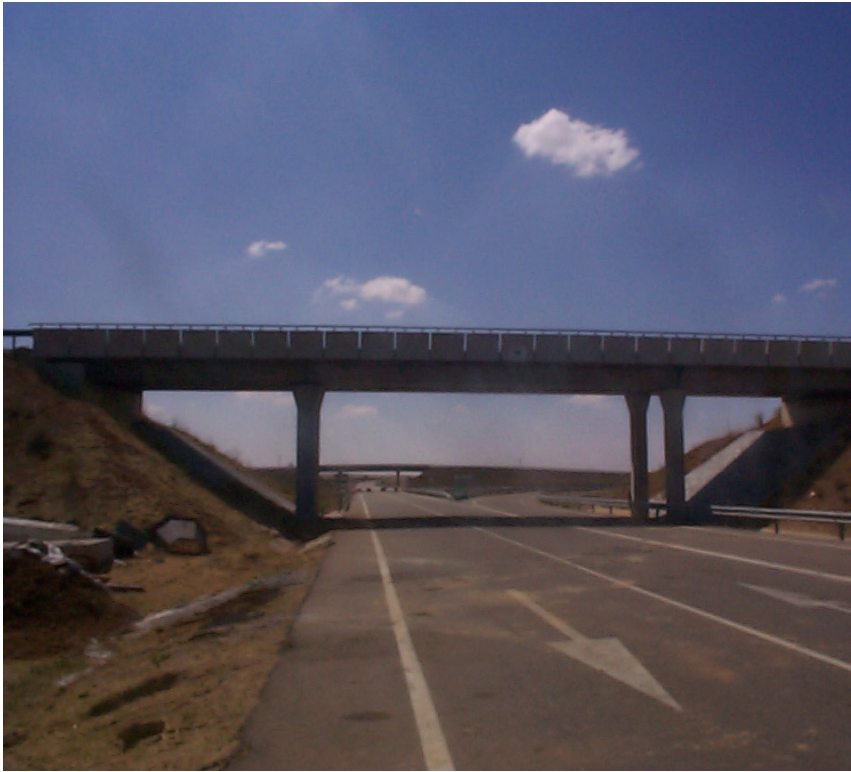
1.0	Description of Event / Incident
Description of Bridge	<p>3 span bridge crossing over route N-610, near the city of Palencia (Castilla y León, Spain).</p> <p>Each span is a precast pre-stressed concrete box girder (2 girder) with a reinforced concrete deck. Each girder is supported on one precast reinforced concrete column.</p>
Picture of Bridge

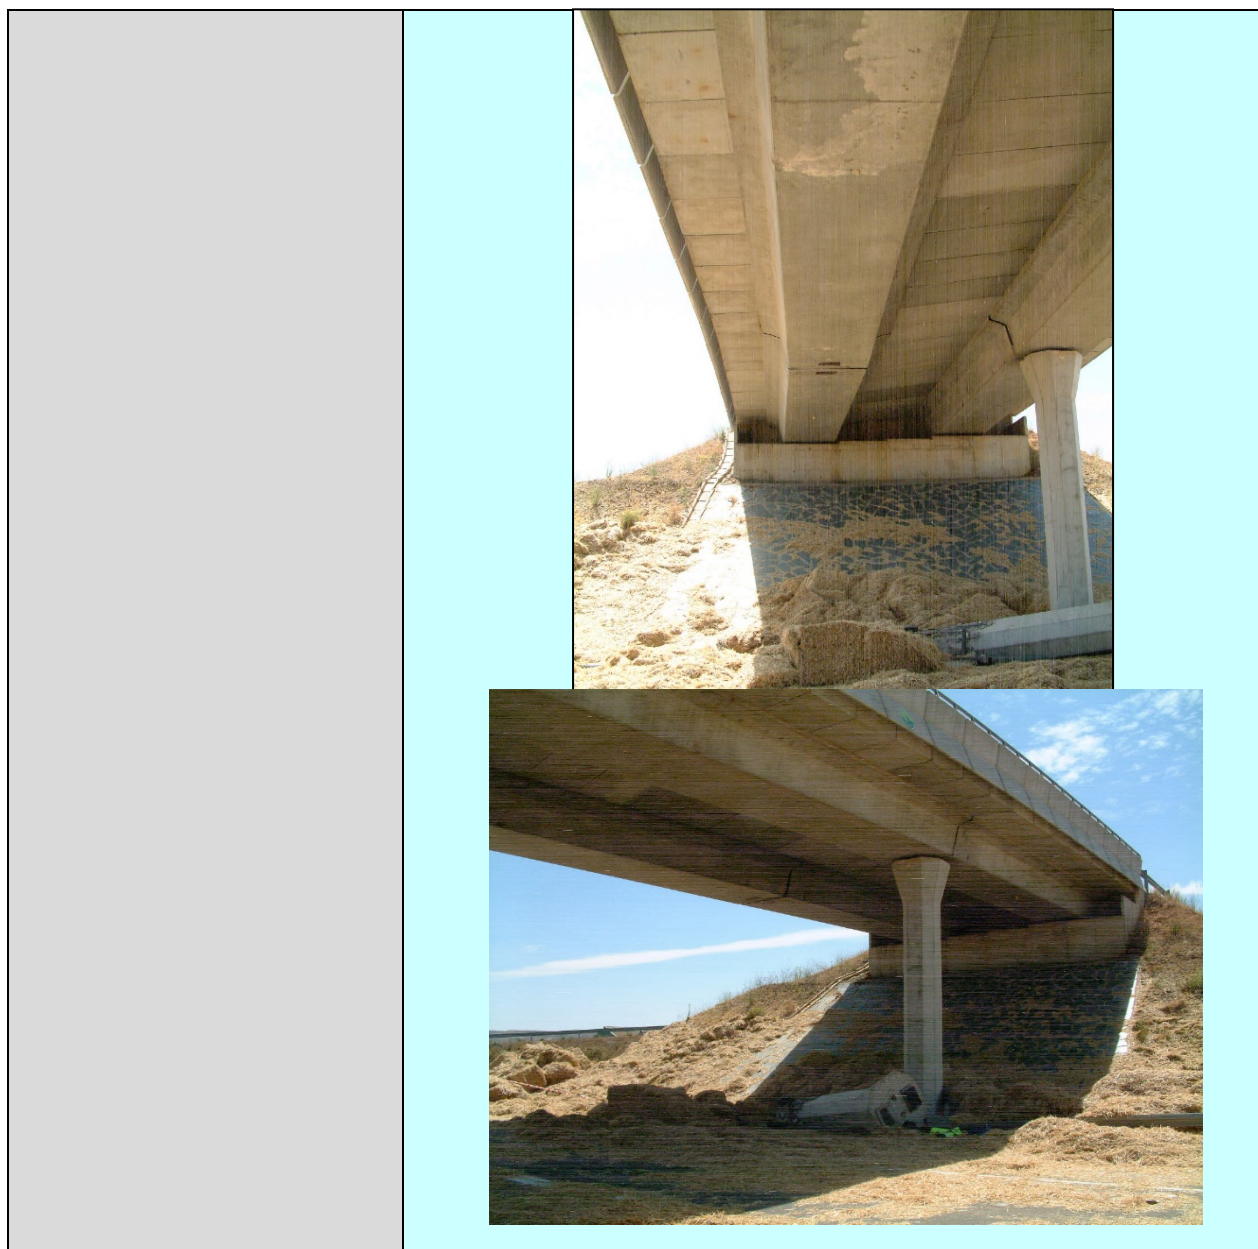
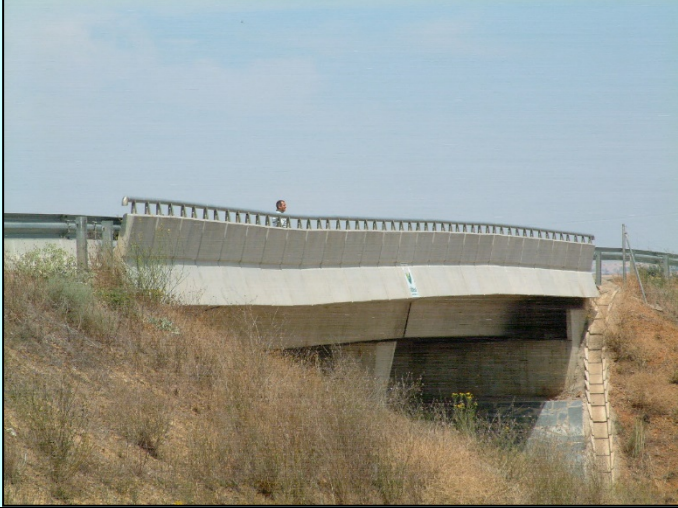
Answer	<p>A heavy vehicle hit one of the columns of pier #1, causing the collapse of it. The girders supported by this column stand on its place and were hanging on the deck.</p> <p>The deck suffered a great deformation and cracking, visible through the pavement over it.</p>

Answer	<p>Traffic was closed over and under the bridge, while decision was delivered: demolishing the structure or repairing it. Big hydraulic jacks where put in place under both girders without support, near the collapsed column.</p> <p>A complete damage map was drawn, while a structural assessment was developed, in order to demonstrate through an iterative process if the damages on the deck where repairable or not.</p> <p>The foundation of the column was discovered, in order to evaluate possible damages on it, but it was in good condition. New reinforcement rebars were anchored on the foundation for the new column.</p> <p>As the original position of the girders was obtained with the lift of the hydraulic jacks, a new on site reinforced concrete column was constructed under the bridge. For the upper part of the column two holes where made on the deck, so the concrete could be put in place.</p>

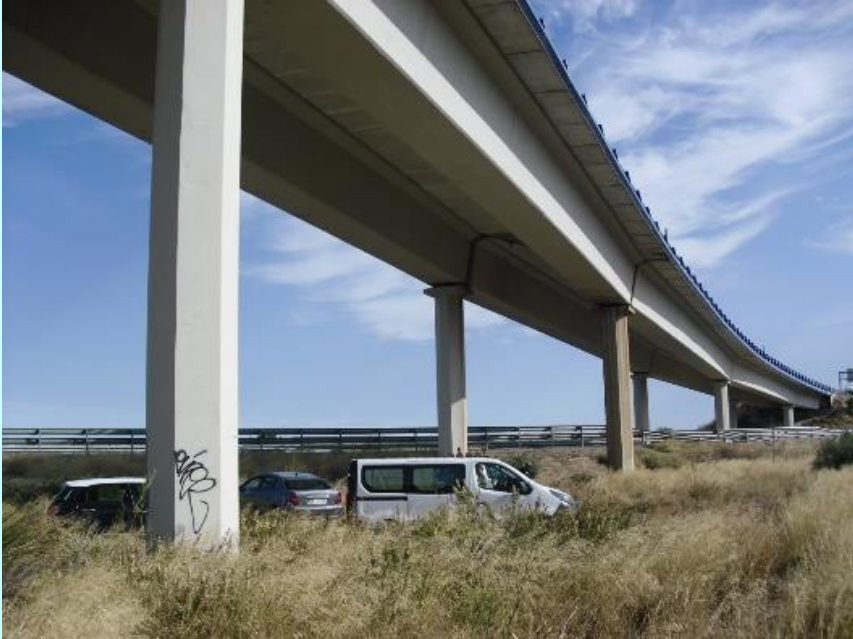
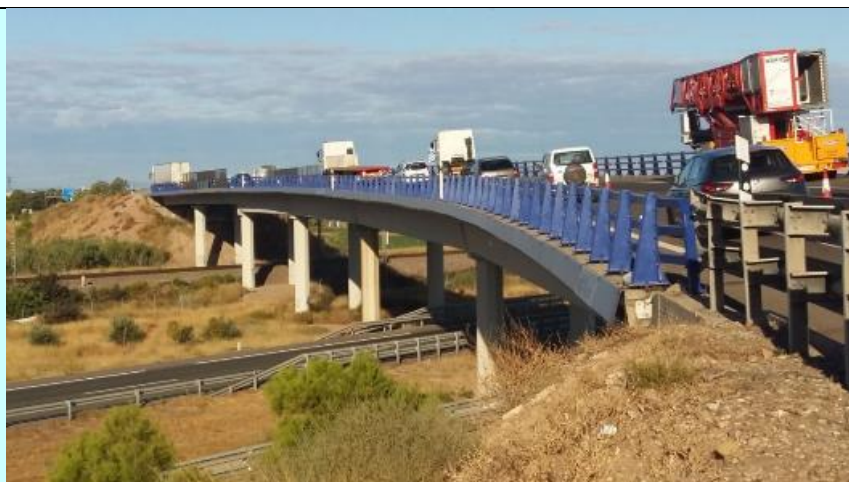
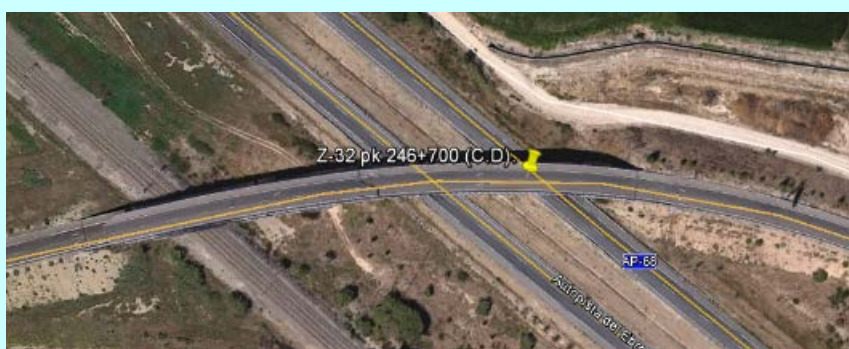
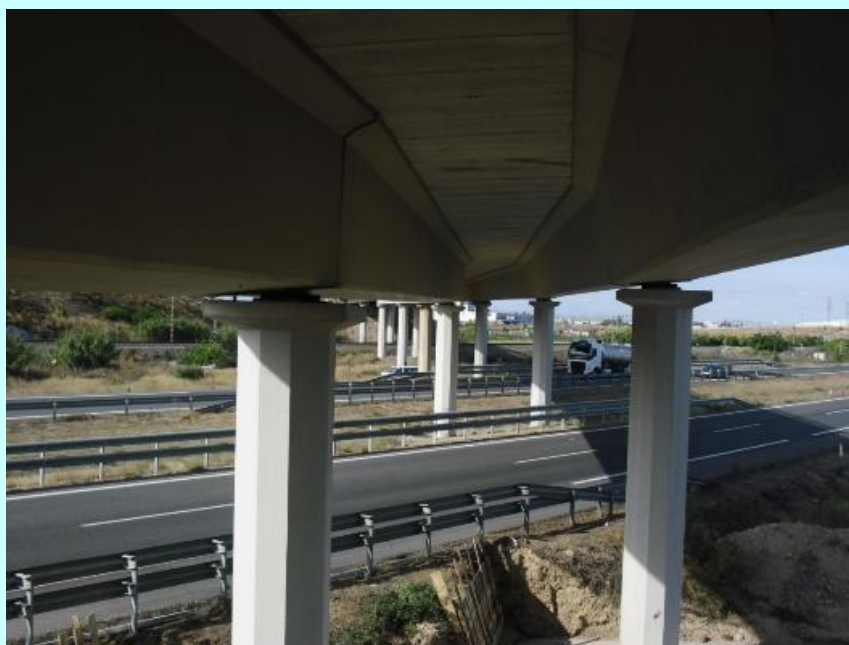
1.0	Description of Event / Incident
Description of Bridge	<p>It is the viaduct that allows the right road of the Z-32 to overcome both the AP-68 toll road and the Zaragoza suburban railroad, at p.k. 246 + 700 of that road.</p> <p>It is a bridge of prefabricated trough-shaped prestressed concrete beams, with seven spans (two trough-shaped beams by span). The spans are variable, in the following order of magnitude: 16, 43, 42, 32, 30, 31 and 21 m. As the bridge has a very considerable skew angle (32° in span 1, 36° in span 2, 41° in span 3 and somewhat higher in the rest) and the above spans are measured to the deck axis, the span of each of the two beams of each stretch differs markedly: for example, in span 1, these beams are 16.40 and 25.37 m long. The deck is about 11.5 m wide and curved in plan, to the left, as it runs from the abutment 1 to 2. Its initial radius of curvature is about 500 m and decreases to the order of 1000 m in E2.</p> <p>The abutments are closed, with walls in turn, and each of the six pillars has two reinforced concrete octagonal-shaped shafts, which top off at a plateau with a rectangular section of 1.50x1.80 m. On these 'rectangular tables' we can find the steel reinforcement elastomeric bearing devices, all of them rectangular non-anchored and of different dimensions, according to their location in the viaduct: a single bearing device is located at each end of each trough-shaped beam, whose longest dimension is arranged along the axis of the joints. The heights of the pillar's shafts are also variable, between 7 and 10 m, approximately.</p> <p>The foundations of all the shafts are direct, by means of reinforced concrete footings.</p> <p>The upper slab is 0.25 m thick, which locally on the pillars reduces its thickness to 0.08 m ("slabs of continuity" of 1.5 m width).</p> <p>As the bridge is curved in plan, the cant is also very marked, with a 5.8% in abutment 1 and slightly lower values in the rest of supports (of the order of 5.2-5% in pillars 2 and 3, descending gradually in the second half of the viaduct, to 2.2% in E2).</p>

<p>These strong cants produce an eccentricity between the axis of the beams (measured in the head of these) and the axis of the elastomeric bearings. This eccentricity is 0.20 m in the abutment 1, 0.19 m in pillar 1 and 0.15 m in pillar 3.</p> <p>In addition to the expansion joints on the abutments, the bridge has a third joint on pillar 3. This joint, by cutting perpendicular to the two beams of the viaduct on each of the two shafts of the pillar (shafts 3.1 and 3.2) and because of the skew angle, adopts a 'letter Z' form in plan. This expansion joint was originally made of reinforced elastomer but it had had to be repaired in numerous occasions since the opening of the viaduct (2004). Currently, this joint presents some stretches of reinforced elastomer and other of modified bitumen.</p>
Pictures of Bridge

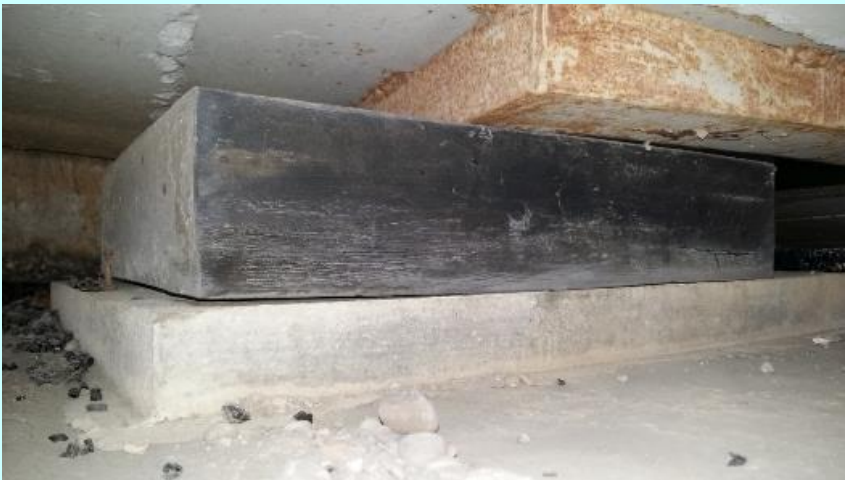
<p>Description of the event and the trigger that caused the assessment</p>	<p>Examples: bridge hit, excessive deterioration, flood, scour, Routine Inspection resulting in critical finding, emergency, moving super load, etc.</p>
<p>Answer</p>	<p>The road maintenance personnel had detected a transverse displacement of the deck, which translated into carriageway in a twist of almost 20 cm of the white road mark of the edge of its shoulder, when crossing abutment 1. Of course, the traffic railing had also been deformed because of the lateral displacement of the deck with respect to the abutment.</p>   <p>Underneath the deck, in said abutment 1, it was appreciated that it had moved laterally with respect to the neoprene bearings (which remained in place on the front wall of the abutment) in the order of 18 cm. Said displacement was toward the deck's</p>

<p>center of curvature, curved "to the left" in plan. The relative lateral displacement (deck-substructure) had also been in the direction of the cant, a 5.8% to the left in abutment 1.</p>

<p>The white road line had been painted recently and the lateral movement of this viaduct had occurred suddenly between July and September of 2016. It should be noted that the white line did not show any discontinuity as it passed through the other abutment or through the Z-shaped central joint (in pillar 3). In the later inspections, it was possible to verify that the lateral displacement was maximum in abutment 1 and pillar 1, decreasing with a homothetic function towards pillar 3 (the only central expansion joint), where this lateral movement was already null.</p> <p>The lateral displacements at abutment 1 and pillar 1 were a serious danger because the deck was supported by a very small portion of the neoprene bearing and, especially in Pillar 1, a new displacement of the order of the already produced would have left the prefabricated trough-shaped beams without any support, being able to free fall. It should be noted that the reinforced elastomeric bearings of the bridge were not anchored neither inferior nor superiorly, nor was there any type of lateral retention stop of the deck that could prevent greater displacements with respect to pillars and/or bearings.</p>

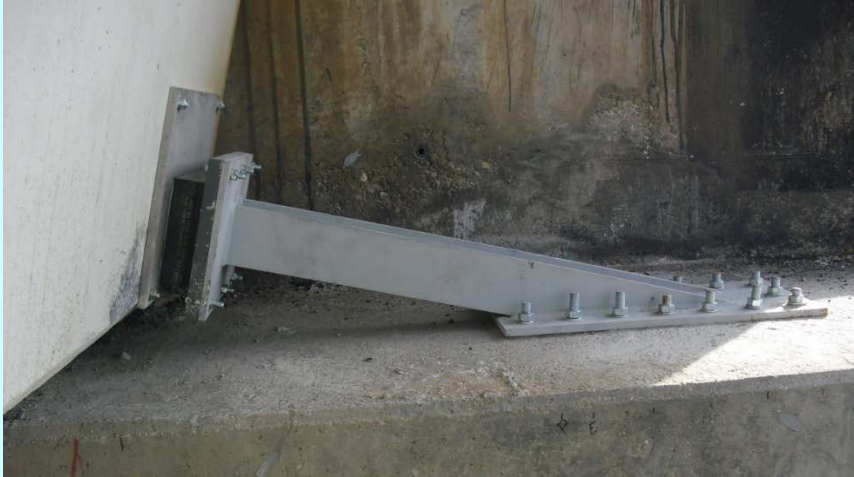
assessment, in 2d or 3d? What were the potential temporary / permanent fixes considered at the time of the decision?	
Answer	<p>The first immediate action, to avoid greater lateral sliding of the deck over pillars and abutments, was to place side stops on the abutment 1, that is, where it had had more lateral displacement. These steel stops were designed, manufactured and placed quickly.</p>

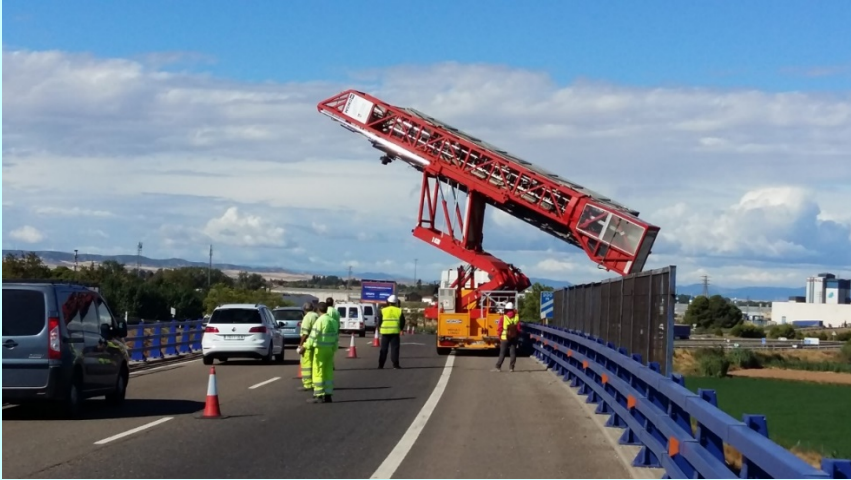
Answer	<p>Special inspection (with a truck with gangway for under deck jobs)</p>

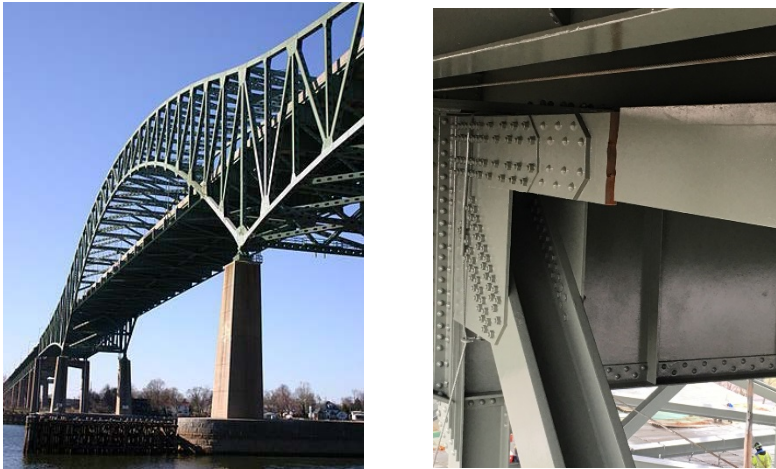
Issue: D3.3 – Special inspections and Damage Assessment Techniques	
Country	United States
Prepared by	Joey Hartmann
Date Prepared	09.06.2017
1.0	Description of Event / Incident
Description of Bridge	<p>The Delaware River Bridge carries I-276 across the Pennsylvania/New Jersey border, the Delaware River, PA State Route 13, several local roads, and Amtrak. The bridge opened in 1956 and is owned jointly by the New Jersey Turnpike Authority (NJTA) and Pennsylvania Turnpike Commission (PTC), with each state owning up to the state line.</p> <p>The bridge has 31 spans, with a total structure length of 6,751-feet and a main river span of 682-feet. The overall deck width is 80-feet. As shown in Figure 1, the main river span is a distinctive arch-shaped through truss, with suspended deck and vertical clearance of 135-feet. In 2014 the average daily traffic was 42,000 vehicles.</p>
Picture of Bridge

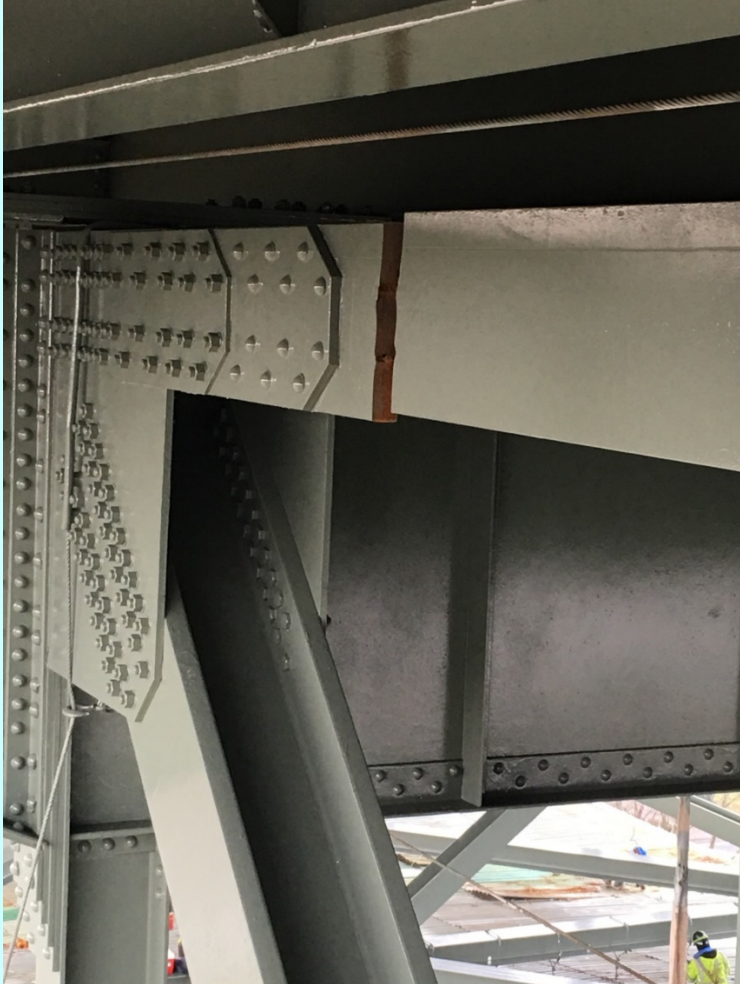
Answer	A construction inspector for an active painting job noticed a full-depth fracture in the top (tension) chord on one of the Pennsylvania deck truss approach spans, where the truss is continuous over the pier. The fracture had initiated at the site of a fabrication defect, two holes drilled through a flange that had been partially filled with weld material.

Answer - What were the potential temporary / permanent fixes considered at the time of the decision?	The 3 options considered included (1) repair the fractured chord, (2) replace the fractured chord, and (3) replace the 4-span unit that included the fracture chord.

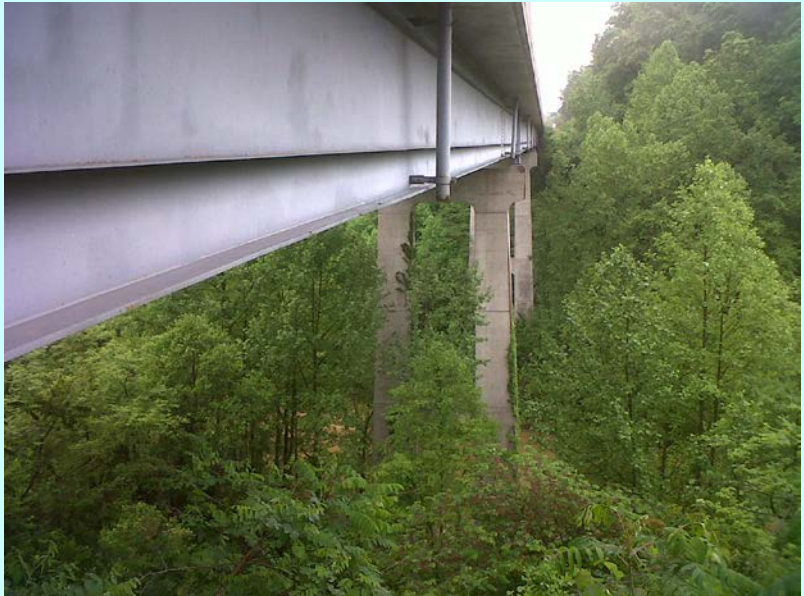
Issue: D3.3 – Special inspections and Damage Assessment Techniques	
Country	United States
Prepared by	Joey Hartmann
Date Prepared	04.08.2017
1.0	Description of Event / Incident
Description of Bridge	<p>The I-75 Bridge at Mile Post 27.9 over Lynn Camp Creek (I-75 Bridge) near Laurel-Whitley County Line in Corbin, Kentucky consists of three continuous steel girder spans (140 ft – 200 ft – 140 ft). The bridge, which was originally constructed in 1968, is a concrete slab on girder construction with 4 longitudinal beam lines, cross-frames at 20 ft intervals and a lateral bracing system in the bottom of the center bay. The 2 lanes of the bridge carry over 22,000 ADT.</p>
Picture of Bridge

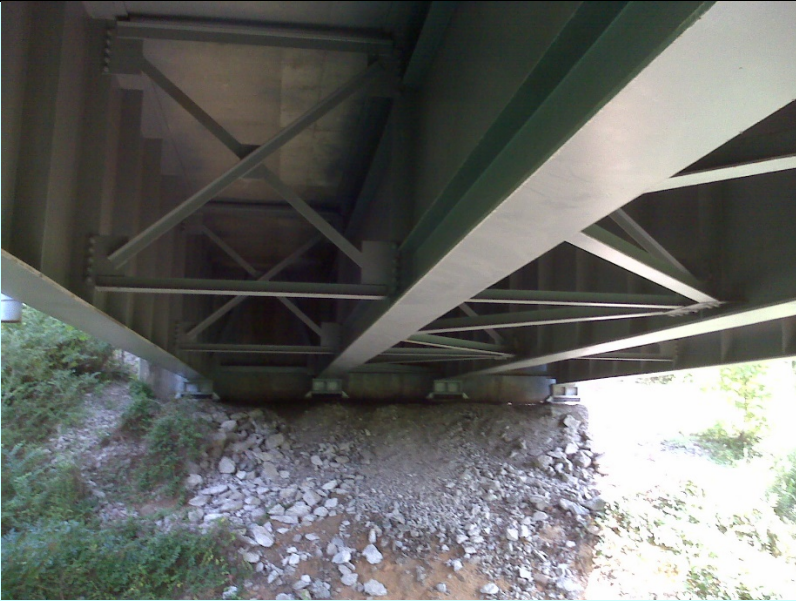
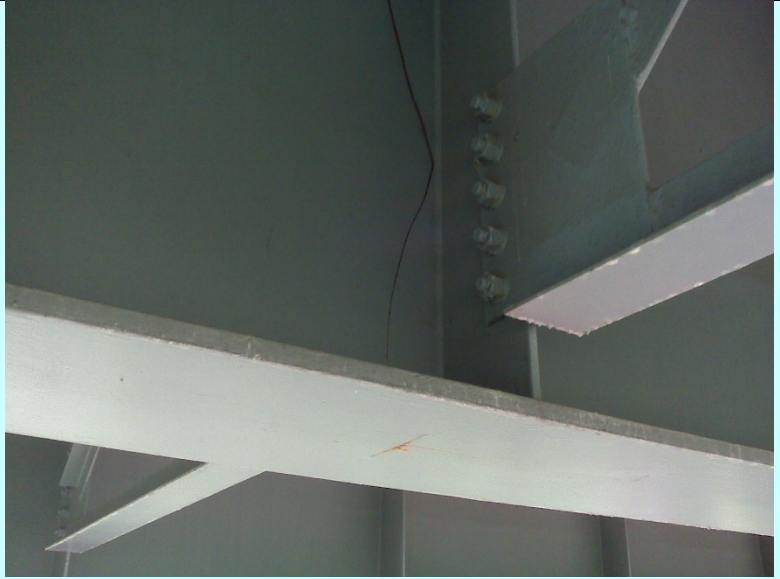
<p>Description of the event and the trigger that caused the assessment</p>	<p>Examples: bridge hit, excessive deterioration, flood, scour, Routine Inspection resulting in critical finding, emergency, moving super load, etc</p>
<p>Answer</p>	<p>A routine bridge inspection identified a fracture of the web and bottom flange of an interior longitudinal girder. The fracture was approximately vertical and originated in the area of an intersecting weld detail.</p>

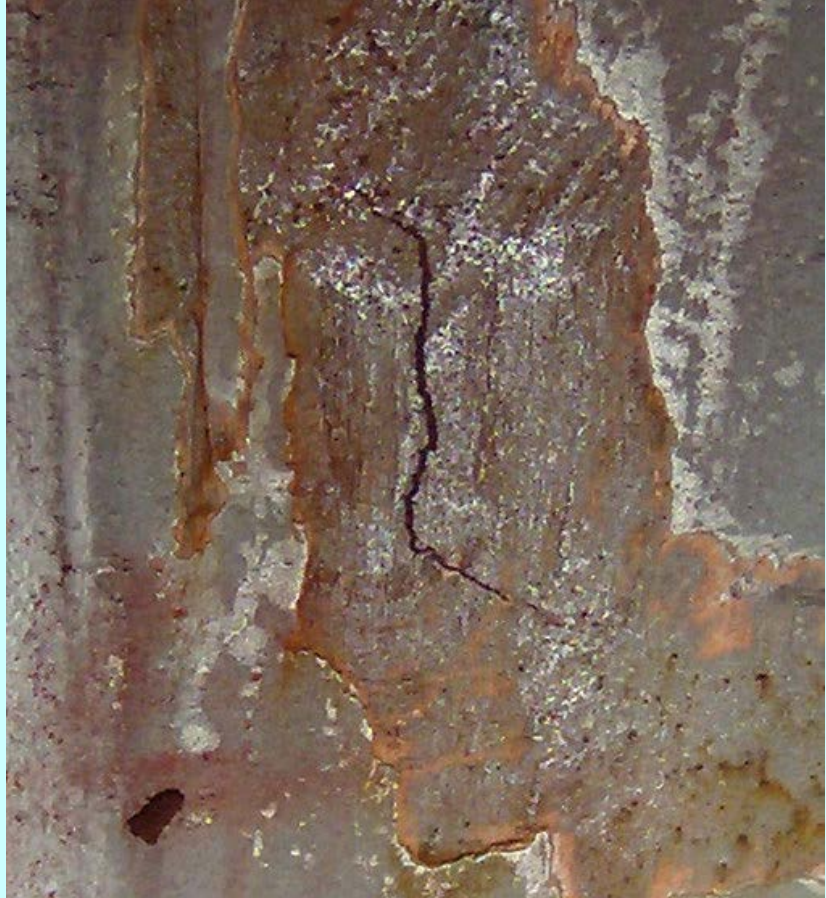
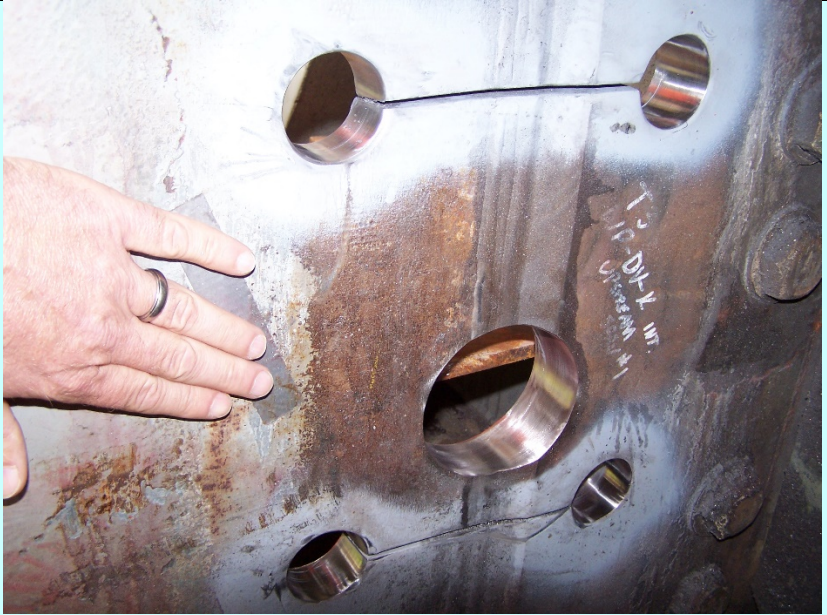
Answer	<p>A fracture critical (rigorous) inspection identified several cracks in the tension ties of each span. These surface</p>

breaking cracks were perpendicular to the primary stress range and typically adjacent to and parallel with butt welds. Any failure of the butt welds in the tie chord could result in a fracture of the tie chord and the potential collapse of the superstructure span itself.

<p>Answer</p>	<p>There were no appropriate immediate or temporary fixes other than closing the bridge. The only judgment exercised was a consensus that the defects/cracks identified had likely been the result of poor hydrogen control during fabrication and, as the cracks were found during an inspection that occurred in the early spring during warming temperatures, that rupture was unlikely in the near future if there was no more growth. As the extent and severity of the issues were unknown at the time of the decision, the process going forward was designed to consider newly developed data to inform actions.</p> <p>Analyses were conducted to establish safety (strength and fracture) and understand the potential for crack growth due to live load fatigue.</p> <p>To establish material properties and as-built geometries, cores were taken and tested, and plate sizes documented. In addition, the tie chords were monitored for live load stress range and thermal stress range. These results were used to refine strength and fracture calculations.</p>

Answer - How did the timeframe of returning the bridge to full service influence the decision?	Although a number of options were considered in detail, the only pragmatic repair solution was to plate over 3200-feet of tie chord. Both acquiring the materials necessary and installing the plating were projected to take 6 months. A desire to avoid a closing of this length for an ADT of 75,000 in an already congested metropolitan area motivated a sophisticated approach that could result in maintaining the bridge open at an appropriate level of safety.

Answer - What were the potential temporary / permanent fixes considered at the time of the decision?	As the tie chords lacked redundancy, the potential repairs all considered adding mitigating a potential fracture motivated by a progressing defect or change in conditions and adding redundancy to the tie chord. To increase redundancy, the options included (1) post-tensioning of the tie chord, (2) partial plating of the tie chord, and (3) full plating of the tie chord.

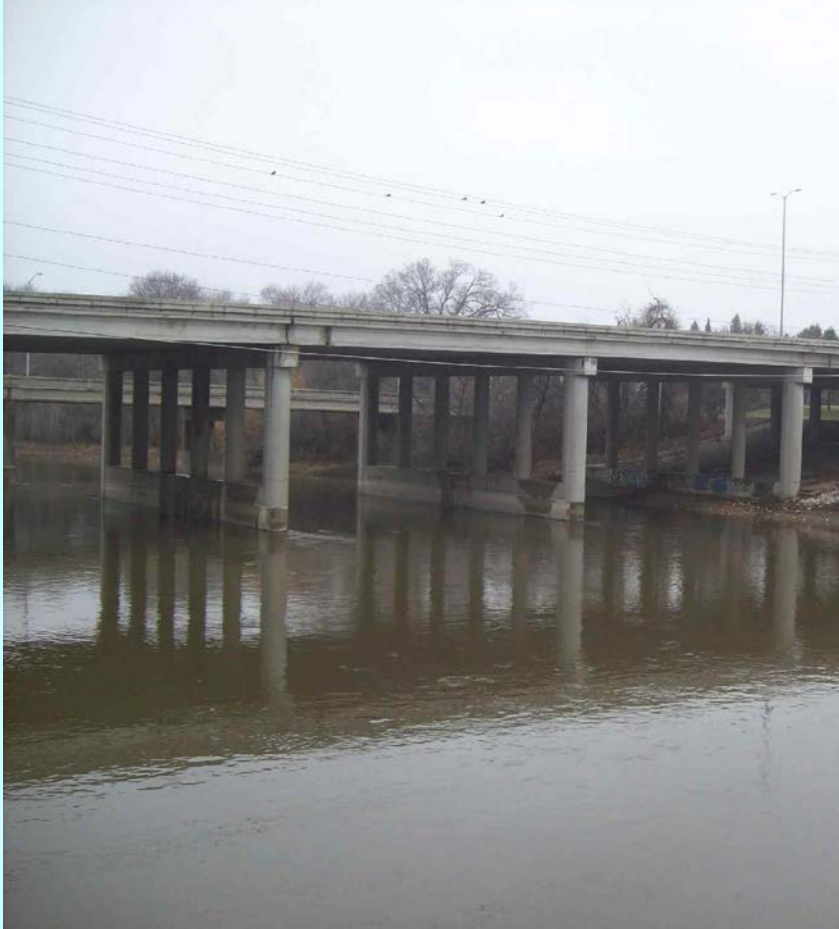
Description of the event and the trigger that caused the assessment	Examples: bridge hit, excessive deterioration, flood, scour, Routine Inspection resulting in critical finding, emergency, moving super load, etc
Answer	Excessive deterioration along underside of pier cap

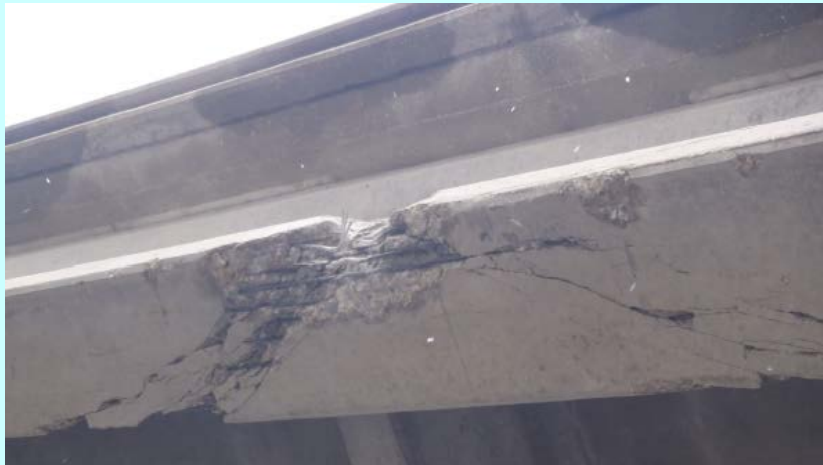
Description of the event and the trigger that caused the assessment	<p>Examples: bridge hit, excessive deterioration, flood, scour, Routine Inspection resulting in critical finding, emergency, moving super load, etc</p>
Answer	<p>Bridge hit by backhoe on a trailer damaged exterior girder and center girder (among 9 girders). Strands severed and significant loss of concrete section.</p>

Answer	Visual inspection for initial response, then load rating analysis to determine strength of damaged girder with severed strands. The bridge was already planned for 2017 replacement so short-term repair options were considered. FRP repair was decided.

Answer	Analyzed the prestressed girders with thinner web and bottom flange to account for concrete section loss, and also removed strands from model to account for severed strands. This was the first FRP design that was not contracted out to the FRP supplier. Our agency designed and specified the FRP repair.
Date event resolved or concluded	Same day as bridge hit: traffic restriction removed, leaving only a restriction on overweight vehicles. Summer 2016 – repairs under way
Describe the results and outcome and any lessons learned including other factors that may have influenced your decisions.	Examples: prestress bridge girder struck by vehicle, closed lane of traffic on bridge, removed loose concrete, added FRP patched bridge, and opened bridge. Other factors may include contracting mechanisms, procurement of materials, and familiarity with repair.

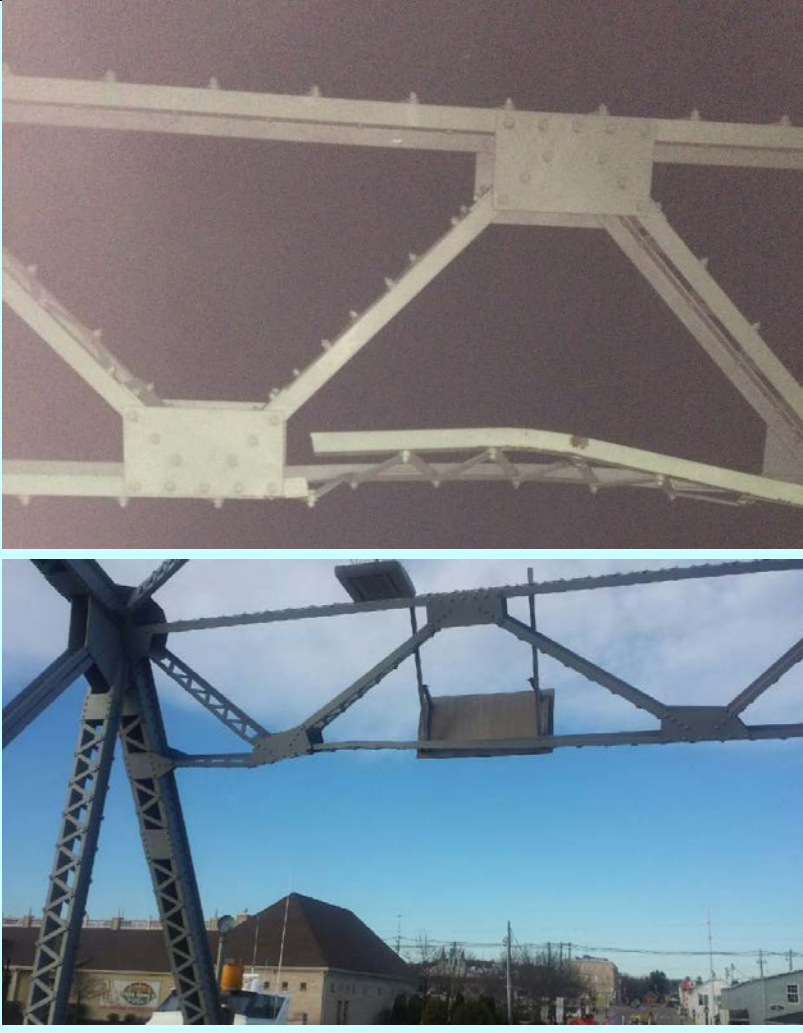
Description of the event and the trigger that caused the assessment	Examples: bridge hit, excessive deterioration, flood, scour, Routine Inspection resulting in critical finding, emergency, moving super load, etc
Answer	Bridge hit by backhoe on a trailer damaged bottom chord of lateral bracing at 9 locations through two truss spans.

Answer	<p>Initial closure occurred due to extent of damage as a conservative response. Inspector sent photos to structural engineer. Structural engineer determined damage had only occurred to secondary members, so bridge could carry routine traffic and emergency vehicles (20-ton load limit). Within the following week, another more extensive inspection occurred with additional photos and measurements, accompanied by 3-D finite element analysis and calculation of wind load effects on the damaged lateral bracing members.</p> <p>Time was critical due to this bridge being one of 3 servicing a popular tourist area, and the busy season coming soon.</p>

One of those bridges was already out due to construction, so closing this bridge left only one in service. Consideration was given to straightening vs replacing members. Since they were secondary members and road closure was to be avoided as much as possible, most of the damaged members were replaced a few weeks after the incident.
