B D A Associates, LLC
Engineering Consulting Group

Project: 5992-09-82/83/85/86/87/88, CTH M
Raymond Road, Unacceptable Storm Sewer Pipe
Subject: Concrete Pipe Tunnel Restoration Plan

This cover letter will provide an executive summary of the Raymond Road Elliptical Pipe Restoration work. BDA Associates, LLC objective was to provide a design:

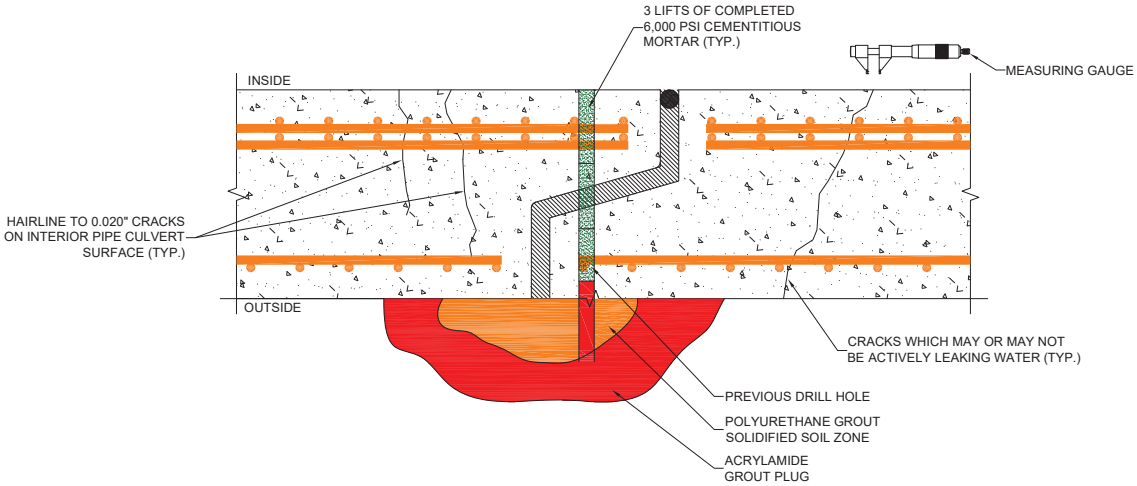
1 CRYSTALLINE WATERPROOF TREATMENT

HAIRLINE TO 20 MIL CRACKS IN CONCRETE PIPE, EXISTING CONDITIONS

1. MEASURE WIDTH OF ALL CRACKS:
2. NOTE THE FOLLOWING:
   - 2.1. CRACKS LESS THAN 0.021 INCHES (21 MILS) SHALL BE SURFACE TREATED WITH CRYSTALLINE WATERPROOFING
   - 2.2. CRACKS GREATER THAN 0.020 INCHES AND LESS THAN 0.040 INCHES (40 MILS) SHALL BE INJECTED WITH POLYACRYLATE GROUT
   - 2.3. CRACKS GREATER THAN 0.040 INCHES (40 MILS) SHALL BE INJECTED WITH EPOXY RESIN

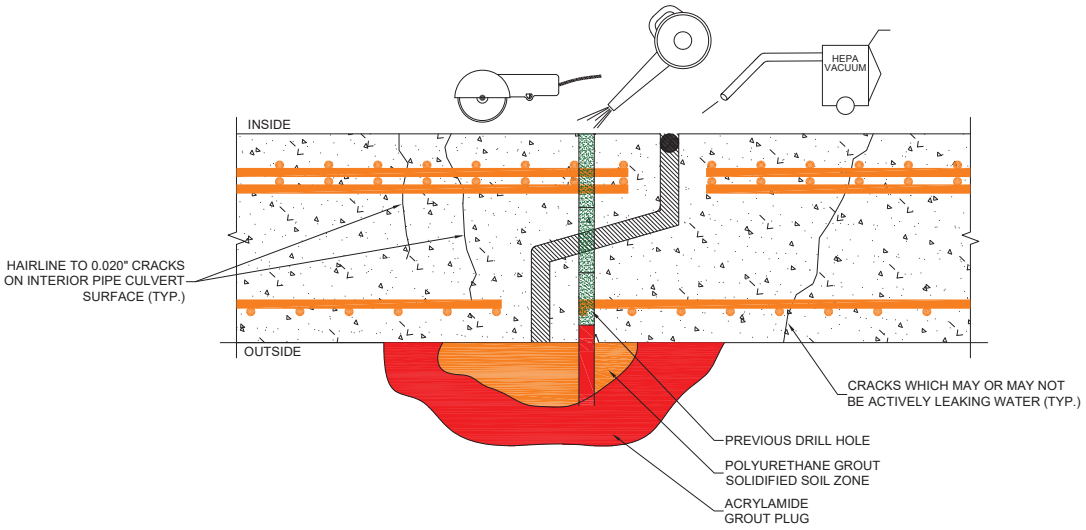
2 CRYSTALLINE WATERPROOF TREATMENT

HAIRLINE TO 20 MIL CRACKS IN CONCRETE PIPE, SURFACE PREPERATION

1. MIX CRYSTALLINE WATERPROOFING SLURRY PER MANUFACTURER'S DIRECTIONS

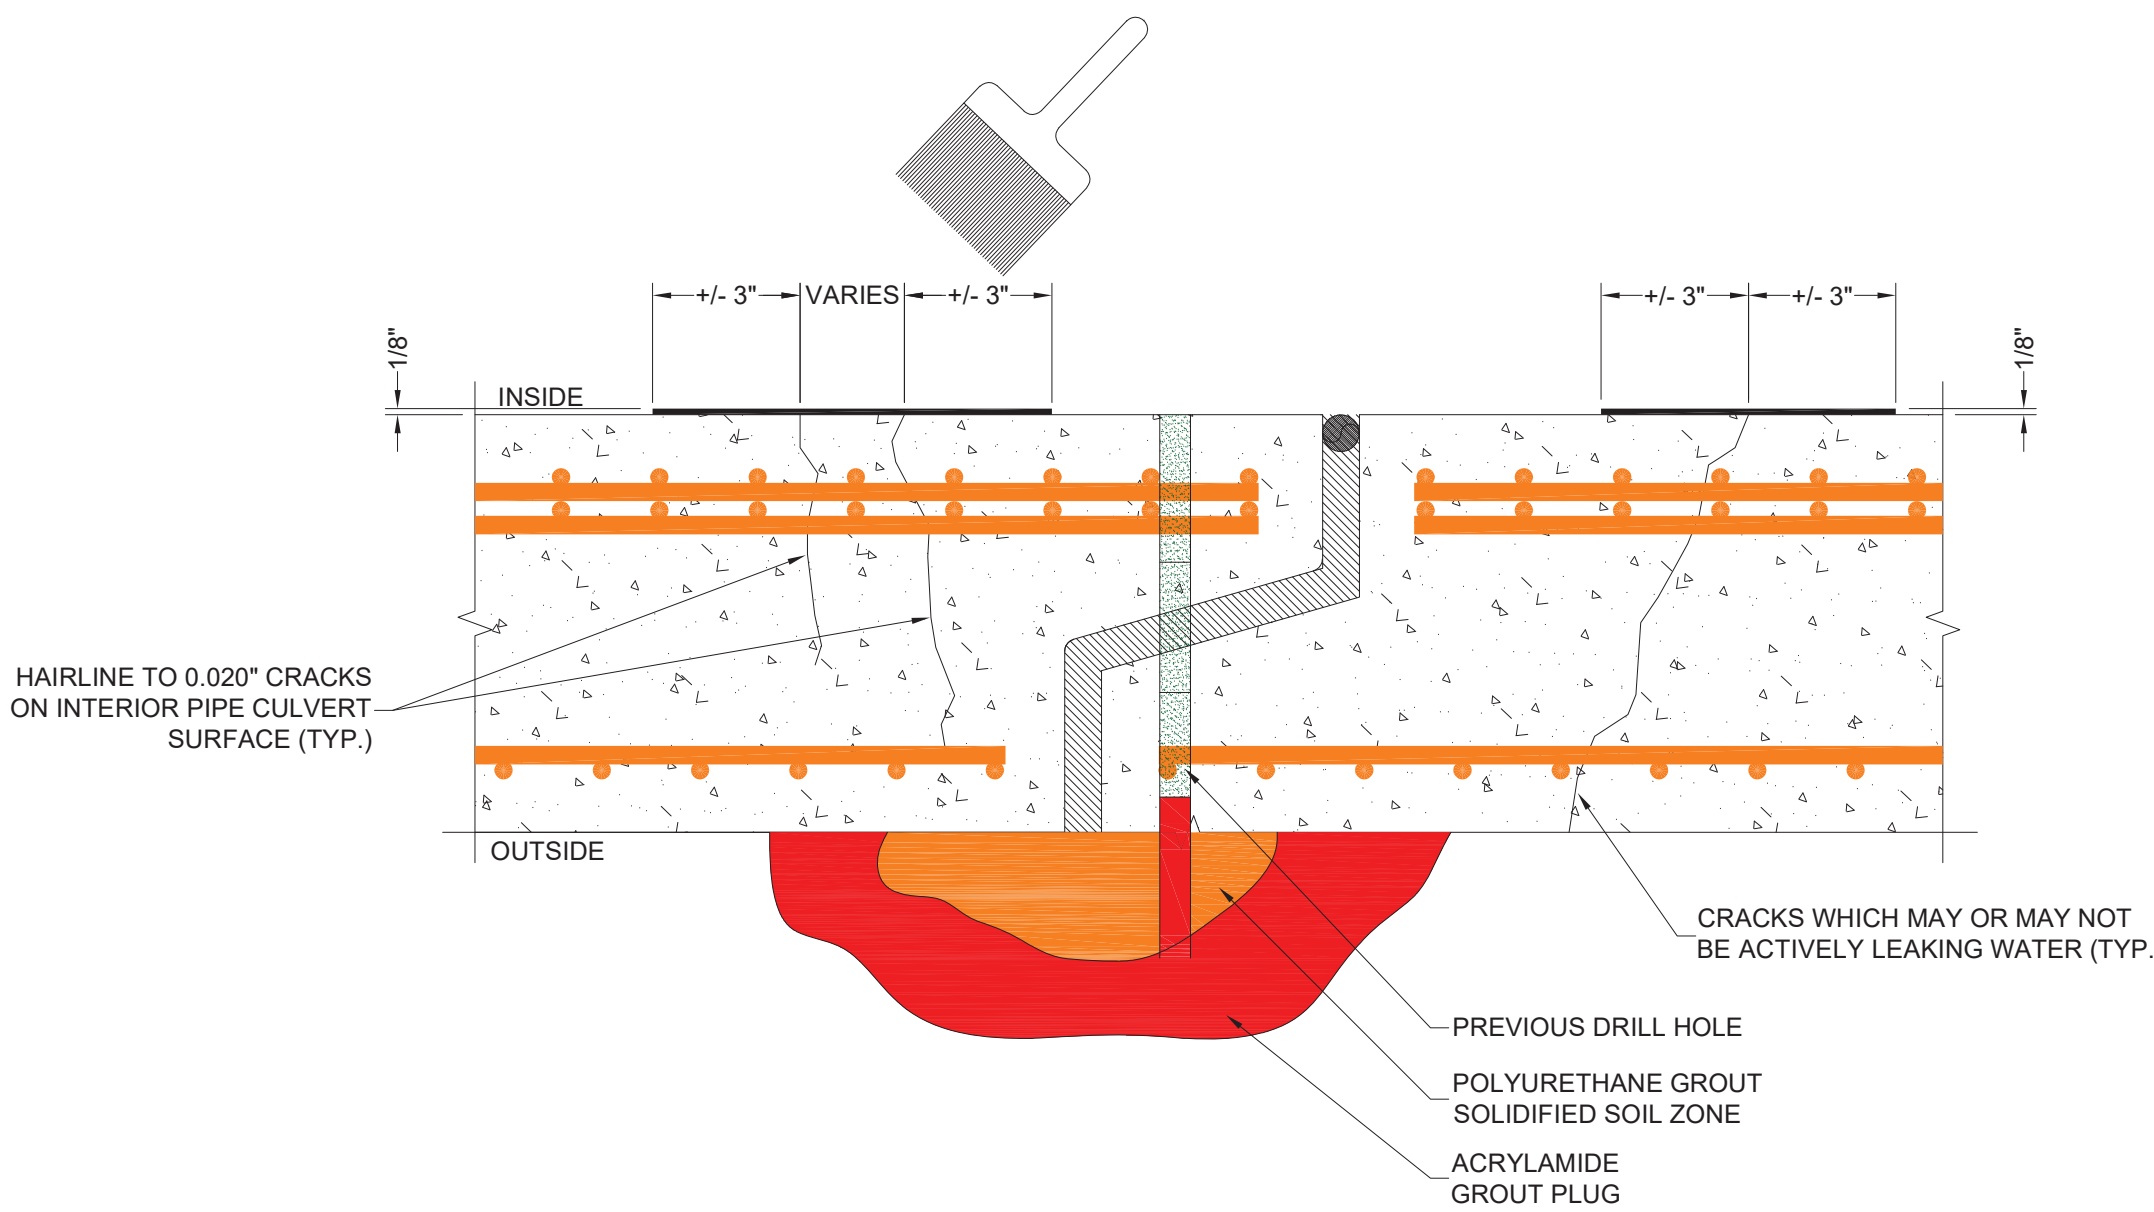
4 CRYSTALLINE WATERPROOF TREATMENT

HAIRLINE TO 20 MIL CRACKS IN CONCRETE PIPE, TREATMENT APPLICATION

1. APPLY 2 SLURRY COATS OF CRYSTALLINE WP APPROXIMATELY 3" ON EACH SIDE OF CRACKS LESS THAN 0.021 INCHES (21 MILS)
2. ALLOW 3 HOURS BETWEEN +/- 1/16" COATS
3. KEEP MOIST FOR 3 DAYS OR SPRAY CURING COMPOUND ON SURFACE

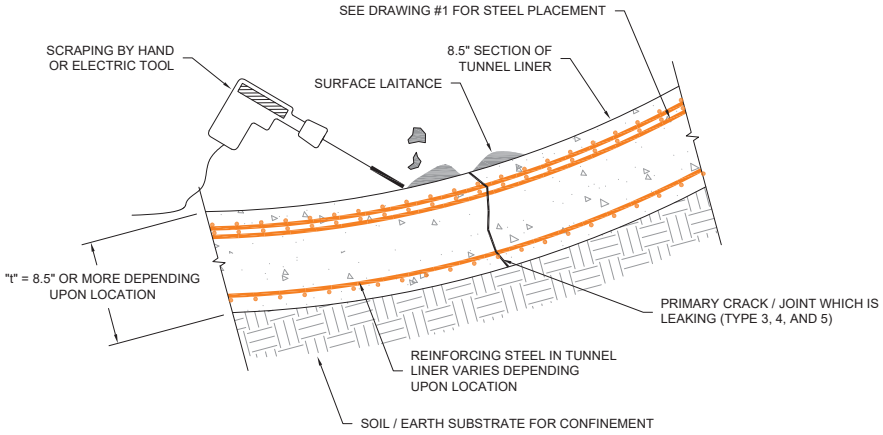
2 POLYACRYLATE GROUT, CRACK INJECTION

INJECTION INTO CRACKS / PREPERATION

1. ENSURE APPROPRIATE PPE IS BEING WORN BY ALL TRADES
2. SCRAPE, CHIP OR GRIND SURFACE CLEAN AS SURFACE PREPERATION
3. CHAIN DRAG OR SOUND AREA OF CONCRETE WITH ACOUSTIC IMPACT AROUND THE CRACK FOR DELAMINATIONS, ABOUT 8 INCHES OUT ON BOTH SIDES (BY OTHERS IF DEEMED NECESSARY)
4. LOCATE STEEL REINFORCING BAR, AND EMBEDDED COMMODITIES WITH GPR OR SIMILAR AND MARK ON SUBSTRATE
5. MARK LOCATIONS OF 5/8 INCH Ø DRILL HOLES FOR CRACK INTERCEPTION
   - 5.1. PERPENDICULAR TO CRACK LENGTH, MARK DRILL HOLE LOCATION (4-5) INCHES OUT [(t/2) = x]
   - 5.2. PARALLEL TO CRACK LENGTH, MARK OUT DRILL HOLE LOCATIONS ON ALTERNATING SIDES OF CRACK, (6-8) INCHES ON CENTER
   - 5.3. DRILL HOLE LOCATIONS CAN ALTERNATE IN DIRECTION, OR FROM ONE SIDE ONLY

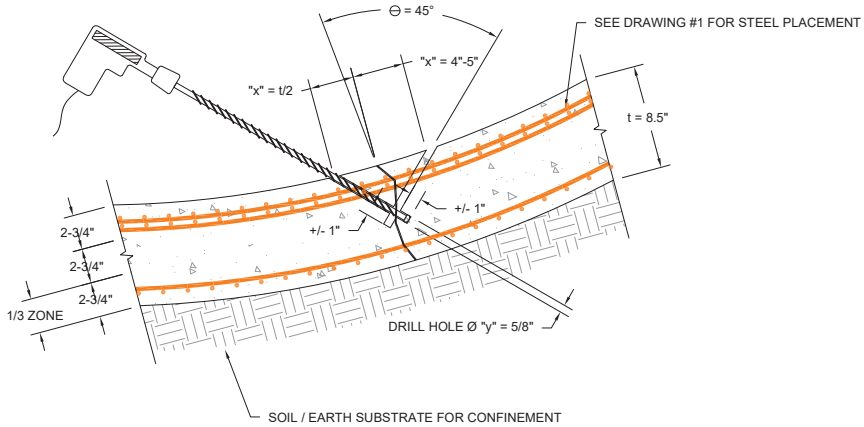
3 POLYACRYLATE GROUT, CRACK INJECTION

INJECTION INTO CRACKS / DRILL PROCEDURE

1. ENSURE APPROPRIATE PPE IS BEING WORN BY ALL TRADES
2. MARK SPOTS FOR HAMMER DRILLING ALONG CRACK / JOINT LENGTH
3. DRILL HOLE LOCATIONS SHALL BE 4" to 5" OUT, ON EACH SIDE OF CRACK, APPROXIMATELY (6 to 8) INCHES ON CENTER. CAN USE ALTERNATING PATTERN. "x" = 6", z = 8" to 10".
4. BASED ON A DRILL ANGLE OF 45° FROM SURFACE OF CONCRETE, DRILL TO A DEPTH WHEREBY DRILL BIT EXTENDS PAST CRACK / JOINT, TYPICALLY BY +/- 1".
5. DIAGONAL DRILL DEPTH SHALL BE APPROXIMATELY 10".

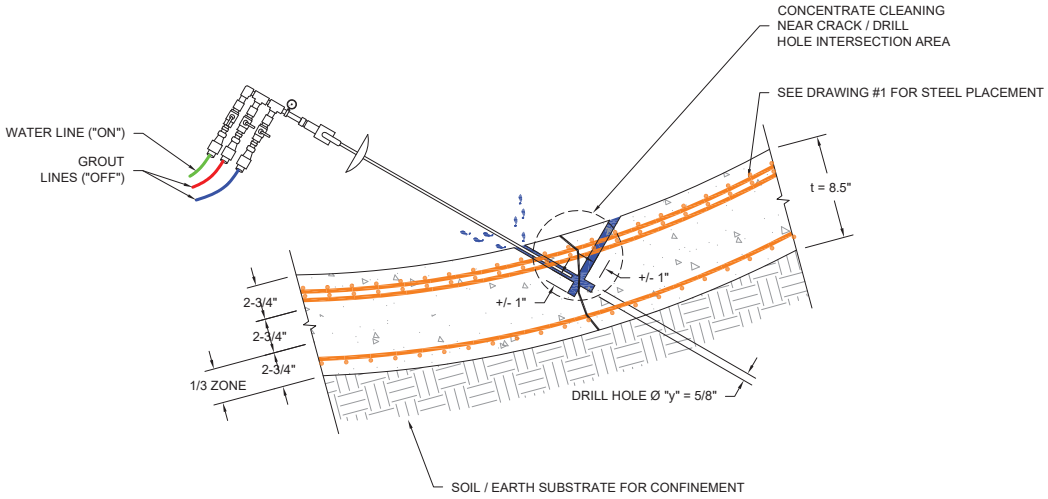
5 POLYACRYLATE GROUT, CRACK INJECTION

INJECTION INTO CRACKS / CRACK CLEANING PROCEDURE

1. AFTER AIR-BLASTING DRILL HOLE IS COMPLETED, ATTACH WATER FLUSING WAND TO "E" ASSEMBLY AND WATER BLAST DRILL HOLE TO RID FURTHER DEBRIS, CONCENTRATE CLEANING EFFORTS NEAR CRACK INTERCEPTION AREA
2. WATER PRESSURE FROM FLUSHING PUMP CAN VARY FROM (500 TO 1000) psig FOR CLEANING PURPOSES OF DRILL HOLE

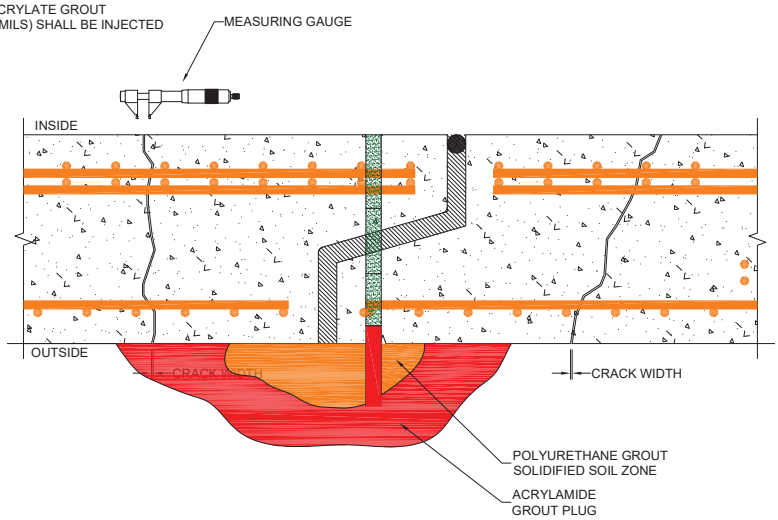
SHEET: 1F

1 EPOXY RESIN GROUT, CRACK INJECTION
MEASURING CRACK WIDTHS IN EXCESS OF 40 MILS (0.040")

1. MEASURE WIDTH OF ALL CRACKS:
2. NOTE THE FOLLOWING:
   - 2.1. CRACKS LESS THAN 0.021 INCHES (21 MILS) SHALL BE SURFACE TREATED WITH CRYSTALLINE WATERPROOFING
   - 2.2. CRACKS GREATER THAN 0.020 INCHES AND LESS THAN 0.040 INCHES (40 MILS) SHALL BE INJECTED WITH POLYACRYLATE GROUT
   - 2.3. CRACKS GREATER THAN 0.040 INCHES (40 MILS) SHALL BE INJECTED WITH EPOXY RESIN

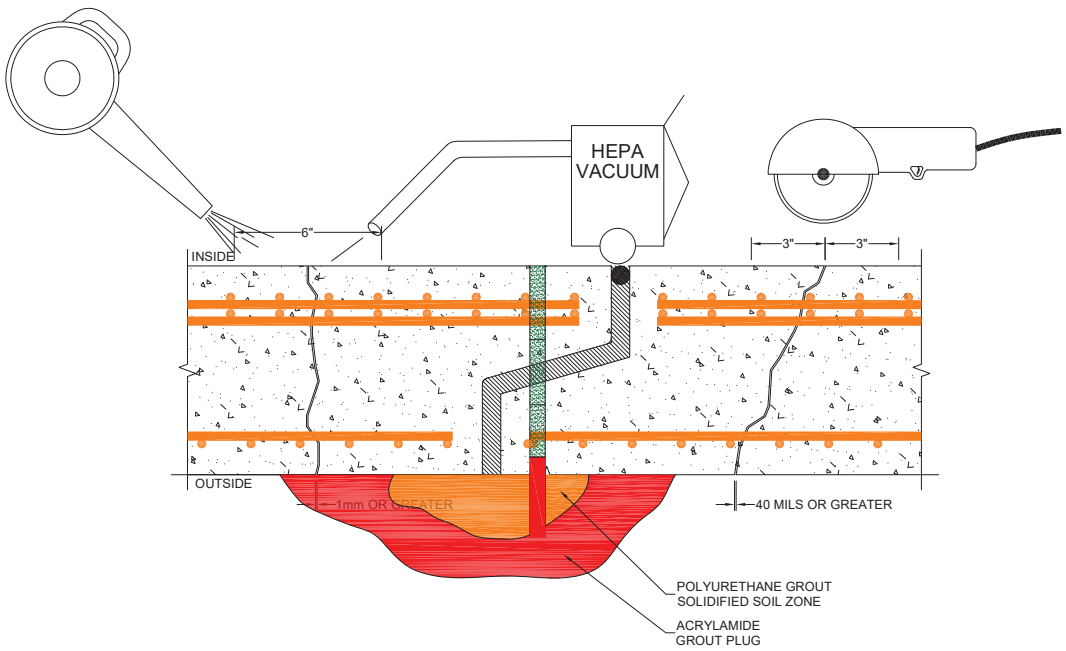
SHEET: 2F

2 EPOXY RESIN GROUT, CRACK INJECTION
SURFACE PREPERATION

1. CENTER EPOXY INJECTION PORTS OVER CONCRETE CRACKS AT 6"-8" O.C.
2. PLACE EPOXY PASTE OVER CRACK APPROXIMATELY 2"-3" WIDE AND 1/8" THICK

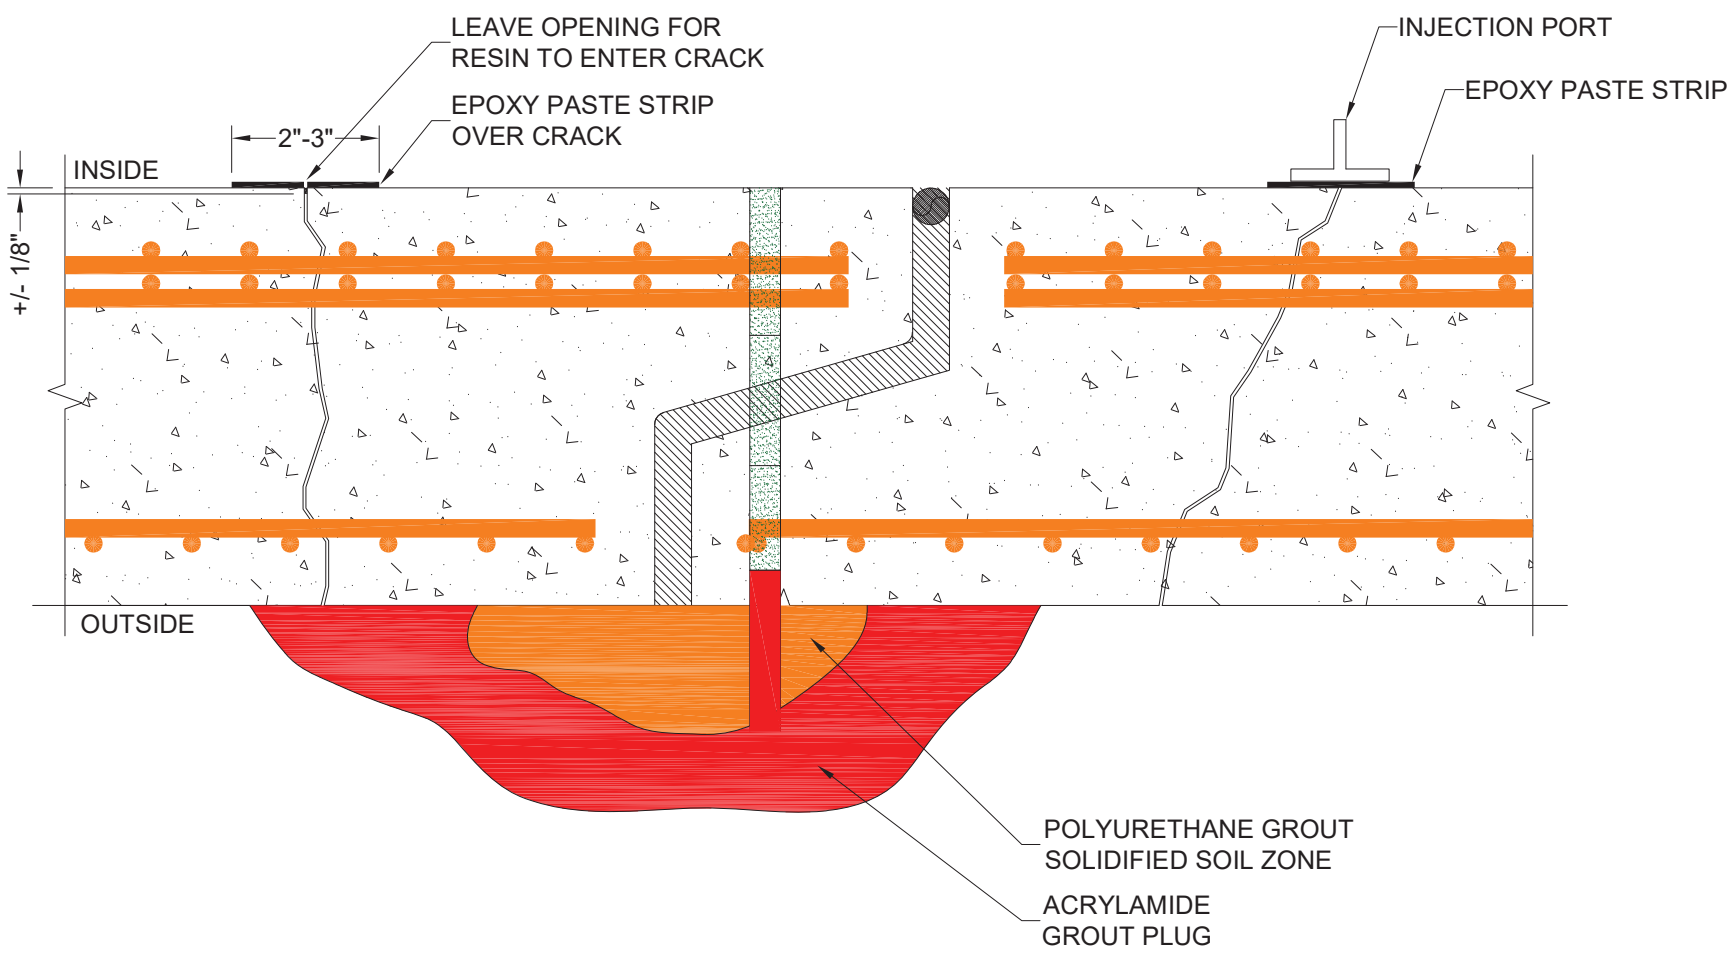
SHEET: 3F

3 EPOXY RESIN GROUT, CRACK INJECTION
PLACEMENT OF EPOXY ADHESIVE FOR PORTS

1. PLACE EPOXY PASTE OVER PORT SIDES TO ENSURE AGAINST LEAKAGE.

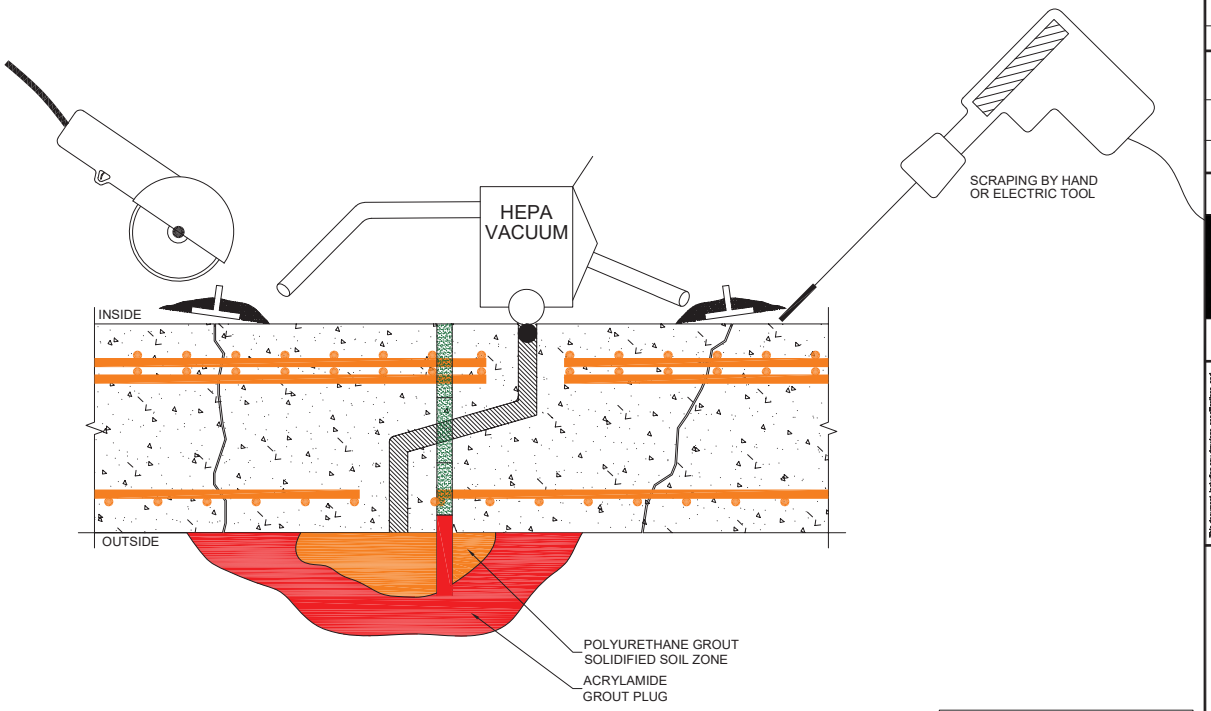
6 EPOXY RESIN GROUT, CRACK INJECTION
REMOVAL OF SURFACE PORTS

1. CHIP AND / OR GRIND EPOXY INJECTION PORTS FROM SURFACE

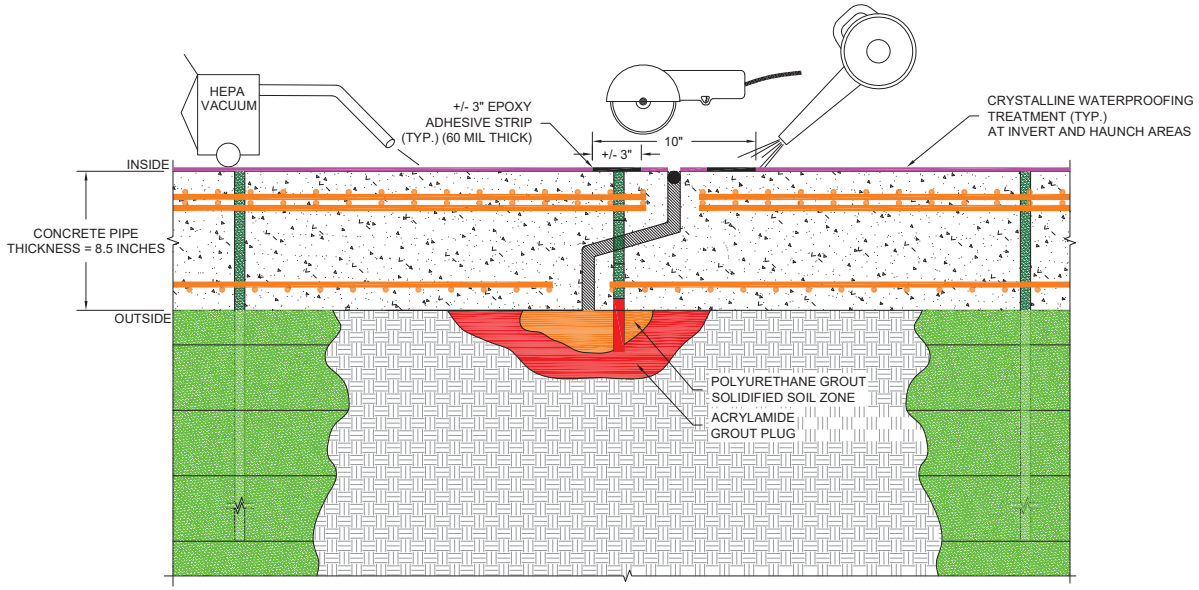
SHEET: 1G

1 STRIP SEALS, AT JOINTS IN EXCESS OF 1.5 INCHES

SURFACE PREPERATION, APPLICATION OF EPOXY ADHESIVE

1. INSTALL 60mil ELVALOY PVC STRIP INTO EPOXY ADHESIVE
2. PRESS 10 INCH WIDE, 60 mil, ELVALOY PVC STRIP INTO EPOXY ADHESIVE
3. ENSURE 10 INCH WIDE SHEET IS UNIFORMLY EMBEDDED, AND END LAPPED ONTO ITSELF A MINIMUM OF 4 INCHES
4. END LAPS SHALL BE WITHIN 2 LINEAL FEET OF TUNNEL CROWN
5. HEAT WELD LAP
6. TOOL EXCESS EPOXY OVER EDGE OF MEMBRANE

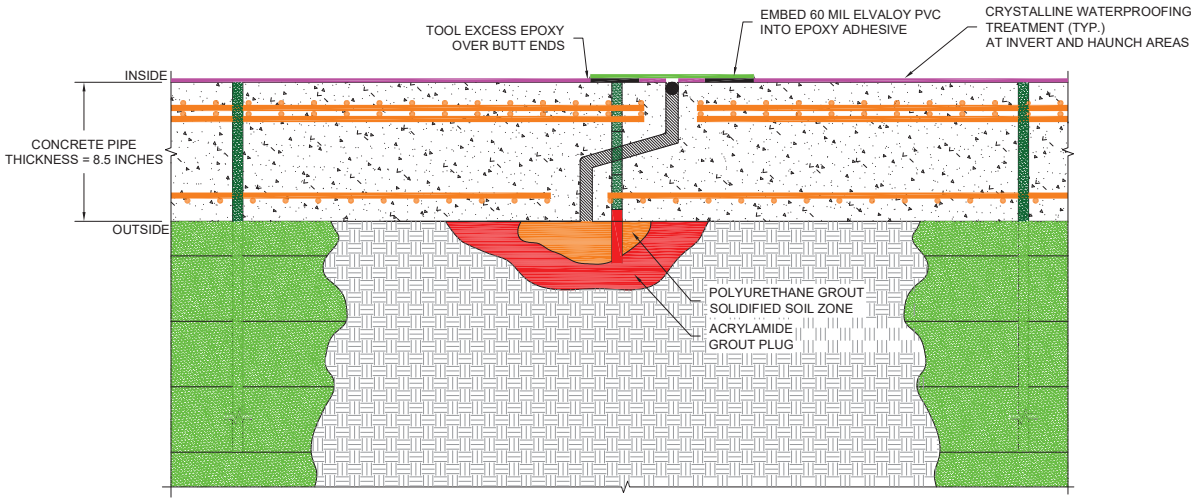
SHEET: 2G

2 STRIP SEALS, AT JOINTS IN EXCESS OF 1.5 INCHES

MEMBRANE EMBEDMENT INTO EPOXY ADHESIVE

1. INSTALL TERMINATION BAR (STAINLESS OR PULTRUDED FIBERGLASS) AT 6" O.C. DRILL -IN PINS.

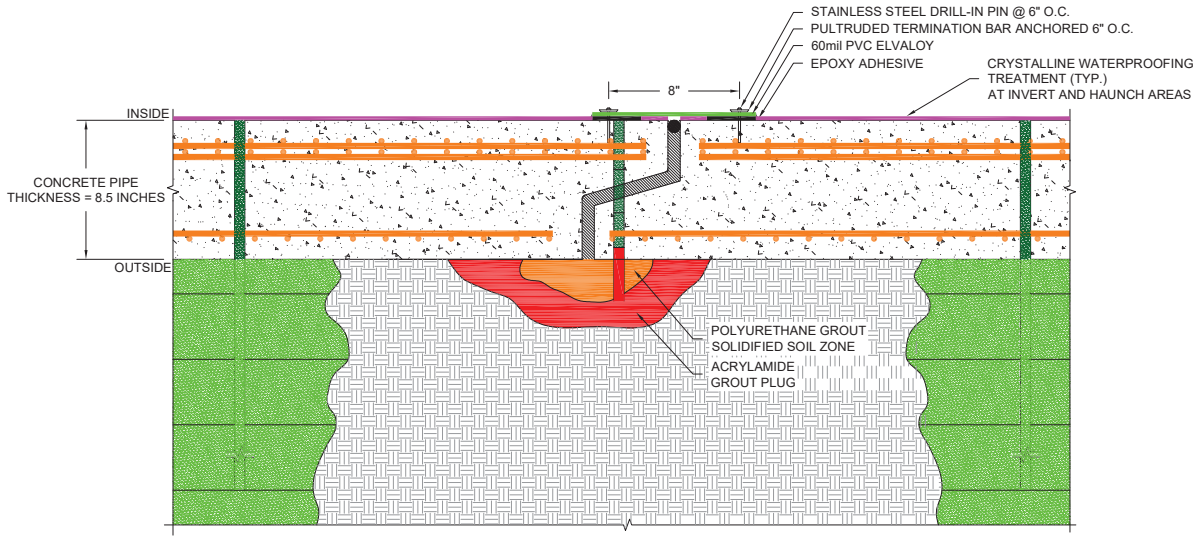
SHEET: 3G

3 STRIP SEALS, AT JOINTS IN EXCESS OF 1.5 INCHES
TERMINATION BAR APPLICATION

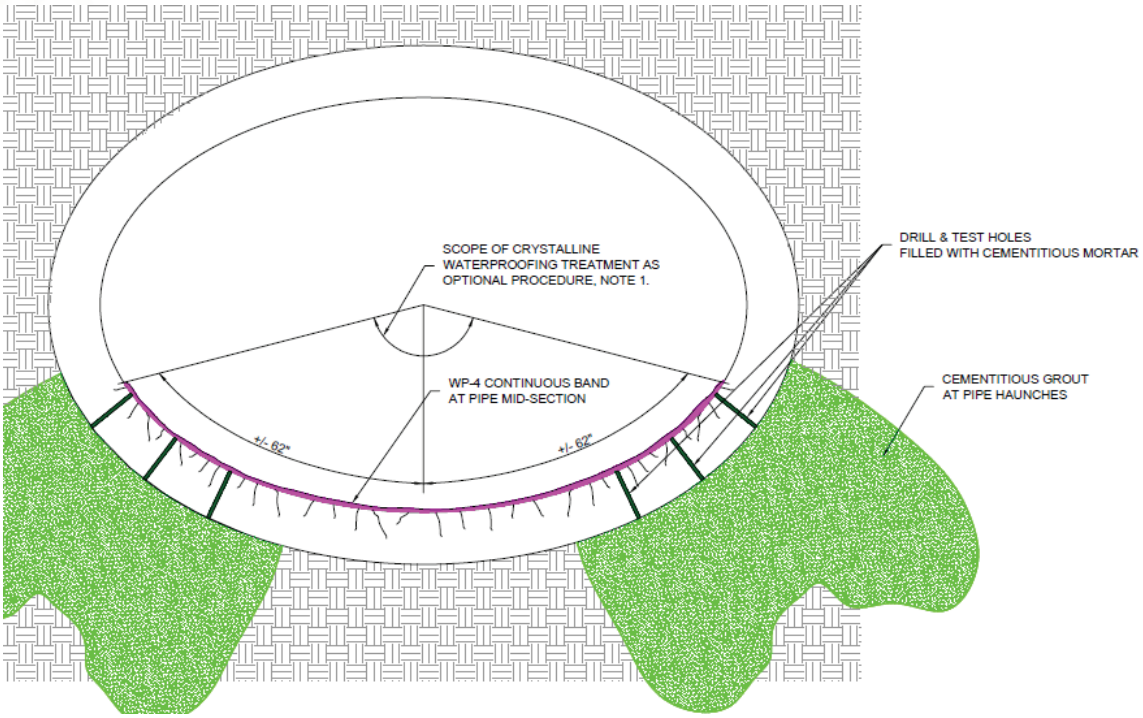
15. Two 5/8" holes will be drilled at each large crack to inject it with grout. These holes will be drilled at an angle and will almost certainly be drilled through the rebar. Again, there is nothing in the plans and specifications on how to address this situation, and nothing is included in CNA's Structural Analysis to account for this situation of damaged/disturbed steel reinforcement in all classes of the concrete pipe.

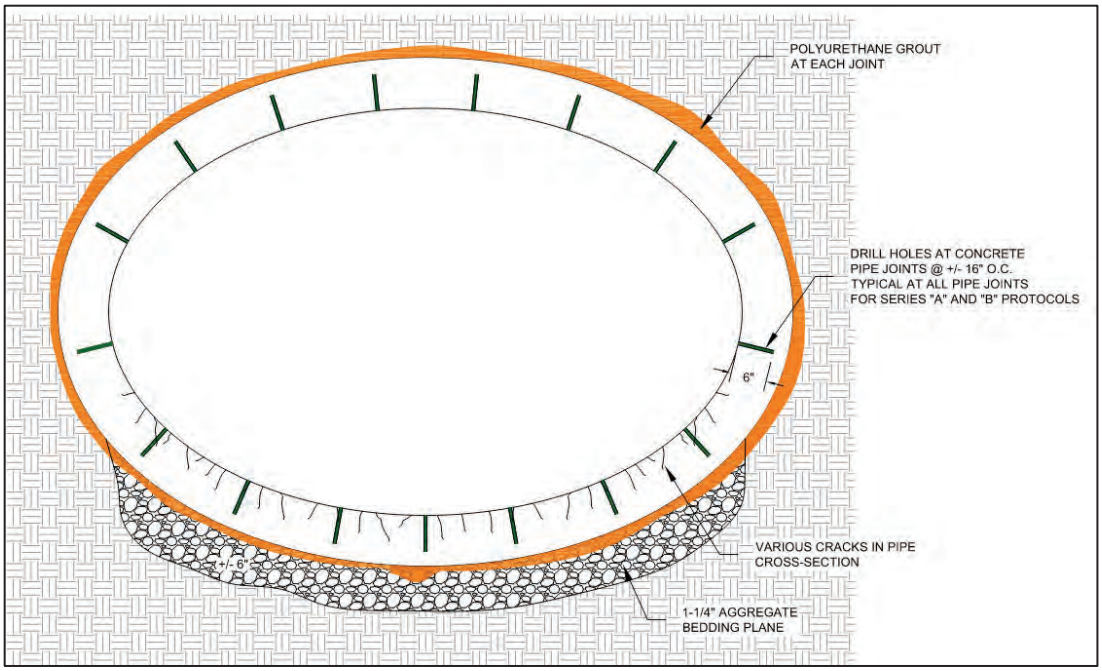
- Per joint according with Project Drawing 16A, see image 1.a.
- The cement grout holes (8 each) located between joints in the haunch area, see Image 1.b.
- Drill holes for crack interception (cracks with width greater than 0.021 inches).

Image 1.a. Location of drill holes at each joint.

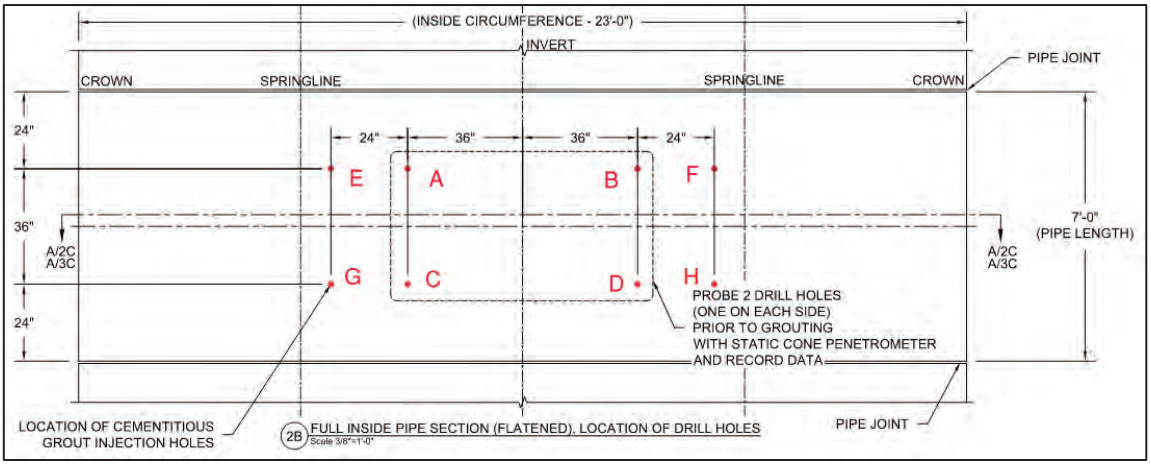
Image 1.b. Location of drill holes at the haunch area.

Holes 3/4 inch diameter will be drilled at locations marked according with Image 1b and Image 4, to a depth of 6 inches below the culvert pipe for the grouting holes. The testing holes will be drilled through the pipe with no protrusion per the QC plan.

The ultrafine cementitious grout will be injected following the sequence of Image 1b, injecting the volume indicated in Image 5, in lifts from bottom to top, at a rate of ½ gallons per minute at 40 psig of pressure (injection pressure will be verified/corrected during mock-up test if invert lifting is observed). Refusal criteria will be met when pumping rate drops at ¼ gallons per minute at 30 psig, for 5 consecutive minutes. Once the hole is grouted, the packer will be capped.

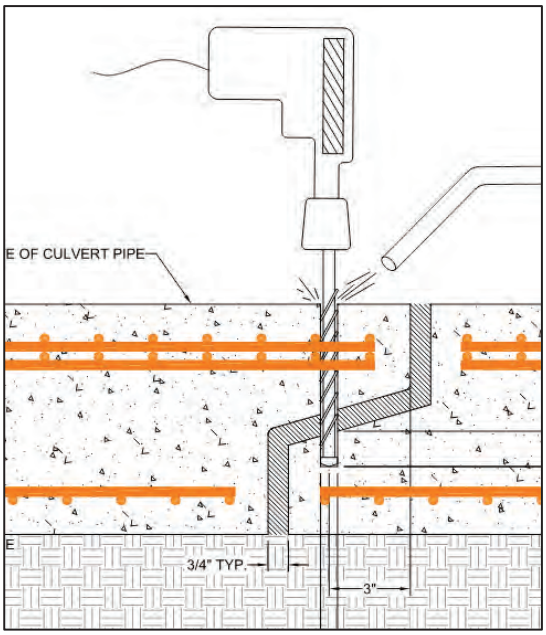
Holes at the joint will be offset +/-3 inches in the pipe flange to intercept the center of the joint (see Image 2). The tolerance of hole location is included in the Quality Control Plan.

Image 2. Location of drill holes at each joint.

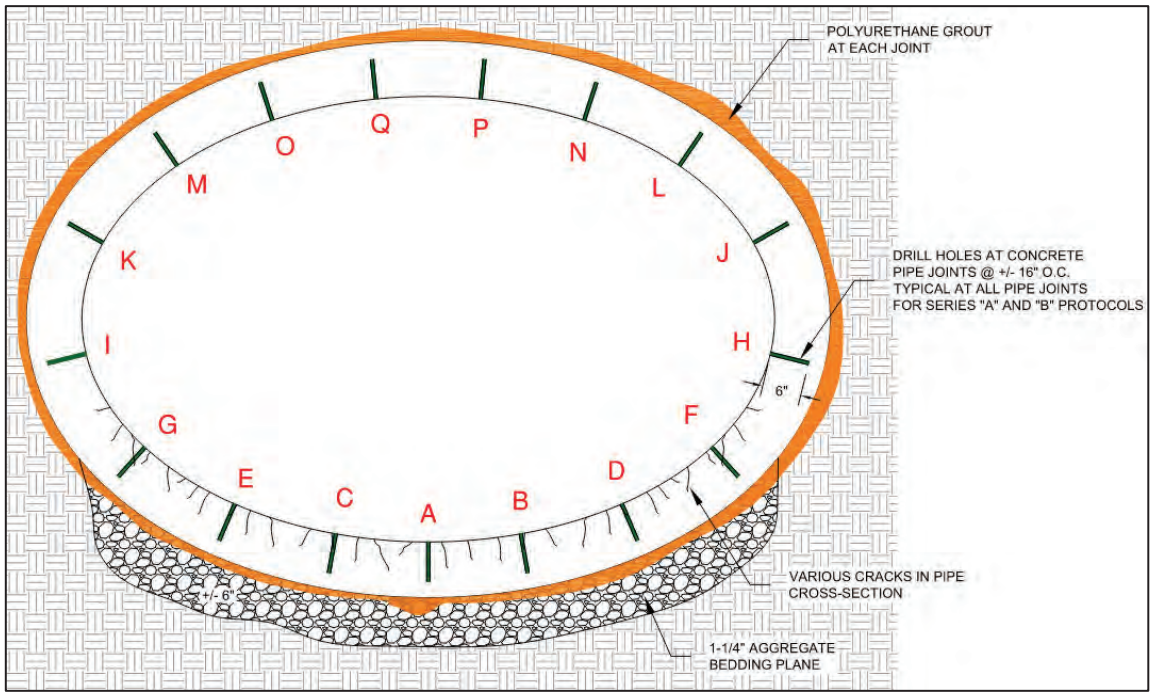
The sequence of the grout process will follow the letters of the holes of Image 3, starting in the invert with hole “A” and continuing chronologically as noted in Image 3.

Image 3. Grout sequence.

Part A and B will be statically mixed and injected through surface mounted ports/packers following the sequence of Image 3 at a rate of ¼ gallon per minute and a maximum pressure of 40 psi. A maximum of 3 gallons of grout will be injected per hole. If acrylamide grout leaks up through pipe joint, pumping operations will stop for 2-3 minutes to let the grout set. The hole will be re-drilled and re-injected with at least 2 gallons of grout. Any grout spill/leakage will be cleaned and disposed per the ECI Safety Plan.
