Subject: PHASE I HAZARDOUS MATERIAL REPORT
Project I.D.: 2410-13-00
Roadway: W. National Avenue
Termini: S. 62nd Street to S. 65th Street
Highway Number or indicate if local road: Local Road
County: Milwaukee

Phase 1 Hazardous Materials Assessment

Project ID 2410-13-00
West National Avenue
S. 65th Street to 62nd Street
Milwaukee County

April 15, 2020

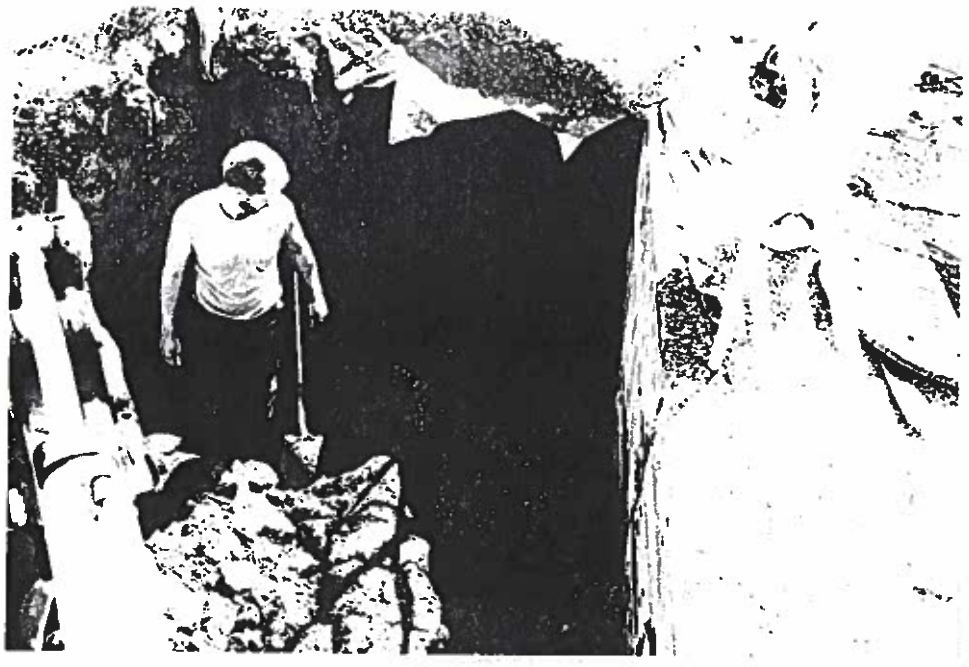
While excavating along the west side of the tank, a storm sewer lateral was encountered at a depth of 5.0 feet, approximately 1.5 to 2.0 feet west of the tank. After uncovering the tank and exposing the west side, the Contractor attempted to drag the tank out of the pit. The tank appeared to be in very poor condition, with excessive pitting and corrosion. While raising the tank, product and water escaped through numerous holes in the bottom of the tank shell. The tank was immediately set down on an angle to prevent the remaining product from escaping. The chain was reattached and the tank was removed and set on its side. A commercial absorbent material was used to clean up the product released onto the concrete drive.

SEWER LATERAL RUNNING THROUGH THE EXCAVATION

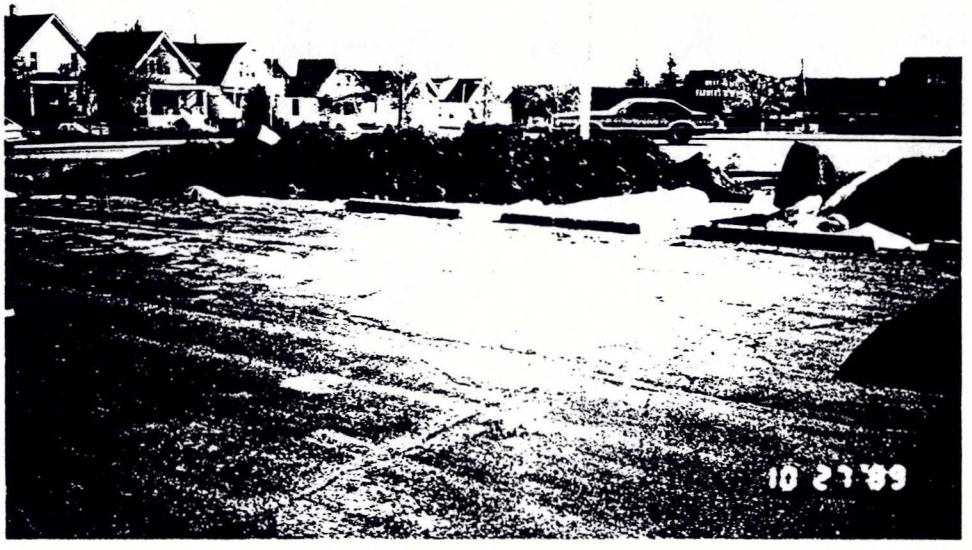
CONTAMINATED EXCAVATED SOILS STAGING AREA

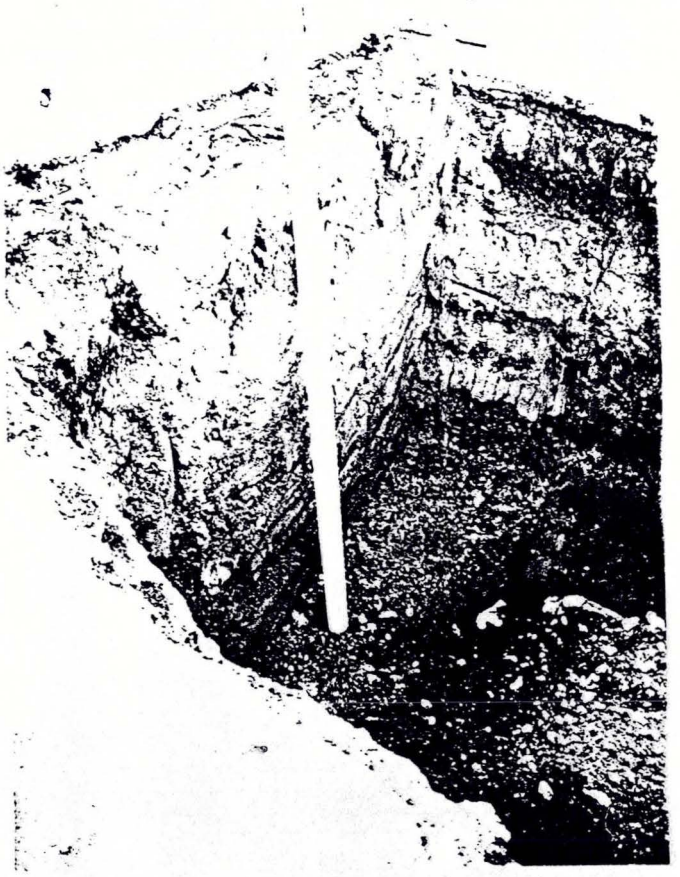
SOIL VENTING SUMP

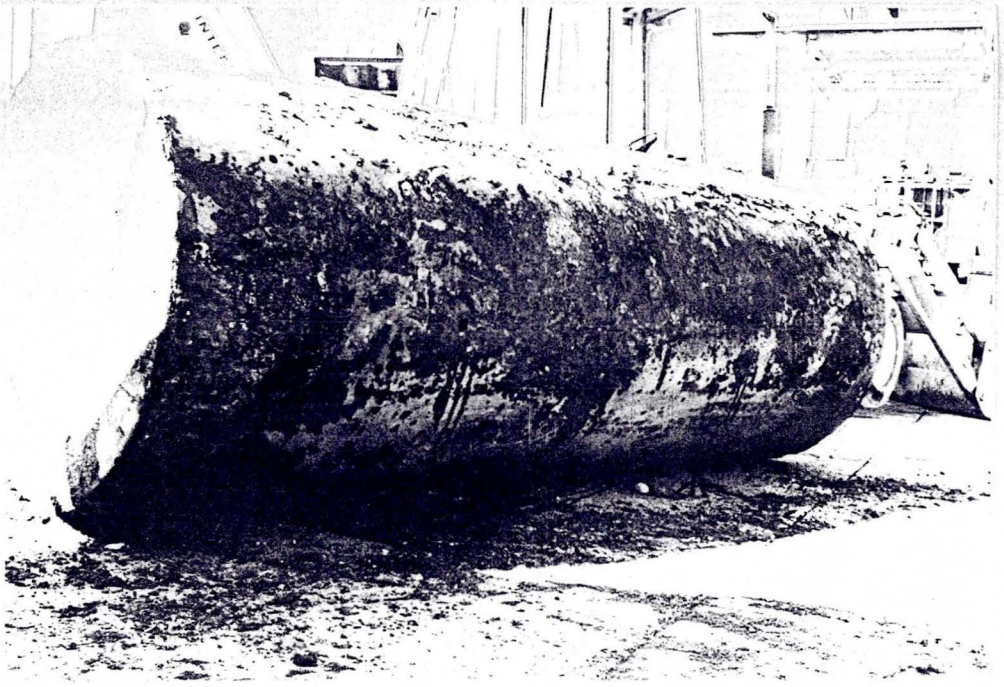
HOLES ARE VISIBLE ON THE BOTTOM OF THE TANK SHELL
