Performance and Policy Related to Aluminum Culverts in Wisconsin

After Close-Out Presentation (ACOP) Final Report

WisDOT ID no. 0092-17-05

May 2019

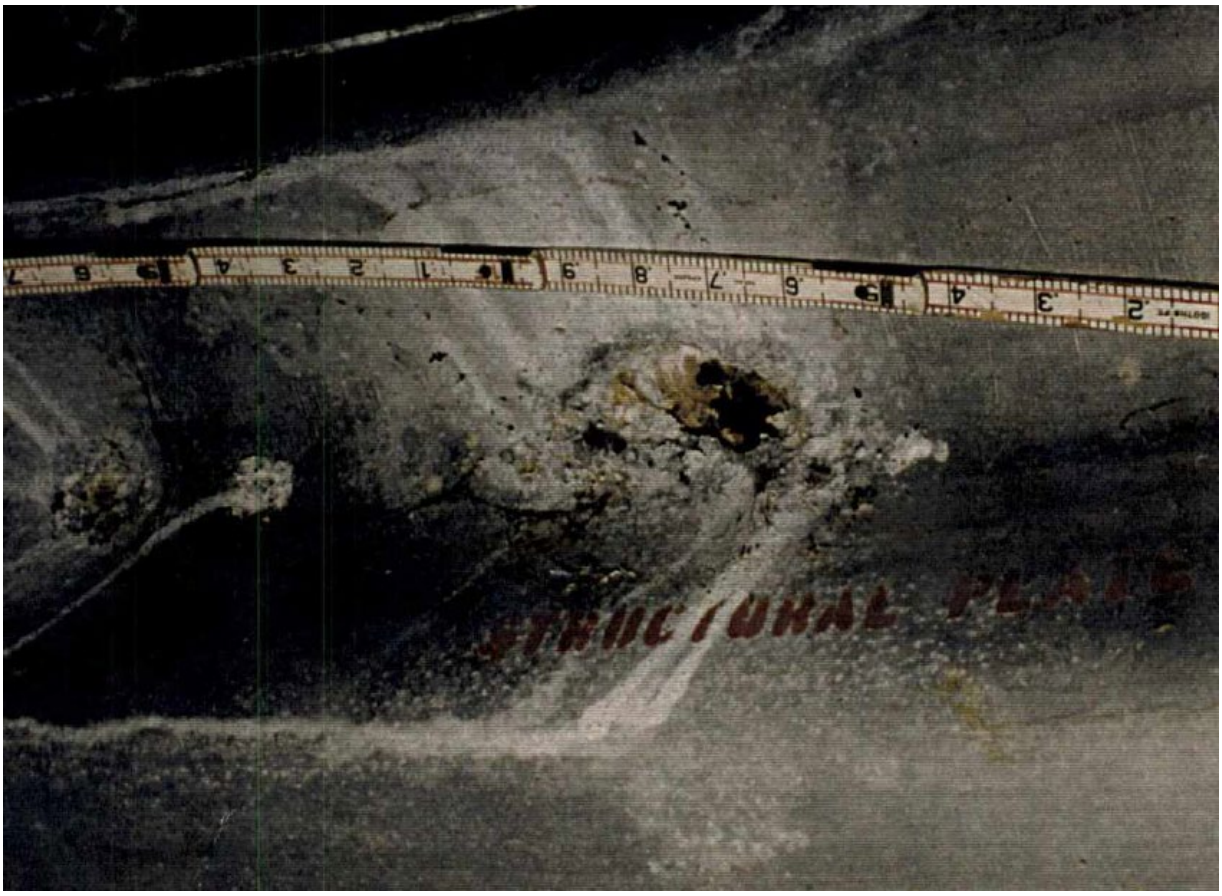
Of ten aluminum drainage structures examined on State Highway 82 west of Mauston in southwestern Juneau County, nine were in an advanced state of deterioration at the crown, particularly near the center of the pavement. There were typically perforations with white precipitate found (Figure 1). These structures were covered with cracked flexible pavement and were at a range of soil cover depths. Based on the wide geographic distribution of aluminum culvert sites exhibiting corrosion, composition of soil was not considered to be strongly correlated to corrosion. Having the inverts of the structures below the flow lines of many pipes indicated that the corrosion was not related to chemistry of the water flowing through the pipes. Conclusions from review of the ten structures included that the corrosion was more severe on more heavily traveled and heavily salted roads and that the corrosion correlated well with extensive pavement cracking. Soil cover height and soil type did not correlate well with corrosion. The report noted that collapse of the top of a structure may be potentially more serious than collapse of the invert. Based on the findings, the report recommended that use of aluminum culverts be restricted on heavily salted roads unless the installation included protection for the outer surface of the structures from road salt.

Figure 1 – Aluminum Structural Plate Culvert Installed in 1969 with 2 In. Perforation from Corrosion Observed in 1993 (Reproduced from [*6*])

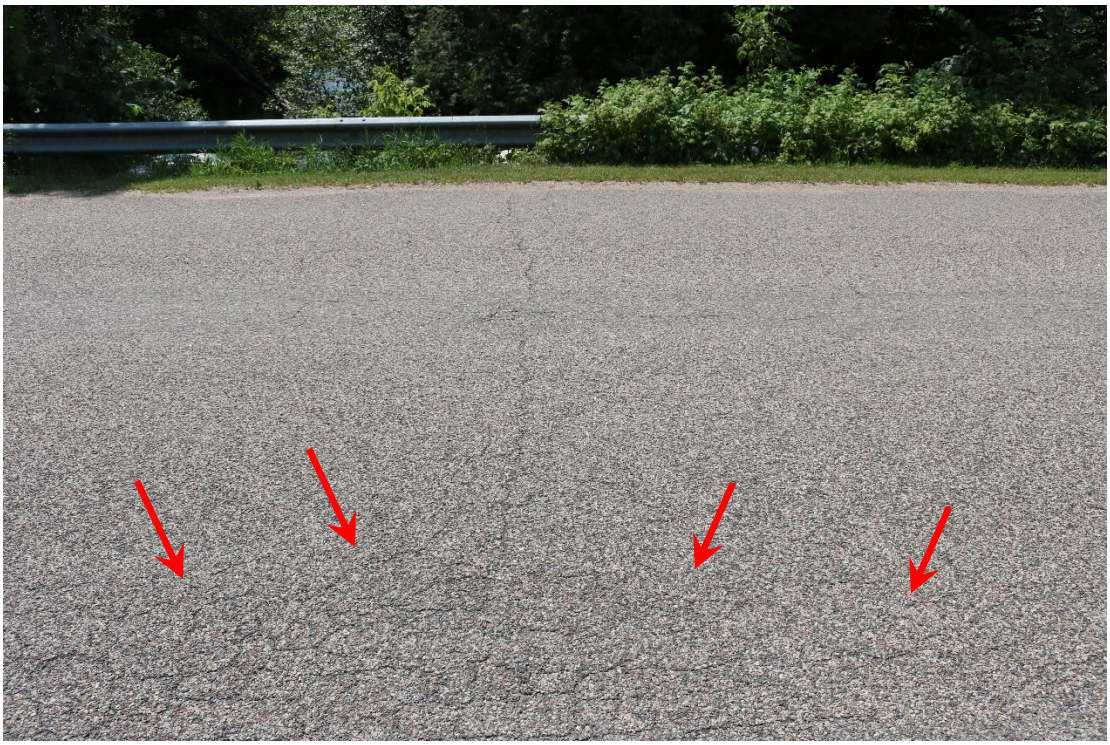
Culvert 2 is a three-barrel culvert of similar corrugated aluminum structural plate pipe arch construction to Culvert 1. Culvert 2 is below a local road and carries a river branch that had active flow through each of the three barrels at the time of inspection. We measured the fill depth above the culvert to range from 0.75 to 1.5 ft including slight roadway crown and variation in fill depth over the width of the road. The pavement above had narrow, unsealed cross cracks and slight rutting of the wheel paths with map cracking in the wheel paths (Figure 23). The pavement cracking directly above the culvert was less severe than the more prominent map-type cracking and deeper rutting observed on the roadway about 100 ft away from the culvert.

Figure 23 – Pavement Cracks above Culvert 2 Including Pavement Transverse Crack above Culvert Barrel (Center of Photo) and Map Cracking in a Wheel Path (Red Arrows at Lower Portion of Photo)

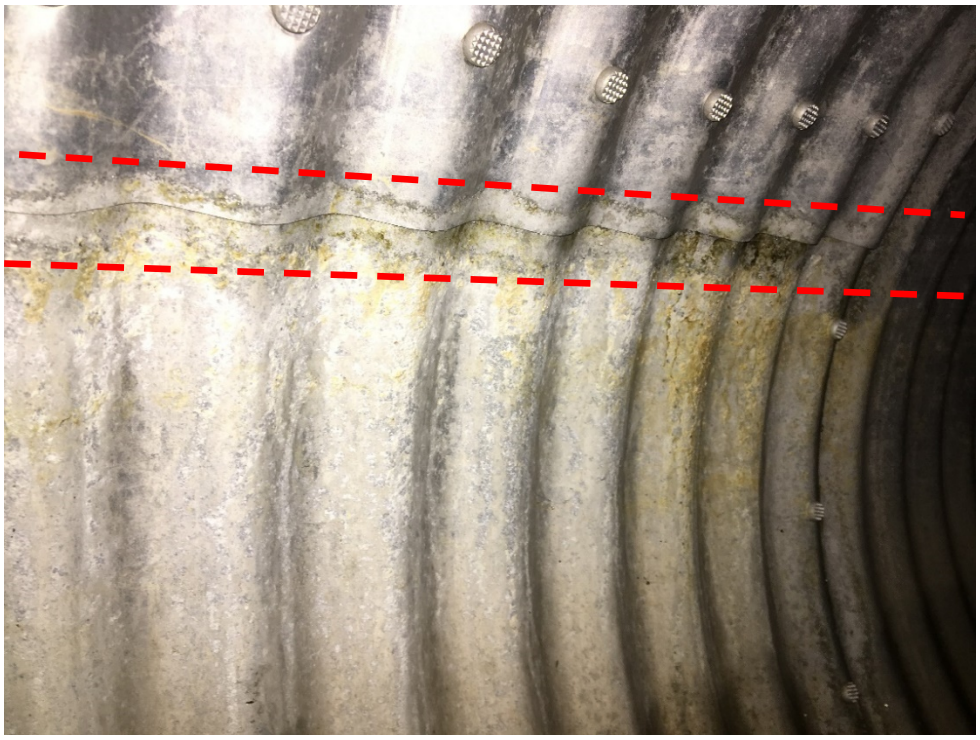
Figure 26 – Heavy White Corrosion Staining below Longitudinal Seam (between Dashed Red Lines) where Upper Section Nests Inside Lower Section at the 10:30 Clock Position near Center of Roadway

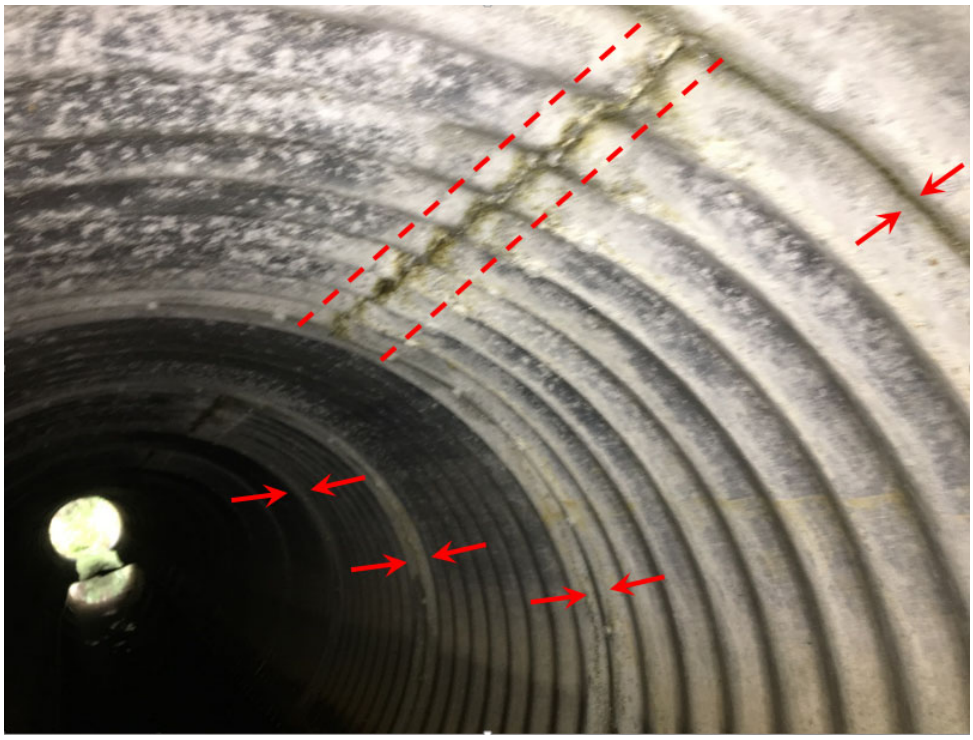
Figure 27 – Heavy White Corrosion Staining Emanating from Longitudinal Seam (between Dashed Red Lines) and at Circumferential Seams (between Pairs of Red Arrows) Further Into Photo; Photo Location Is Below Roadway Travel Lane

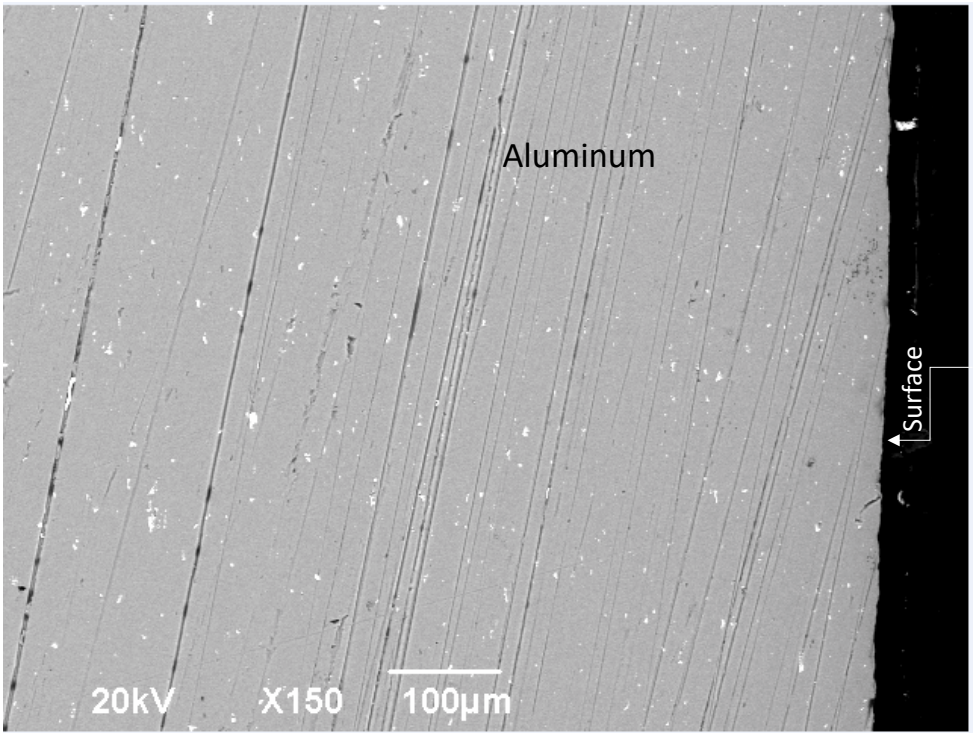
Figure 30 – Scanning Electron Microscope View of Uncorroded Aluminum Sample from Culvert 1 Showing No Visible Evidence of Corrosion or Cladding

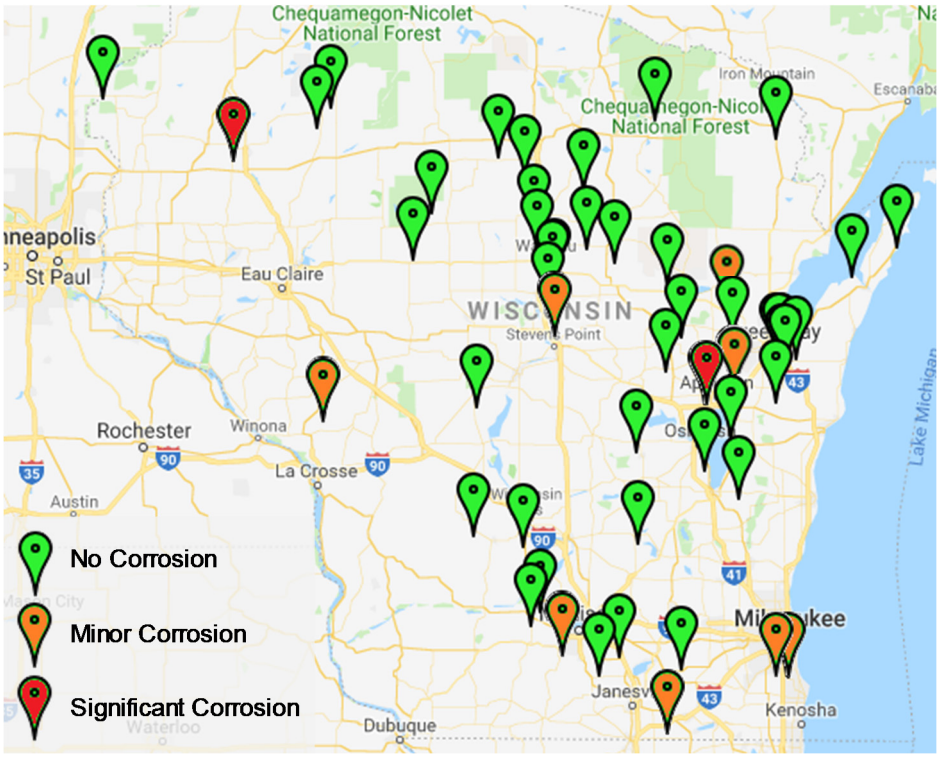
Figure C.1

Geographic distribution of aluminum culverts in Wisconsin HSIS database with corrosion level based on review of most-recent inspection report.

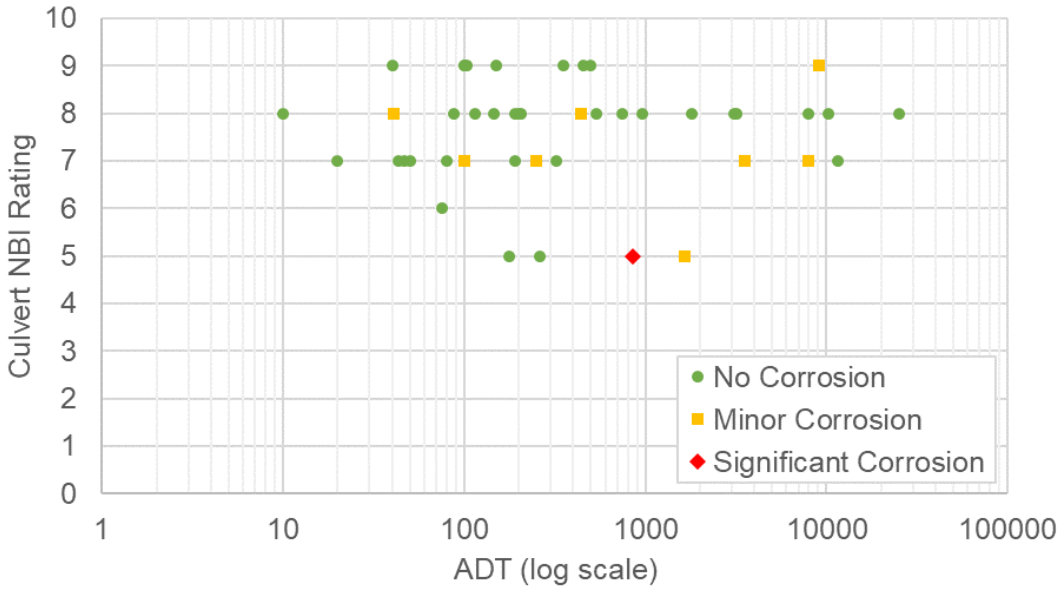
Figure C.10

- **Average Daily Traffic (ADT, Figure C.10):** The data do not appear to show a significant correlation between corrosion level and ADT. This is surprising, considering the likelihood for increased use of deicing salts and chemicals on roadways with higher ADT.

Culvert NBI rating vs. ADT (log scale) with corrosion level based on review of most-recent inspection report.

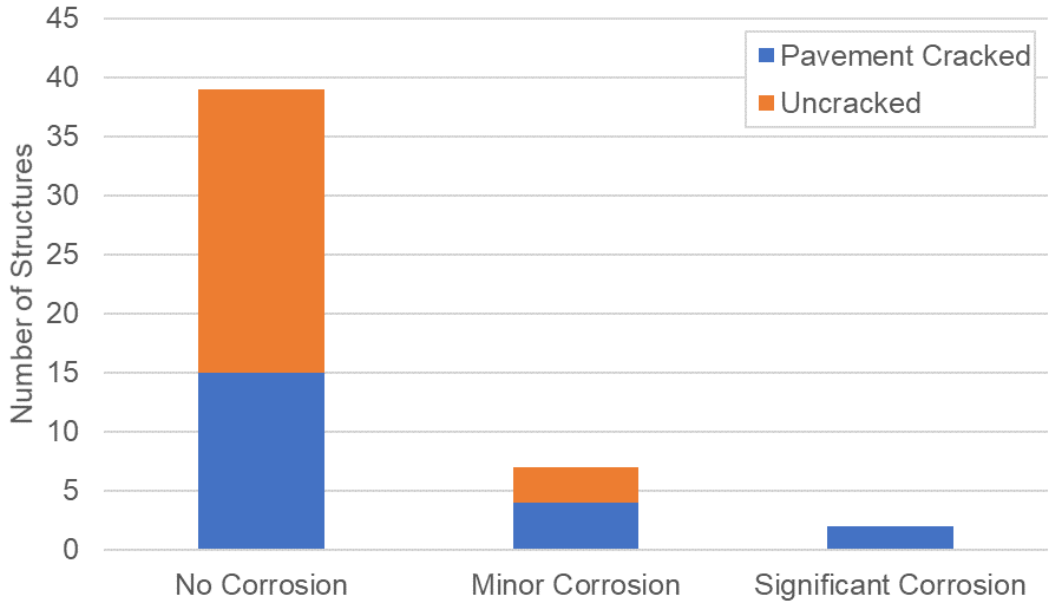
Figure C.11

- **Pavement Cracking (Figures C.11 and C.12):** The data show increased corrosion in culverts where the pavement condition was noted as cracked in culvert inspection reports. The data do not provide pavement history, preventing direct correlation of pavement condition over time with levels of corrosion.

Histogram of culvert corrosion level and identification of cracked or uncracked pavement both based on review of most-recent inspection report.

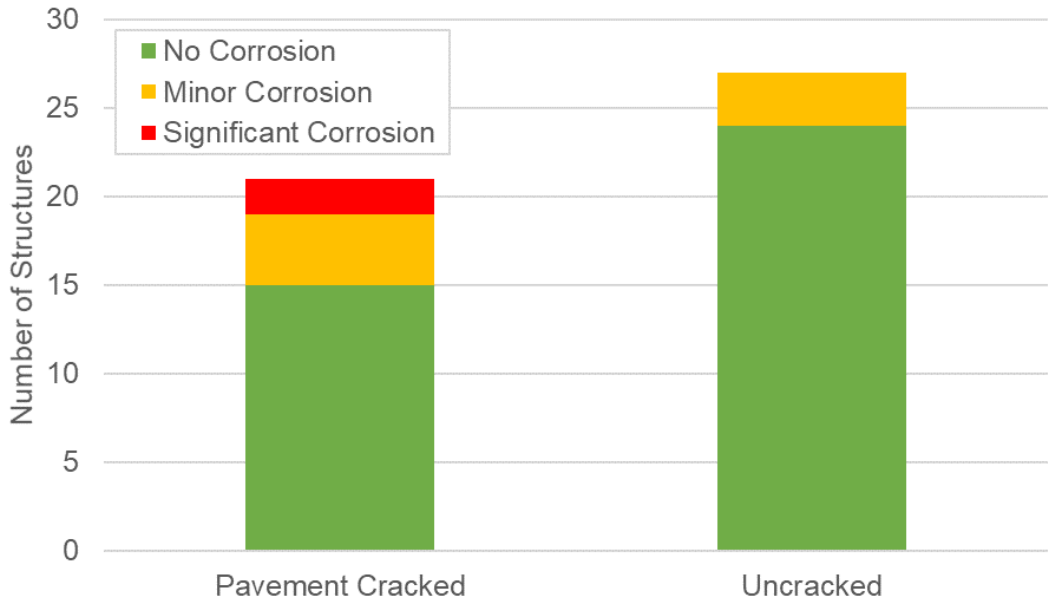
Figure C.12

Histogram of culverts identified with cracked or uncracked pavement with corrosion level based on review of most-recent inspection report.

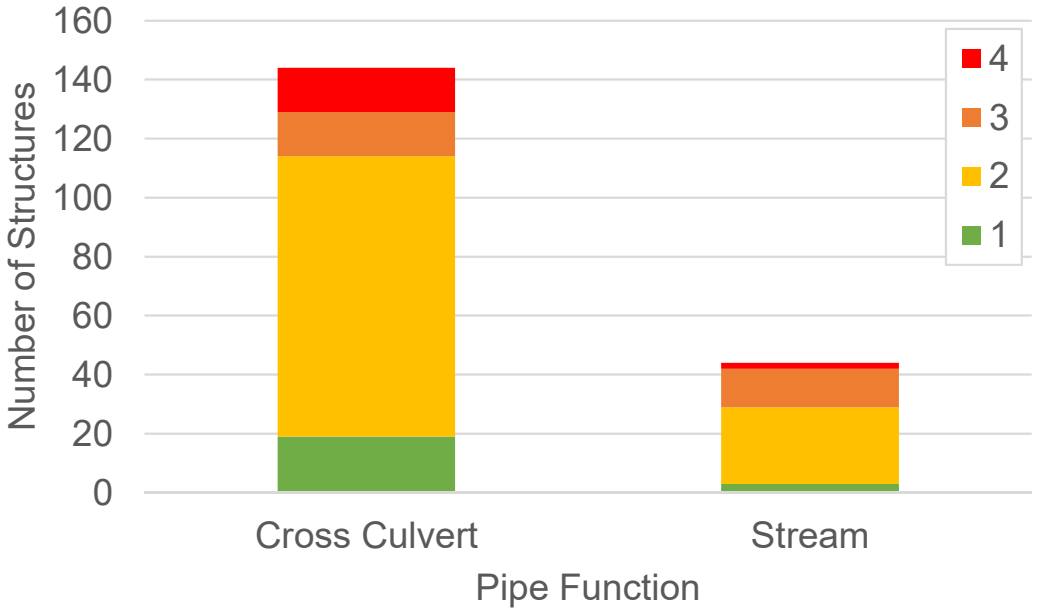
Figure C.17

- **Culvert Function (Figure C.17):** The reported function of the culvert (cross culvert or stream) does not have significant correlation with the reported corrosion rating.

Histogram of reported pipe function with reported corrosion rating.

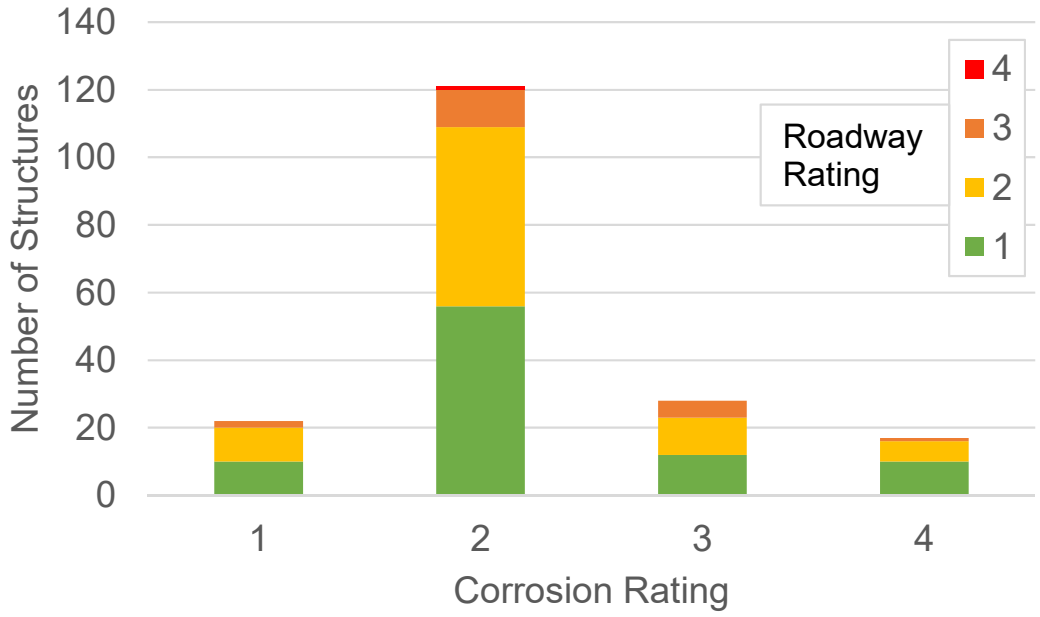
Figure C.18

- **Pavement Cracking (Figures C.18 and C.19):** There is no significant correlation between roadway rating and corrosion rating. However, culverts with higher corrosion rating are more likely to have higher cracking rating. The discrepancy between roadway rating and cracking rating correlation may be due to other factors considered in roadway rating beyond pavement cracking.

Histogram of reported roadway and corrosion ratings.

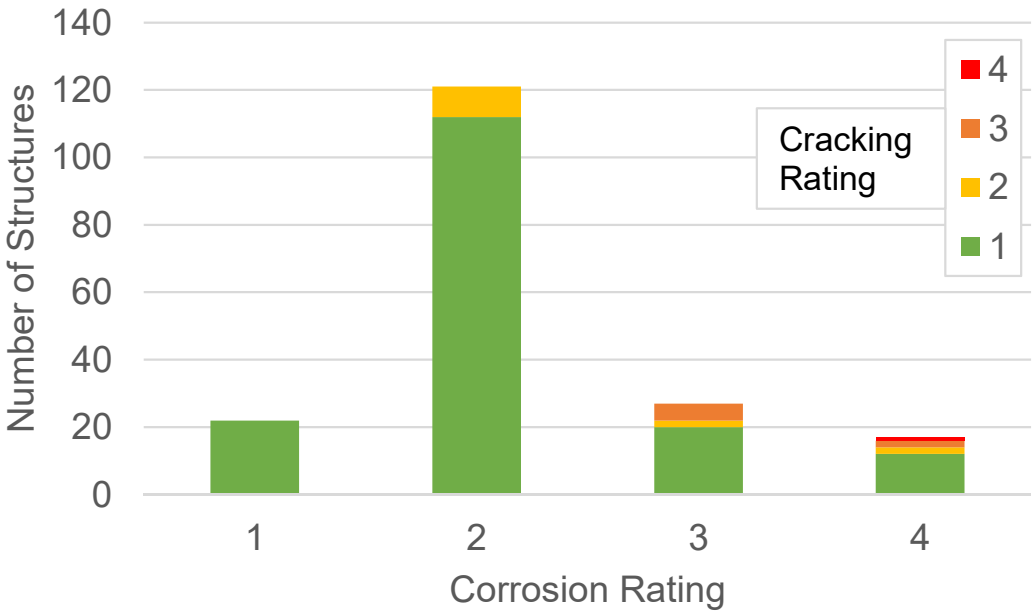
Figure C.19

Histogram of reported cracking and corrosion ratings.

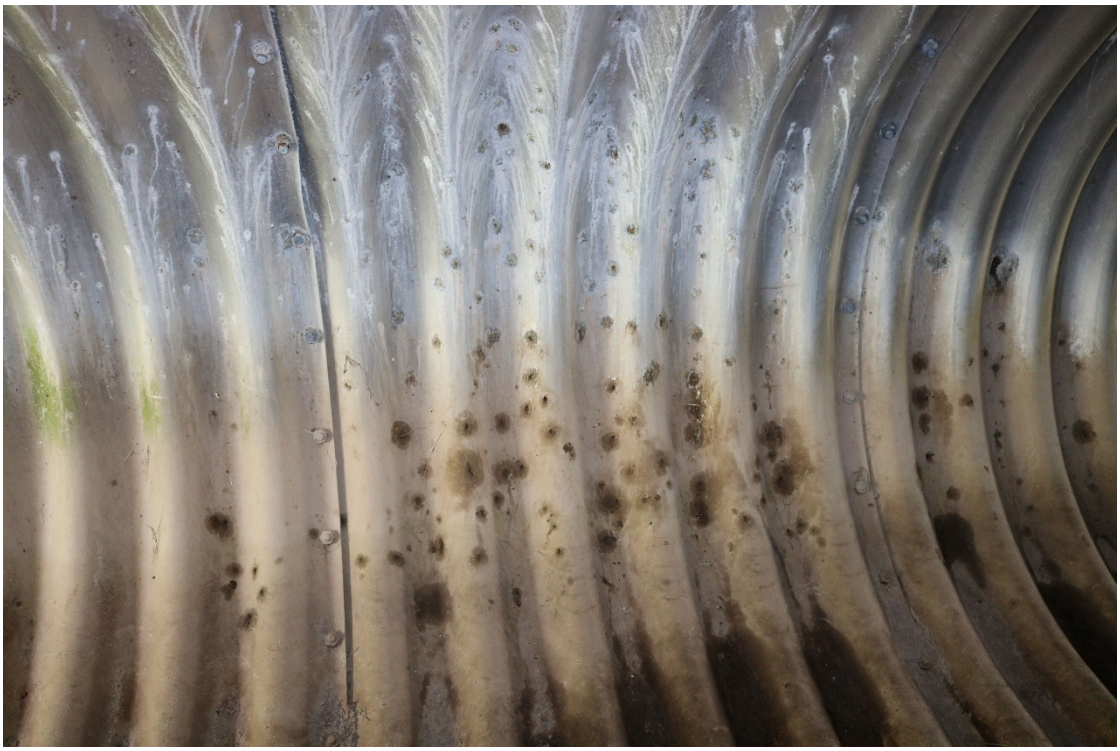
Photo 12

Area of through-wall pitting and corrosion staining at north springline, below west shoulder.

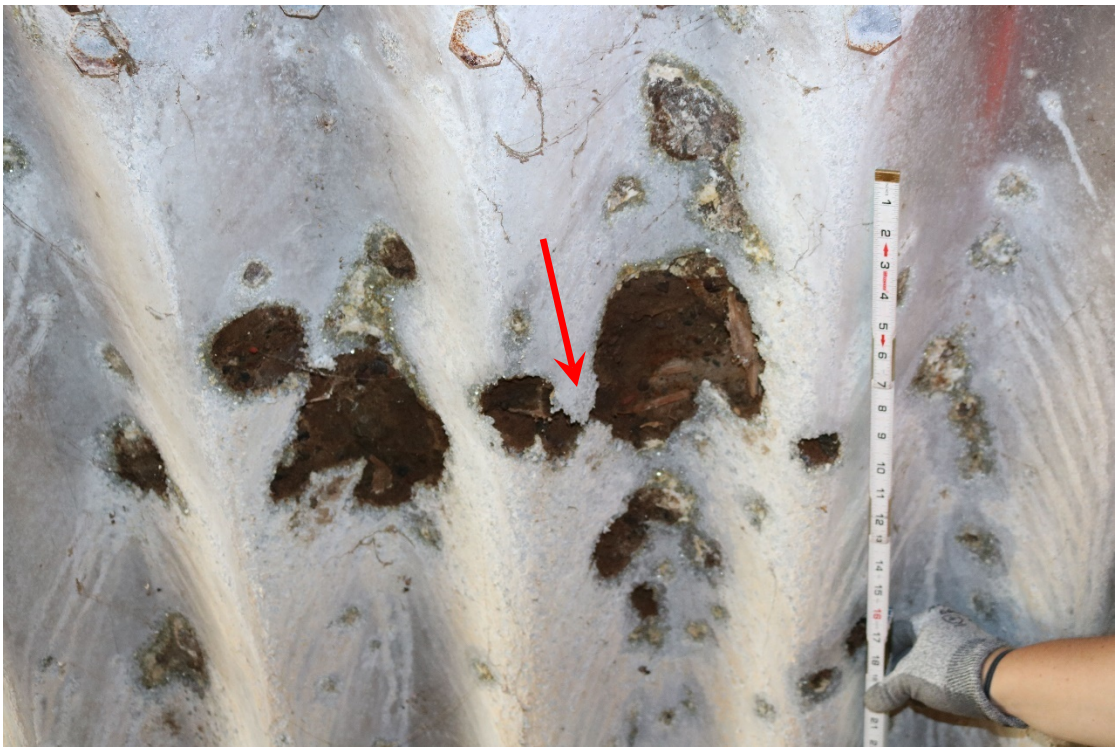
Photo 13

Area of coalesced through-wall pitting with severe corrosion staining and soil visible along north springline below east shoulder. Arrow points to area from which corrosion sample was removed.

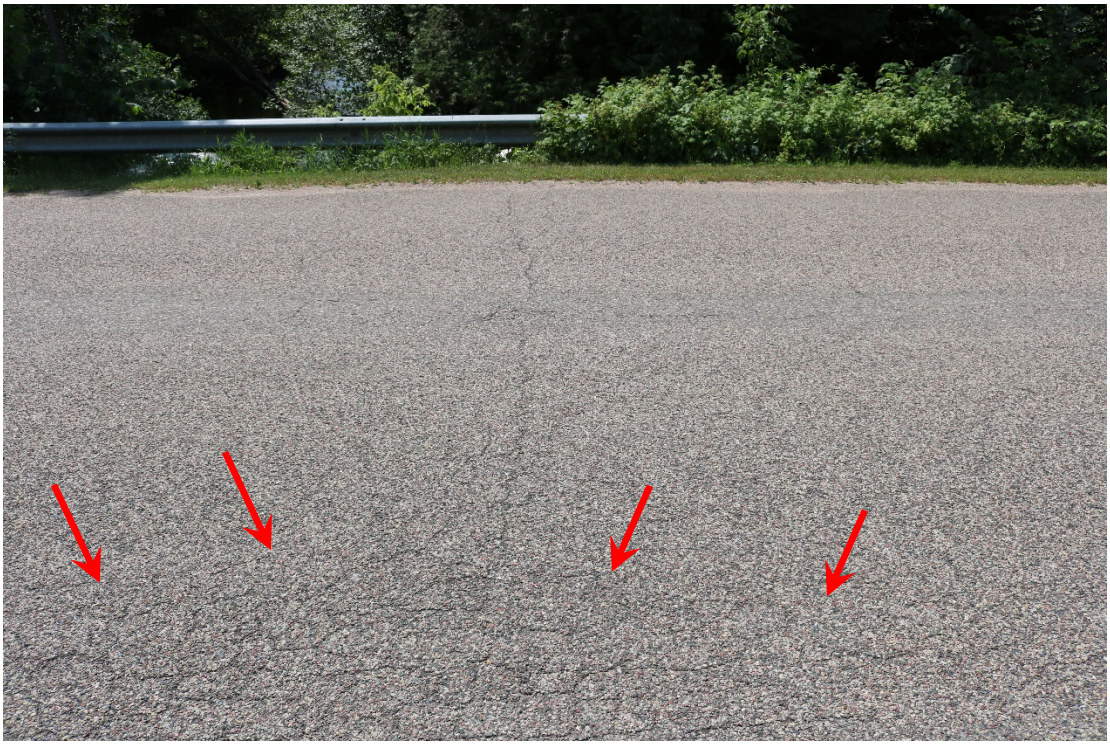
Photo 2

View looking north toward upstream end of culverts showing large cross crack aligned with crown of culvert, and additional alligator-type pavement cracking in foreground (red arrows).

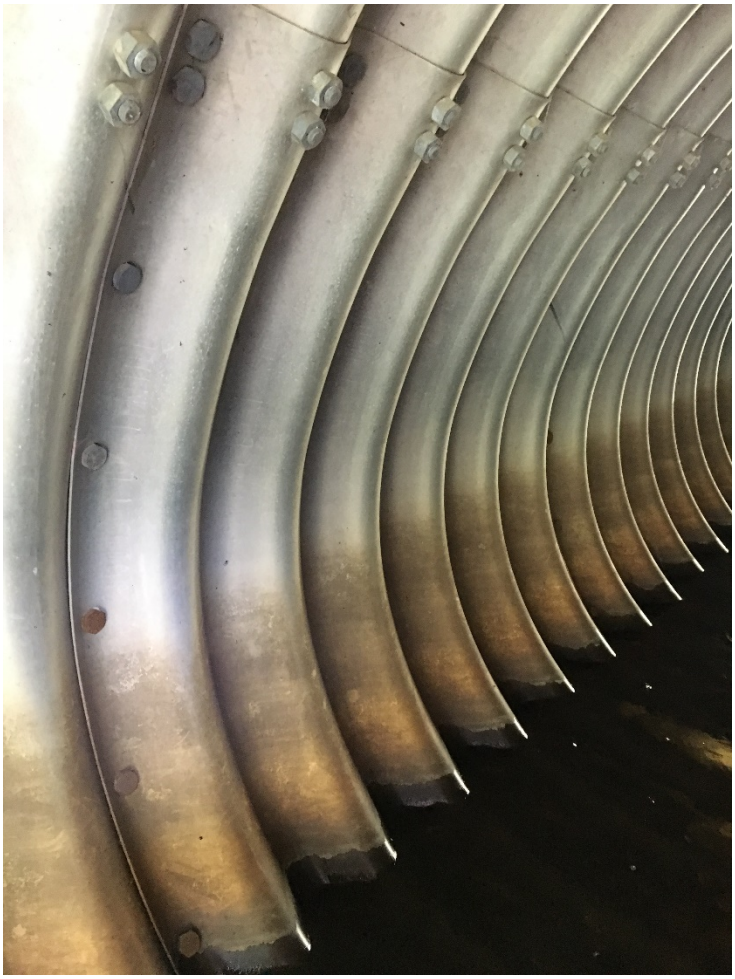
Photo 18

Typical brown staining in lower portion of barrel, and typical fastener condition with minor surface corrosion at high water line fasteners.
