**I-43 Leo Frigo Memorial Bridge
B-5-158
ID 1220-15-01
Green Bay, Wisconsin**

Investigation Report Volume I: Text, Tables and Exhibits

May 2015

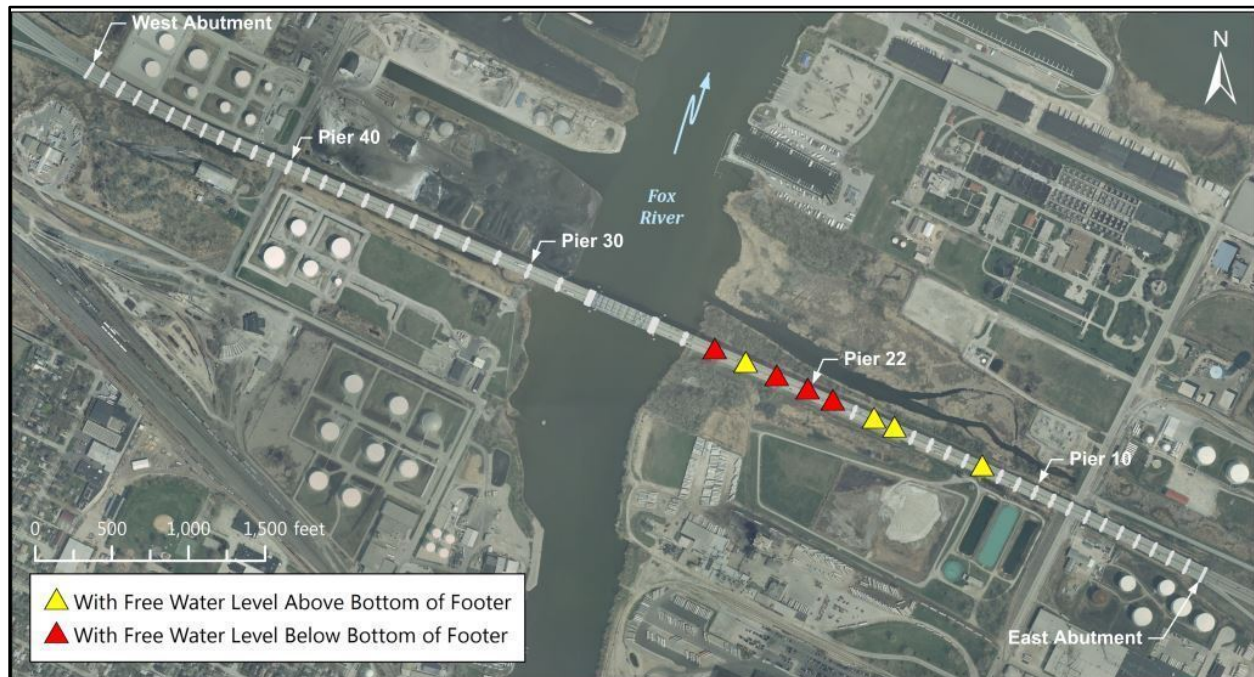
Figure 2.4: Plot of Fly Ash Locations Encountered

At Piers 21 through 25, the fill is predominantly very loose to loose fly ash, coal ash, and foundry sand. The thickness of the fly ash, coal ash, and foundry sand stratum varies from approximately 0 feet around most of Pier 24 to a maximum of about 19 feet at Pier 22. At Piers 22 and 25, the fly ash is exposed at the ground surface.

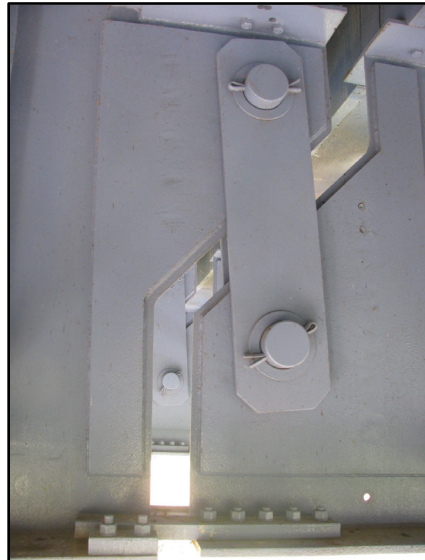
Figure 3.3: Span 21 Pin & Hanger at Girder 8 (looking north)

- c) The vertical hanger plates were rotated approximately 3.5 degrees (see Figure 3.3)
- d) The bottom of the wind lock plates were not in contact with the top of the bottom flange of the adjacent girder with an average gap of approximately 5/8-inch (see Figure 3.4)

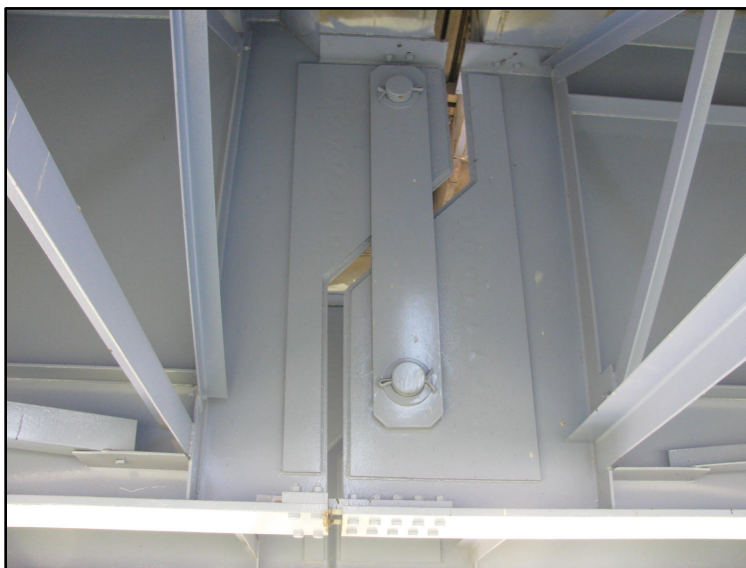
Figure 3.5: Span 23 Pin & Hanger at Girder 2

- e) The vertical hanger plates were vertical and flat (see Figure 3.5)
- f) The wind lock plates were in contact with the top of the bottom flange of the adjacent girder at the end of the adjacent girder. However, at the end of the wind lock plate itself, there was an average gap of approximately 3/16-inch (see Figure 3.6)

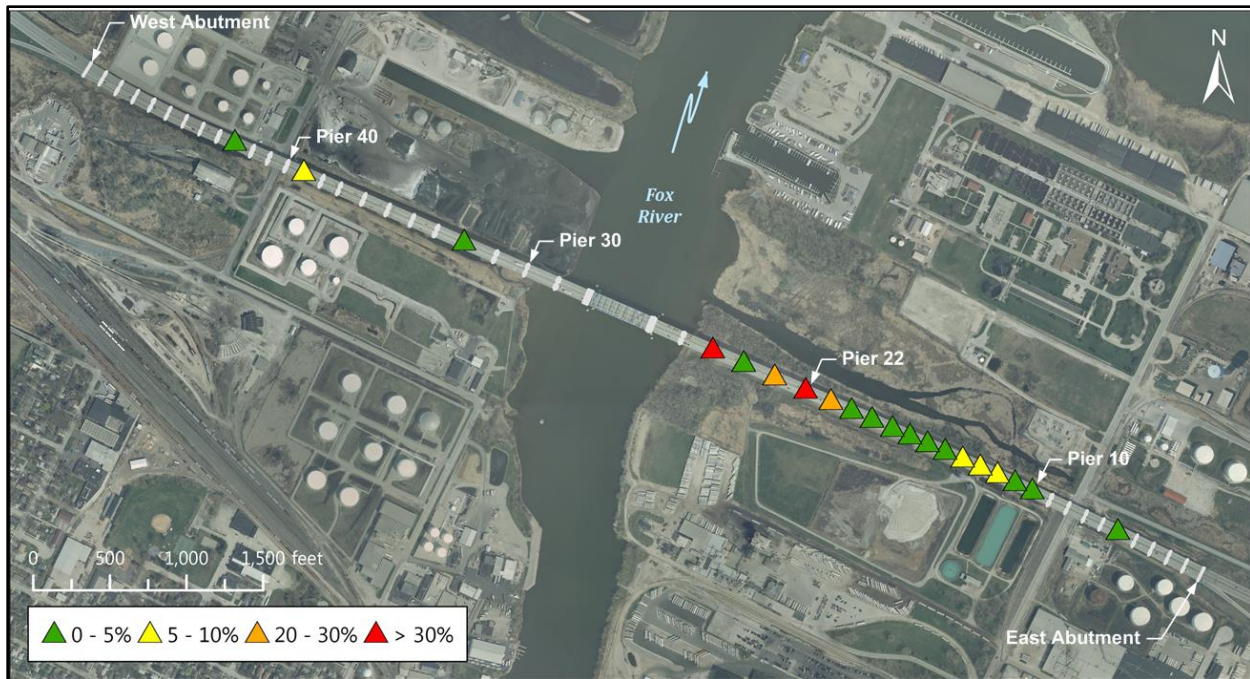
Figure 3.8: Plot of Average Section Loss Observed Over Exposed Pile Length (Visually Rated)

Figure 3.8 shows the results of visual ratings on average pile section loss observed. A visual rating range of 1 (poor condition) to 10 (good condition) were assigned based on the condition of pile exposed. Typical photographs for the condition of piling with respect the visual rating assigned is provided in Figure 3.7 below. Table 5 present detailed rating results. In general, a visual rating of 1 was assigned to the exposed piling at Pier 22 where section loss was visually estimated to exceed 40%; visual ratings of 2 to 4 were associated to piling where the average section loss was estimated to be approximately 20 to 30%; visual ratings of 5 to 6 were associated to piling where the average section loss was estimated to be approximately 5 to 10%; and visual ratings of 7 to 10 were associated to piling where the average section loss was estimated to be approximately 0 to 5%.

Select piles were exposed at test pits, and representative samples of corrosion product were collected for subsequent laboratory testing, including petrographic and electron microscopic examination. The number, location, and visual rating of the pile condition are summarized in Table 4 and shown in Figure 3.8.

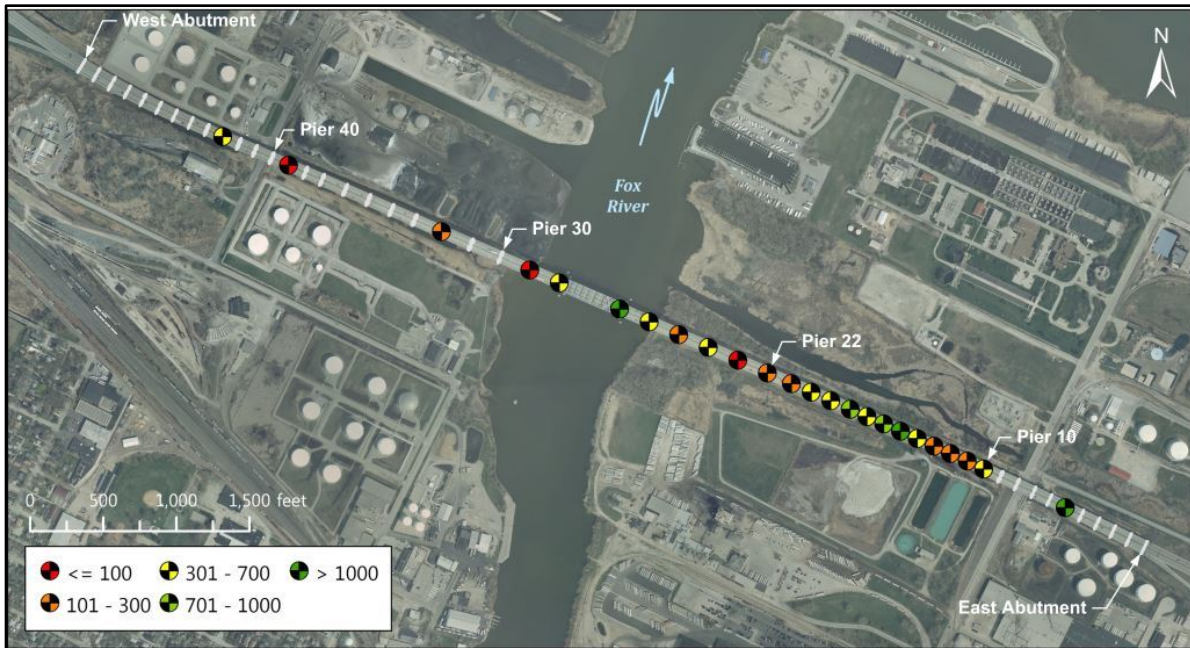
Figure 3.9: Plot of Minimum Laboratory Soil Resistivity Measurements (ohms-cm)

The soil with the lowest minimum soil resistivity was sampled at Pier 23 on the east side of the Fox River, and at Piers 29, 32 and 39 on the west side of the Fox River (between Bylsby Avenue and the Fox River).

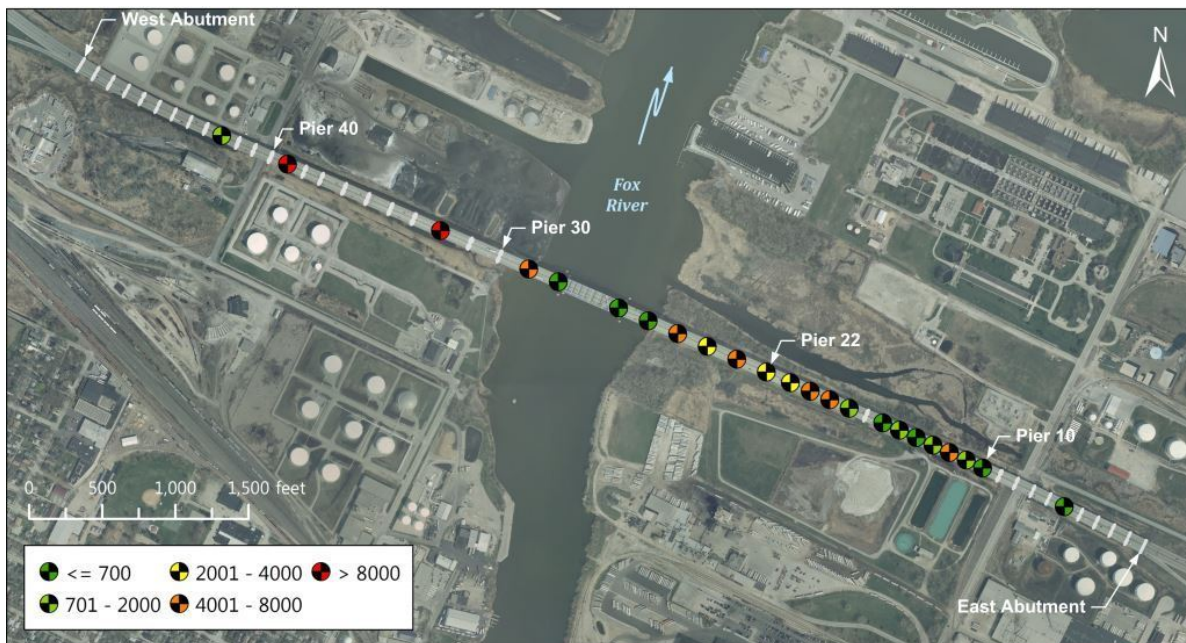
Figure 3.10: Plot of Maximum Soil Chloride Concentrations (mg/kg)

East of the Fox River, the highest soil chloride concentration was at Piers 19, 20 and 23. West of the Fox River, the highest soil chloride concentration was at Piers 29, 32 and 39.

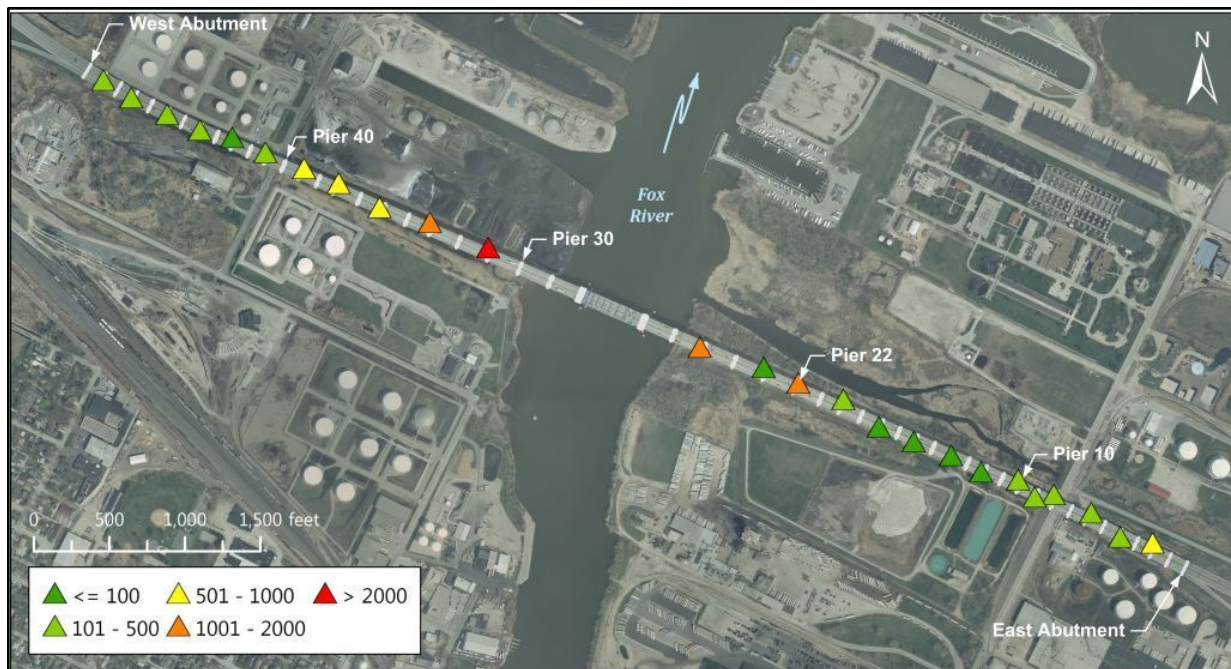
Figure 3.13: Plot of Maximum Water Chloride Concentrations (mg/L)

The highest water chloride concentrations were determined for perched water samples that were collected on the west side of the Fox River near existing stockpiles of salt (present on an adjacent parcel).

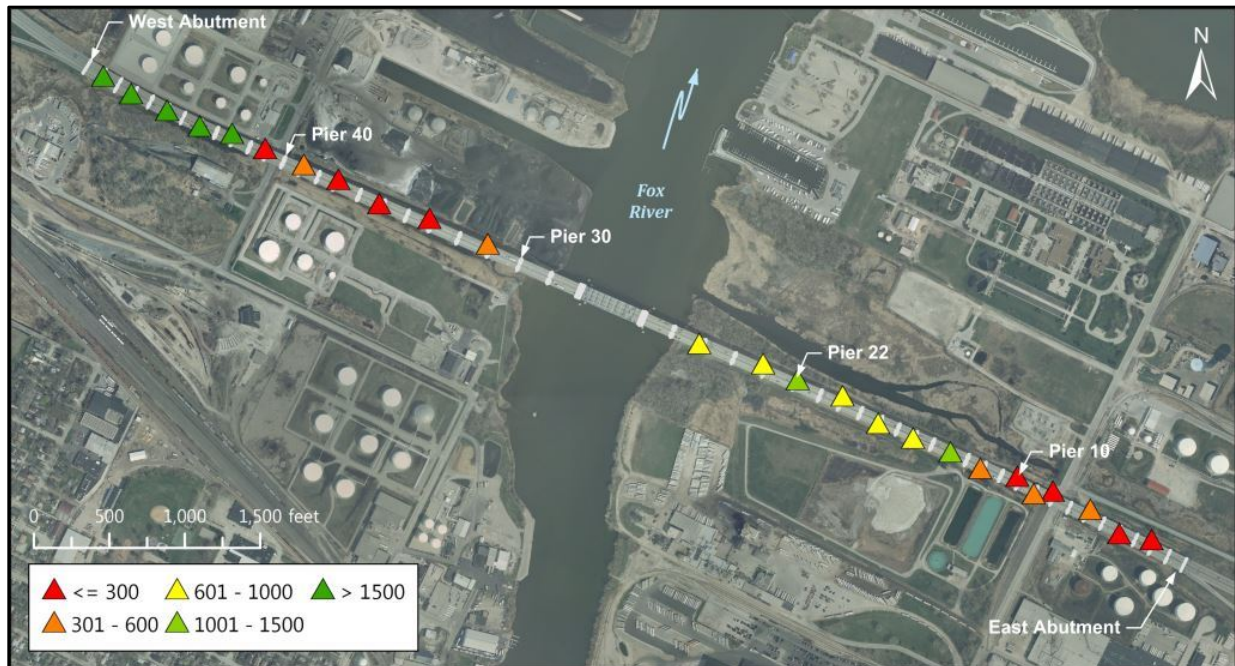
Figure 3.14: Plot of Maximum Water Sulfate Concentrations (mg/L)

The highest water sulfate concentration was obtained from a perched water sample that was collected on the west side of the Fox River near existing stockpiles of coal (present on an adjacent parcel).

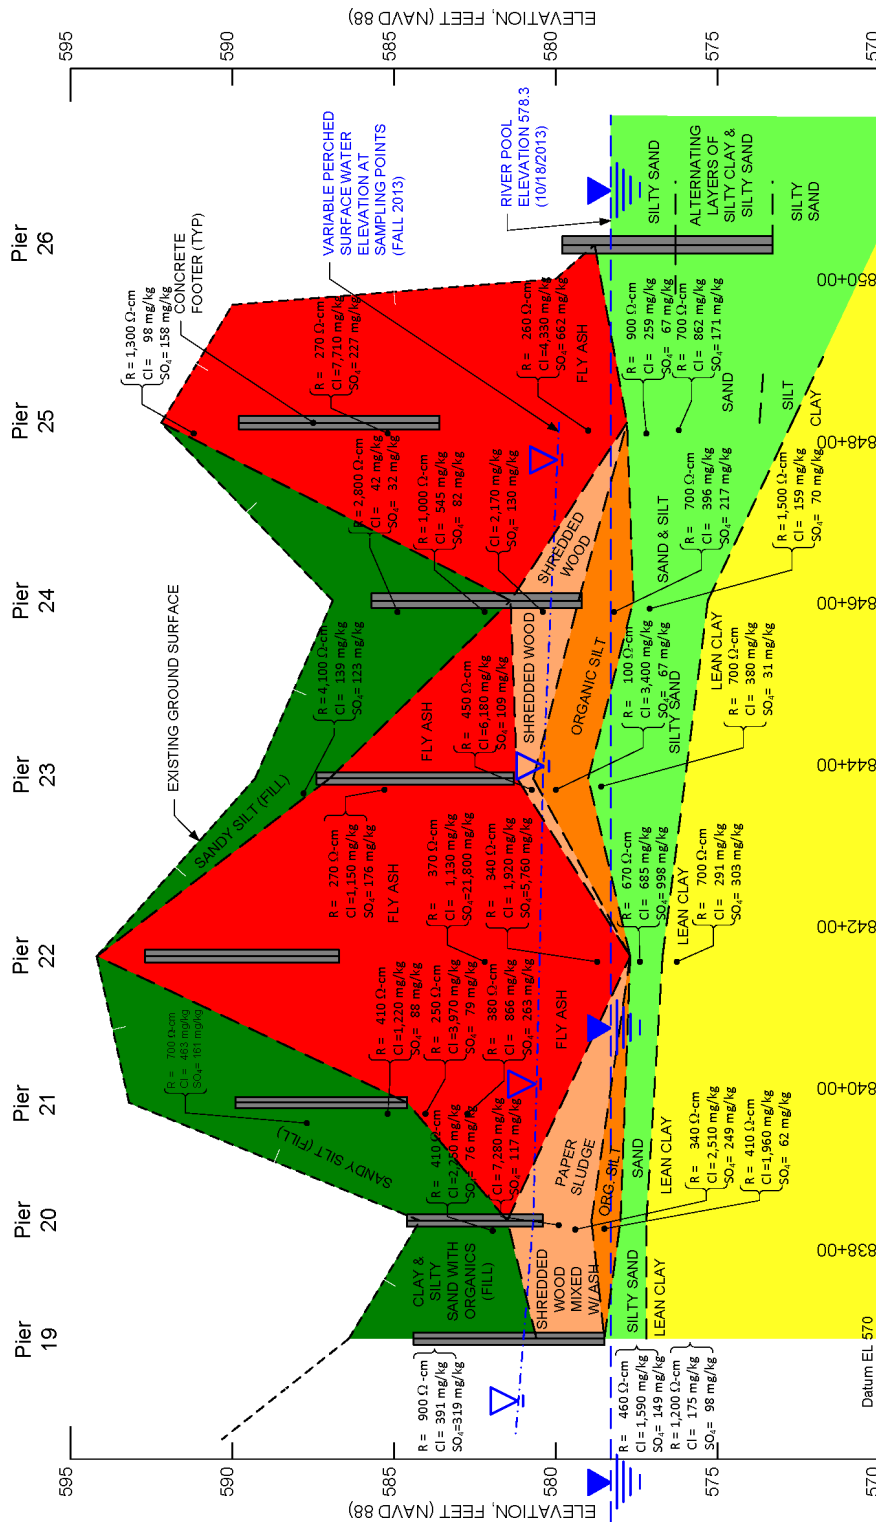
Figure 3.16: Distribution of Select Representative Chemical Analysis Results at Piers 19 through 26

Figure 3.16 illustrates the correlation of soil resistivity with available chorides/sulfates in relation to the position of the perched water and bottom of the pile-supported concrete footings.

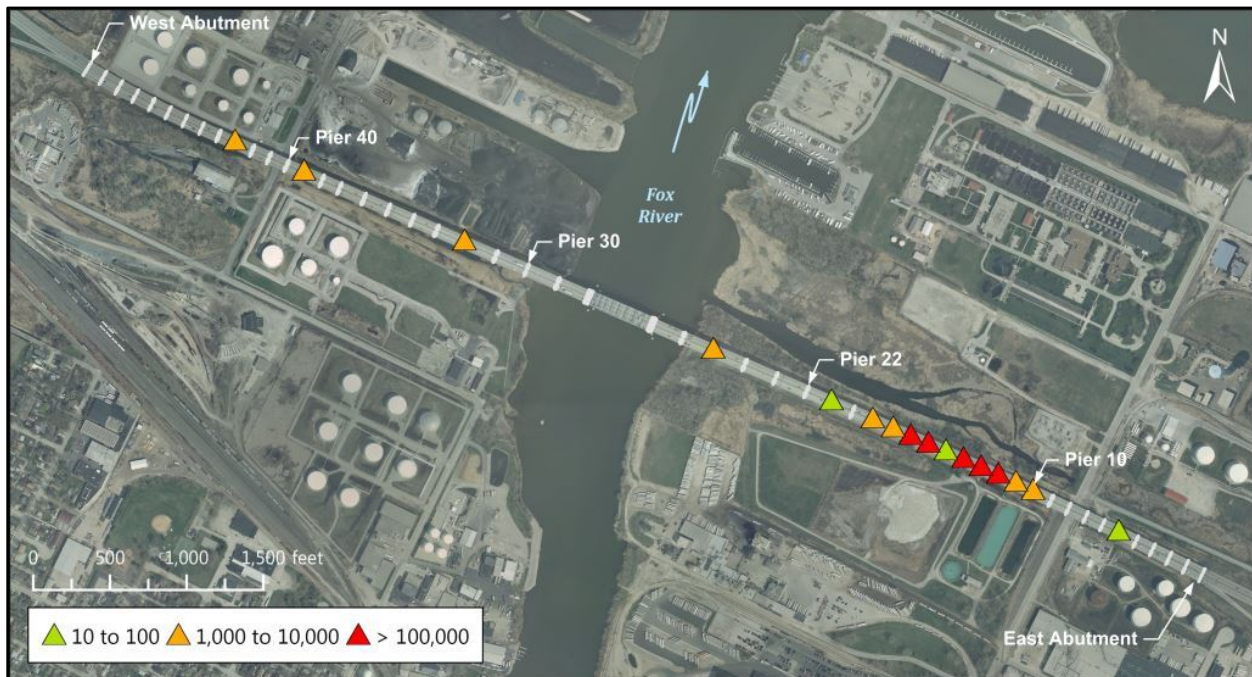
Figure 3.17: Plot of Low Nutrient Bacteria (colonies/mL)

The highest concentration of low nutrient (aerobic) bacteria was detected on the east side of the Fox River between Piers 10 and 19.

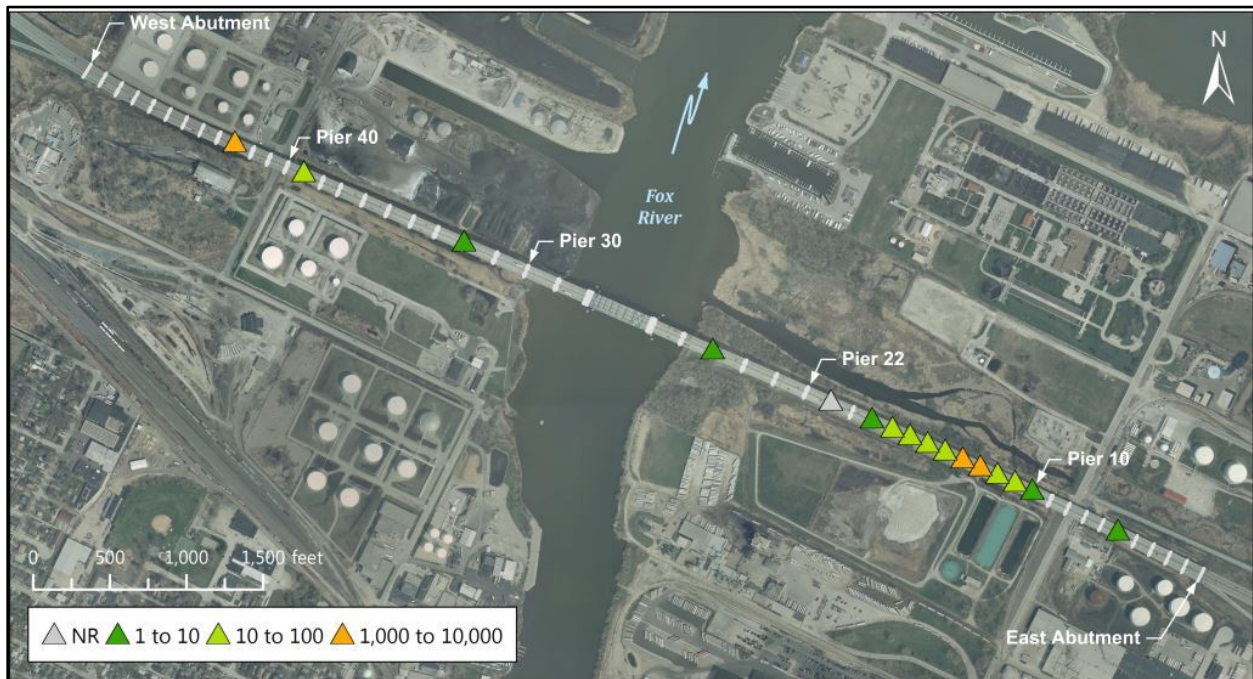
Figure 3.18: Plot of Iron Reducing Bacteria (colonies/mL)

The most significant concentration of iron reducing (aerobic) bacteria was detected at Piers 13, 14 and 43.

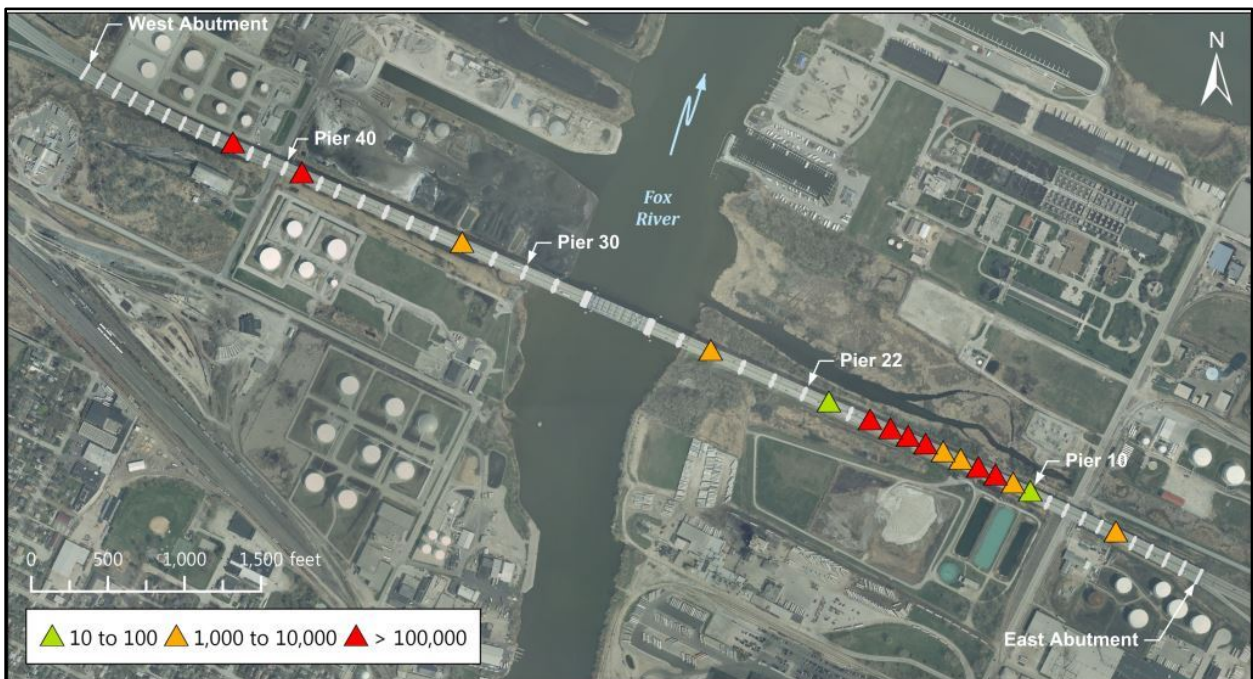
Figure 3.19: Plot of Anaerobic Bacteria (colonies/mL)

The presence of anaerobic bacteria was substantial at all of the piers sampled, except for Piers 10 and 21.

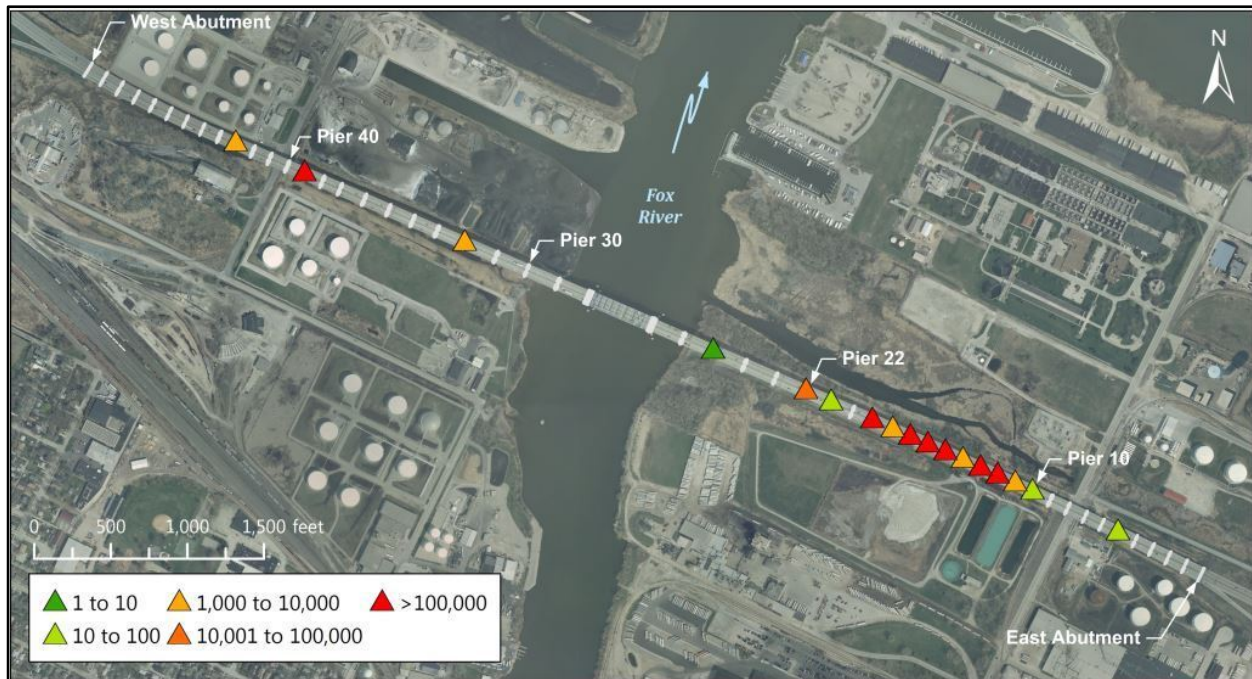
Figure 3.20: Plot of Acid Producing Bacteria (colonies/mL)

Acid producing bacteria was particularly noteworthy on the east side of the Fox River between Piers 11 and 19.

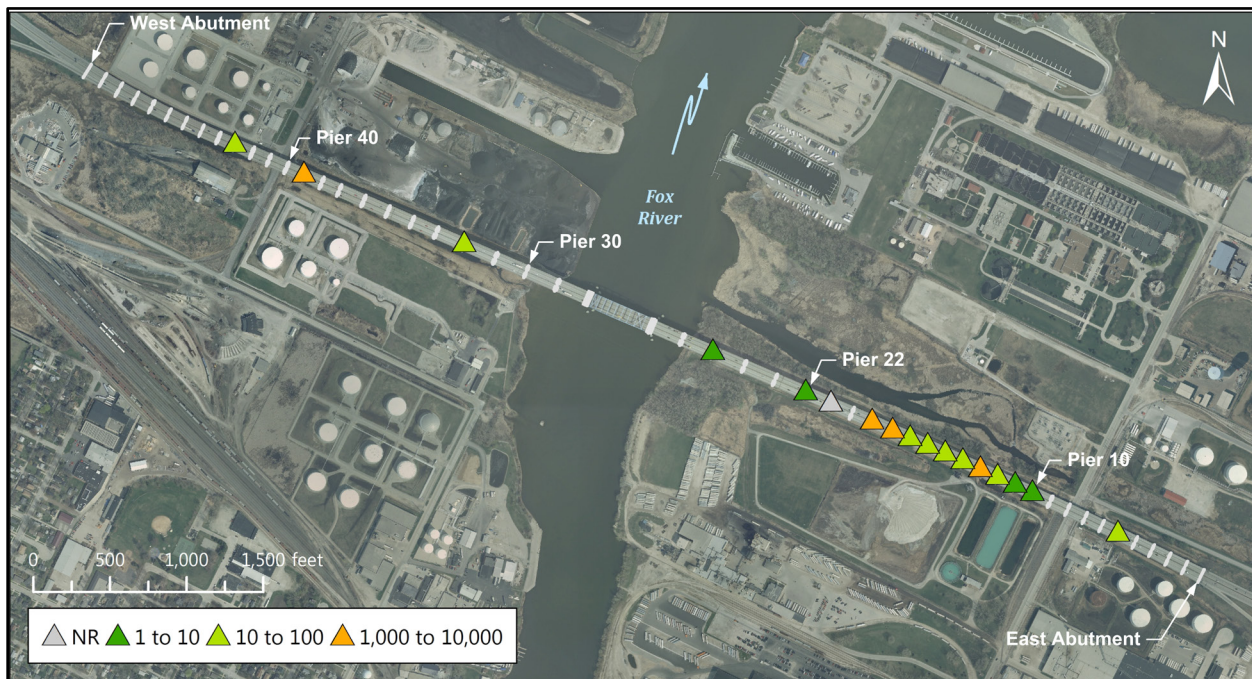
Figure 3.21: Plot of Sulfate Reducing Bacteria (colonies/mL)

The most noteworthy concentration of sulfate reducing bacteria was encountered at Piers 13, 18, 19 and 39. It should be noted that the microbial growth of Sulfate Reducing Bacteria typically requires at least 28

days before an accurate colonial count can be estimated. Given that the maximum incubation times for the samples collected was 15 days, the results shown in Figure 3.21 can be used to verify the presence or absence of SRB at a certain pier location. However, the data presented substantially underestimate the colonial count of the SRB strains.

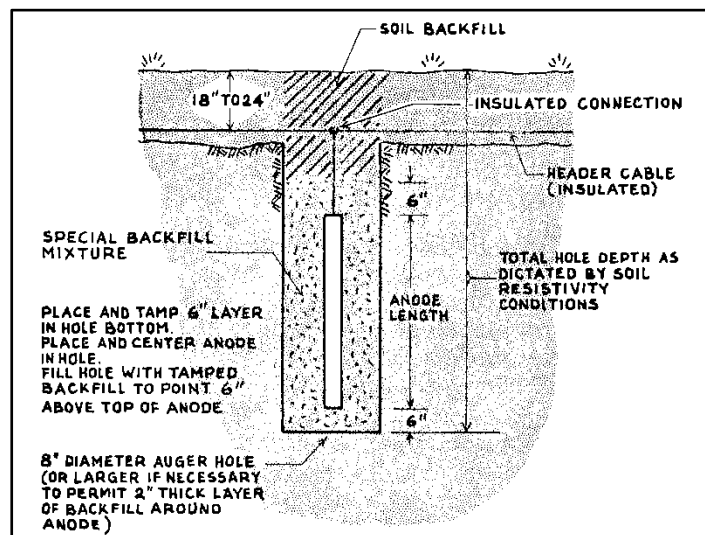
The CP system will slow down the corrosion rate but will not completely eliminate the corrosion. This treatment is not effective in reducing other forms of corrosion, such as macro cell corrosion. There is no information available to predict the corrosion rate post-CP other than that the corrosion rate would be expected to be significantly reduced. It is recommended to use an 80 percent reduction in the expected

Cathodic protection (CP) has been considered to reduce the rate of corrosion at the existing steel H-piles. Both impressed current and passive anode CP system types are available. To reduce future maintenance demand, the passive anode CP system type is preferred for the project site. A ring of passive deep sacrificial anodes would be installed to encircle each designated pile-supported footer. The anodes would create a dissimilar metal corrosion cell with respect to the piling, such that the anodes would corrode and render the piling cathodic to the externally placed anodes. The more active anodes would corrode, in lieu of the piling, and discharge current in the process. Over a period of time, the anodes would require replacement. The number and spacing of anodes can be adjusted to minimize the replacement frequency. When new anodes are required, a new ring of anodes could be installed outside the existing ring.

corrosion rate after the CP application at locations other than at piers where there is a concentration of shredded wood in direct contact with the piling; and it is recommended to use a 60 percent reduction in the expected corrosion rate after the CP application at locations where there is a concentration of shredded wood in direct contact with the piling. The inspection probes are recommended to assist with collecting data to monitor the future corrosion rate.

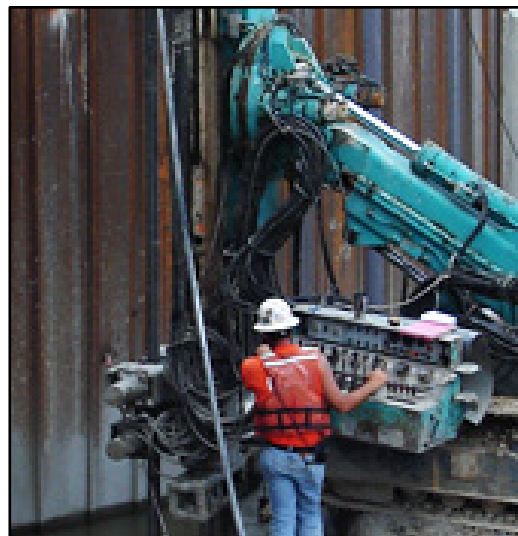
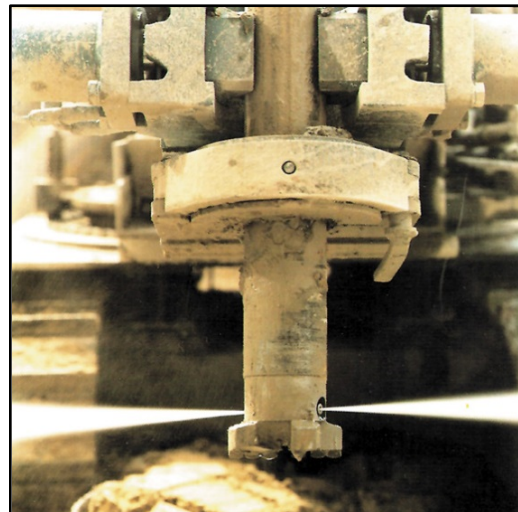
Modification of the environmental setting will aid in isolating fibrous organic matter, like shredded wood, and in separating fibrous organic matter from direct contact with the steel piling. Where the shredded wood is in direct contact with the steel piling, the fibrous wood creates a local anomaly that is oxygen deprived that promotes the development of a microcell that can accelerate localized pitting. Evidence of this was observed at exposed piling in the test pits where an impression of shredded wood had been imprinted on corroded piling.

The jet grouting will slow down the MIC corrosion rate, but it will not completely eliminate the corrosion. This treatment is not effective in reducing other forms of corrosion, such as macro cell corrosion. There is no information available to predict the corrosion rate post-jet grouting other than that the corrosion rate would be expected to be diminished. At locations where there is a concentration of shredded wood in direct contact with the piling, and where jet grouting is used in combination with cathodic protection, it is recommended to use a 70 percent reduction in the expected corrosion rates. The inspection probes are recommended to assist with collecting data to monitor the future corrosion rate.

Further study brought forth the option to jet grout the existing soil beneath pile-supported footings in-place. The primary advantages of jet grouting include increasing the pH of the soil, which is anticipated to diminish microbial activity; encasing fibrous organic matter to reduce available organic nutrients, which will also help to curtail microbial activity; and injecting a cementitious grout that will help to encase and protect the steel piling. Jet grouting will also permit workers to operate equipment from beside rather than under pile supported footings. The disadvantage is that some of the fibrous organic material will remain, although encased in cement grout. A temporary excavation is anticipated to be required to a depth on the order 10 to 15 feet below the bottom of pile footer to allow the operation of horizontal drilling equipment. Sump pumps are anticipated to be required to dewater perched water within the temporary excavation. Temporary sheeting would be used to form a shield at the edge of footer to contain the liquefied soil-cement mass. The sheeting should be installed with a bond breaker so that the temporary sheeting could be retrieved and reused at other designated pier locations for similar treatment. Horizontal holes would be drilled at approximately 4-foot spacing and used to inject a cementitious grout under high pressure to liquefy and mix with the surrounding soil to produce a soil-cement mass directly under the pile-supported footer.

Although jet grouting is a mature technology that has been used in the United States for more than 30 years, and longer abroad, its use to mitigate ALWC beneath pile-supported footings is an unconventional, creative solution that meets the project challenges. The estimated cost for the jet grouting mitigation combined with cathodic protection is estimated to be on the order of \$350,000 per pier.

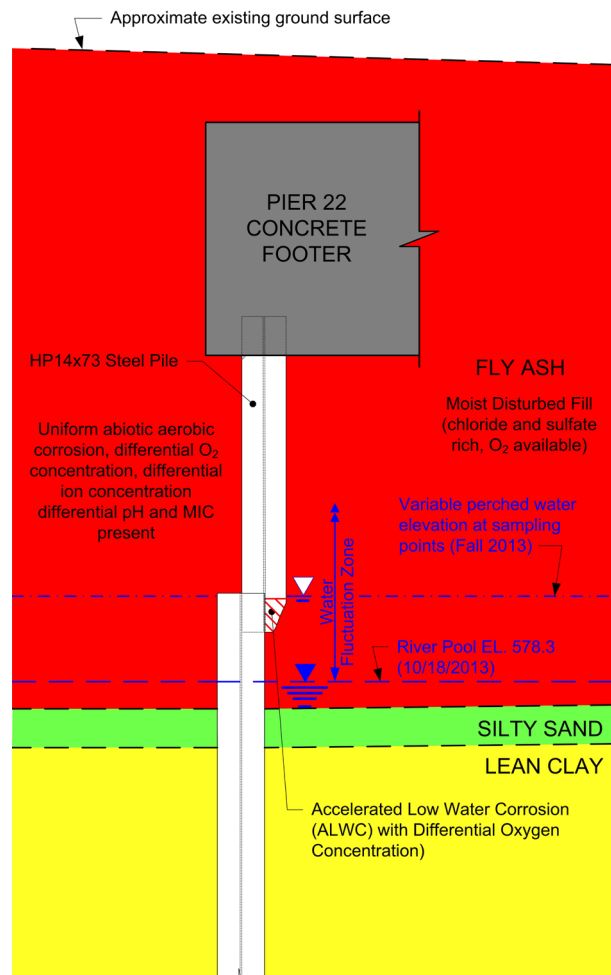
Figure 5.1: Pier 22 Summary Graphic

Visual inspection and soil borings confirmed the presence of fly ash surrounding severely corroded steel piles at Piers 21, 22, 23 and 25. While the piles observed at Pier 24 were substantially less corroded, Pier 24 was conservatively treated similar to Piers 21, 22, 23 and 25 based on its proximity to those critically corroded pier locations. Therefore, repairs were performed at Piers 21 through 25 prior to returning the bridge to service. Tier 1 repairs included installation of new concrete drilled shaft foundations, which are capable of supporting the entire pier design load. These new foundations were then connected to the existing piers and provided corrosion protection measures designed to offer 75 years of service life.

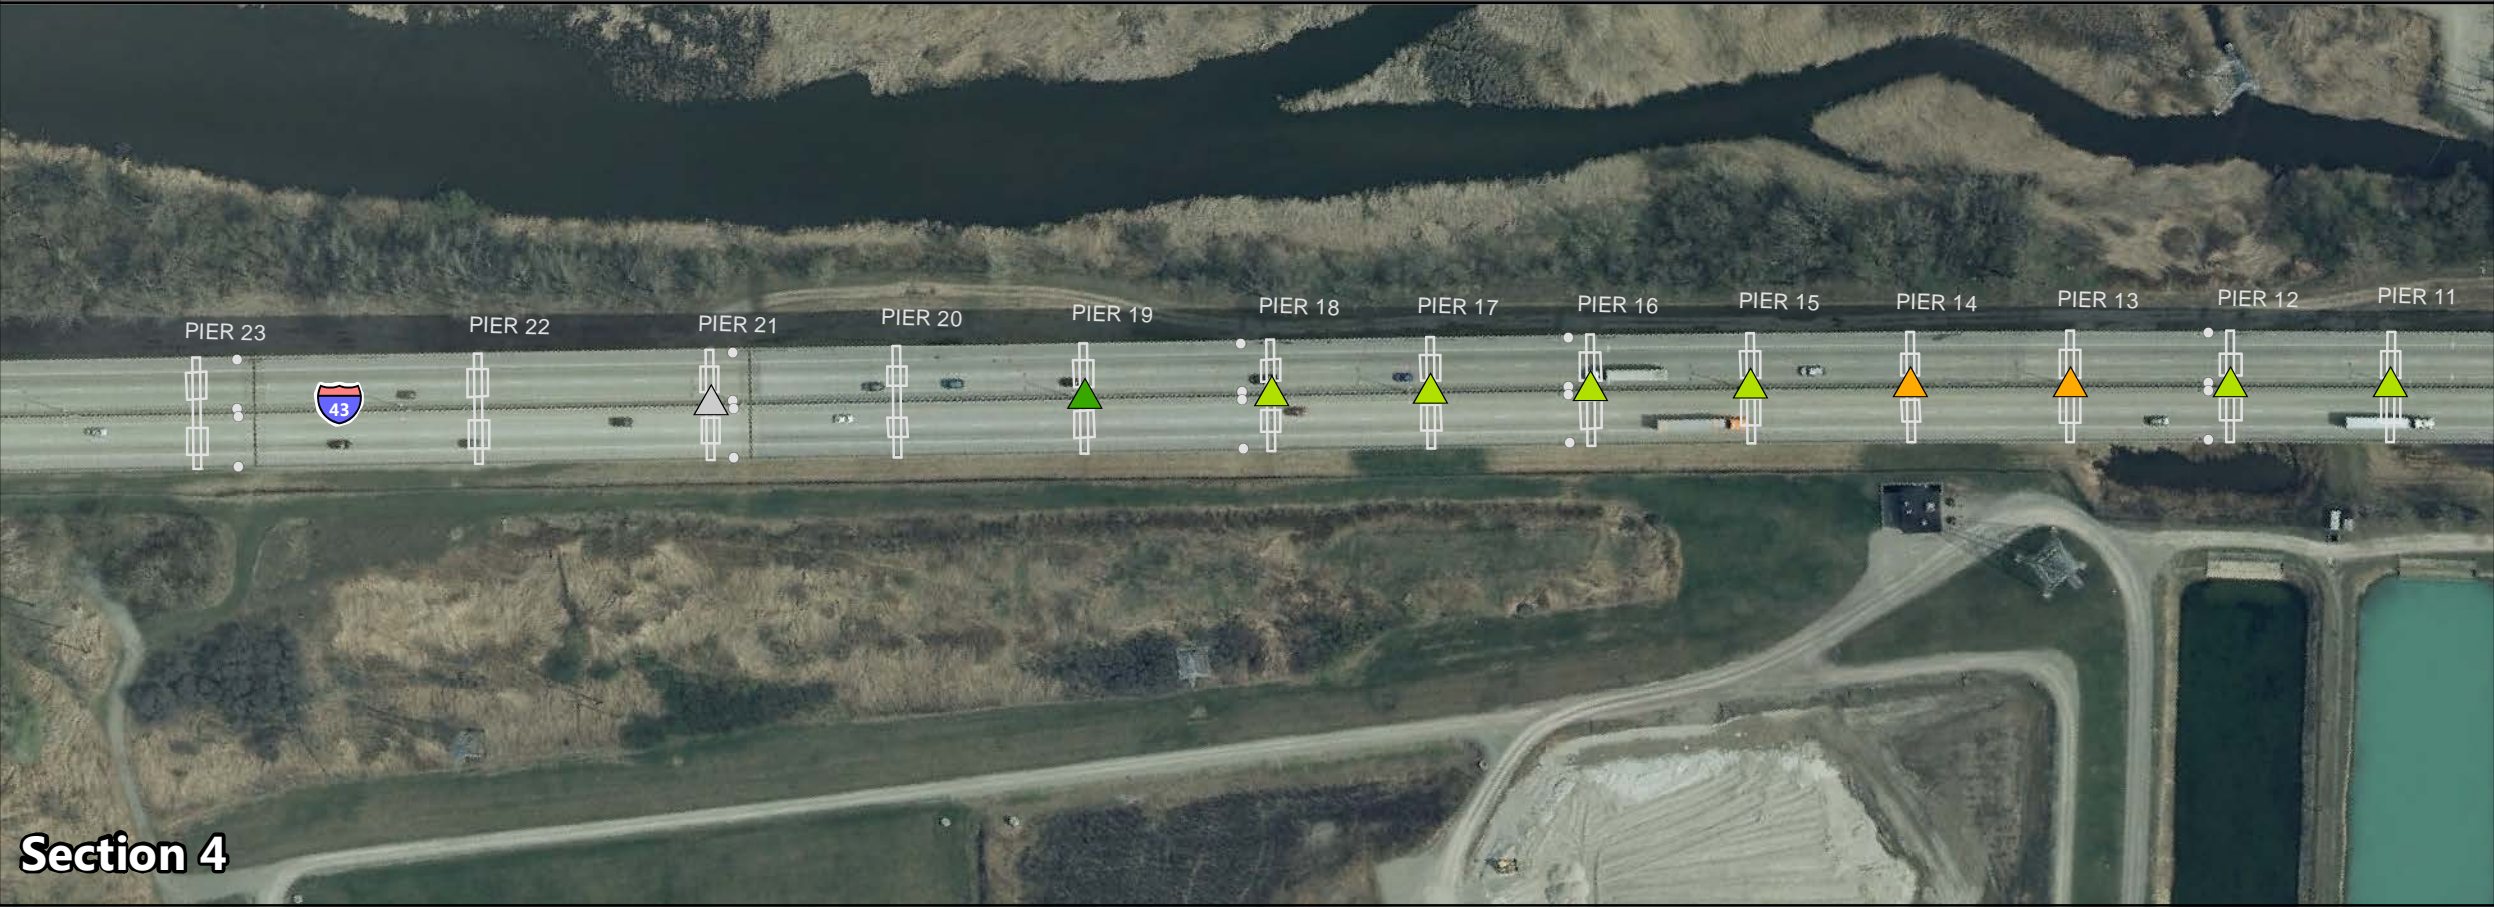
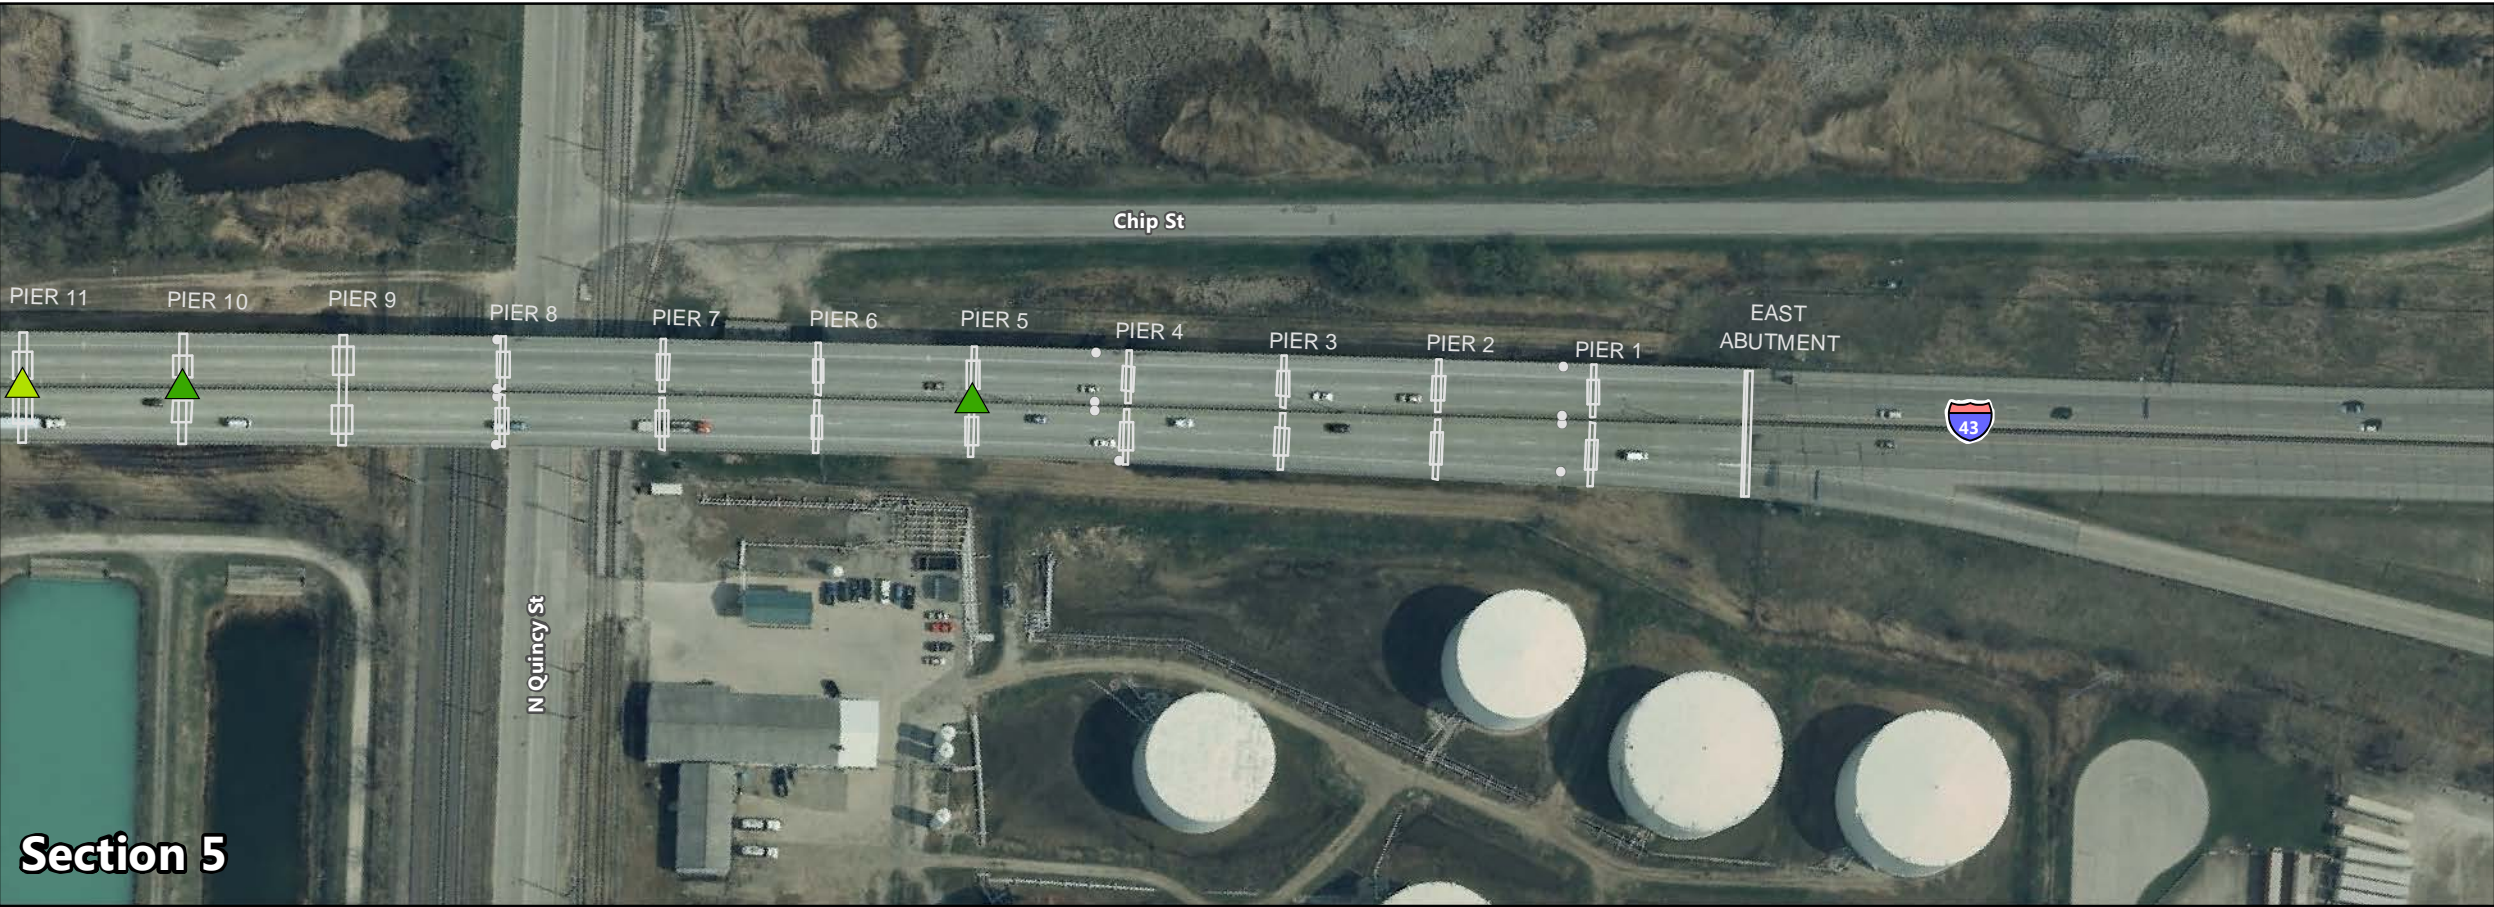
Exhibit 17 – Plot of Iron Reducing Bacteria

Iron Reducing Bacteria (colonies/ml)

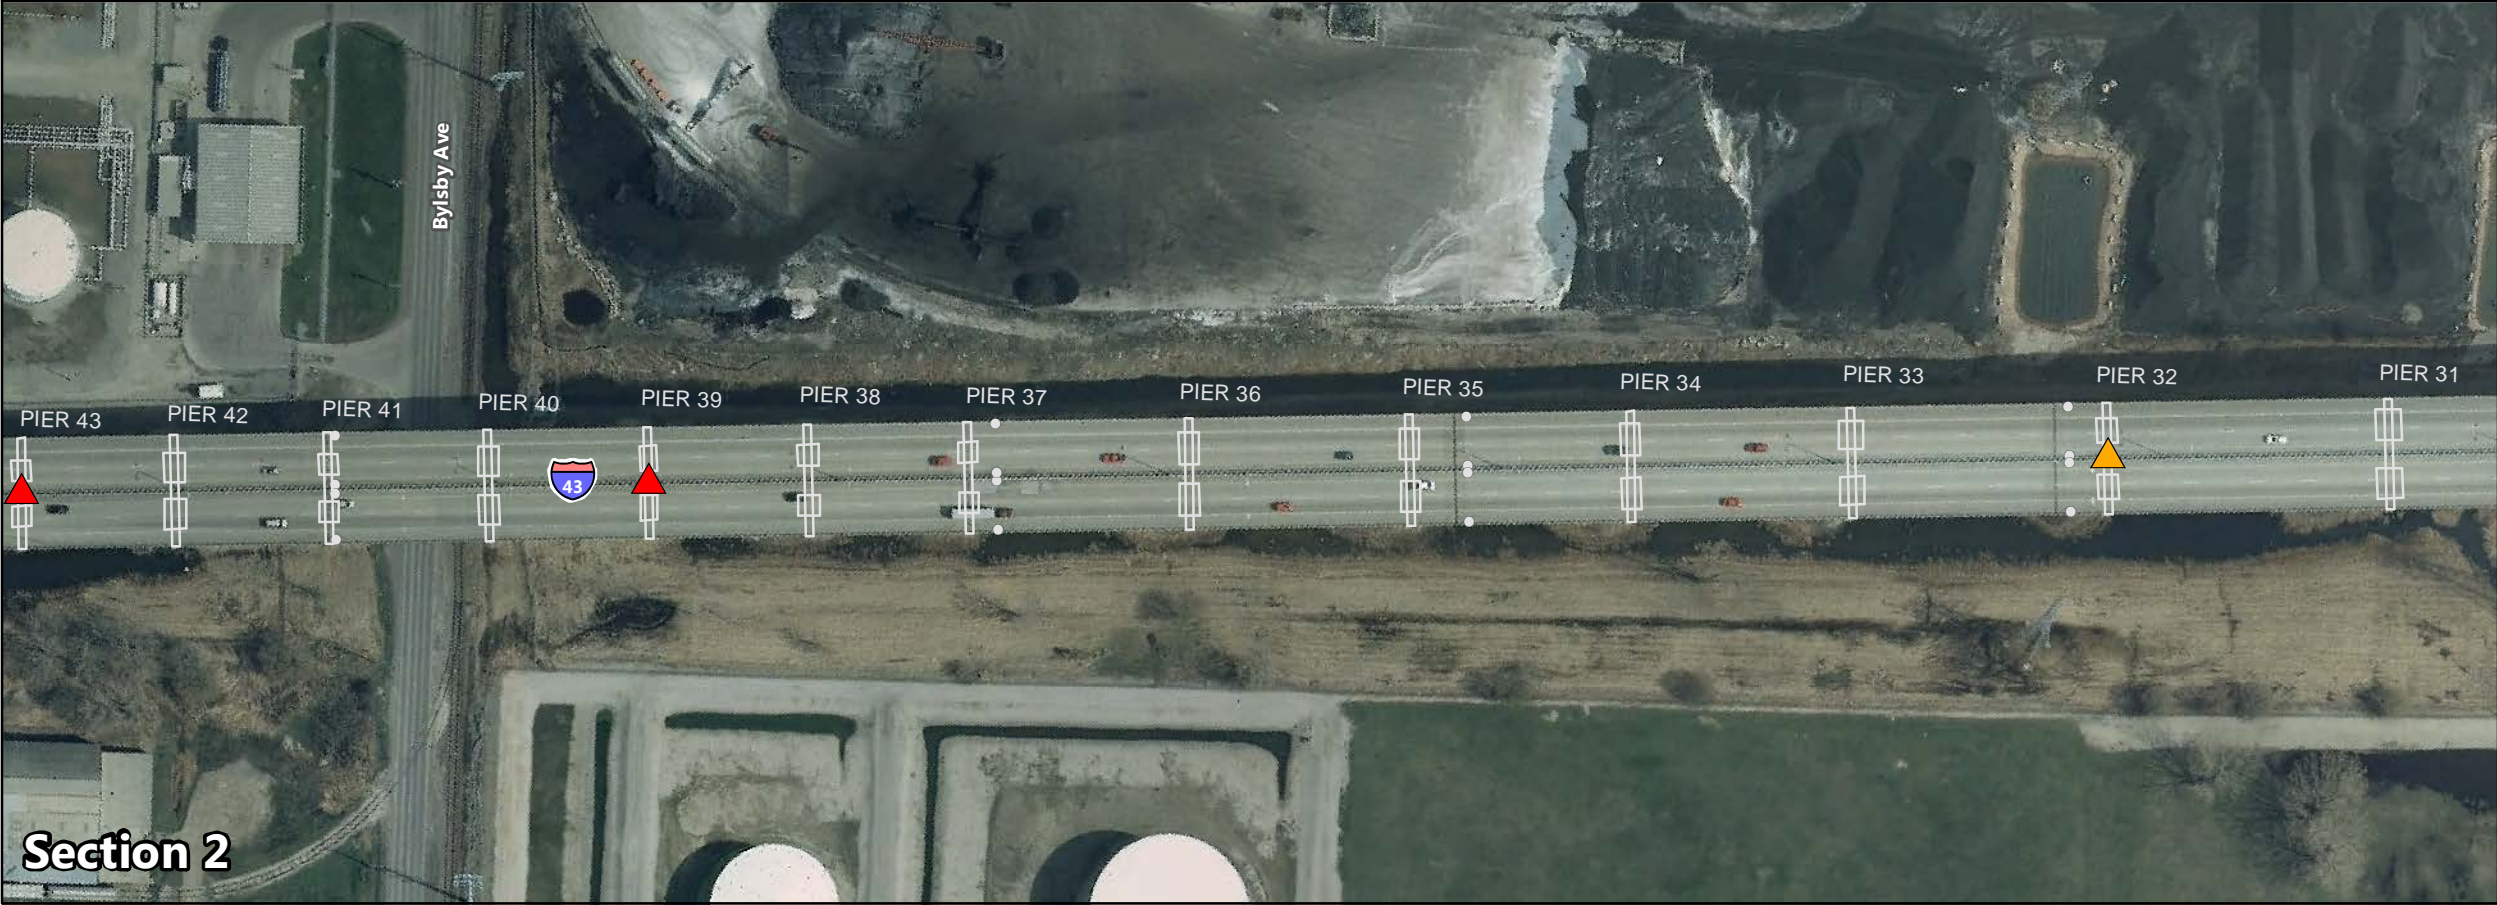
Exhibit 18 – Plot of Anaerobic Bacteria

Anaerobic Bacteria (colonies/ml)
