**I-43 Leo Frigo Memorial Bridge
B-5-158
ID 1220-15-01
Green Bay, Wisconsin**

Investigation Report Volume I: Text, Tables and Exhibits

May 2015

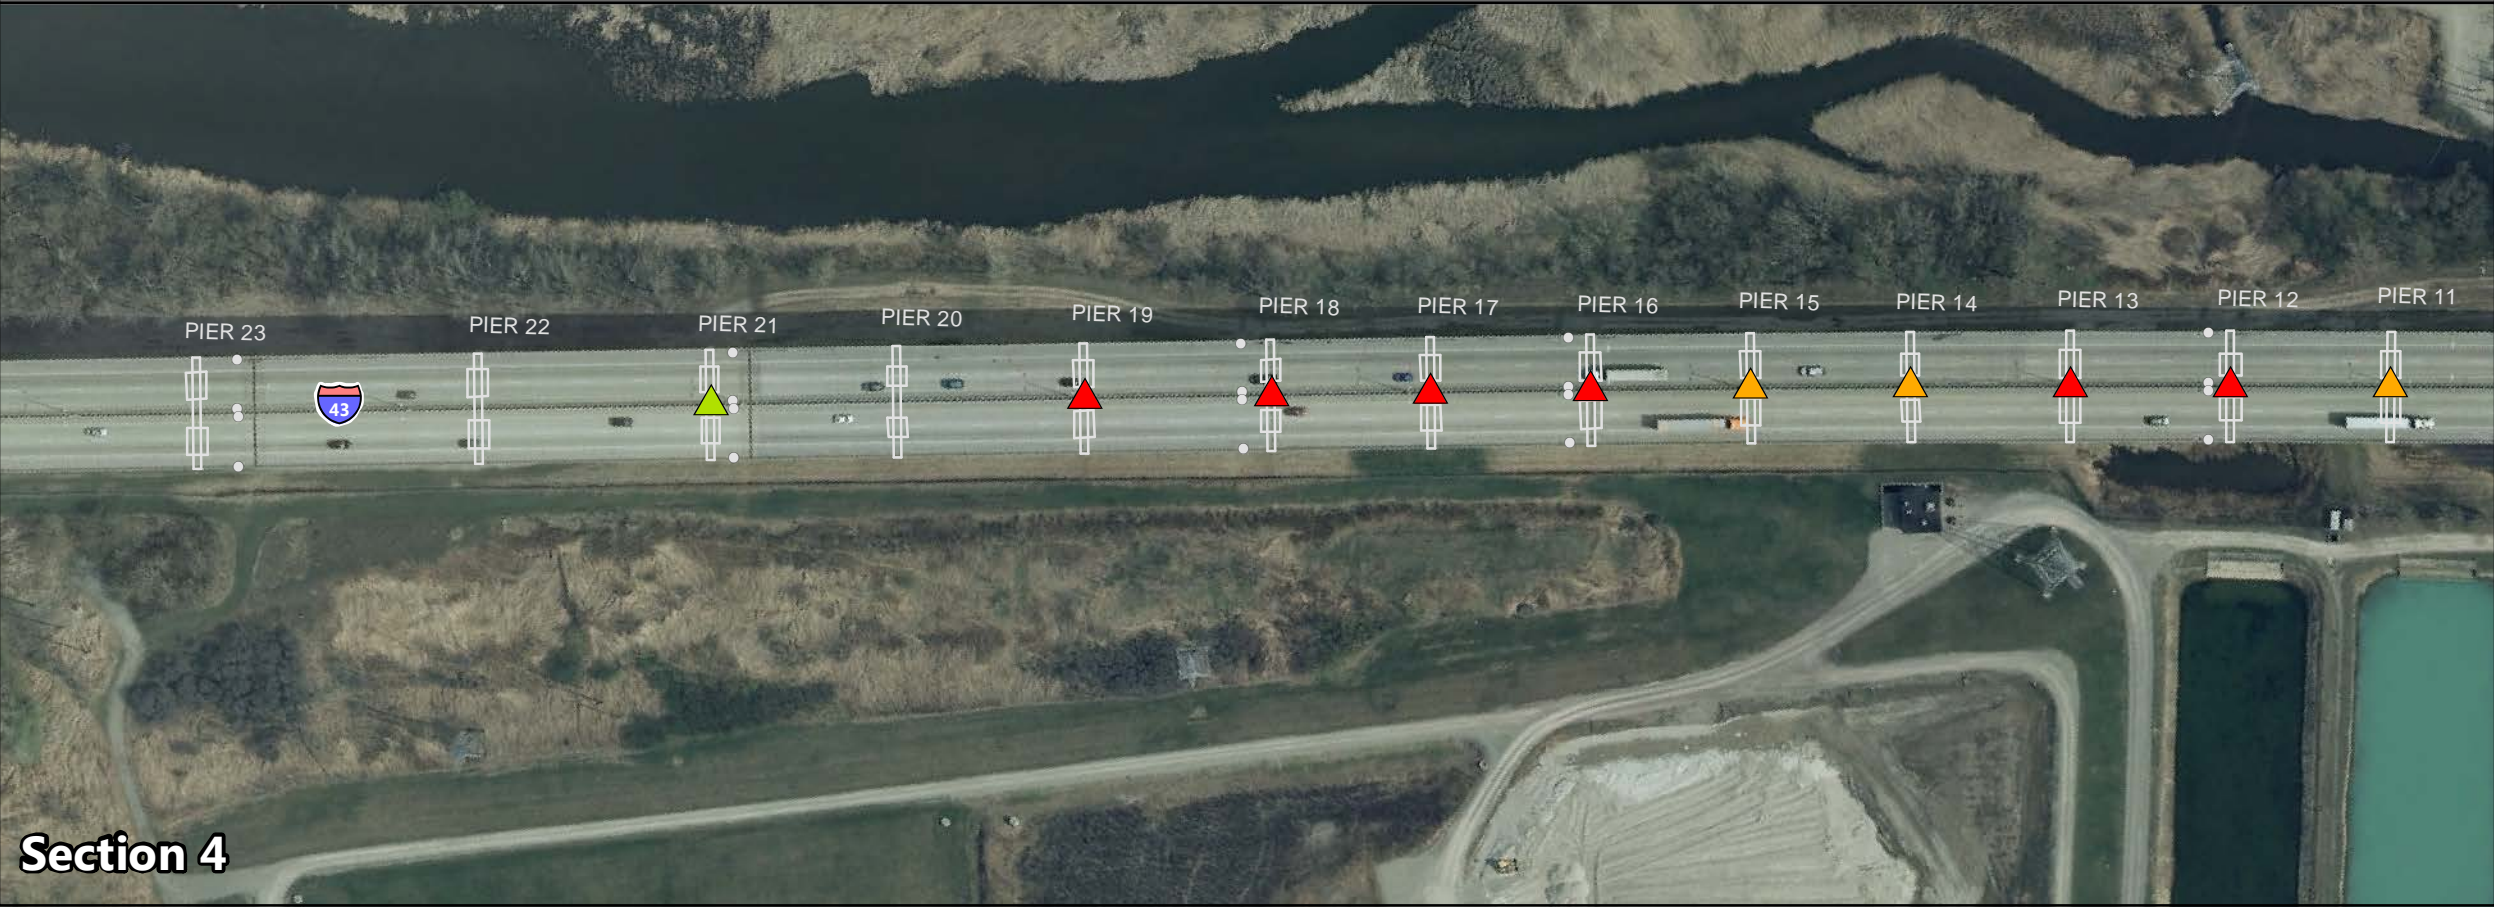
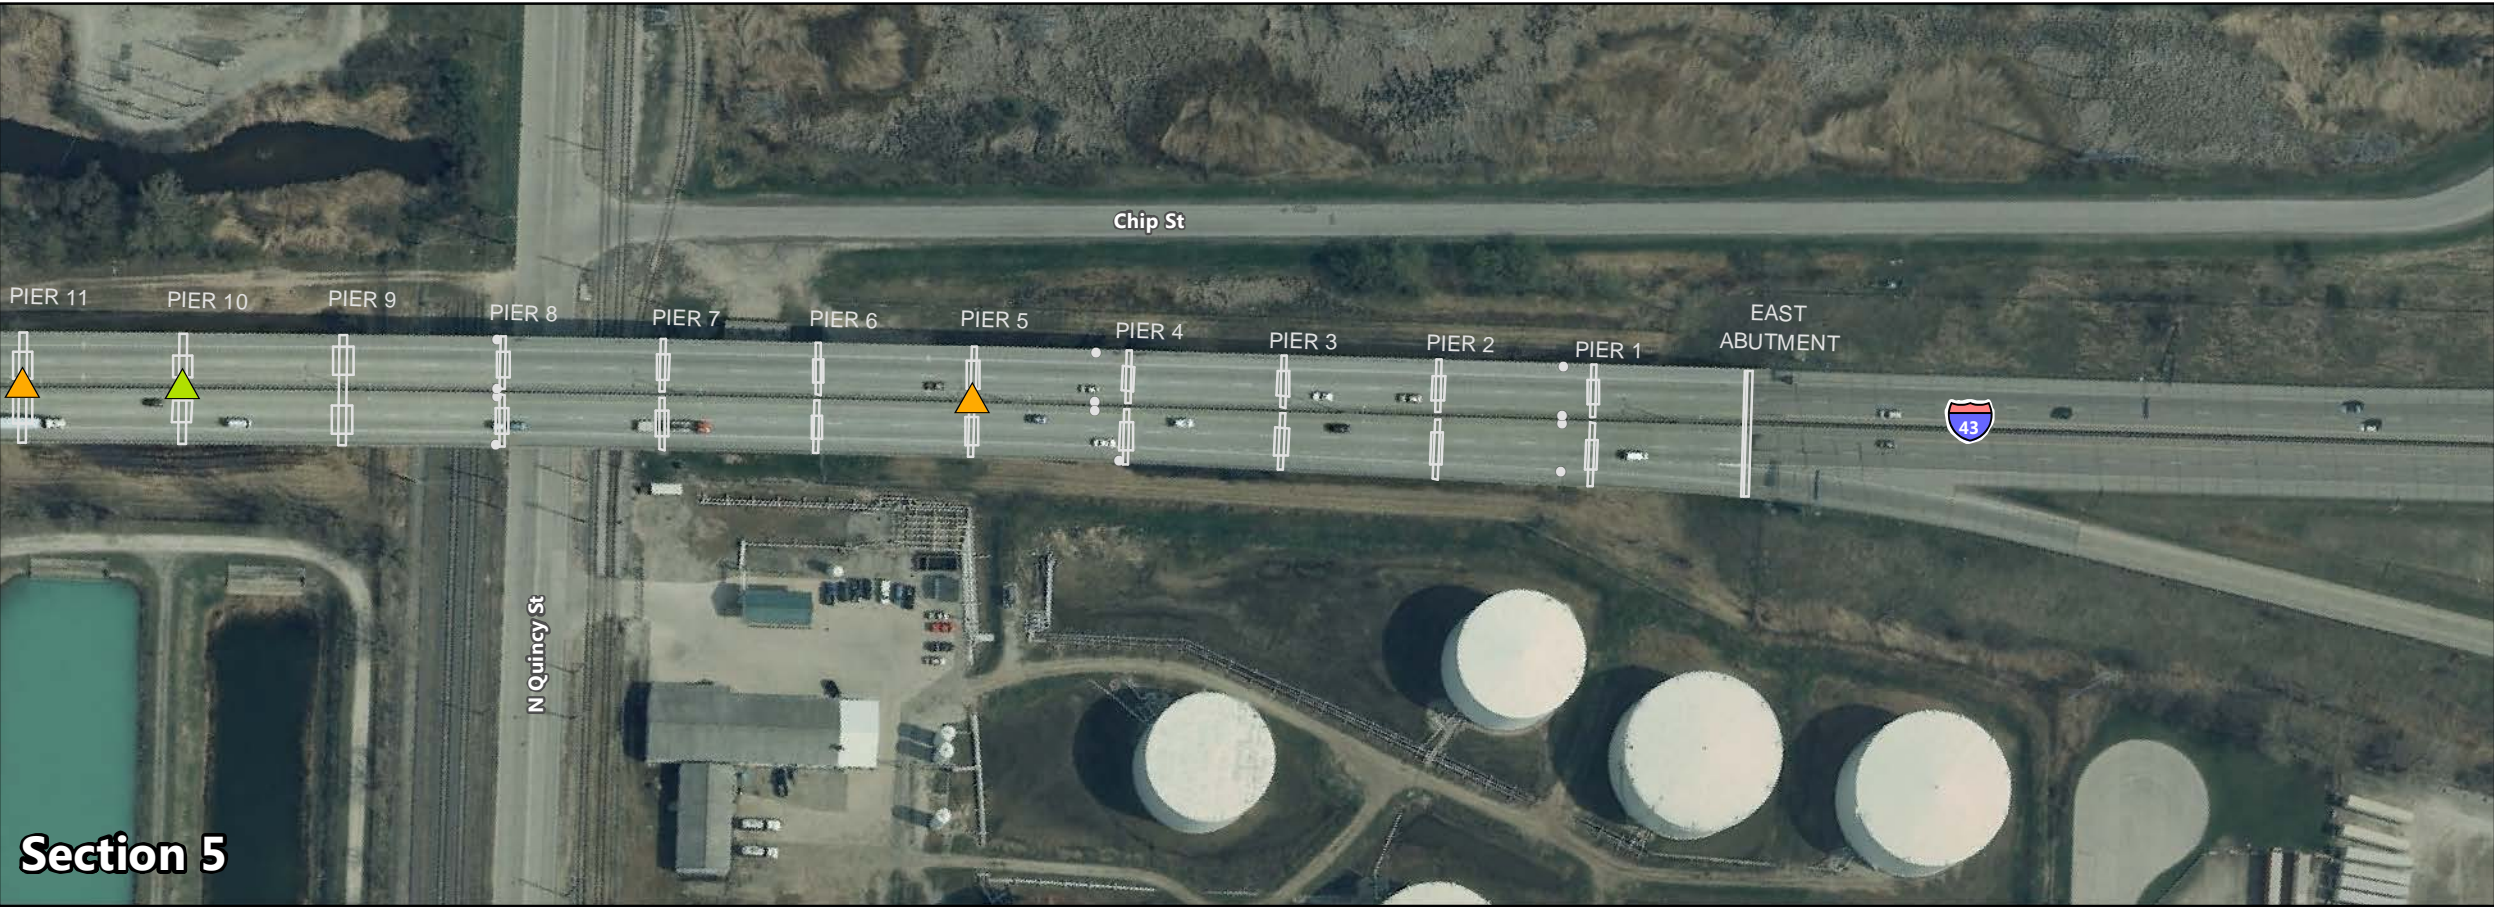
Exhibit 18 – Plot of Anaerobic Bacteria

Anaerobic Bacteria (colonies/ml)

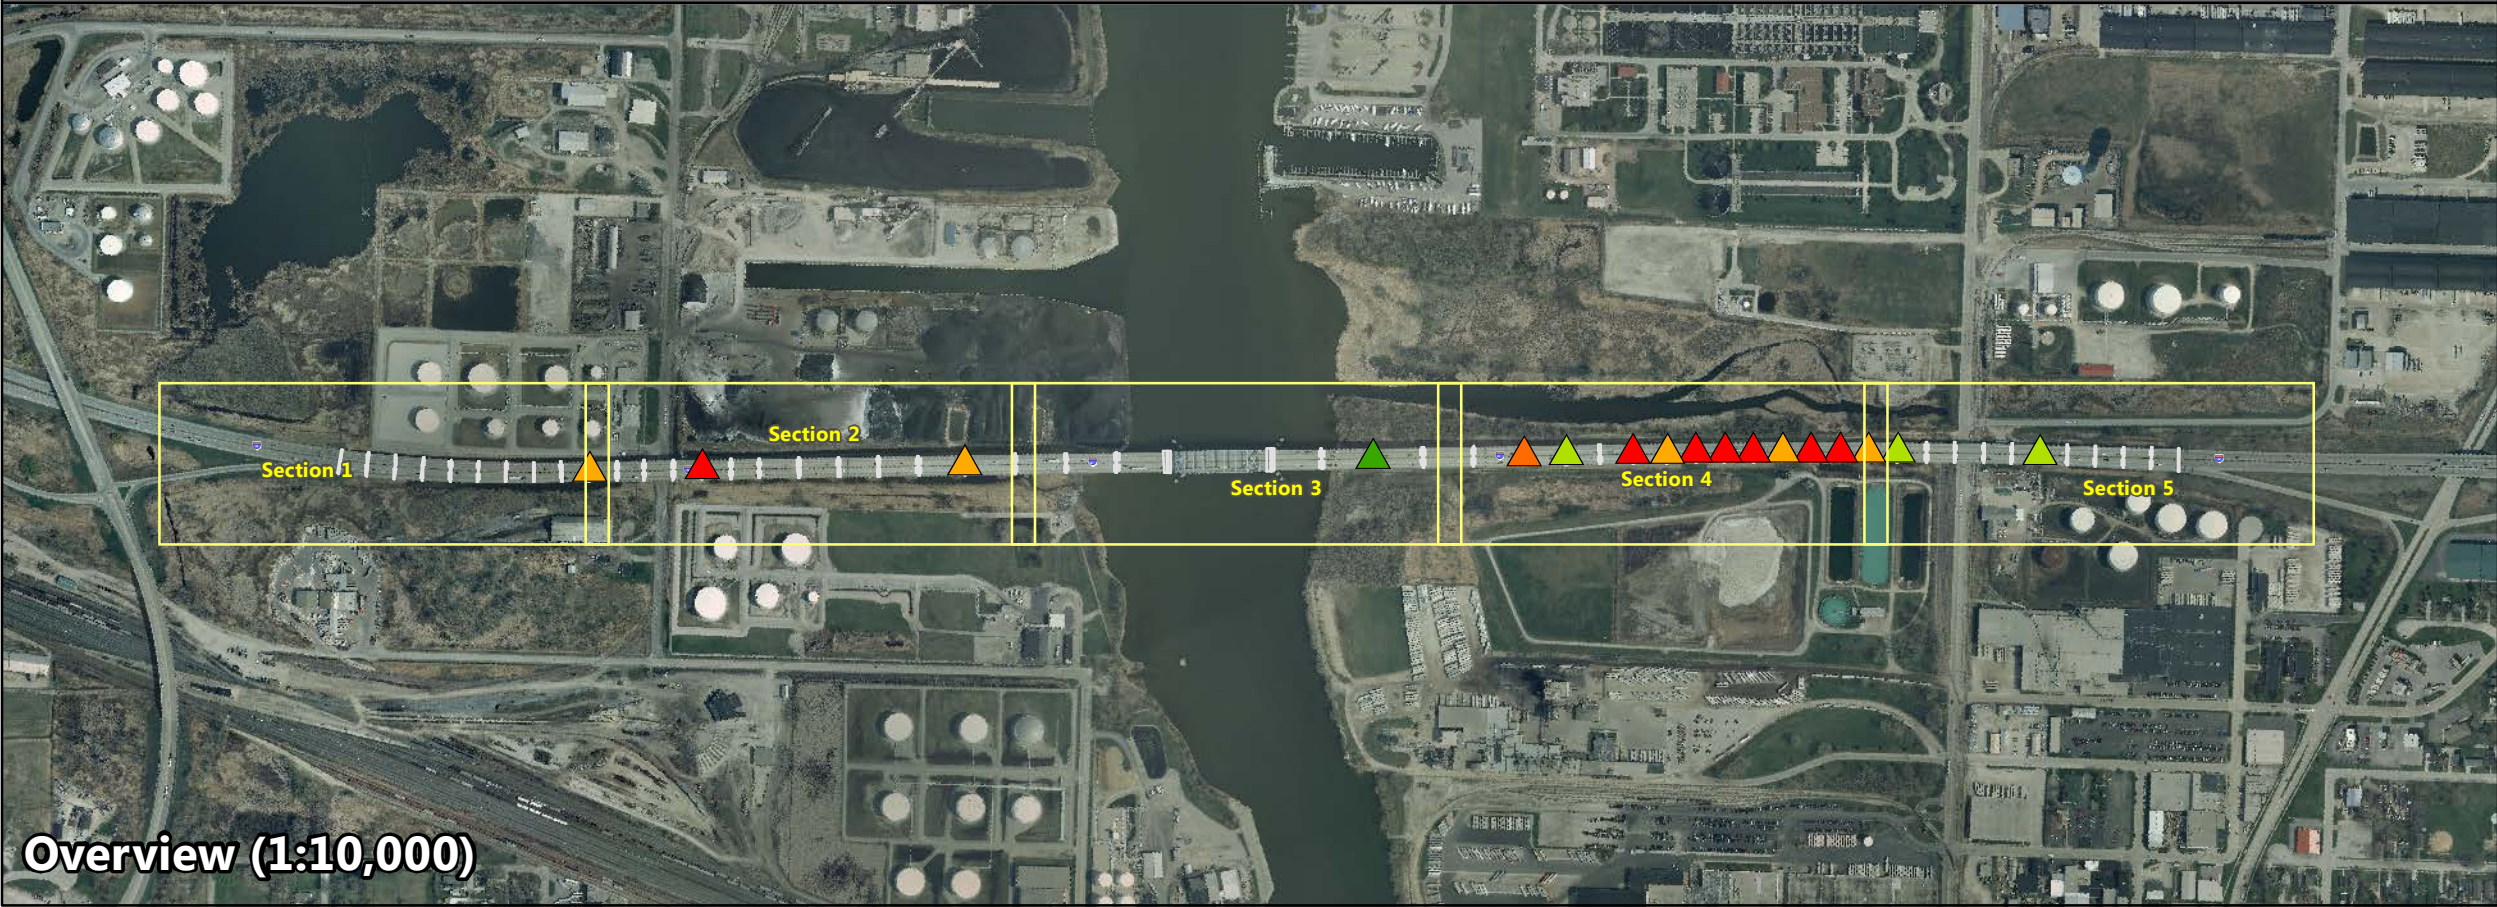
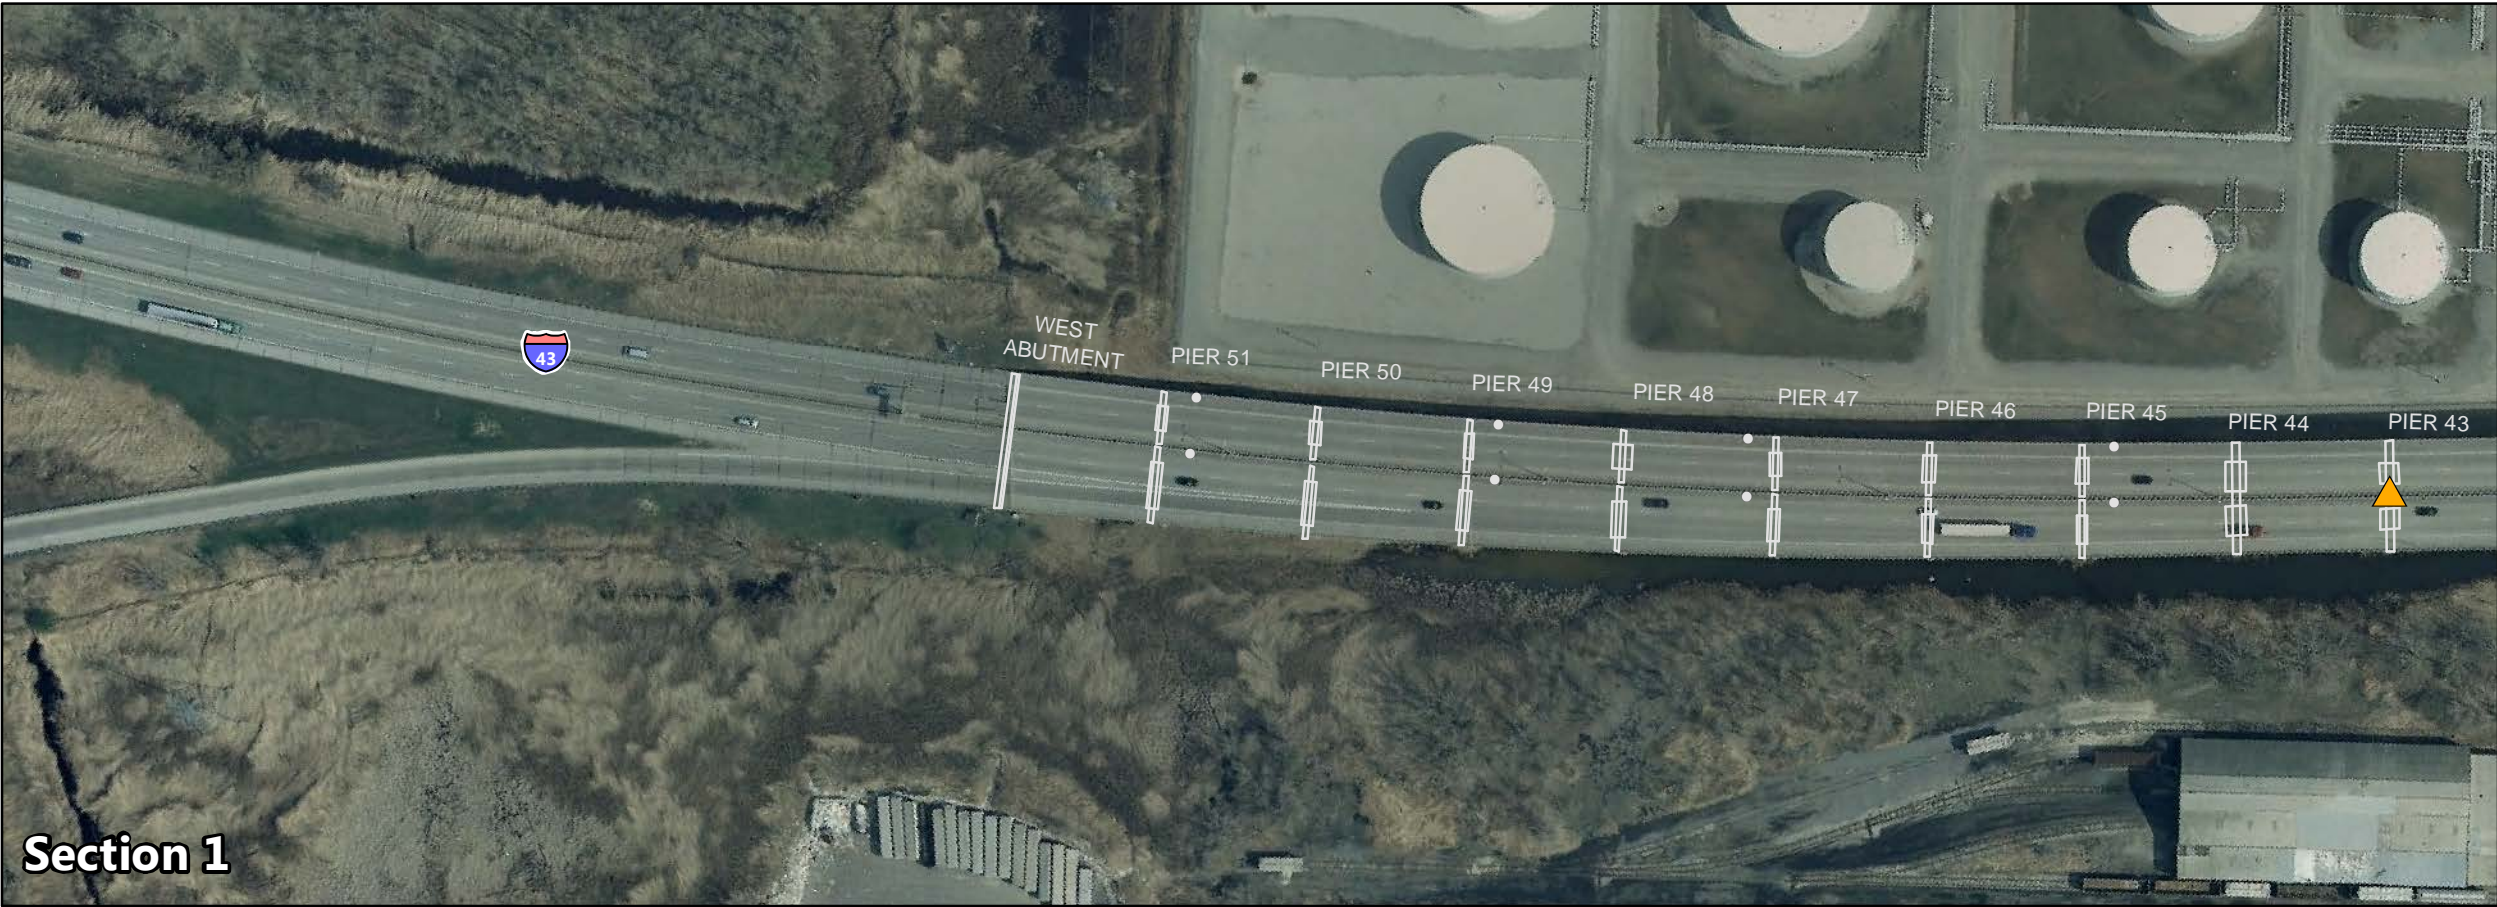
Exhibit 19 – Plot of Acid Producing Bacteria

Acid Producing Bacteria (colonies/ml)

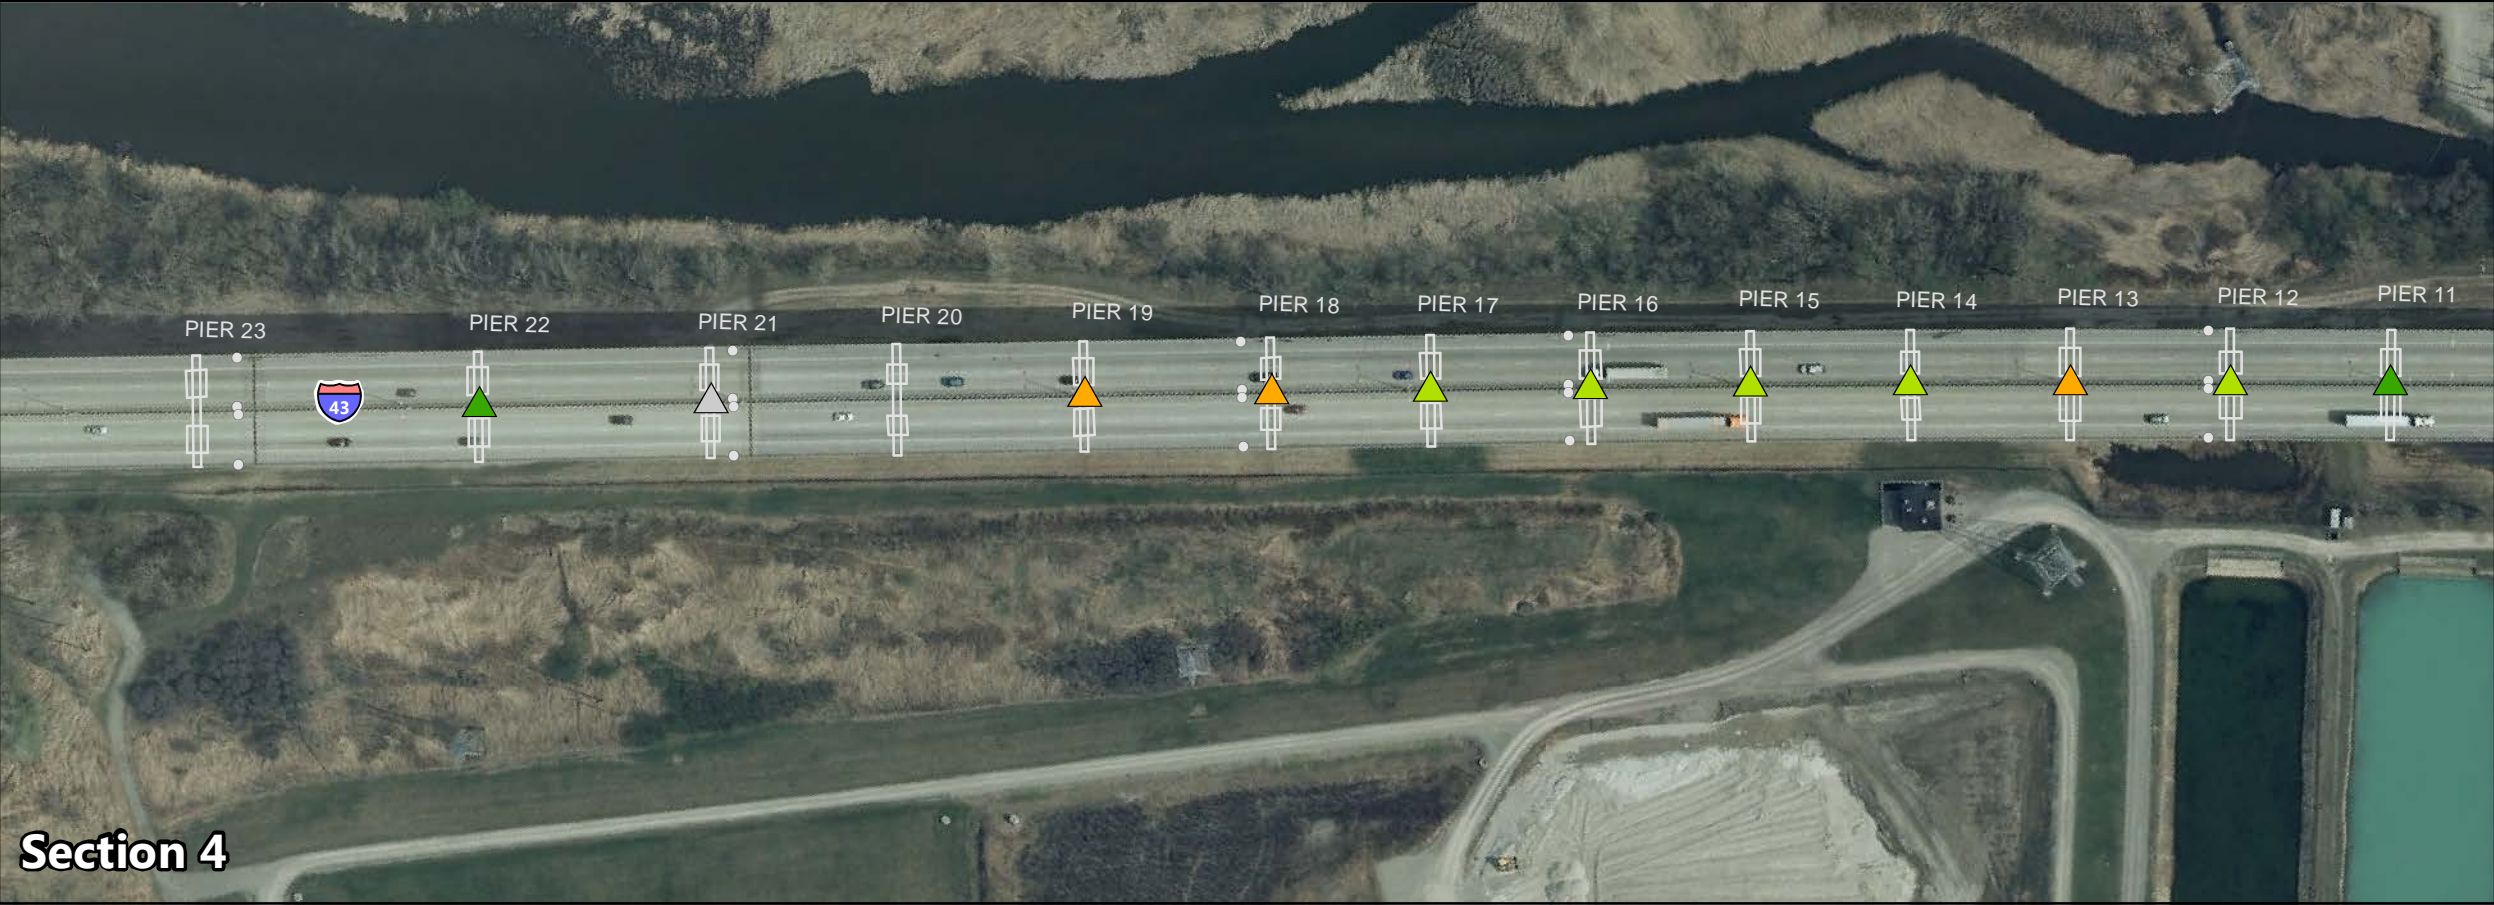
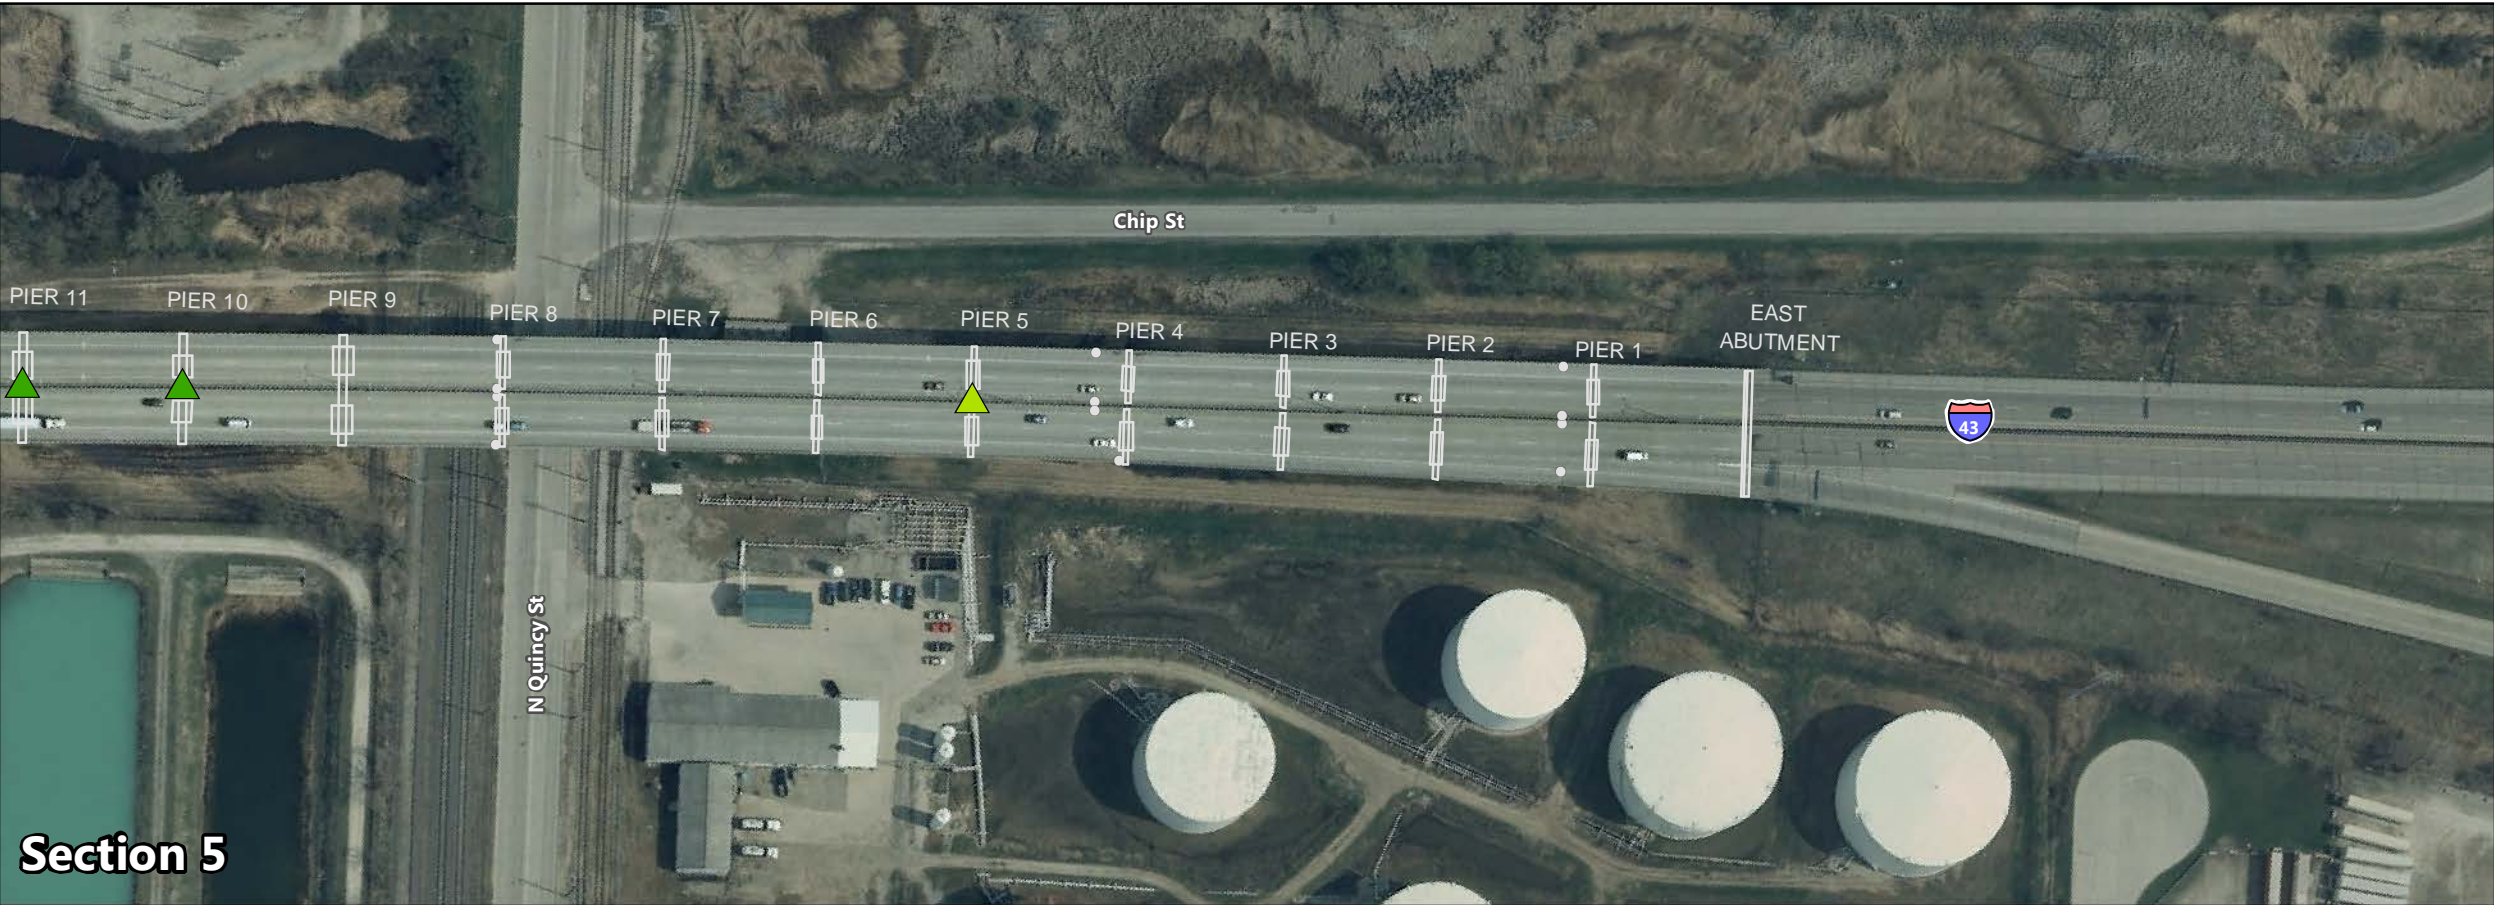
Exhibit 20 – Plot of Sulfate Reducing Bacteria

Sulfate Reducing Bacteria (colonies/ml)

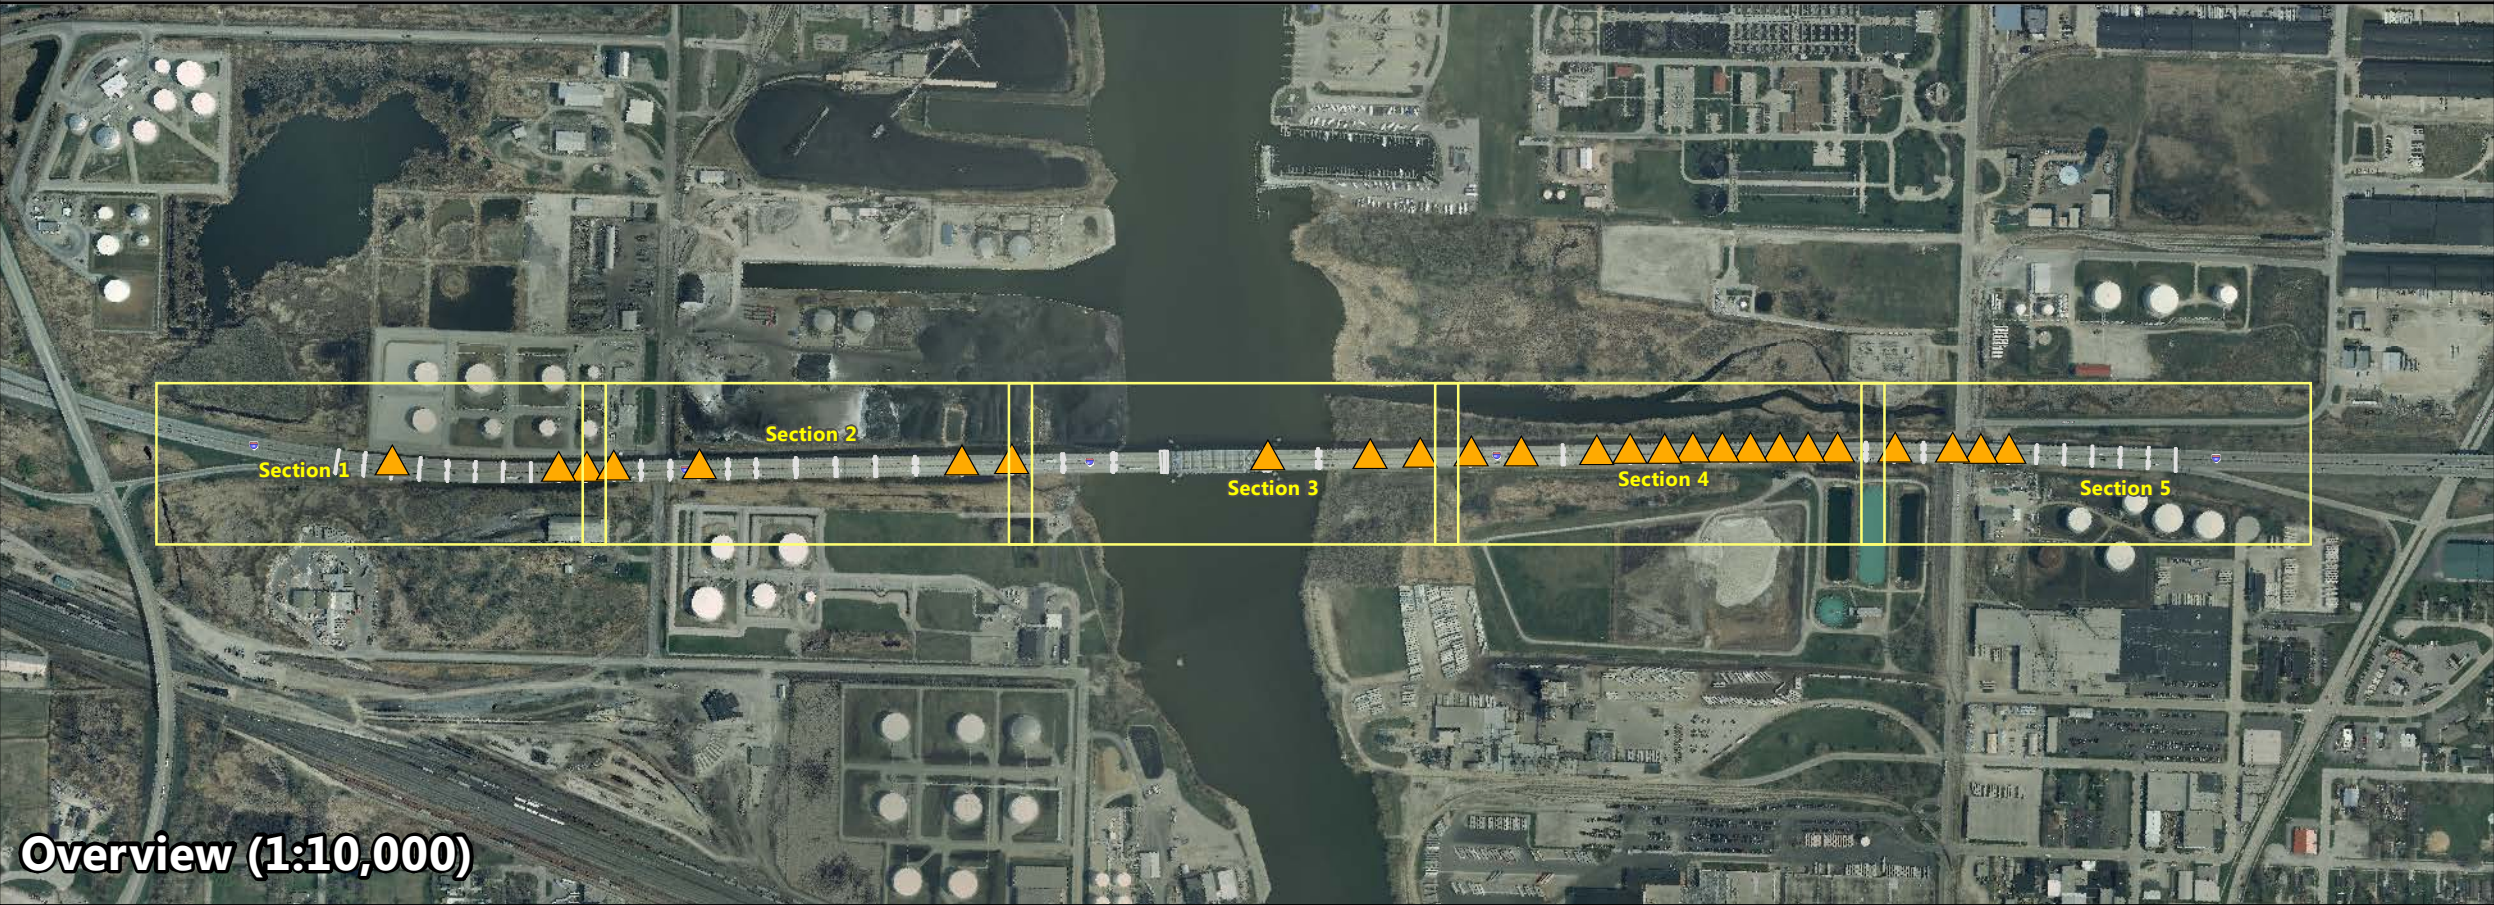
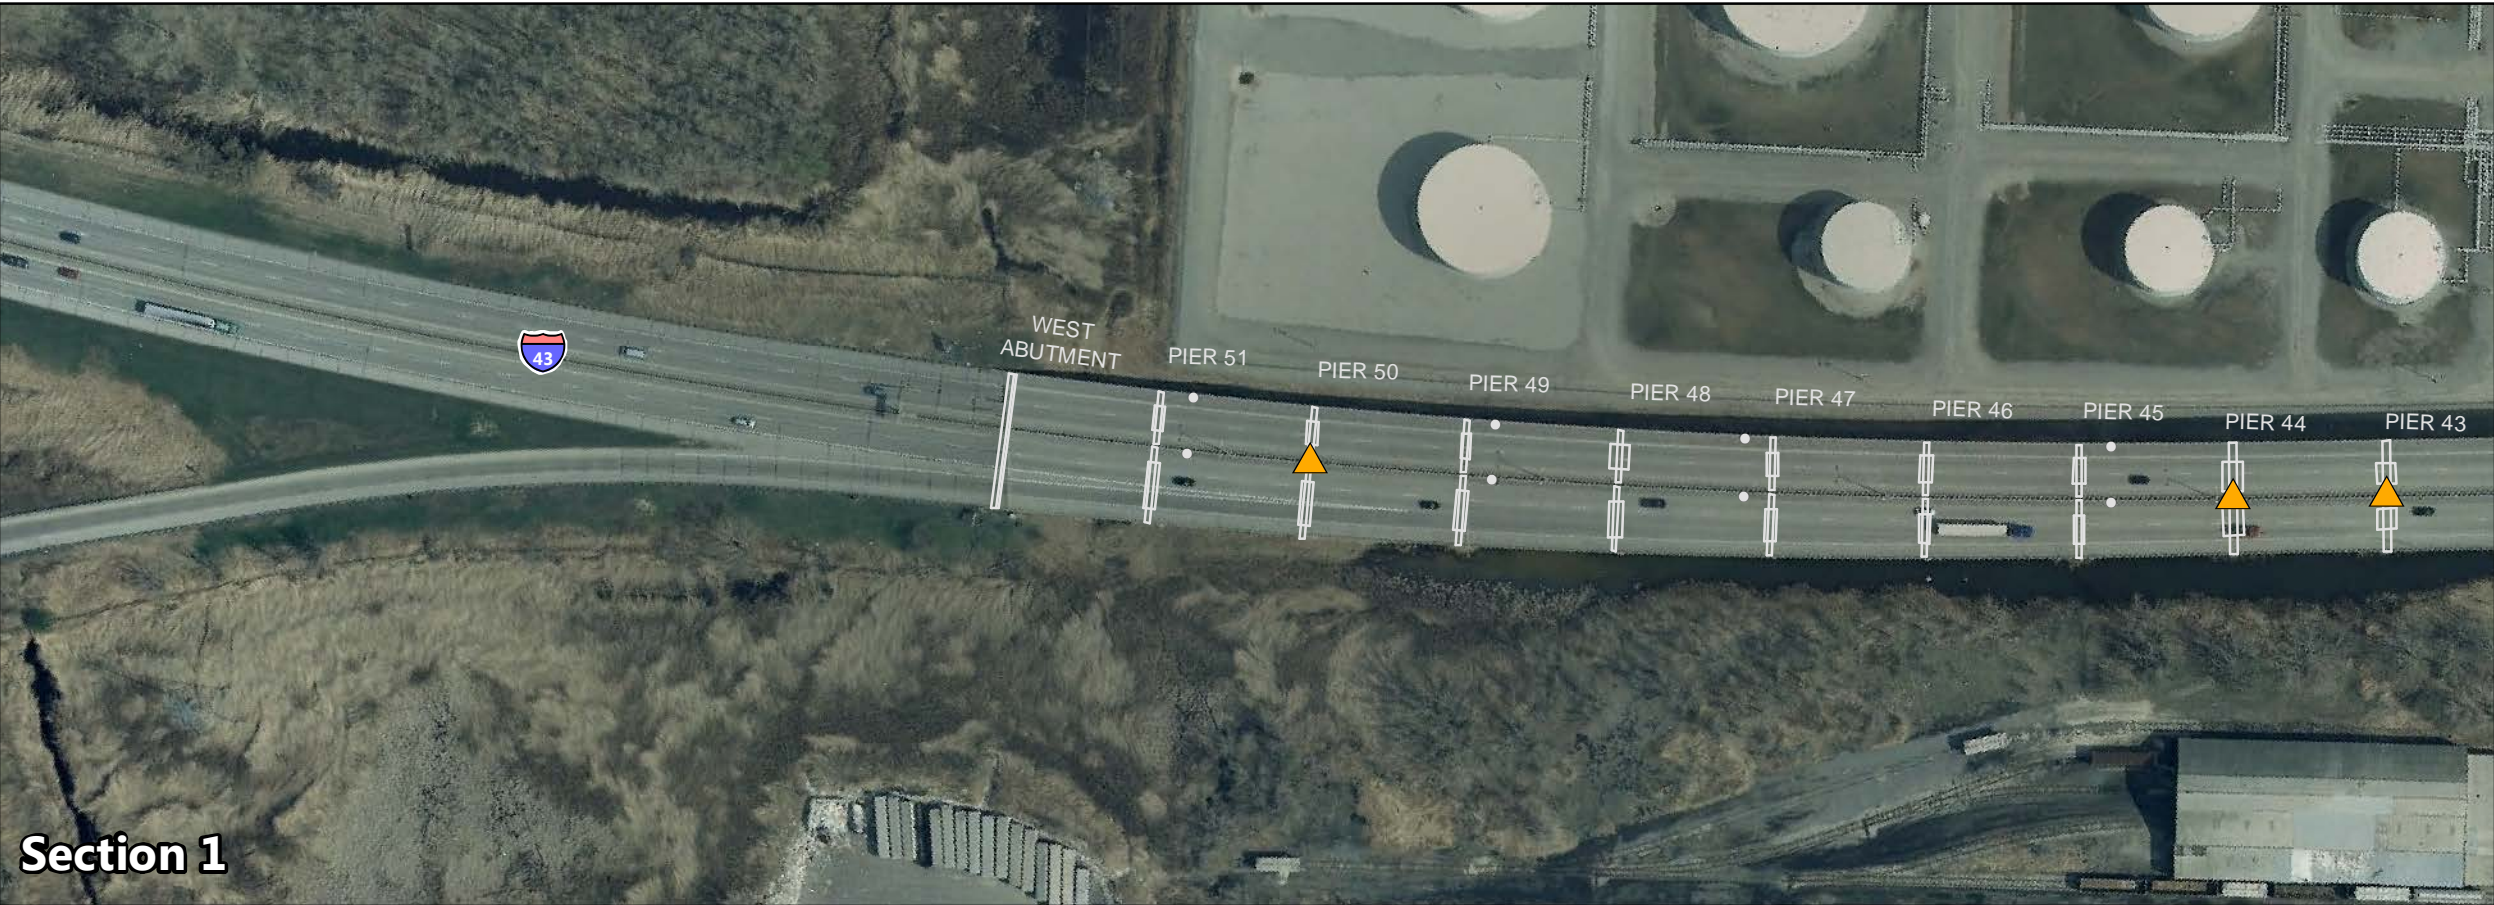
Exhibit 22 – Plot of Organics Encountered

Organics Encountered

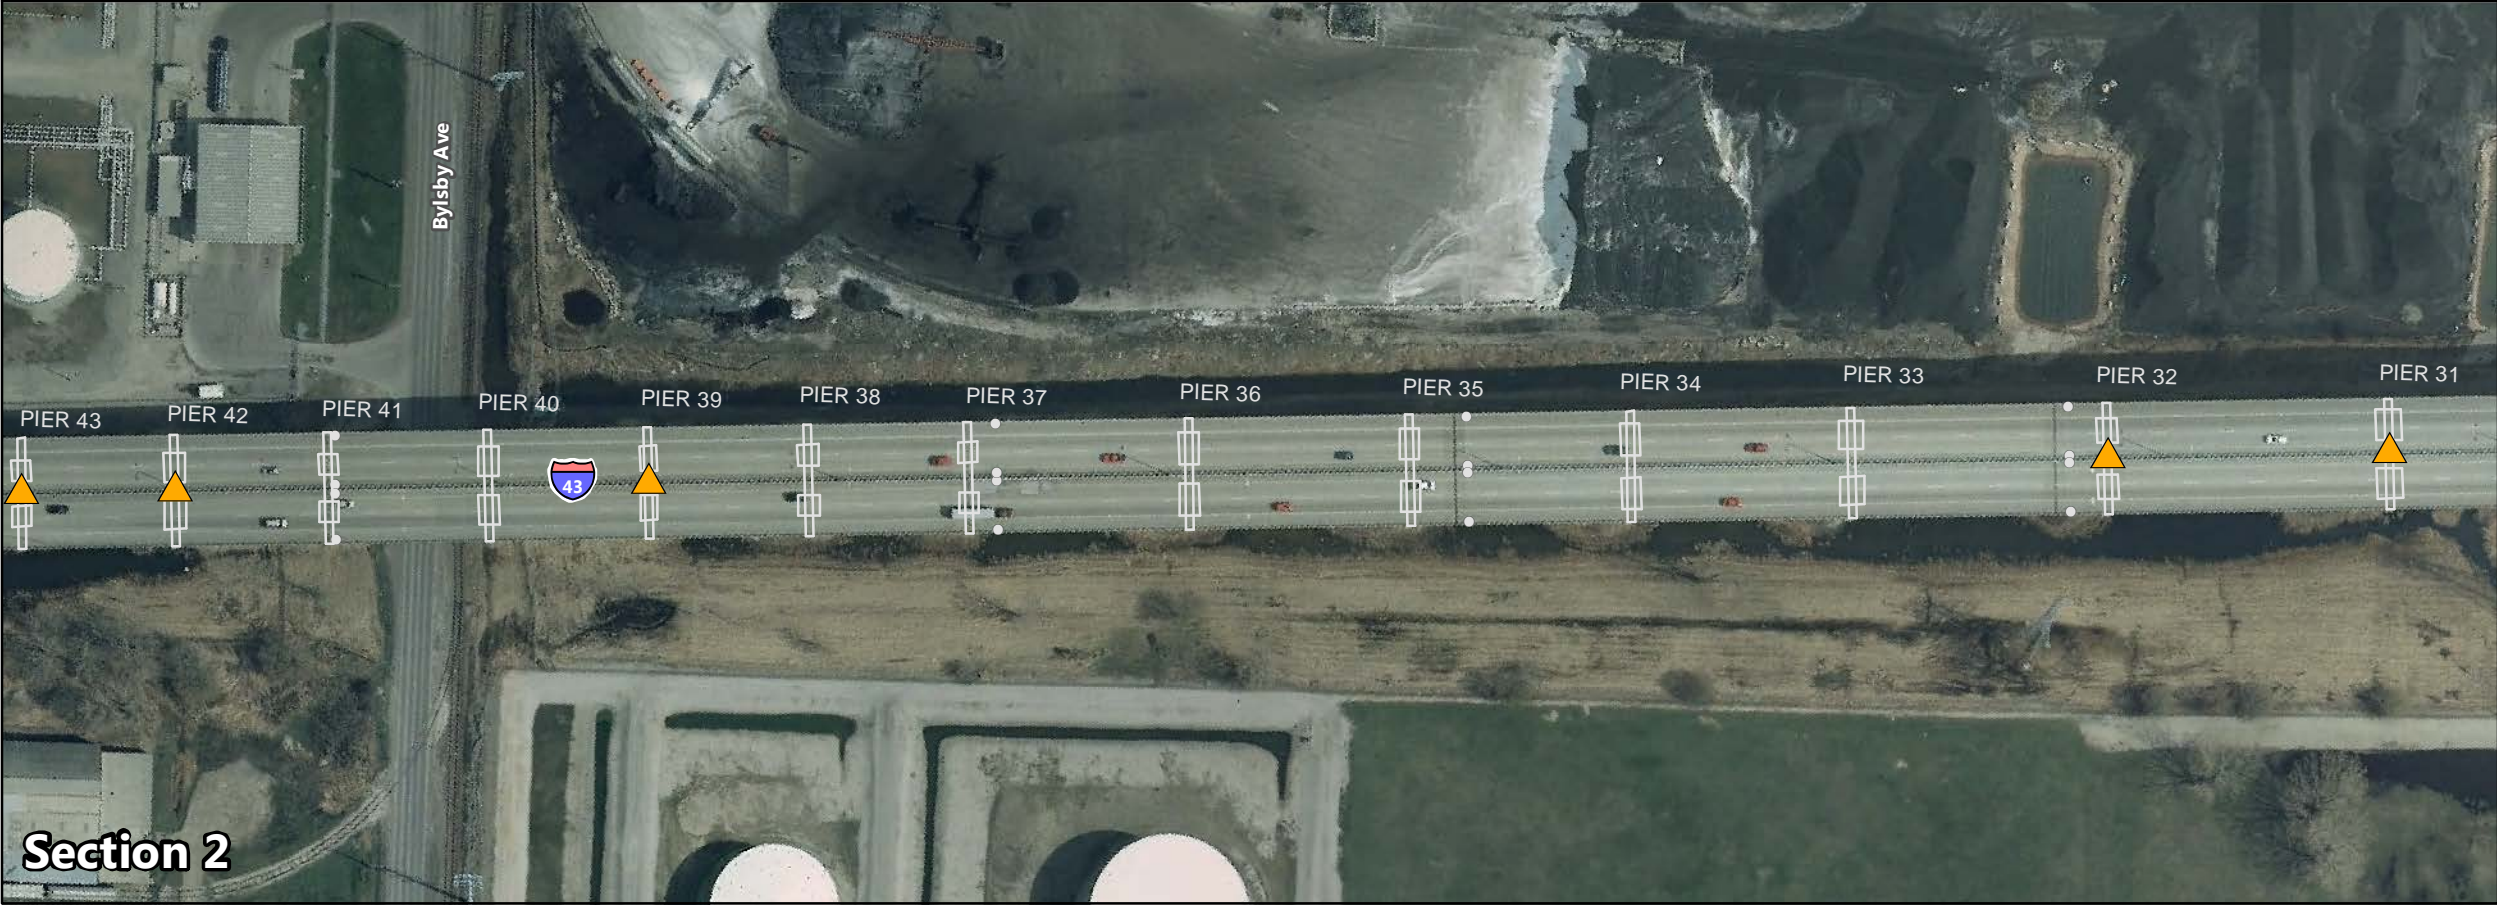
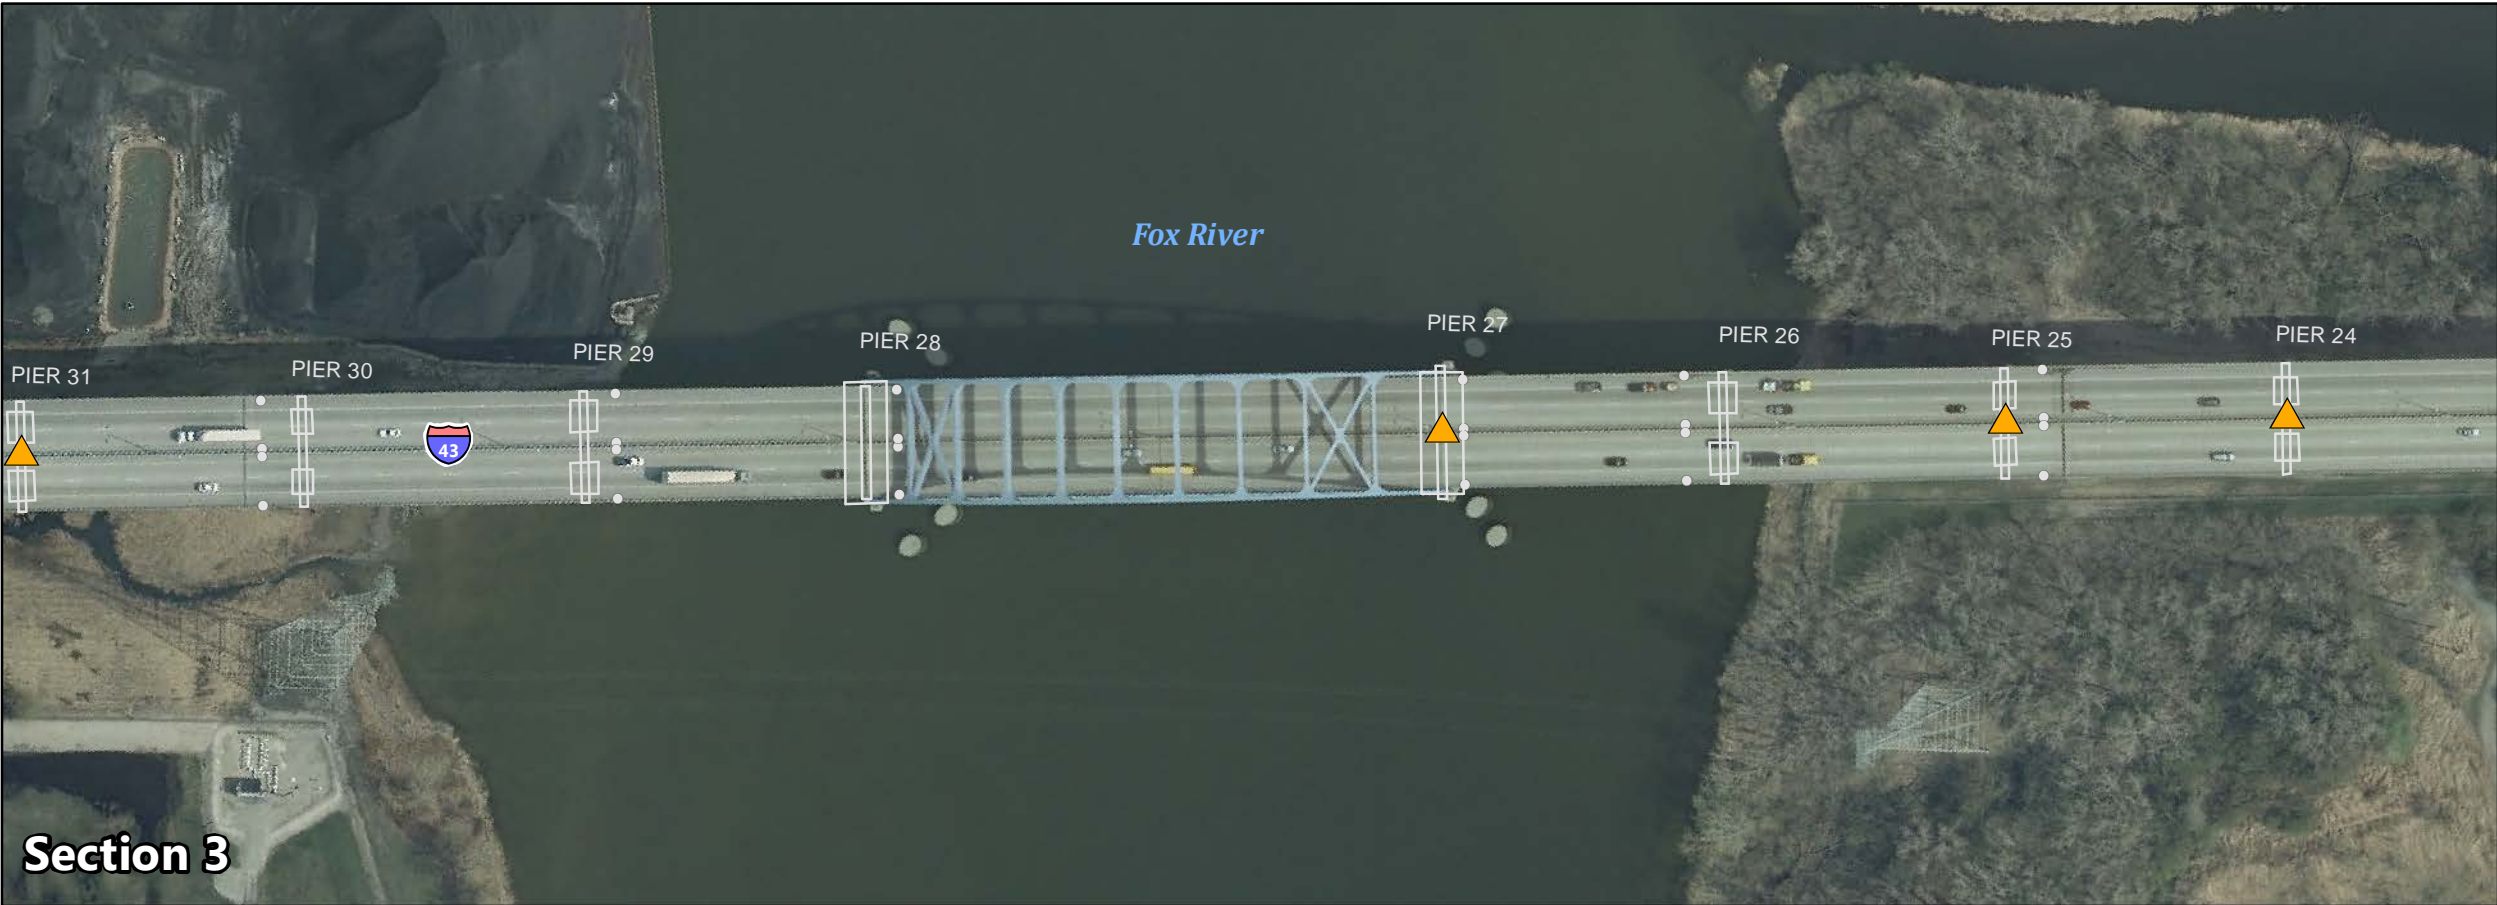
Exhibit 22 – Plot of Organics Encountered

Organics Encountered
