Engineering Study for Bridge Rehabilitation Structure No. B-47-45

Prepared for:
Pierce County Highway Department

Prepared By:
HDR Engineering, Inc.
701 Xenia Avenue South
Suite 600
Minneapolis, MN 55416

Bridge Inspection
Photographs

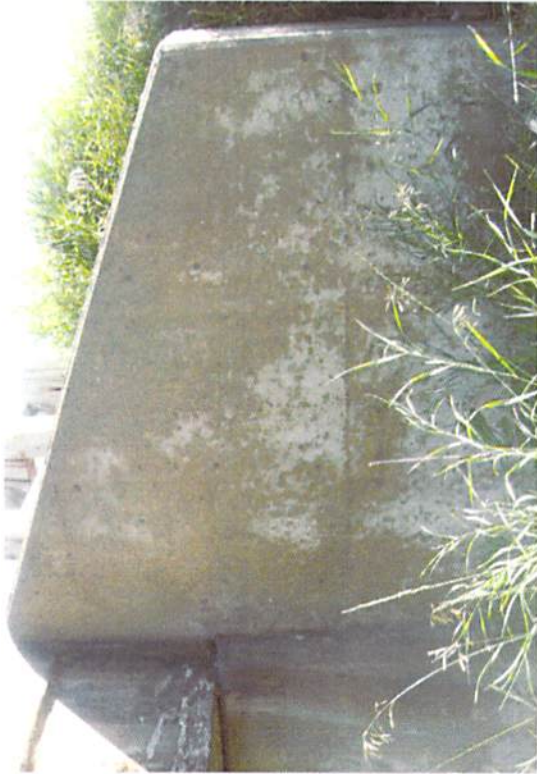
File Name: IMG_6099.jpg

IMG_6099	SE Wingwall	Looking NE at SE wingwall (No cracks)
IMG_6100	NE Wingwall	Looking NE at NE wingwall (No cracks)
IMG_6101	NE Corner of Deck	Showing 40" +/- superstructure depth
IMG_6102	South Fascia Beam	East end of South Fascia beam showing broken wire on bottom strand and 6"H x 3" deep x 3'L Spall
IMG_6103	East Abutment	Looking NE at East Abutment (No cracks)
IMG_6104	West Abutment	Looking NW at West Abutment (No cracks)
IMG_6105	SW Wingwall	Looking SW at SW Wingwall (No cracks)
IMG_6106	West Abutment	Looking south along West Abutment showing concrete slope protection pulled away from abutment
IMG_6107	NW Wingwall	Looking NW at NW Wingwall (No Cracks)
IMG_6108	West Abutment	Showing undermining of West Abutment; Varies to 14" primarily on south half of abutment
IMG_6109	West Abutment	Looking north along abutment showing concrete slope protection pulled away 3" +/-
IMG_6110	South Fascia Beam	Looking north at 4' long by 8" tall full leg width spall with exposed strands near midspan

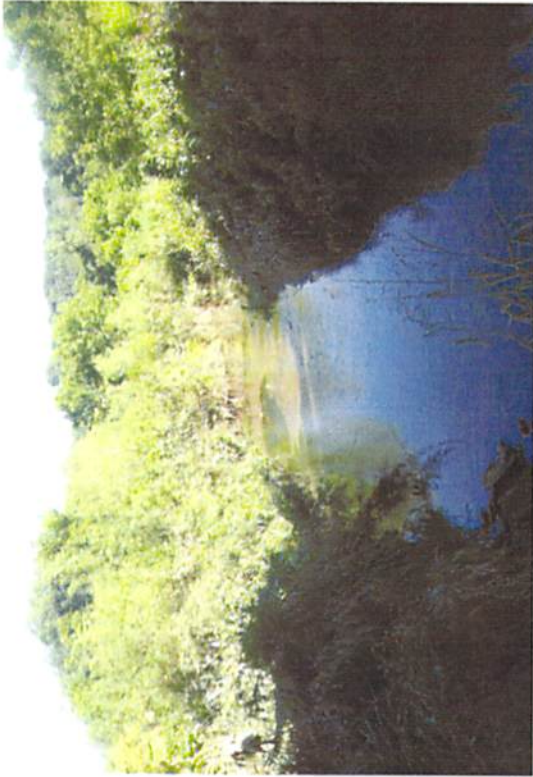
File Name: IMG_6111.jpg

IMG_6111	Channel	Looking upstream at bend in channel just upstream from bridge
IMG_6112	Channel	Looking downstream through structure opening
IMG_6013	Channel	Looking upstream through structure opening
IMG_6114	Rail	Looking east along bridge rail
IMG_6115	Deck	Looking west at repairs in EB Lane
IMG_6116	South Fascia Beam	Looking at spall in leg with exposed strands and up to 4 broken wires
IMG_6117	South Fascia Beam	Looking at spall in leg with exposed strands and up to 4 broken wires
IMG_6118	Approach Roadway	Looking east at approach roadway
IMG_6119	Approach Roadway	Looking west at approach roadway
IMG_6120	North Elevation	Looking SW at North Elevation of Bridge
IMG_6121	South Elevation	Looking NW at South Elevation of Bridge
IMG_6122	North Elevation	Looking SE at North Elevation of Bridge
