STATE OF WISCONSIN  
DEPARTMENT OF TRANSPORTATION

# Inspection Report for B-47-040

USH 10 over ST CROIX RIVER 01

Apr 13, 2017

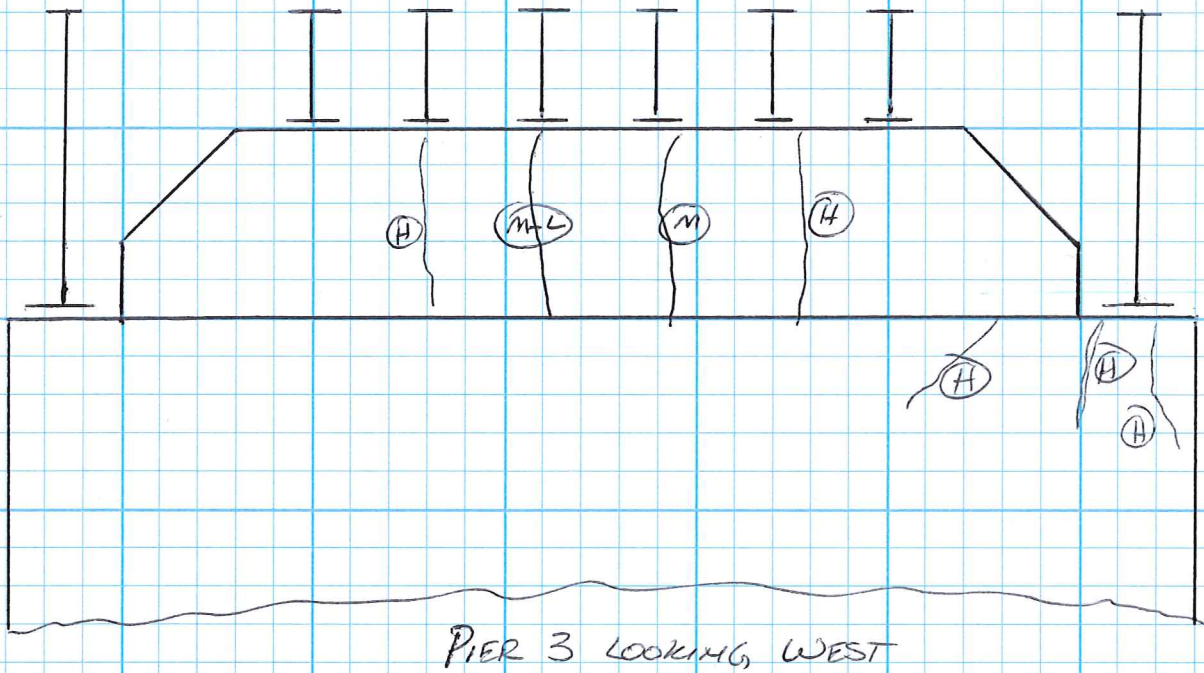
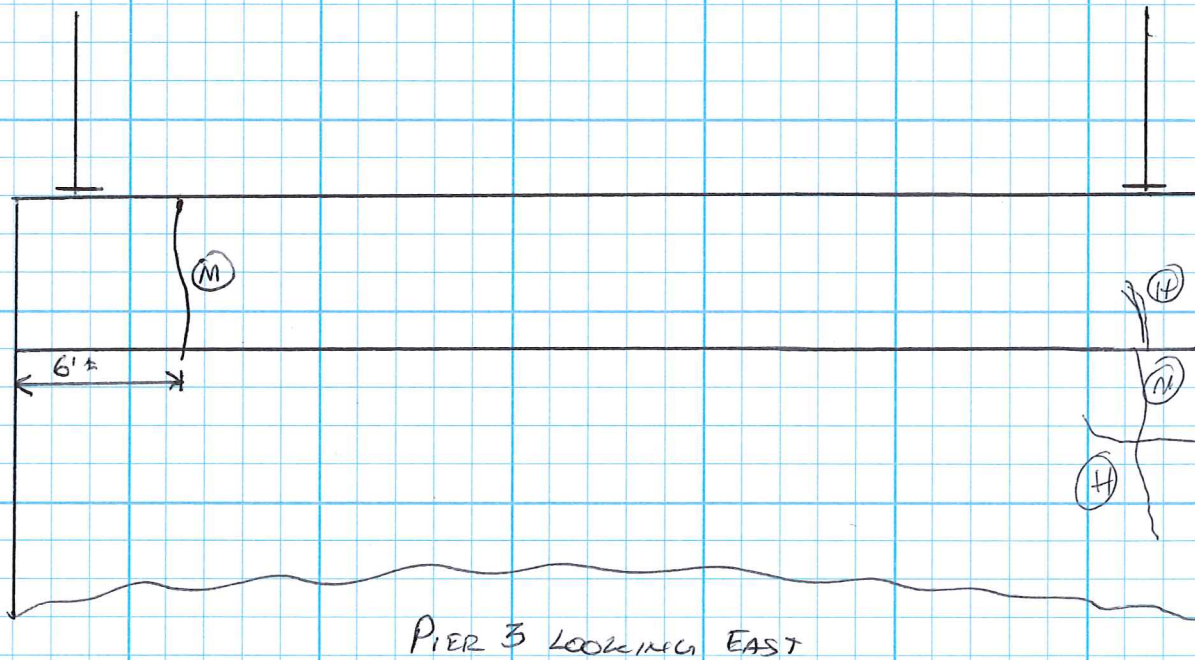
- (H) HAIRLINE
- (M) MEDIUM
- (M-L) MEDIUM TO LARGE
- (L) LARGE

Project/Structure No. B-47-0040	Hwy. No. 10	County PIERCE	Computations by GHH	Date 4/26/10
Name of Road BASCOLE BRIDGE			Checked by	Date
Title/Item INSPECTION SKETCHES			Sheet	Of

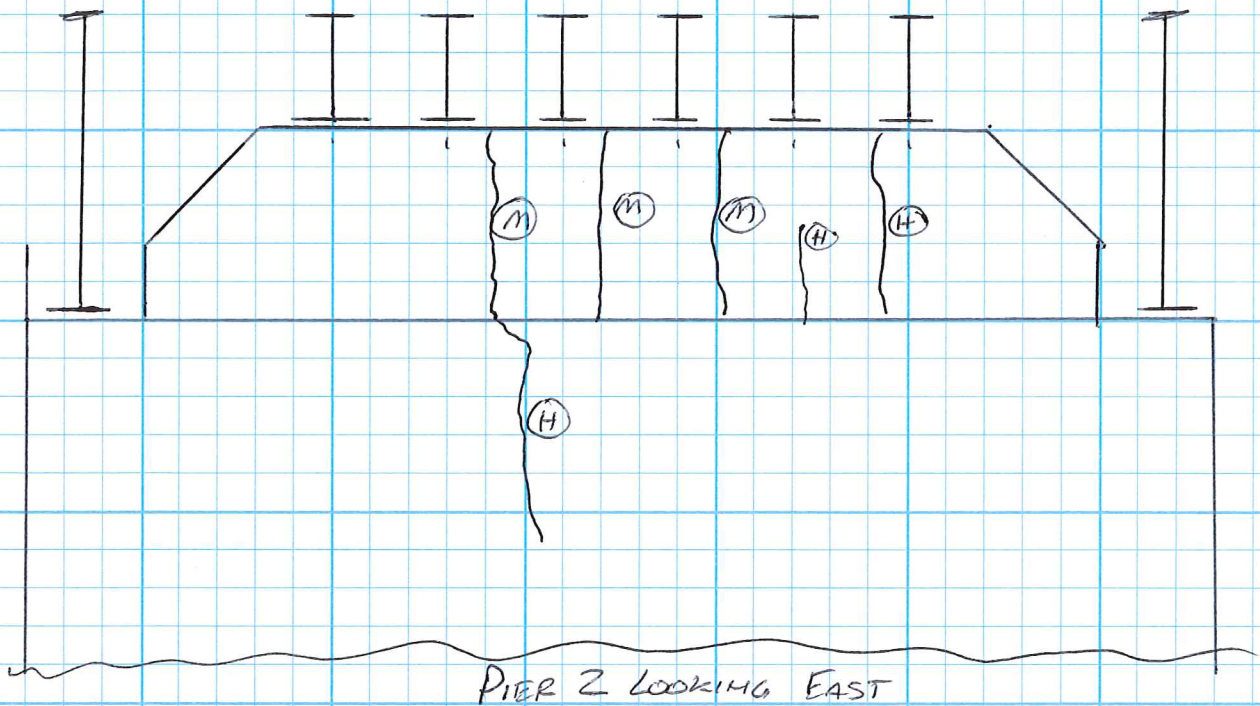
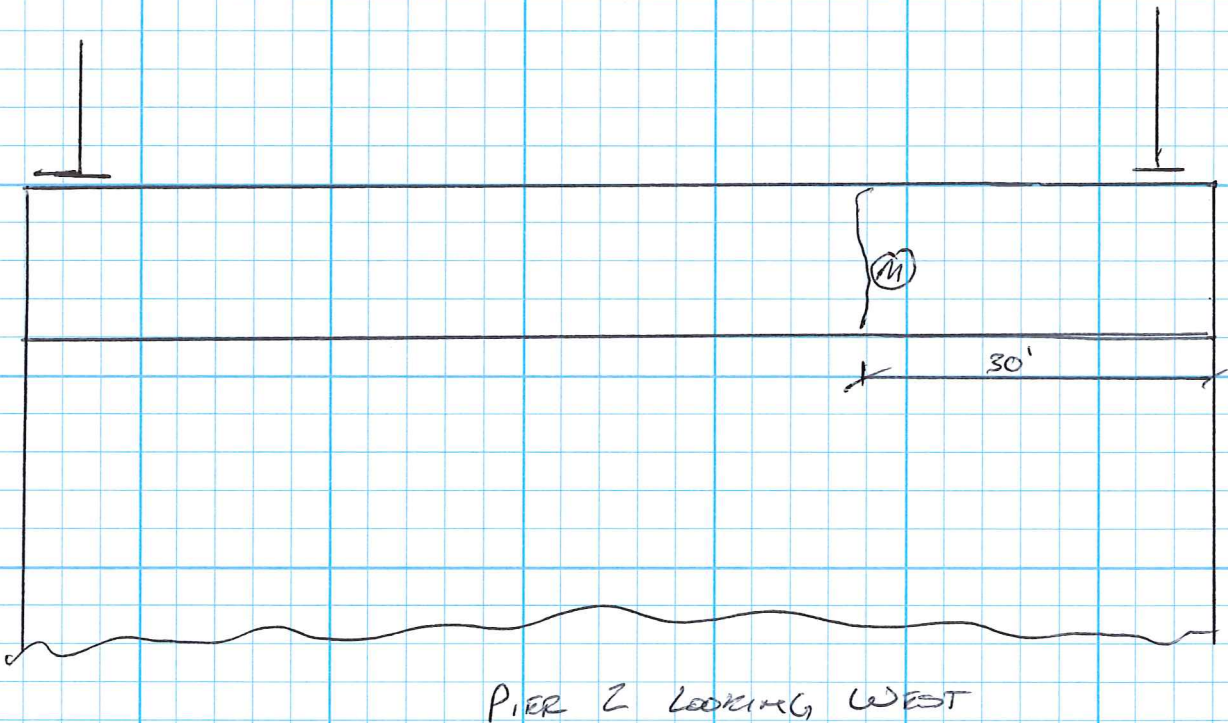
- (H) HAIRLINE
- (M) MEDIUM
- (L) LARGE

Project/Structure No. B-47-0040	Hwy. No. 10	County PIERCE	Computations by GHH	Date 4/26/16
Name of Road BASCOLE BRIDGE			Checked by	Date
Title/Item INSPECTION SKETCHES			Sheet	Of

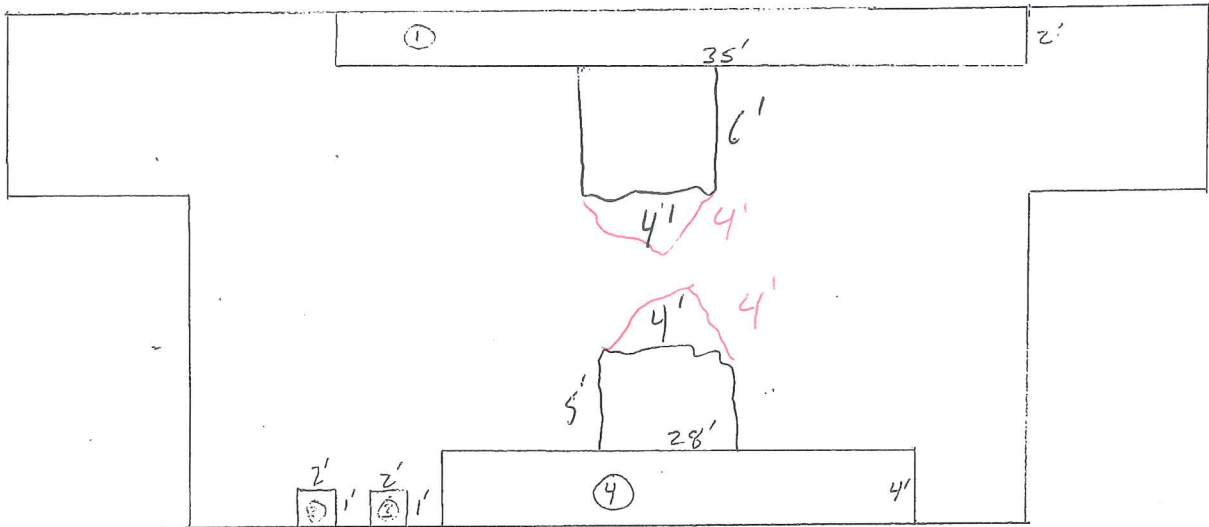
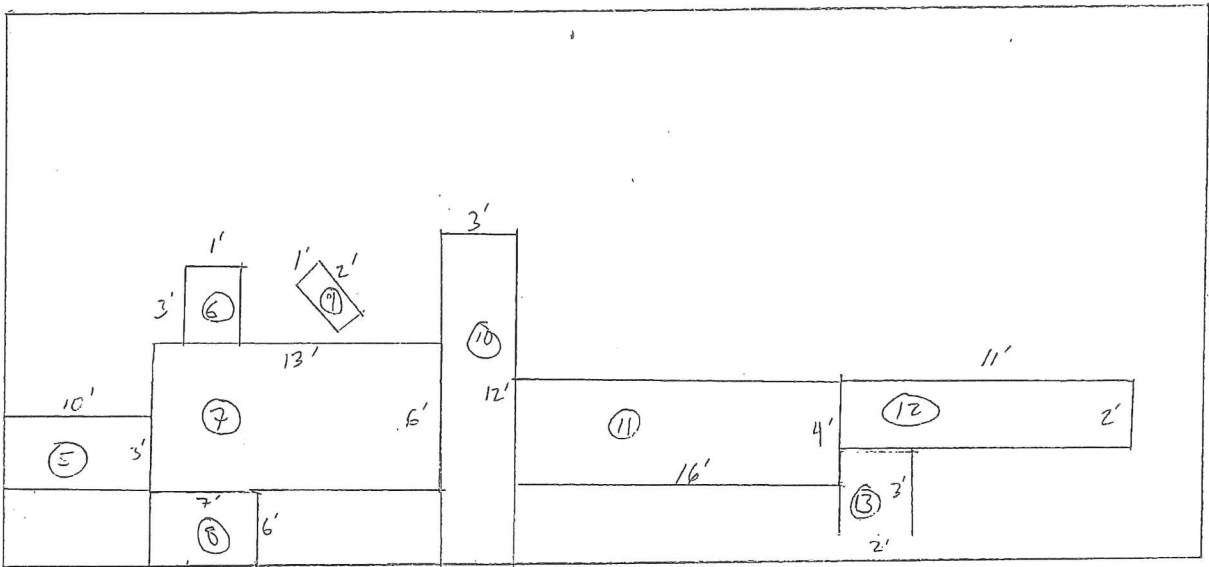
B-47-40  
 RESCOTT BRIDGE  
 CONCRETE SURFACE PLASTER (WE SIDE)

COUNTER WEIGHT

FLOOR

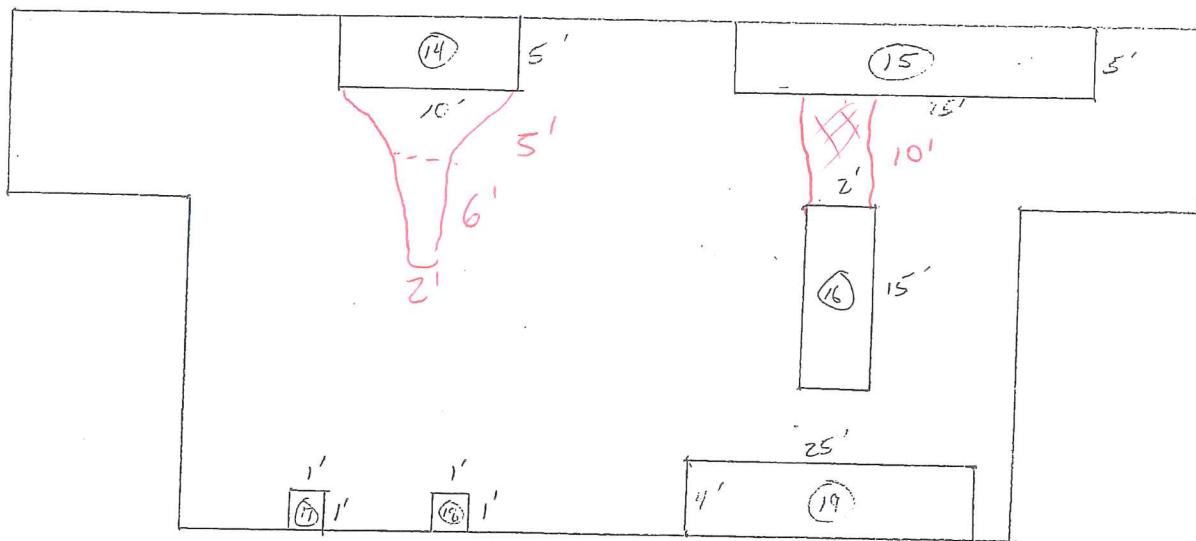
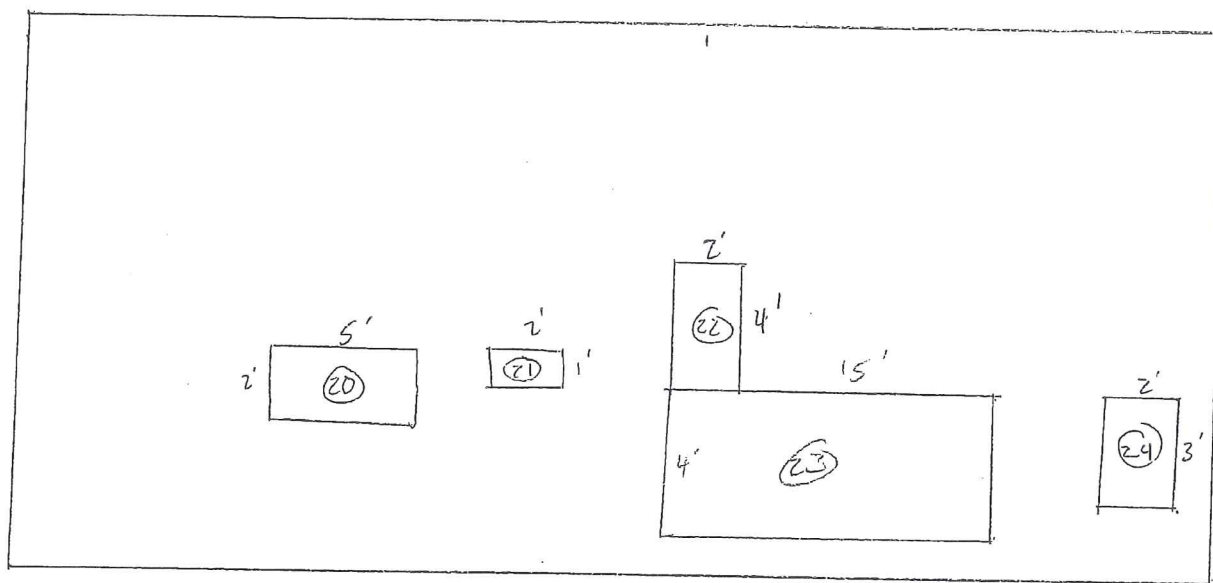
B-47-40  
 PRESCOTT BRIDGE  
 CONCRETE SURFACE REPAIR (MIN SIDE)

COUNTER WEIGHT

FLOOR
