## Bridge Asbestos Inspection Report

**WisDOT Project ID:** 1360-12-00  
**Structure Number:** B-40-0252  
**Structure Name:** 107th Street over STH 145  
**City/County:** City of Milwaukee, Milwaukee County  
**Lat/Long Coordinates:** 430838.72/ 880242.14  
**TRC Project Number:** 292179.0000.0000  
**Date Inspected:** February 22, 2018  
**Inspected By/License Number:** John Roelke, All-119523

## Bridge B-40-0252

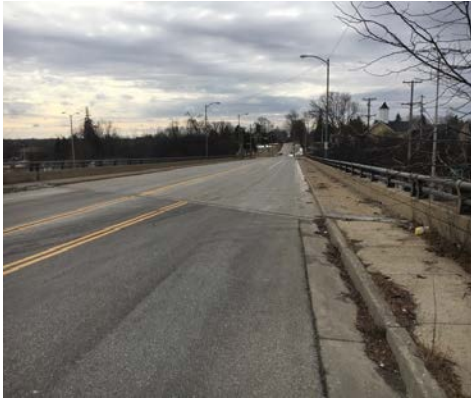
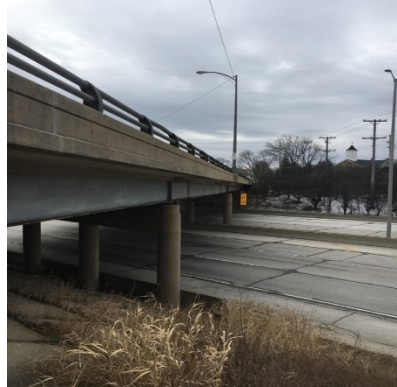
Utilities encased in PVC piping

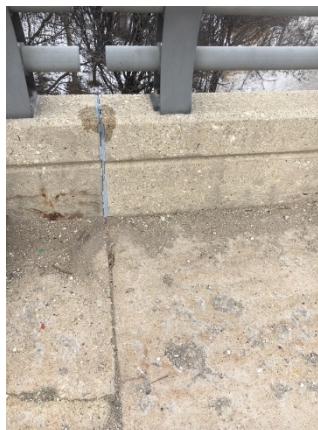
The gaskets located where the railing attaches to the concrete parapet tested positive for asbestos greater than 1% and is therefore regulated ACM. The ACM will be disturbed during the planned demolition and replacement. The ACM must be removed prior to any work. Standard Special Provision (STSP) 203-005 should be incorporated into the specifications.

Gasket under railing attachments
