# REHABILITATION STRUCTURE SURVEY REPORT

| Design Project ID<br>2040-20-00 | | Construction Project ID<br>2040-20-70 | | Highway (Project Name)<br>STH 100 EB BRIDGE OVER CNW RR | |
| Structure Number<br>B-40-0530 | | Section<br>27 | Town<br>5N | Range<br>22E | |

**B-40-0530 Deficiency Photographs**

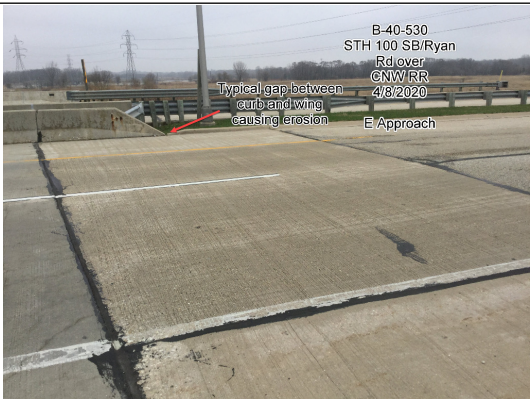
Routine Item 2

| Chk | Element | Defect | Description | UOM | Total | Quantity in Condition State | | | |
|---|---|---|---|---|---|---|---|---|---|
| | | | Approach drain at SW <b>with cracking of rings</b> , drainage flume at SE broken away water not reaching flume. NE/NW corners water not getting off bridge going through joint and around railing /WW joint into abutment backwall. | | | | | | |

| E Appr | <div> <p>B-40-530<br/>STH 100 SB/Ryan Rd<br/>over<br/>CNW RR<br/>4/8/2020<br/>E Approach</p> <p>Typical gap between<br/>curb and wing<br/>causing erosion</p> </div> <div> <p>b40-530_20_Rd2.jpg</p> </div> |

| Item | Priority | Recommended by | Status | Status change |
|---|---|---|---|---|
| NW, NE SE, SW corners. Fill joint between wing and curb to stop erosion. Repair Erosion. Repair joint at top of flume at SE corner | | | | |

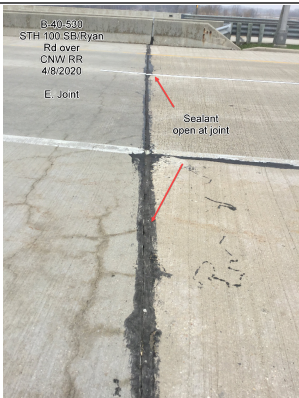
Routine Item 3

| Chk | Element | Defect | Description | UOM | Total | Quantity in Condition State | | | |
|---|---|---|---|---|---|---|---|---|---|
| | | | E Approach: 1/2 inch high @ right shoulder.<br><b>W approach: about 1/2 low along most of approach</b><br><b>Both joint having failing sealant</b> | | | | | | |

| E Joint | <div> <p>B-40-530<br/>STH 100 SB/Ryan Rd<br/>over<br/>CNW RR<br/>4/8/2020<br/>E Joint</p> <p>Sealant<br/>open at joint</p> </div> <div> <p>b40-530_20_Rd3.jpg</p> </div> |

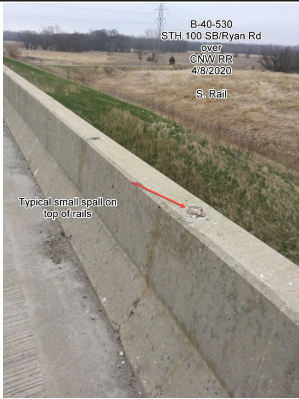
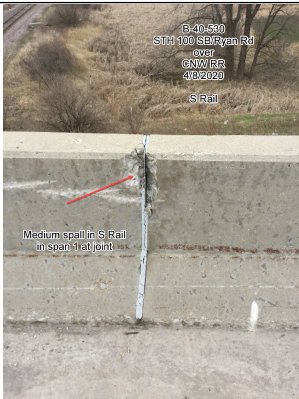
S Rail

| | | 1080 | Delamination - Spall - Patched Area<br>Few small spalls/delam. <b>One medium spall in top of S rail in span 1 at rail joint.</b> | LF | | 0 | 16 | 1 | 0 |
| | | 1130 | Cracking (RC)<br>HL to narrow vert/horiz cracks <b>some with staining.</b> | LF | | 0 | 43 | 0 | 0 |

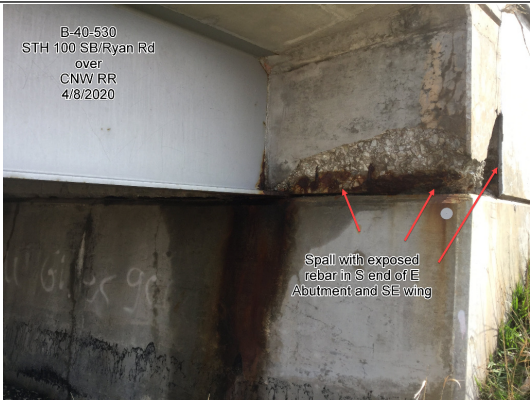
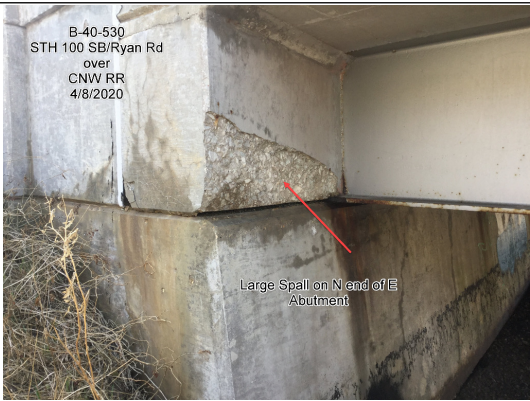
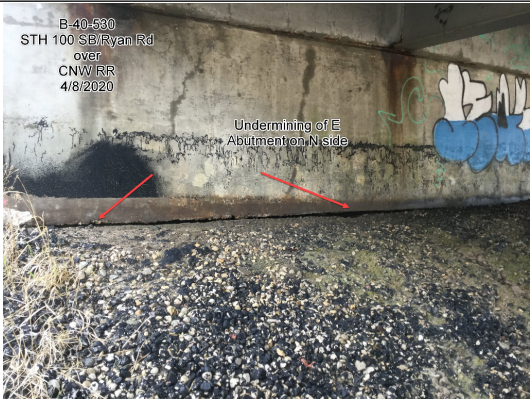
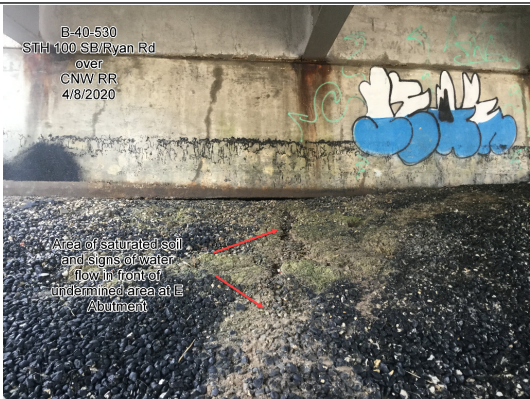
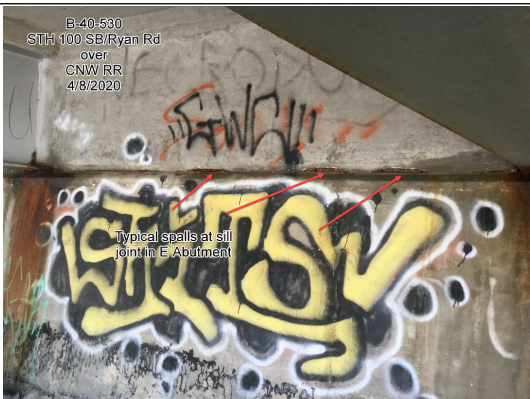
E Abutment

| | | 1080 | Delamination - Spall - Patched Area<br>Large, deep spalls at SE & NW corners with exposed rebar, spalls along Sill Jt, sound patch at SW corner. <b>Large spall on NE corner</b> | LF | | 0 | 4 | 24 | 0 |
| | | 1130 | Cracking (RC)<br>HL to narrow vert cracks with rust stains at both East and West. | LF | | 0 | 9 | 0 | 0 |
| | | 8903 | Wall Deterioration<br>HL map cracks at all; delams and exposed rebar at <b>SE</b> and NW. <b>Concrete repair on SW.</b> | EA | | 0 | 1 | 0 | 0 |

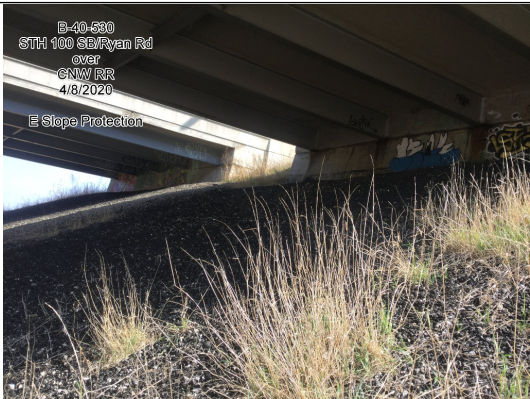
E Slope Protection

| Chk | Element | Defect | Description | UOM | Total | Quantity in Condition State | | | |
|---|---|---|---|---|---|---|---|---|---|
| | | | Resealed 2006; slopes have areas of loose aggregate. Undermined at N end of E abut. Both slopes settled. | | | | | | |

| Item | Priority | Recommended by | Status | Status change |
|---|---|---|---|---|
| <b>SLOPE PROTECTION - REPAIR UNDERMINING OF SUB</b> | HIGH | Ambrose, Paul J (2020) | IDENTIFIED | 04/14/20 |
| Repair erosion/undermining of east abutment. | | | | |

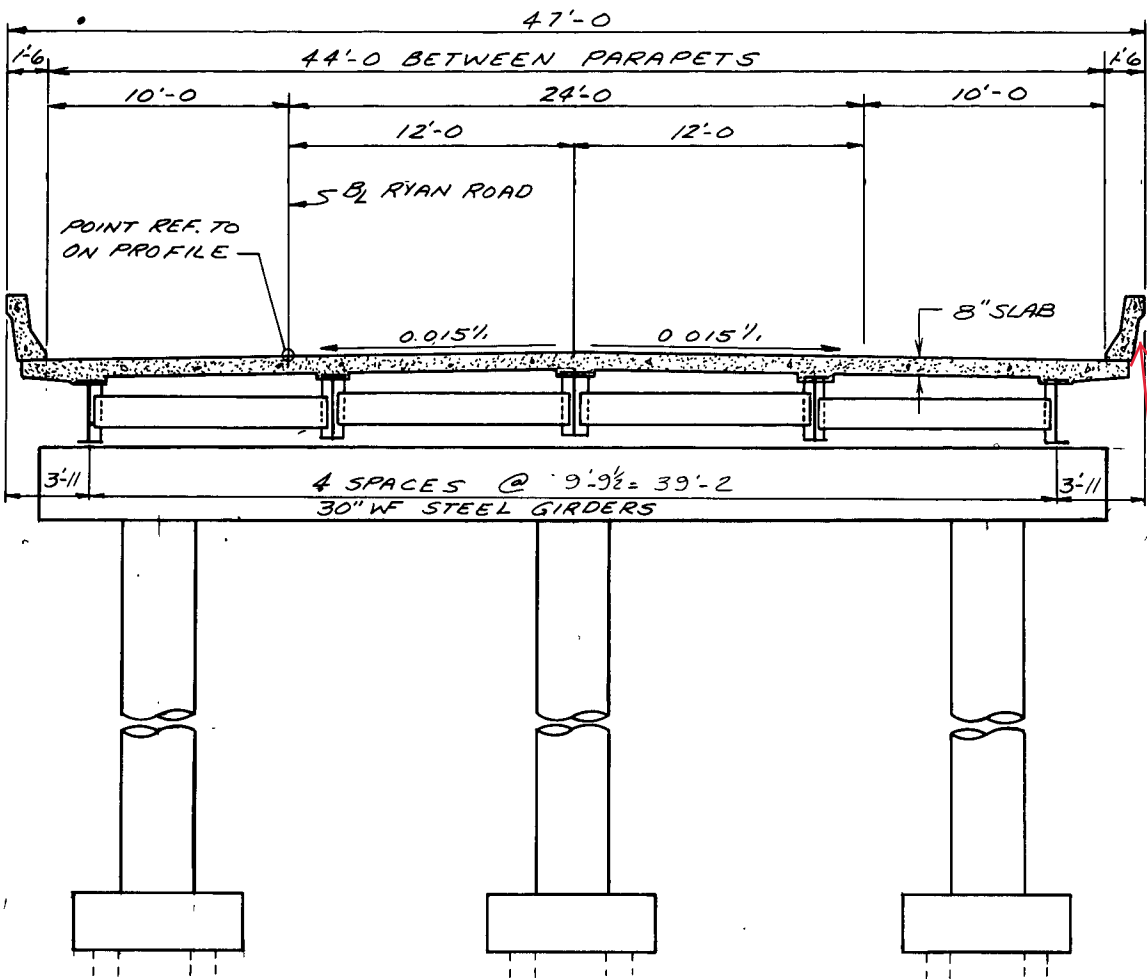
CROSS SECTION THRU ROADWAY LOOKING EAST

Existing parapet not to standard; replace with 42SS parapet

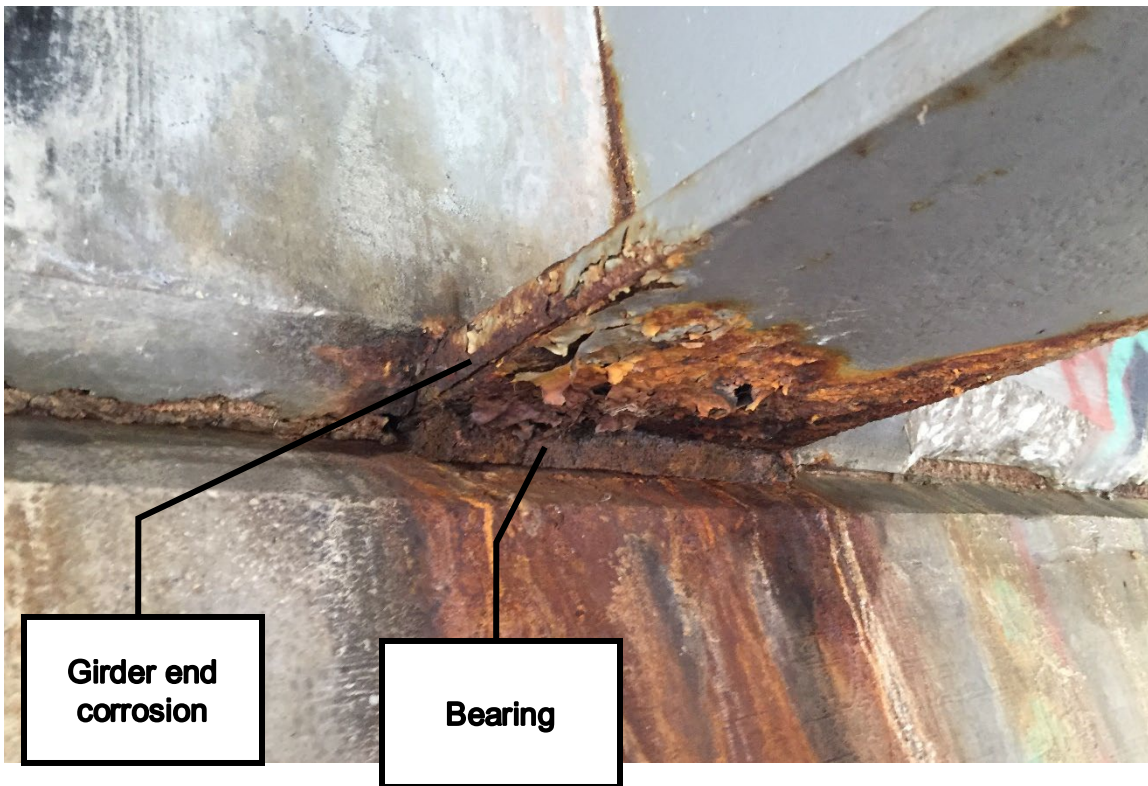
**Water seen  
running out  
from under  
abutment**

For the STH 100 EB bridge deck replacement (B-40-0530) project, there is a scope item we would like to bring your attention to. During a field review, we noticed water draining out from under the east abutment. There is a void under the abutment wall. We discussed this issue with our region maintenance staff and we believe the void may be caused from poor drantile operation behind the abutment wall. They recommend providing a detail for abutment drainage and filling the void with grout.

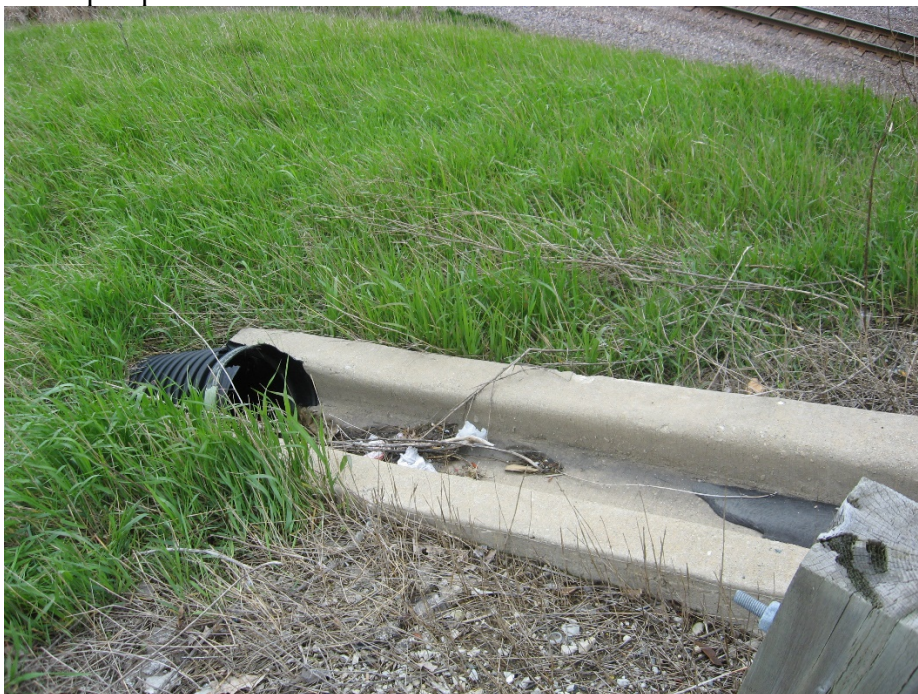
SE flume.
