## Bridge Asbestos Inspection Report

**Structure Number:** B-03-014

# Inspection Report for B-03-014

USH 53 SB over CARLSON SCHOOL DRIVE  
Jun 08,2017

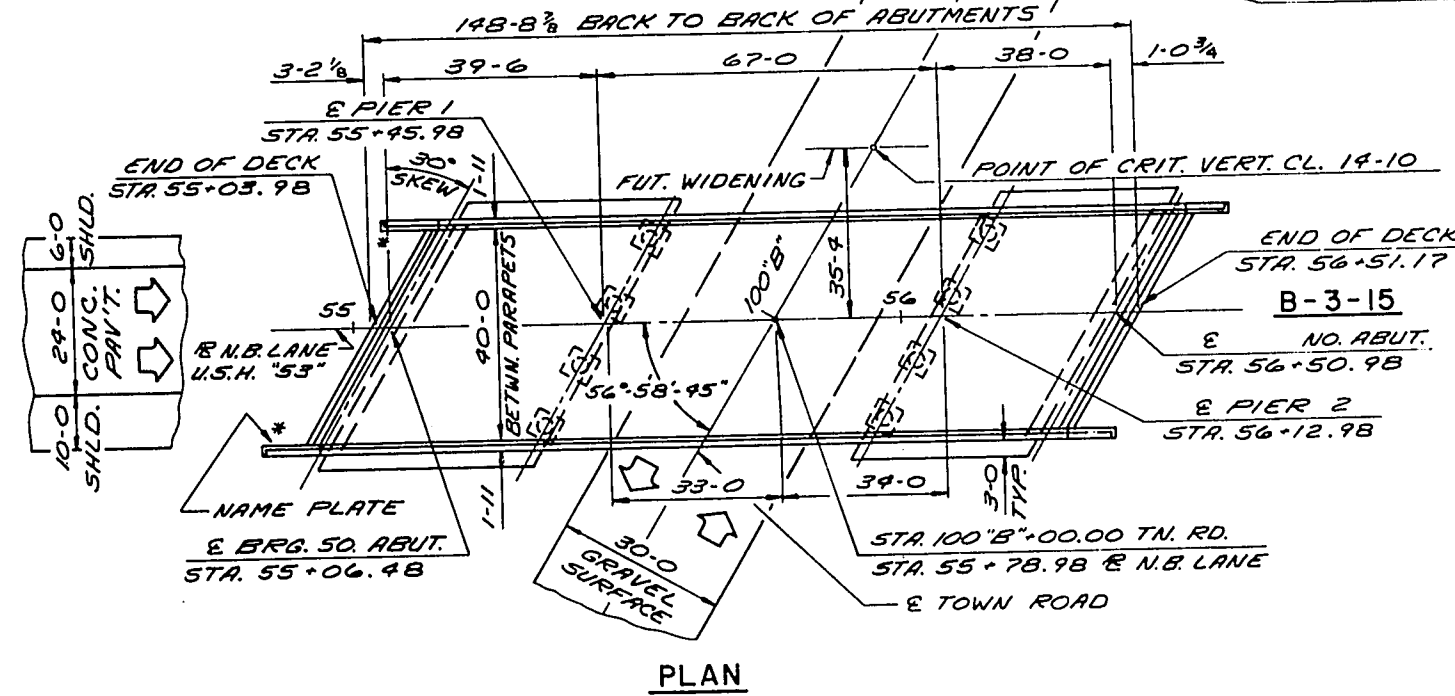
CROSS SECTION THRU ROADWAY  
3 SPAN HAUNCHED SLAB (LOOKING NORTH)

3 SF Concrete Surface  
Repair N. Abut.

3 SF Concrete Surface  
Repair S. Abut.

Parapet in poor condition, spalls/cracks/rust stains on entire length. Approx. 40% of top and roadway surface of parapet need Concrete Surface Repair = 210 SF
