## Bridge Asbestos Inspection Report

**WisDOT Project ID:** 1196-04-02  
**Structure Number:** B-03-026  
**Structure Name:** USH 53 SB over Knapp Street  
**City/County:** Town of Prairie Lake, Barron County, Wisconsin  
**GEI project Number:** 1901822  
**Date Inspected:** April 4, 2019  
**Inspected by:** Kyle C. Sandmire  
**Asbestos Inspector License Number:** All- 217616  
**Consultant Company:** GEI Consultants, Inc.

# BRIDGE INSPECTION REPORT

Inspection Report for  
B-03-026

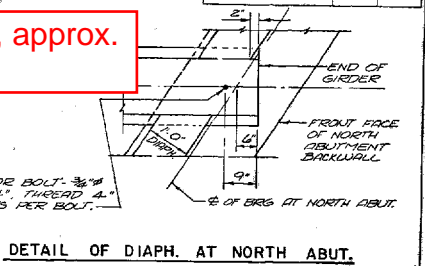
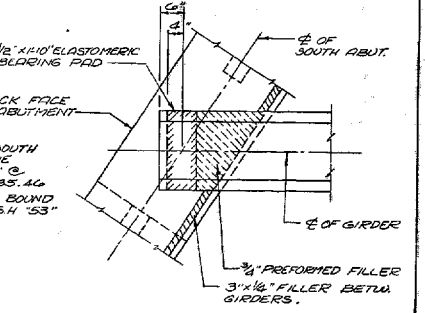
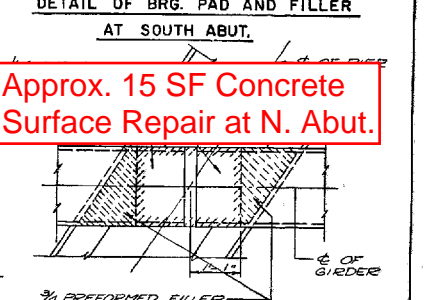
Approx. 15 SF Concrete Surface Repair at N. Abut.

East parapet has crack at top nearly the full length, approx. 135 SF Concrete Surface Repair.
