1090-05-02/72 Rehab items (Consultant – Black) and (DOT-your comments-Red)- While reviewing the inspection reports for the subject bridges, in addition to polymer overlay, we notice that there are some maintenance recommendations that needs to be taken care off for 124^{Th} street bridge. These are :

WisDOT Project ID: 1090-05-02 Structure Number: B-40-0377 Structure Name: 116th Street over IH 43 City/County: City of Greenfield, Milwaukee County Lat/Long Coordinates: 425726.4/ 880328.09 TRC Project Number: 258938.0000.0000 Date Inspected: June 21, 2016 Inspected By/License Number: John Roelke, All-119523

Inspection Report for B-40-377

S 116TH ST over IH 43 Apr 17,2018

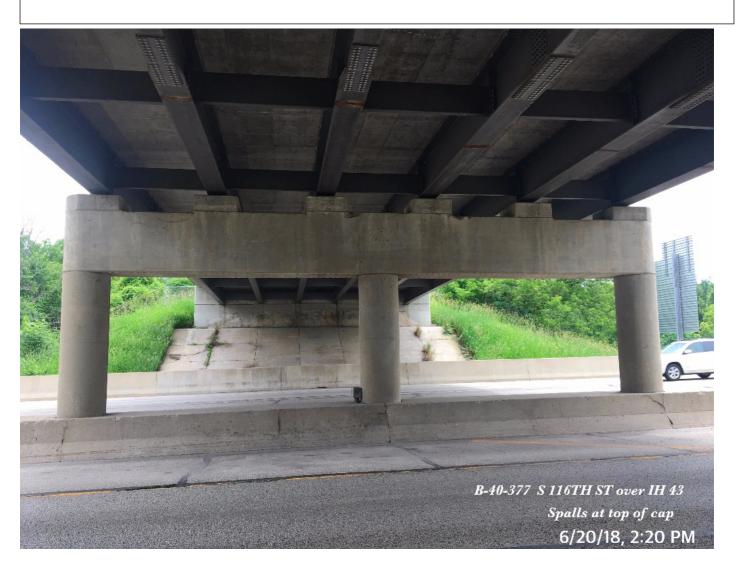
Routine Document Comment/Description South side of pier spalls

- 7. Patch and seal pier cap spalls and cracks Concrete Surface Repair item should be used for patching spalls and delams. Cracks typically aren't addressed in pier caps unless extremely wide.
