# MEMO \_\_\_\_\_ State of Wisconsin

**Date:** Aug 9, 2011  
**To:** Robert Arndorfer  
**CC:** Bill Duckert  
**From:** Michael J Bormett  
Pavement Evaluation Specialist – Adv.2  
**Subject:** Pavement Warranty Report for 2011

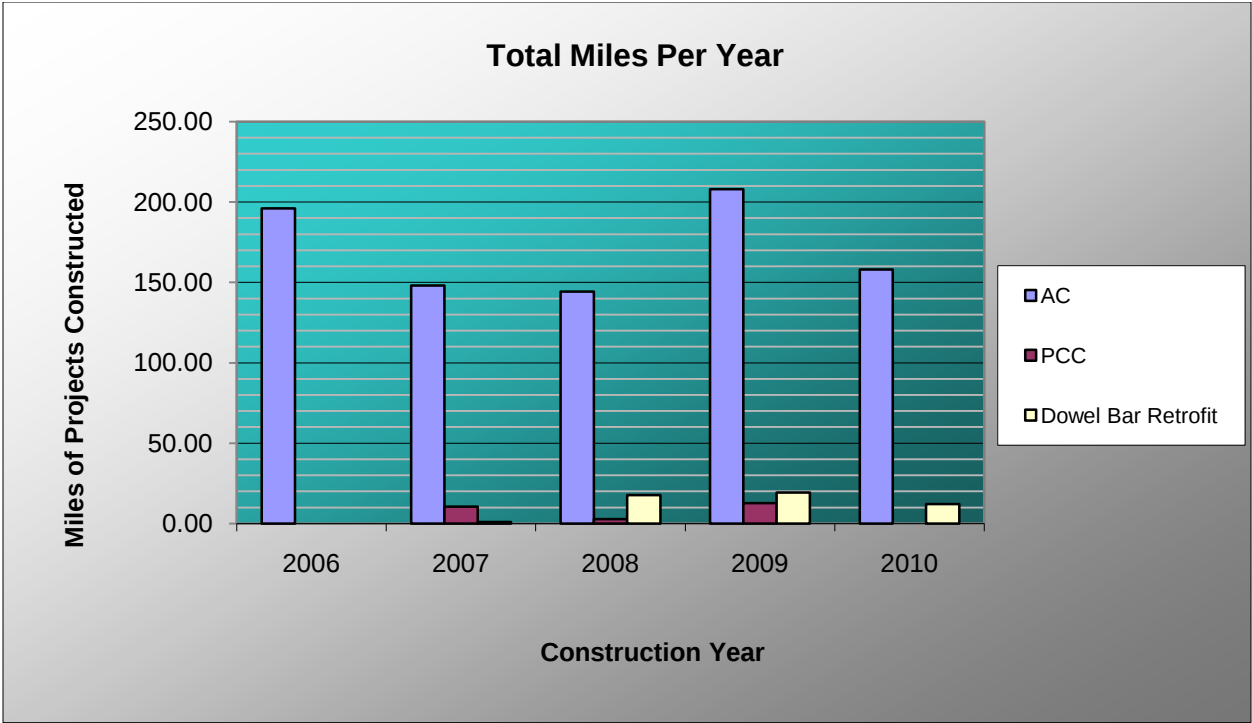
The charts on succeeding pages give an idea of how warranty work has been distributed among the Regions beginning in 2006. These charts have not been updated for 2011 new construction. We will chart this data in the 2012 report
