US 14 Emergency Repairs Black Earth, Wisconsin

WisDOT/ACEC Transportation Improvement Conference, March 6, 2019

US 14 B-13-329 Mazomanie

I-94 Slope Failures Jefferson County Supervisor Jim Oettinger, PM Craig Hardy, PL Jeremy White

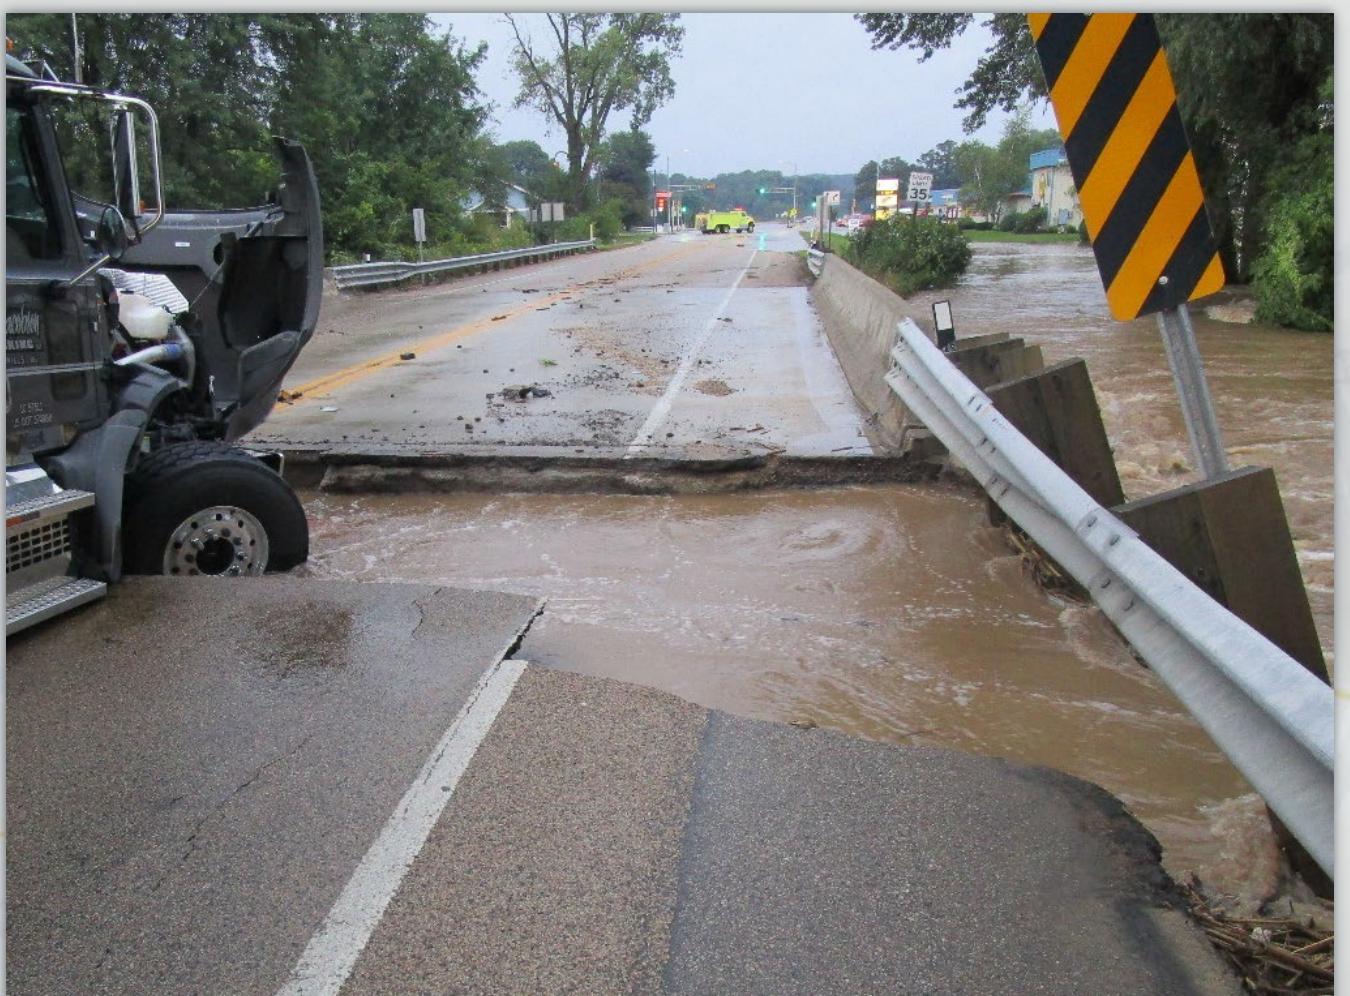
Dane County rainfall

The storm severely affected the western half of the county. The most rain was reported in Cross Plains at over 15 inches.

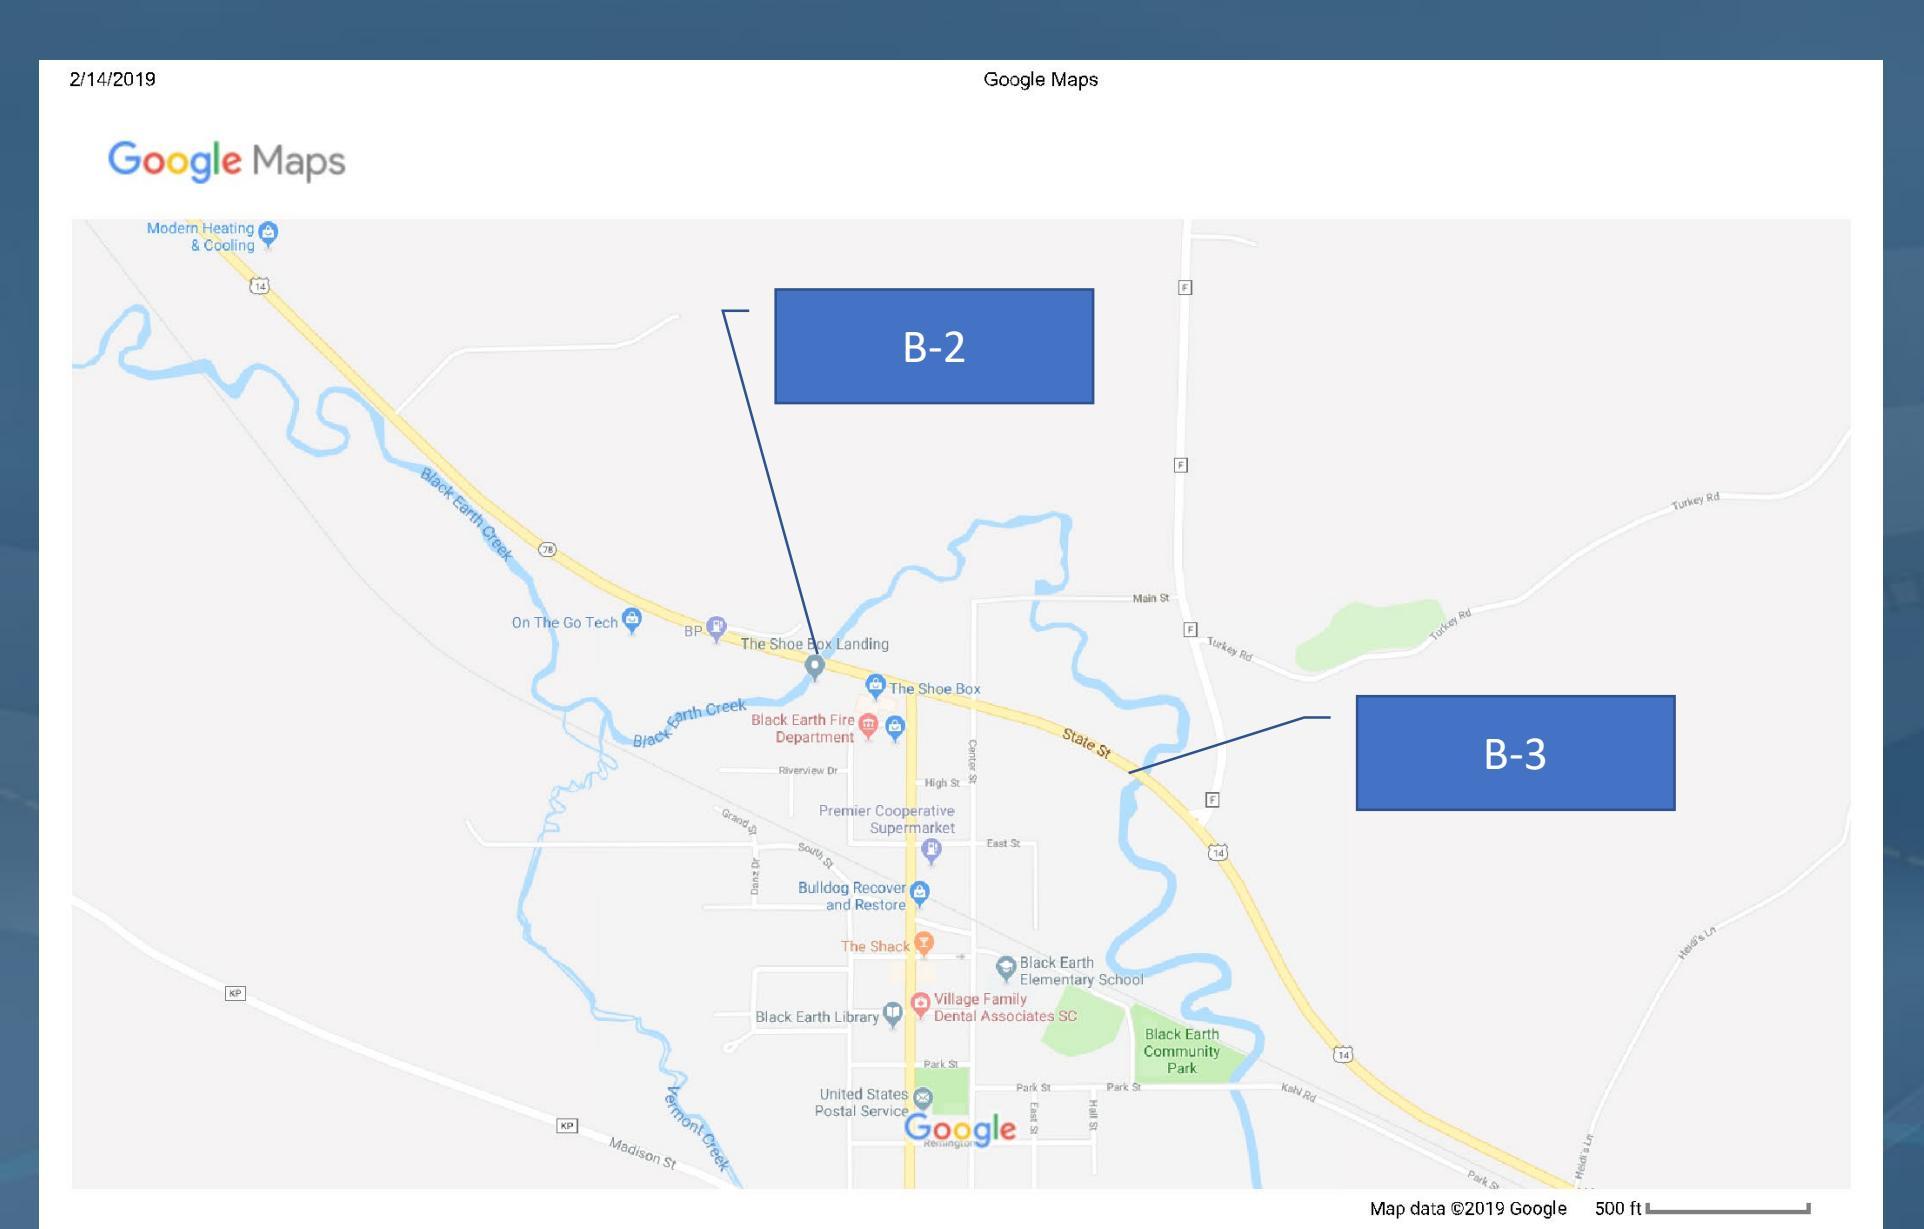
Black Earth, WI

Structure inspection on 8/23 found that both the west bridge B-13-2 (Shoebox) and the east bridge B-13-3 were compromised.

Built in 1935, the bridges were constructed on spread footings. The B-2 west abutment was undermined. The B-3 center pier dropped.

Recommendation: the bridges must be replaced.

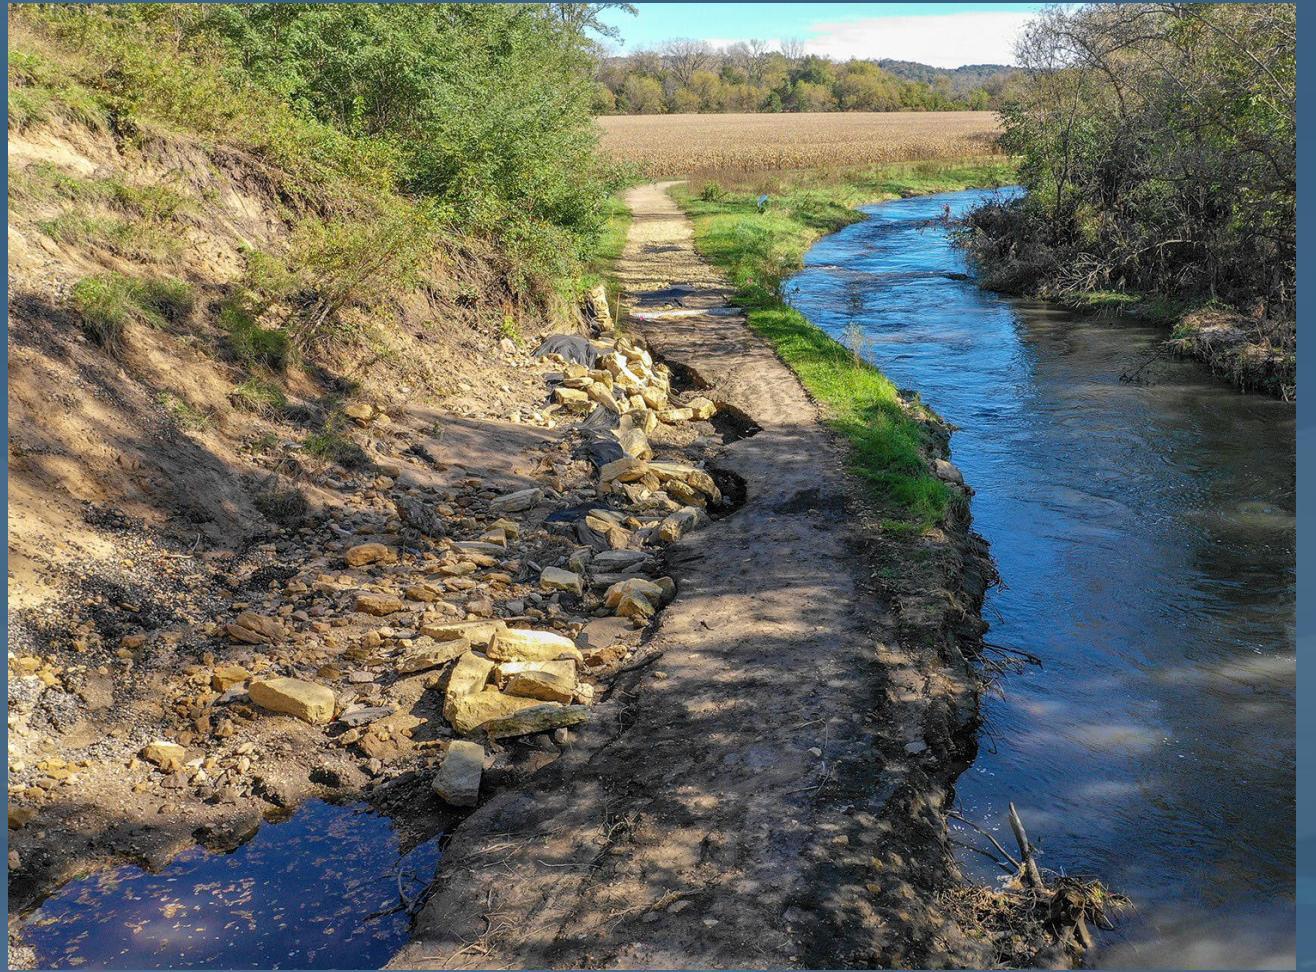
Investigation showed 5 feet of exposed pile under east pier footing.

Large 15 foot scour hole where trail had been adjacent to pier.

- Wolf Run Trail sponsors requested to raise trail elevation.
- Discussion with DNR we can protect the pier footings and fill in scour to replace trail in kind.
 - No extra fill in floodway, no raising of the trail.
- Flood funding only for work within the public right of way.

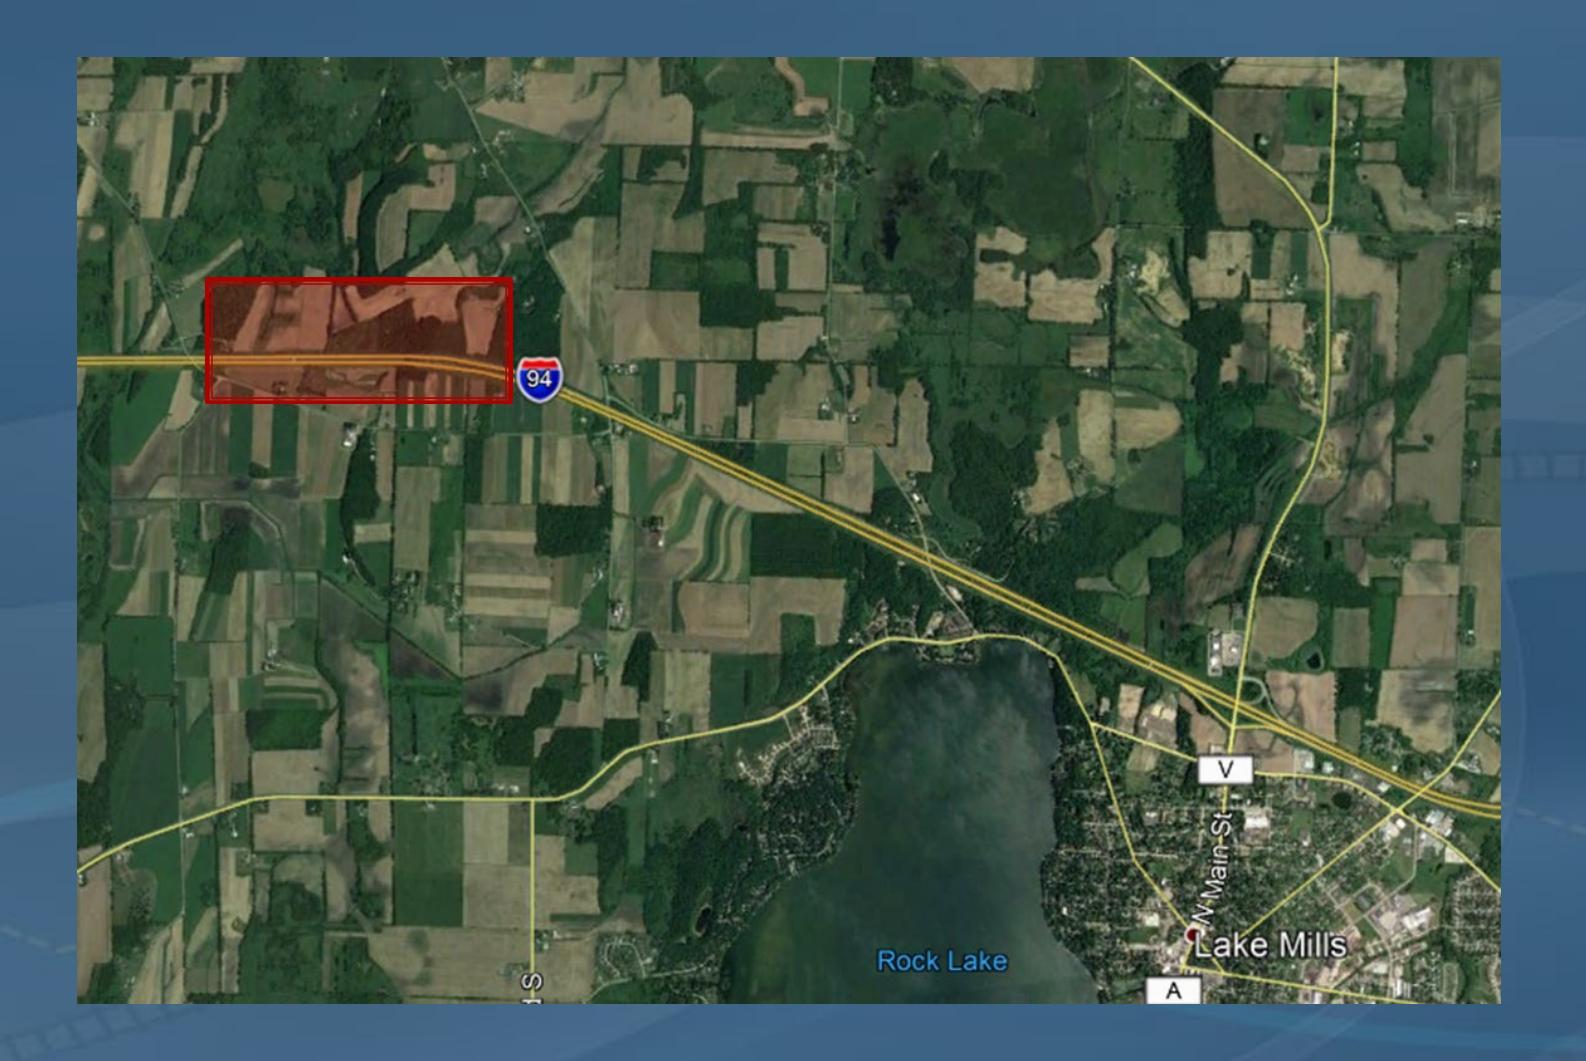
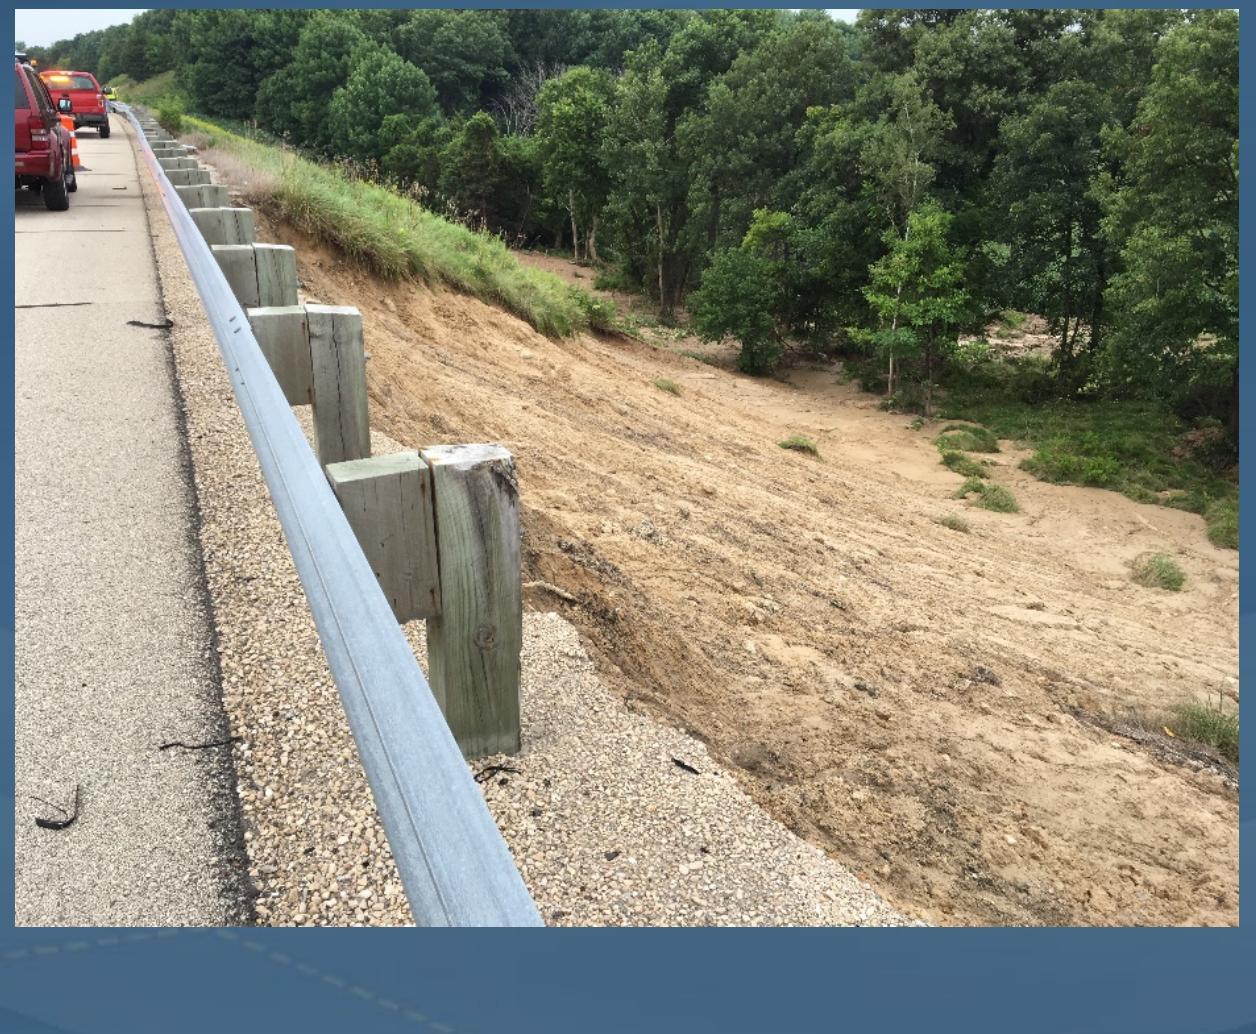
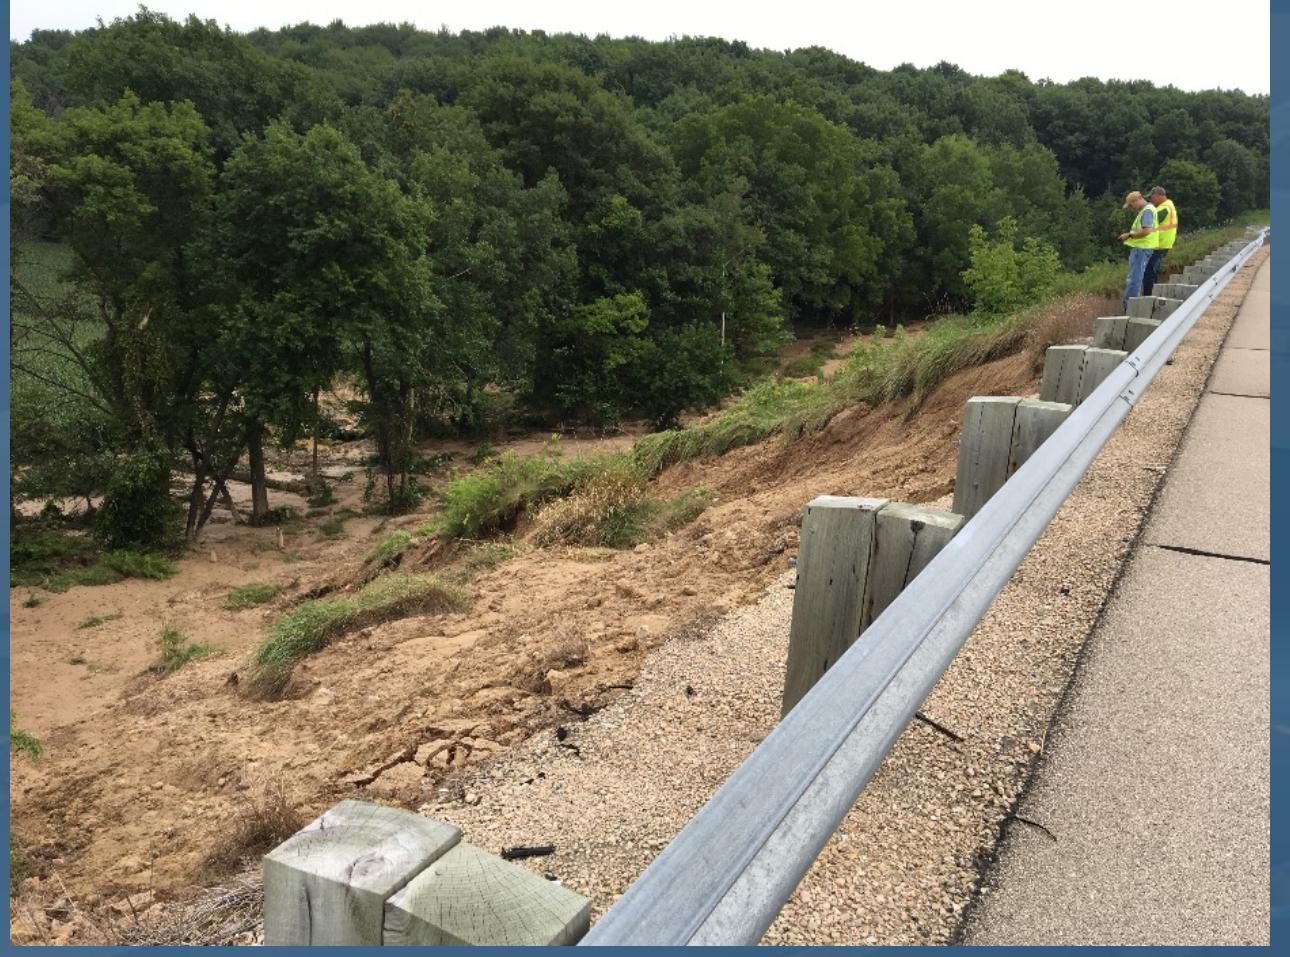
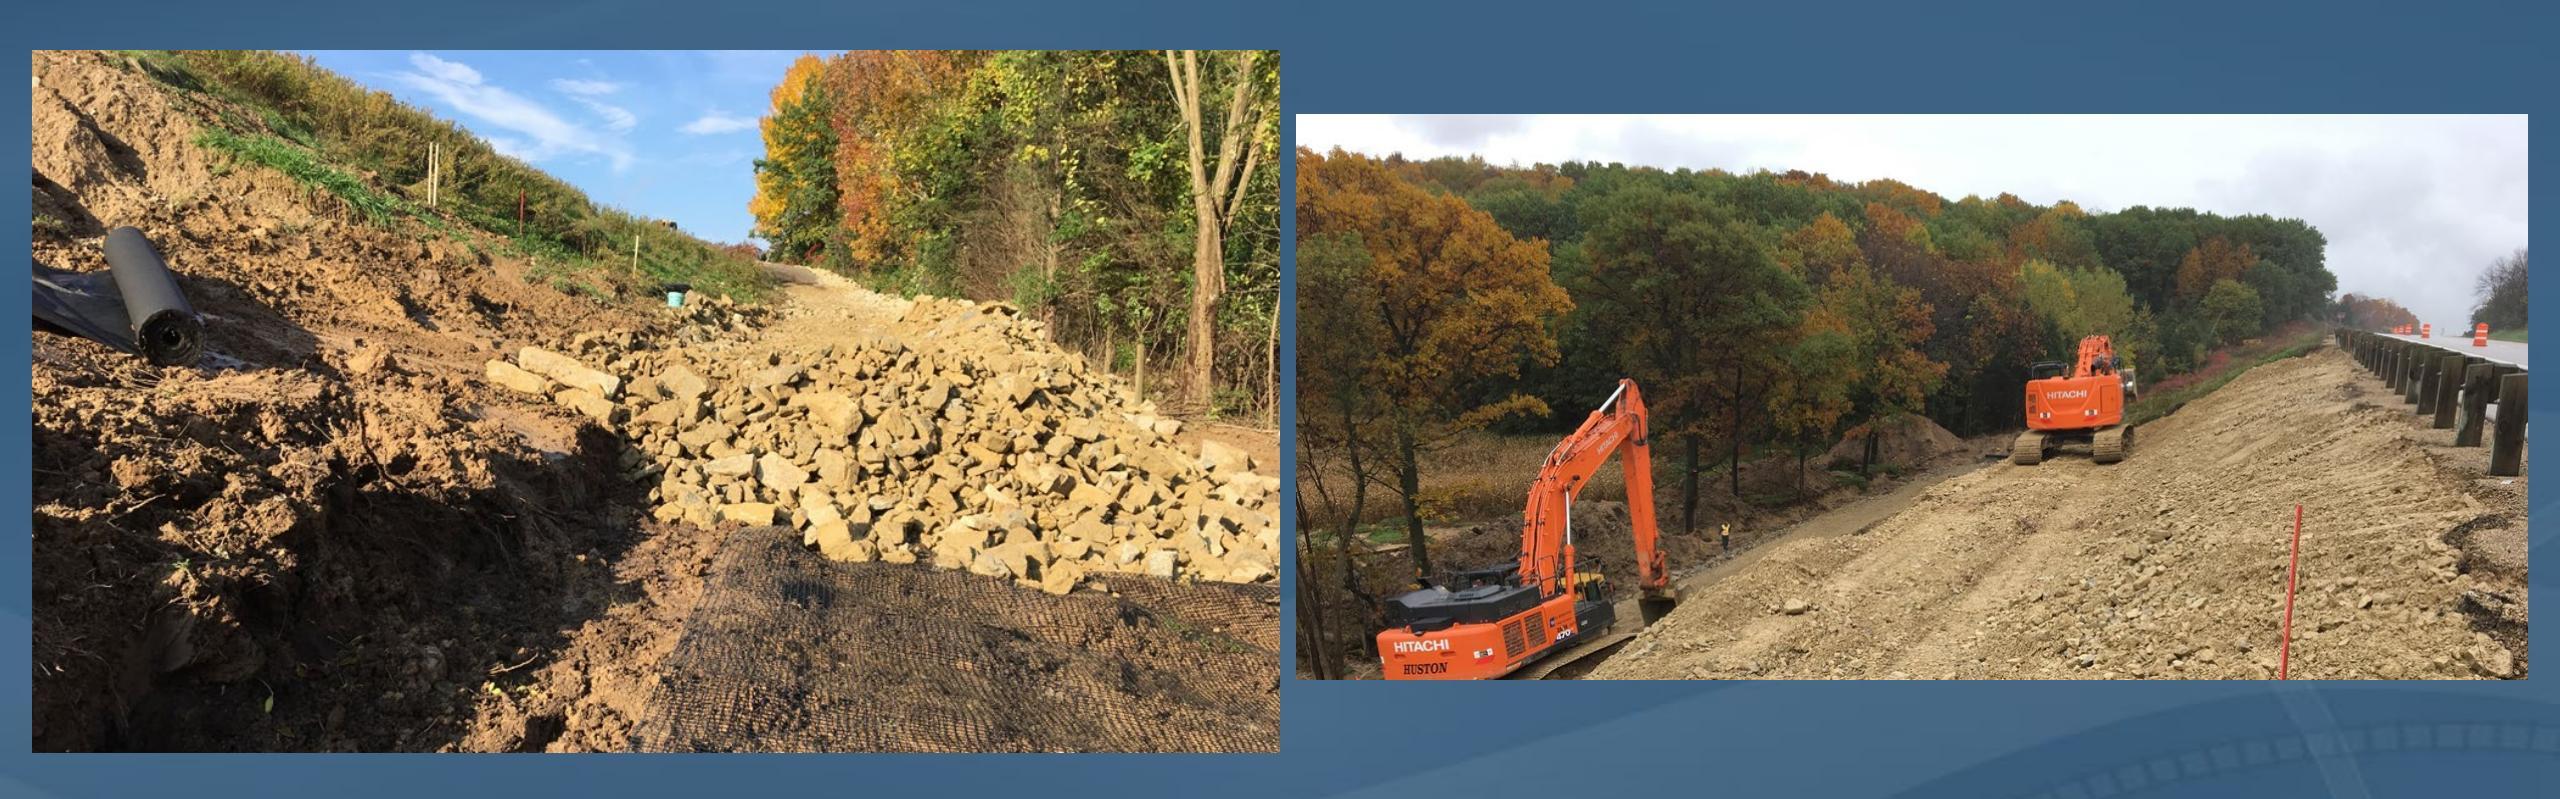
Project included 3 locations where saturated slopes failed following heavy rains August 17 (approximately 10" of rain recorded in the area)

The Fix: Remove all waste material, place a 5' layer of shot rock over geo-grid. Then fill slope with Select Crushed Material. Construction started October 8.

Estimated 2700 CY Ex Common / 1640 Tons Shot Rock / 10670 Tons Select Crushed
