Wisconsin Department of Transportation
Salt Shed Facilities Asset Management Condition Inspection Report

Region: North Central
County: Adams
Site ID: 4-01-7-1
Facility Type: Shed
Site Address: 3275 State Rd. 13, Springville
Date: March 28, 2016
Inspector: Phil Eagan

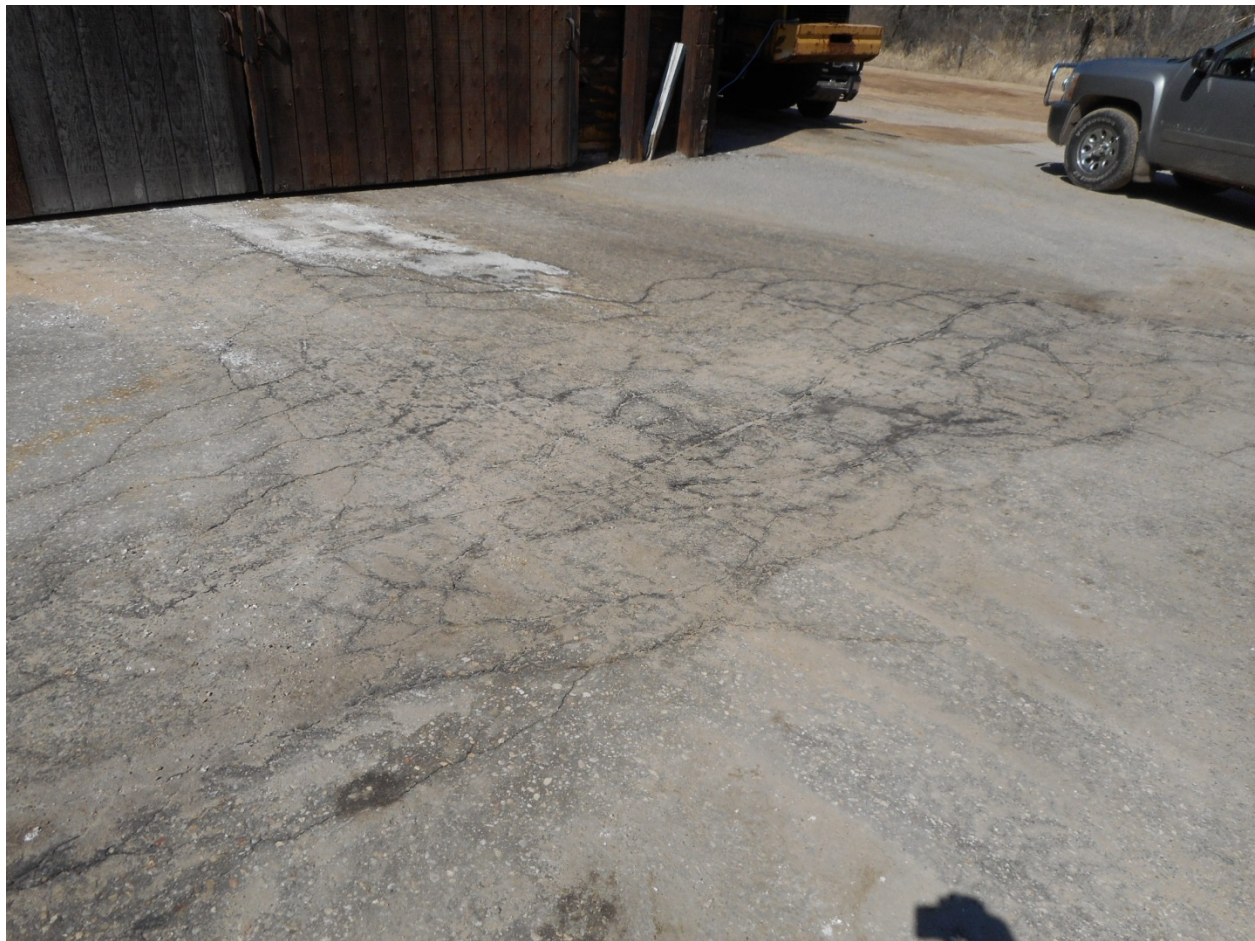
Asset	Comments	1 – Excellent	2 - Good	3 – Okay	4 – Poor	5 – Bad
Apron and Pad	Apron has approximately 50% alligator cracking.				X	
Ceiling and Roof	None		X			
Walls	None		X			
Doors	None		X
