Wisconsin Department of Transportation
Salt Shed Facilities Asset Management Condition Inspection Report

Region: Northwest
 County: Chippewa
 Site ID: 6-09-7-4
 Facility Type: Shed
 Site Address: 8837 200th Ave., Bloomer
 Date: February 8, 2016
 Inspector: Marcus Hopkins

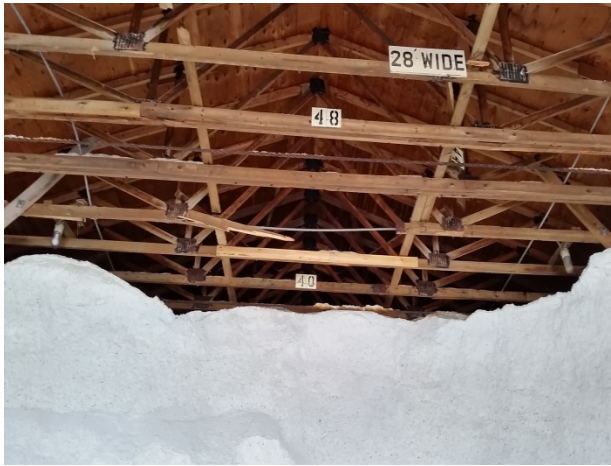
Asset	Comments	1 – Excellent	2 - Good	3 – Okay	4 – Poor	5 - Bad
Apron and Pad	Majority of pad was not visible.	X				
Ceiling and Roof	Damaged trusses throughout; all but one has been temporarily repaired.				X	
Walls	Walls are cracked along the east side of building. Pictures were taken of cracked east wall.				X	
Doors	None		X
