Wisconsin Department of Transportation
Salt Shed Facilities Asset Management Condition Inspection Report

Region: Northwest
County: Clark
Site ID: 6-10-1-1
Facility Type: Shed
Site Address: 3627 Fairgrounds Ave., Neillsville
Date: February 22, 2016
Inspector: Marcus Hopkins

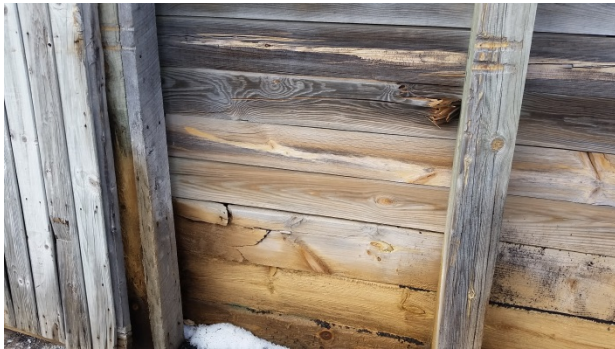
Asset	Comments	1 – Excellent	2 - Good	3 – Okay	4 – Poor	5 - Bad
Apron and Pad	None		X			
Ceiling and Roof	None		X			
Walls	Walls are bowed and there are several cracks. Salt is seeping through south wall.				X	
Doors	Large cracks in the doors.				X
