Wisconsin Department of Transportation
Salt Shed Facilities Asset Management Condition Inspection Report

Region: Northwest
County: Eau Claire
Site ID: 6-18-1-2
Facility Type: Shed
Site Address: 2000 Spooner Ave., Altoona
Date: February 23, 2016
Inspector: Marcus Hopkins

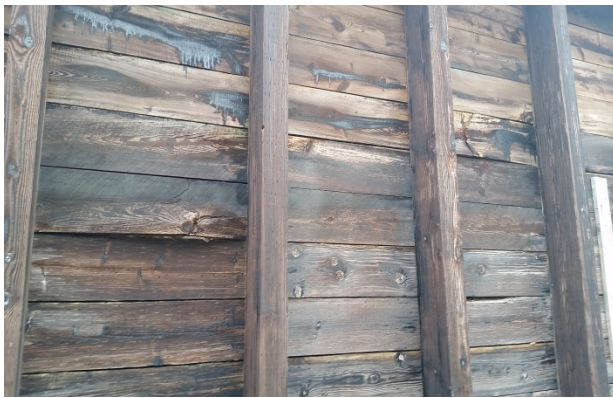
Asset	Comments	1 – Excellent	2 - Good	3 – Okay	4 – Poor	5 - Bad
Apron and Pad	None		X			
Ceiling and Roof	None		X			
Walls	Siding on walls has some cracks, west wall is bowed.			X		
Doors	Doors are chipped/cracked and very difficult to function.			X
