Wisconsin Department of Transportation
Salt Shed Facilities Asset Management Condition Inspection Report

Region: North Central
 County: Oneida
 Site ID: 7-43-1-2
 Facility Type: Shed
 Site Address: 730 W. Kemp St., Rhinelander
 Date: March 8, 2016
 Inspector: Todd Laska

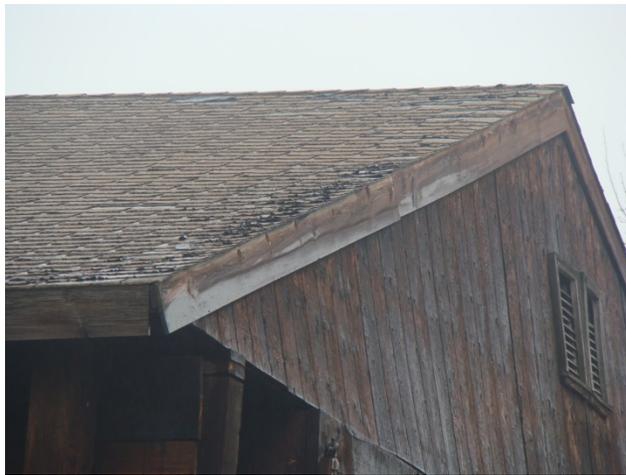
Asset	Comments	1 – Excellent	2 - Good	3 – Okay	4 – Poor	5 - Bad
Apron and Pad	None		X			
Ceiling and Roof	Many weathered and missing shingles.				X	
Walls	Back wall is bowed out; one side is detached from truss. One side previously repaired.				X	
Doors	None		X
