# **Hazardous Materials/Waste**

## **Initial Site Reconnaissance**

Project ID: **3360-16-60**

**STH 175**

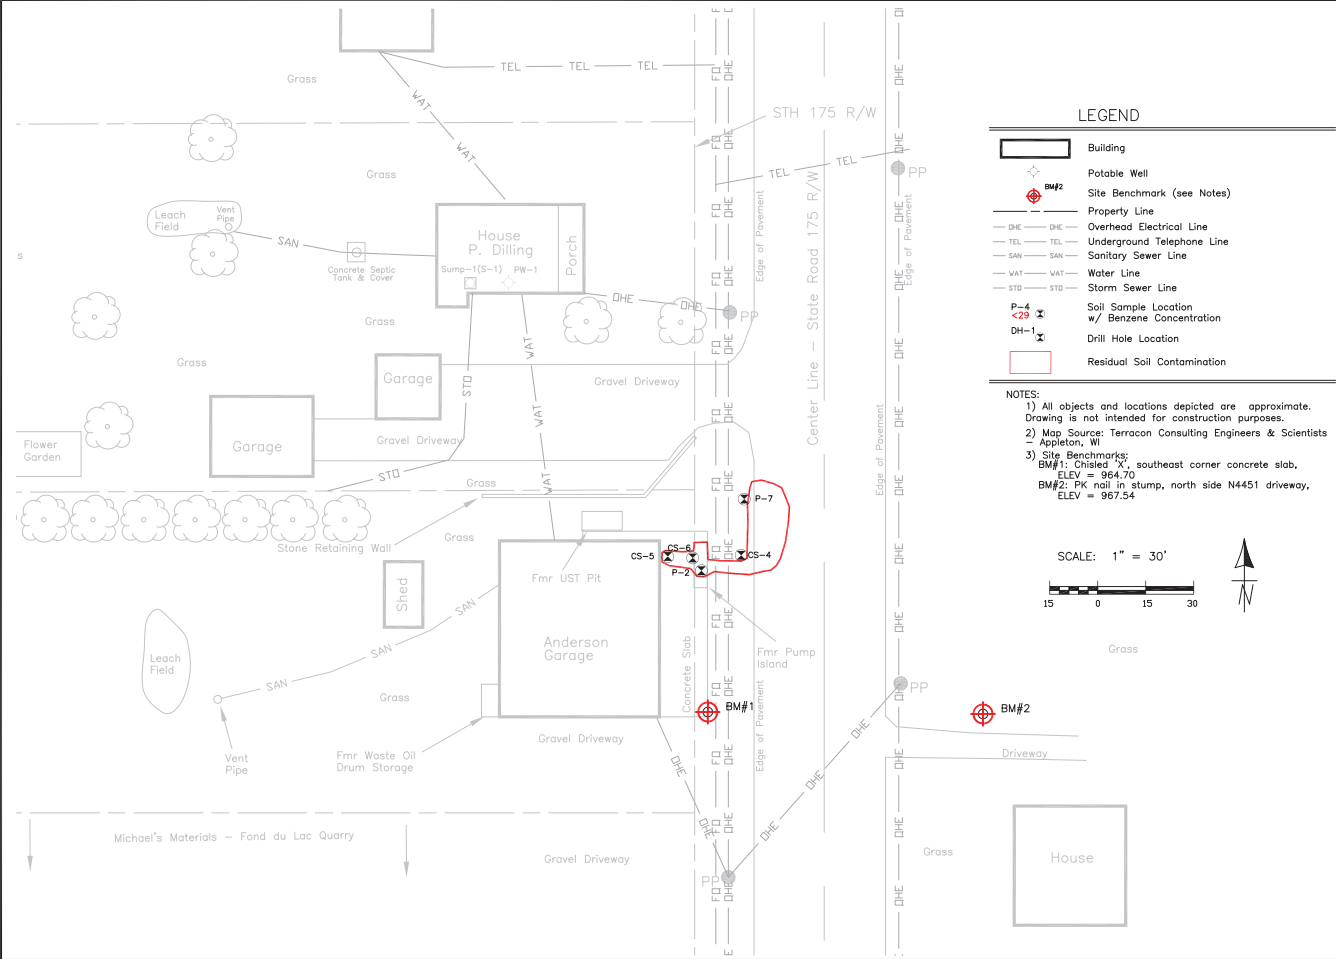
564-01 FIGURE B.2.c.	Pre/Post-Remedial Soil Contamination Anderson Garage Fond du Lac, Wisconsin	ENGEL & ASSOCIATES, INC. N4737 Highway 175 S Fond du Lac, WI 54937 Ph: 920-929-9279 Fax: 920-929-8754	FILE REFERENCE: anderson_garage_plot2-Closure
			REVISED: July 2013 Created: May 2013
