# COLEMAN ENGINEERING COMPANY

14 91 - 21 - 00

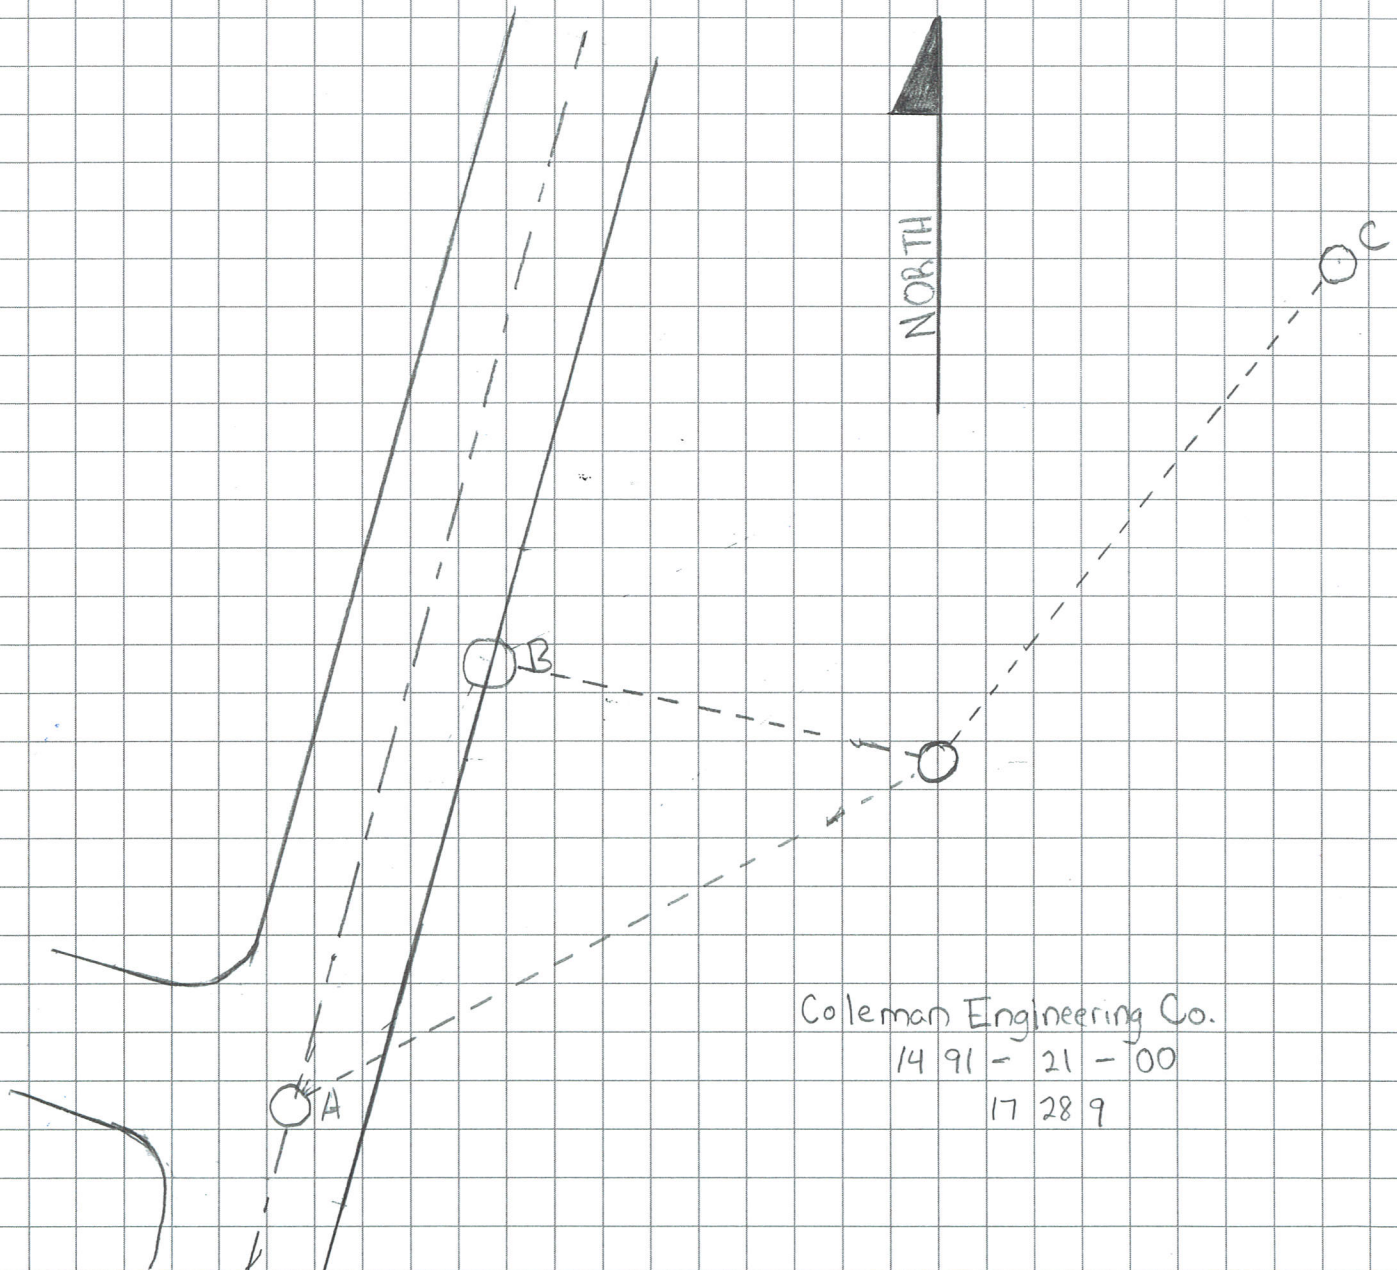
B M 1000

B.B. spike in west side of  
poplar tree

A) 490' N of Dill Rd

B) 74' S 76° E of edge of  
asphalt of US 141

C) 111' S 43° W of PP # 3720 - 26E3

North : 350250

East : 718520

Elev : 980.47

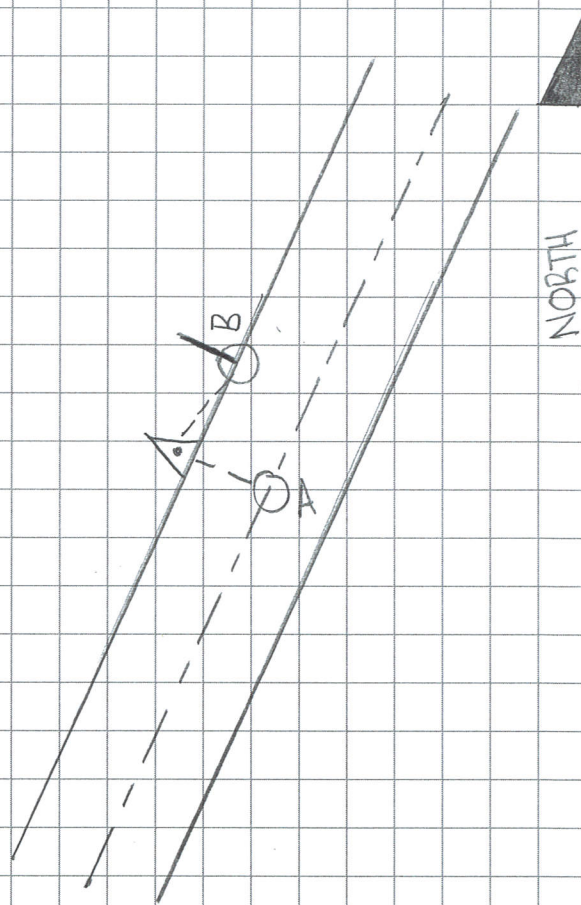
| B M | 10 01 |

Existing WDOT 3½" disk in  
the NW corner of NW abutment  
wall of bridge

| B M | 10 01 |
|---|---|
| North | : 34 91 54 |
| East | : 71 81 39 |
| Elev | : 96 4.80 |

A) 23.2' East to C US 141

B) 16.3' S 10° W of East post of  
Pamebonwon sign

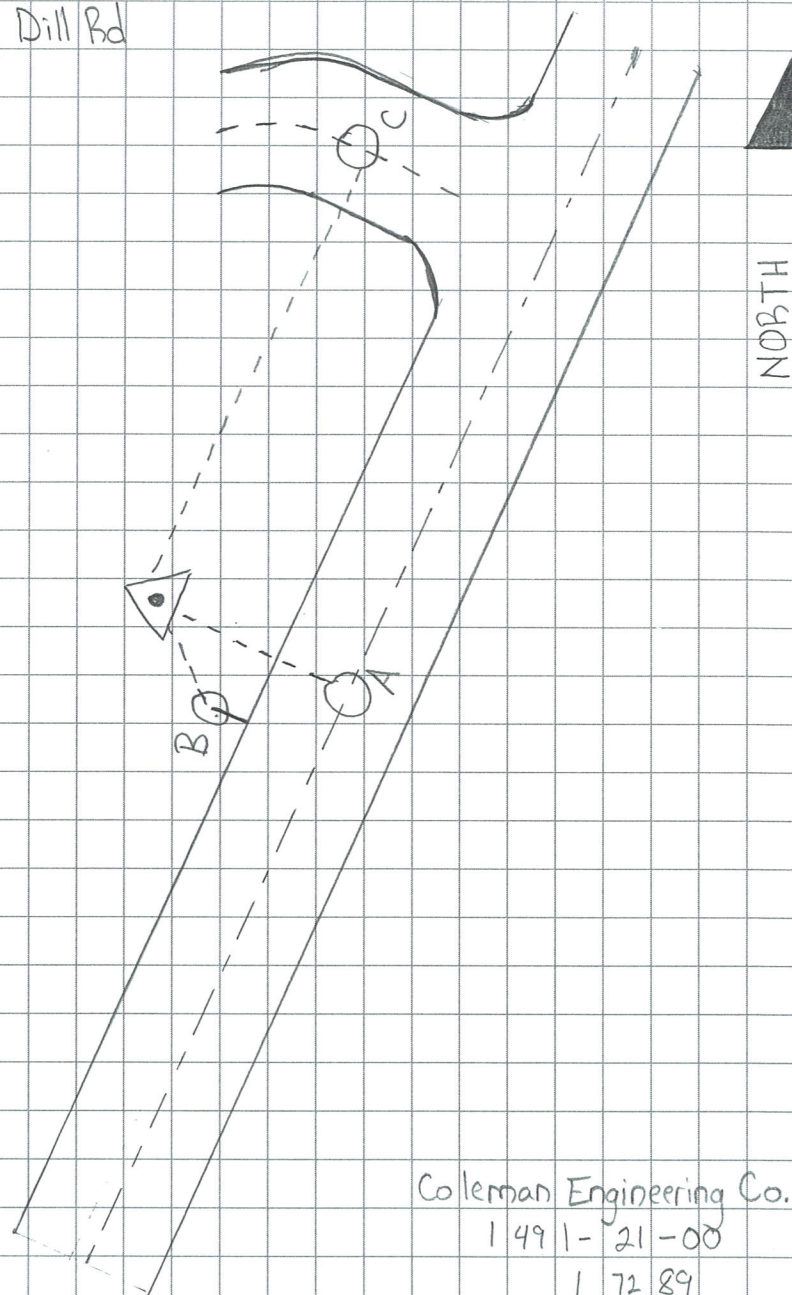
| BM | 10 | 02 |

Chiseled "X" in SW rim of  
a cleanout storm manhole

A) 41.7' East to  $\phi$  US 141

B) 10' N  $66^{\circ}$ W from West post  
of Pambonwon sign

C) 650' South of  $\phi$  Dill Rd

| BM | 10 | 02 |
|---|---|---|
| North | : 34 | 91 77 |
| East | : 71 | 81 25 |
| Elev | : 95 | 8.94 |

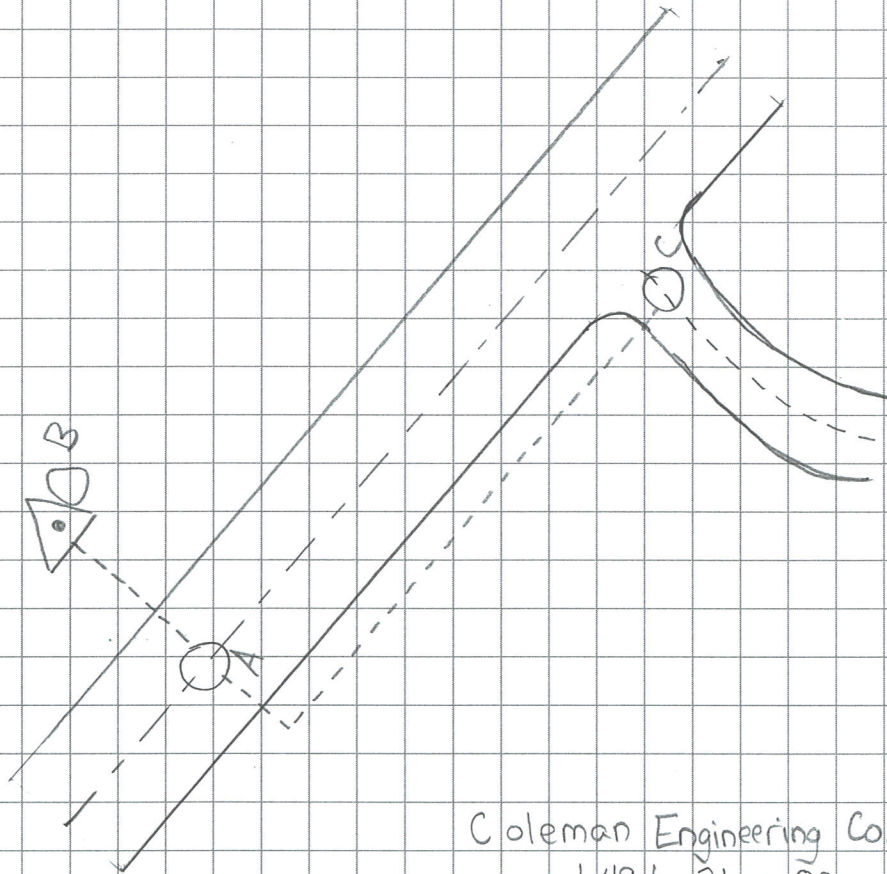
B M 10 03

R.R. spike in P.P. #37-20-26BS  
set on NE side of P.P.

A) 69' NW of  $\angle$  US141

North : 34 83 87

East : 71 78 63

Elev : 97 6.84

B) 3.5' South of E-Ped

C) 65' to FN 19126 SE  
of  $\angle$  CP901
