## MEMORANDUM

**Subject:** Encroachment Report for:

Project I.D. 6918-01-02  
City of Portage, Wisconsin & Dewitt Street  
(Ontario Street - East Pleasant Street)  
USH 51  
Columbia County

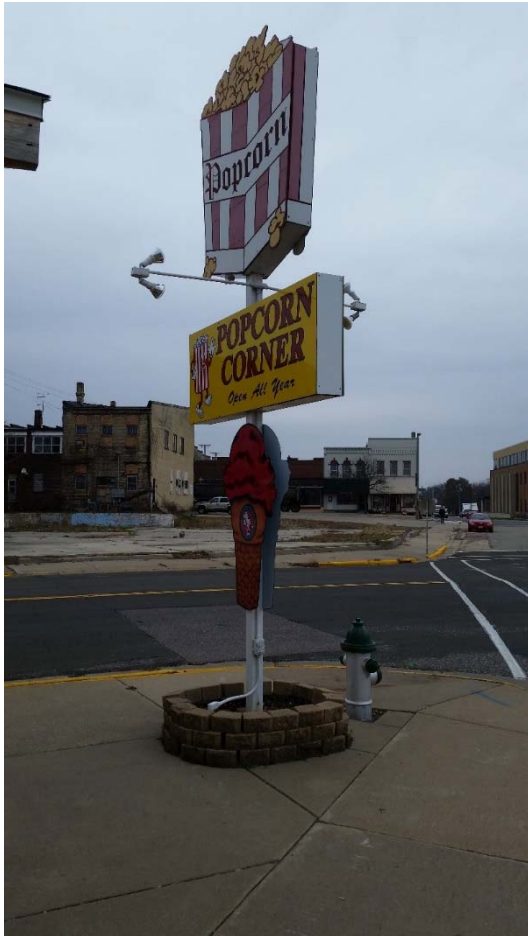
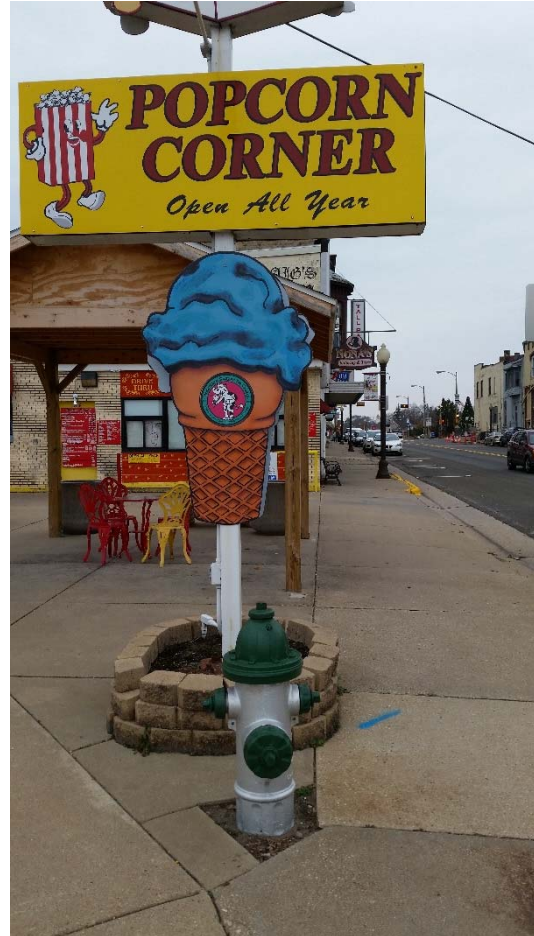
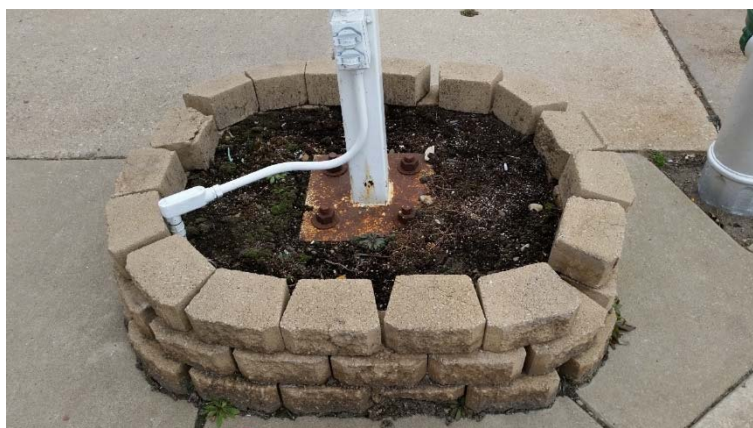
## SITE #1

**Location:** STA 100+47 RT

**Encroachment Type:** Sign and block wall

**Horizontal Encroachment into Existing R/W:** 2 ft (sign), 1.5 ft (blocks)

**Vertical Height above Surface:** 10 ft (sign) 0 - 2 ft (blocks)

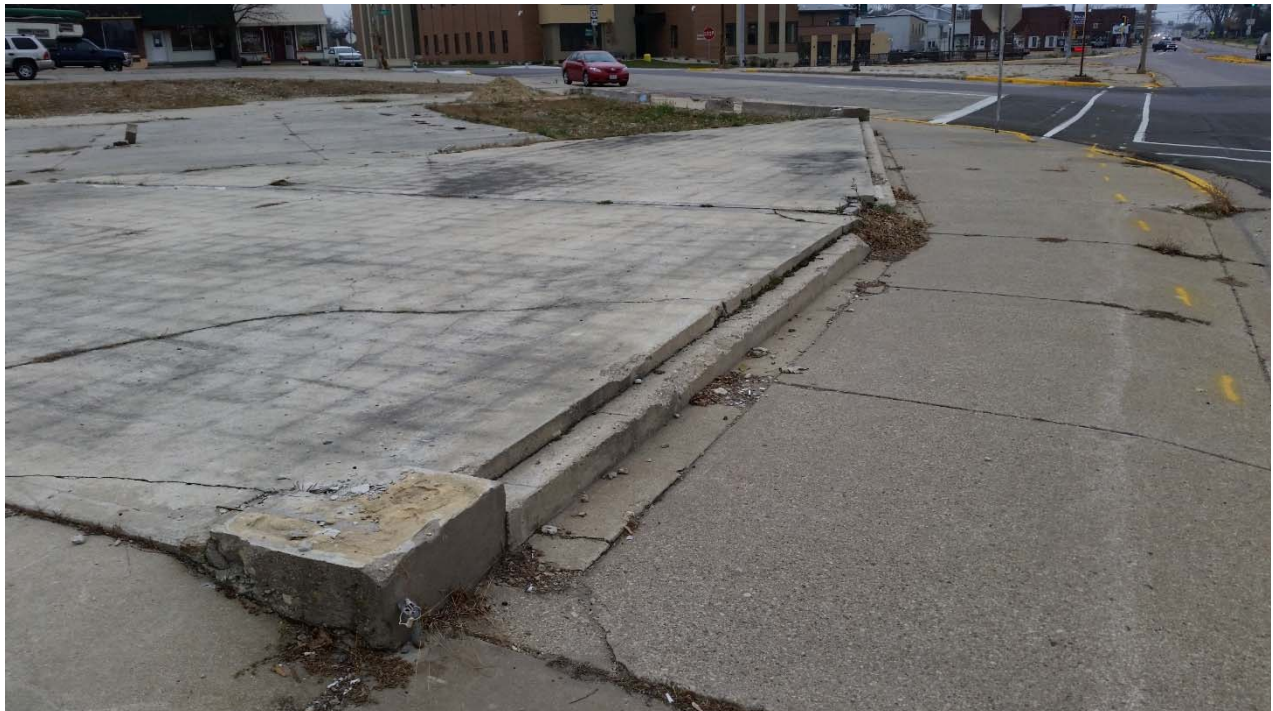
**Encroachment Type:** Concrete building foundation/ Retaining wall

**Vertical Height above Surface:** 0 -2 ft

**Accident Record:** None

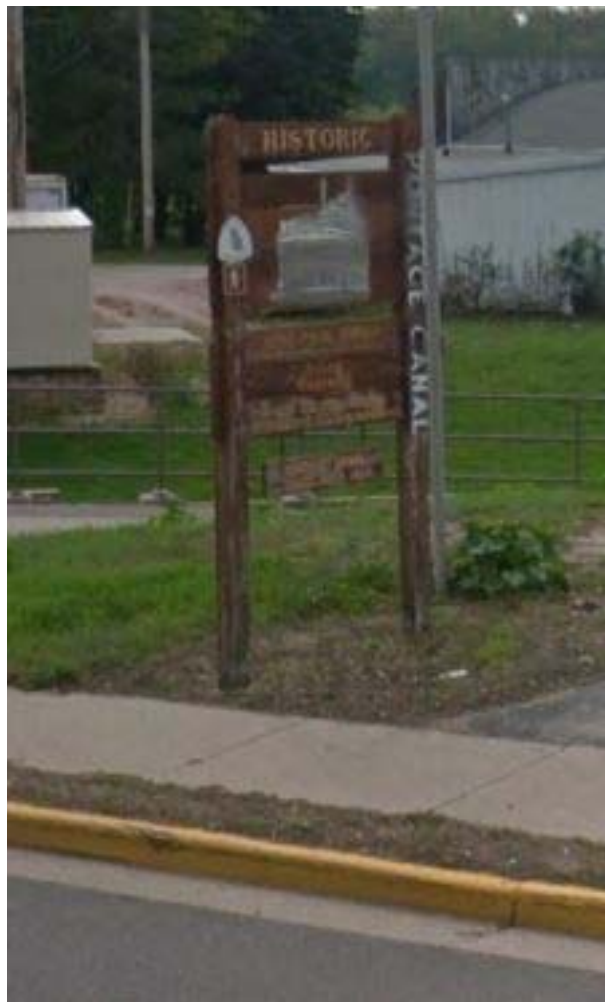
## SITE #3

Location: STA 102+11 RT

Encroachment Type: Sign

Horizontal Encroachment into Existing R/W: 0.5 ft

Vertical Height above Surface: 0 - 5 ft

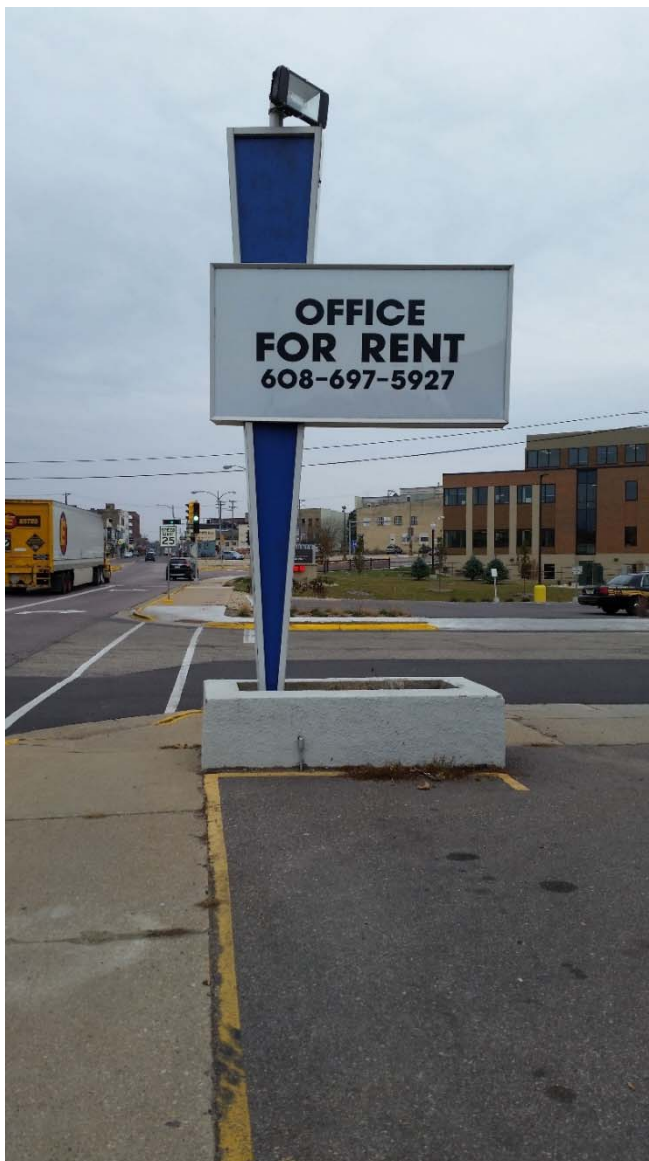
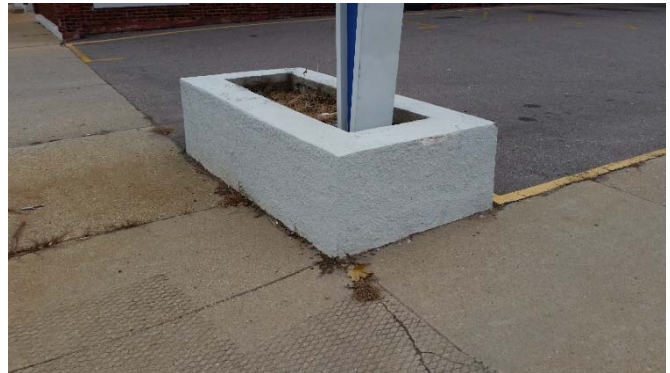
## SITE #4A

**Location:** STA 107+15 LT

**Encroachment Type:** Sign and base wall

**Horizontal Encroachment into Existing R/W:** 0.9 ft

**Vertical Height above Surface:** 0 - 2 ft (Wall), 2 - 15 ft (Sign)

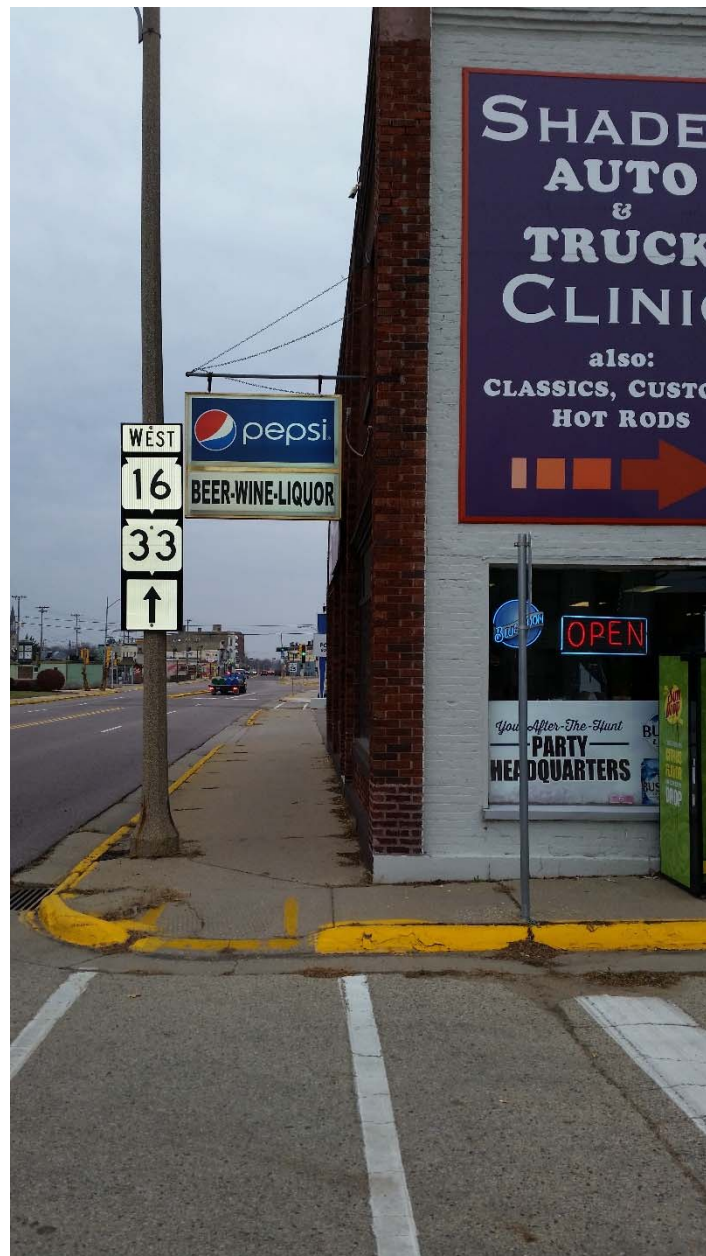
Vertical Height above Surface: 10 ft

Accident Record: None

| Encroachment Site No. | Station | Encroachment Description | Existing R/W Width from R/L | Encroachment Distance | Owner/ Address | Proposed Action | Construction Conflict |
|---|---|---|---|---|---|---|---|
| 3 | 102+11 RT | Sign | 35' | 0.5' | City of Portage<br>(Mailing) 115 W. Pleasant St.<br>Portage, WI 53901 | Removal<br>by Owner | Yes, within<br>slope intercept |

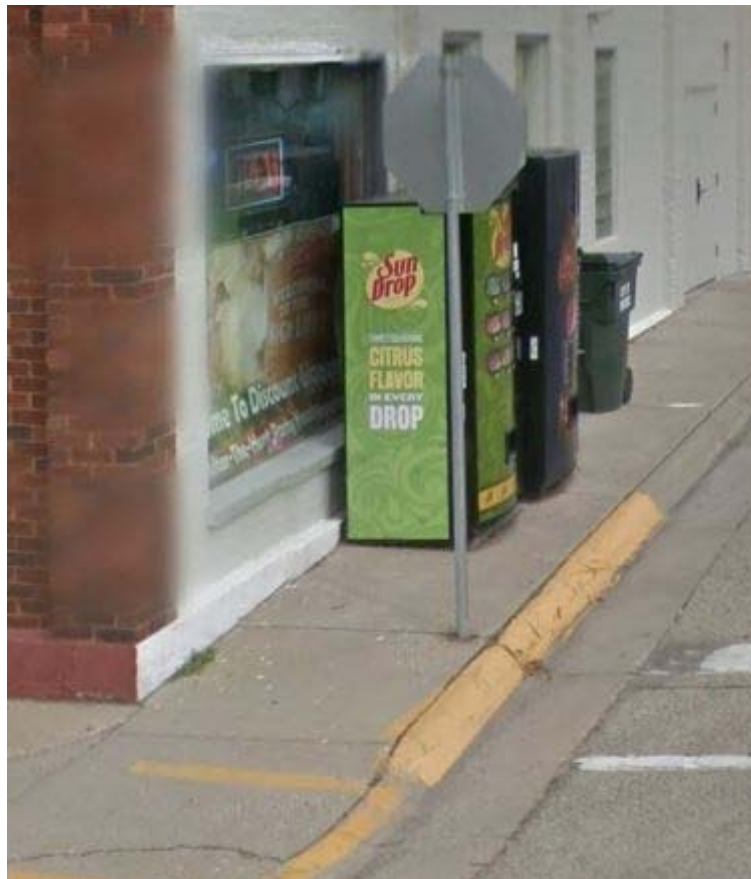
## SITE #4C

**Location:** STA 108+72 LT

**Encroachment Type:** Soda machines

**Horizontal Encroachment into Existing R/W:** 3 ft

**Vertical Height above Surface:** 0 -7 ft

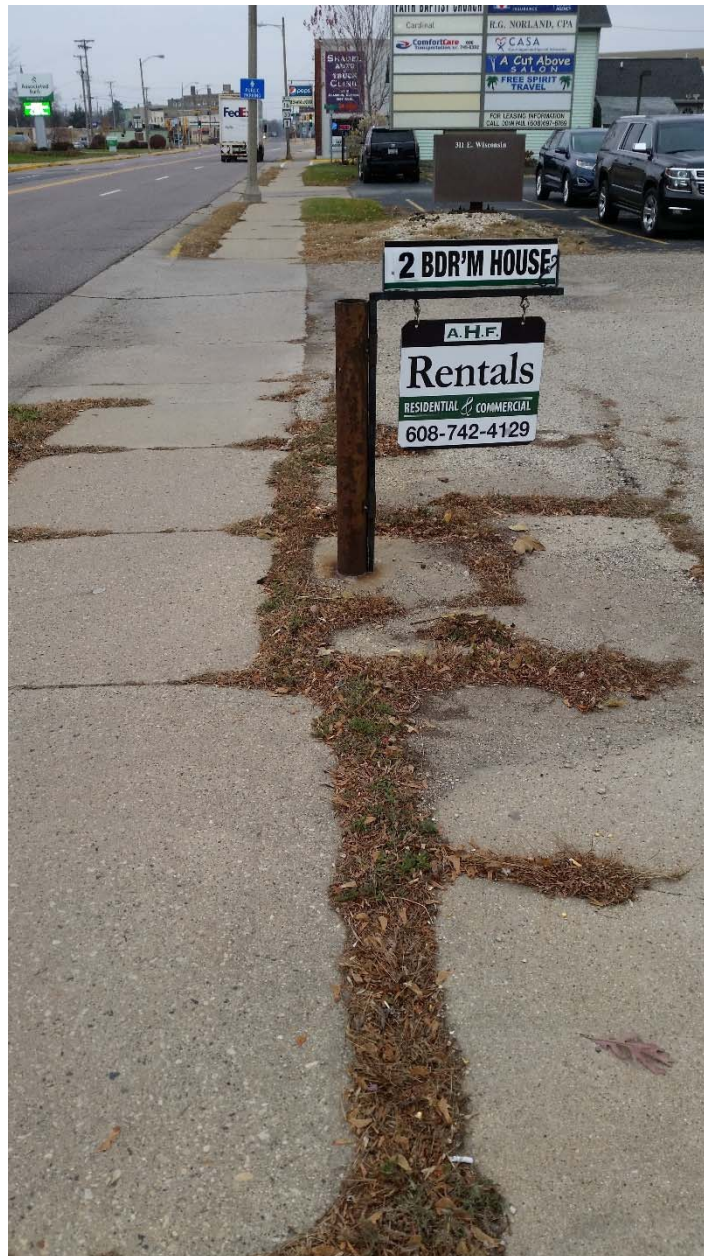
**Vertical Height above Surface:** 0 - 4 ft

**Accident Record:** None

| Encroachment Site No. | Station | Encroachment Description | Existing R/W Width from R/L | Encroachment Distance | Owner/ Address | Proposed Action | Construction Conflict |
|---|---|---|---|---|---|---|---|
| 4C | 108+72 LT | Soda Machines | 32'<br>(Dodge St.) | 3'<br>(Dodge St.) | Christopher D Shadel<br>107 Dodge St.<br>Portage, WI 53901 | Removal<br>by Owner | Yes, within<br>slope intercept |

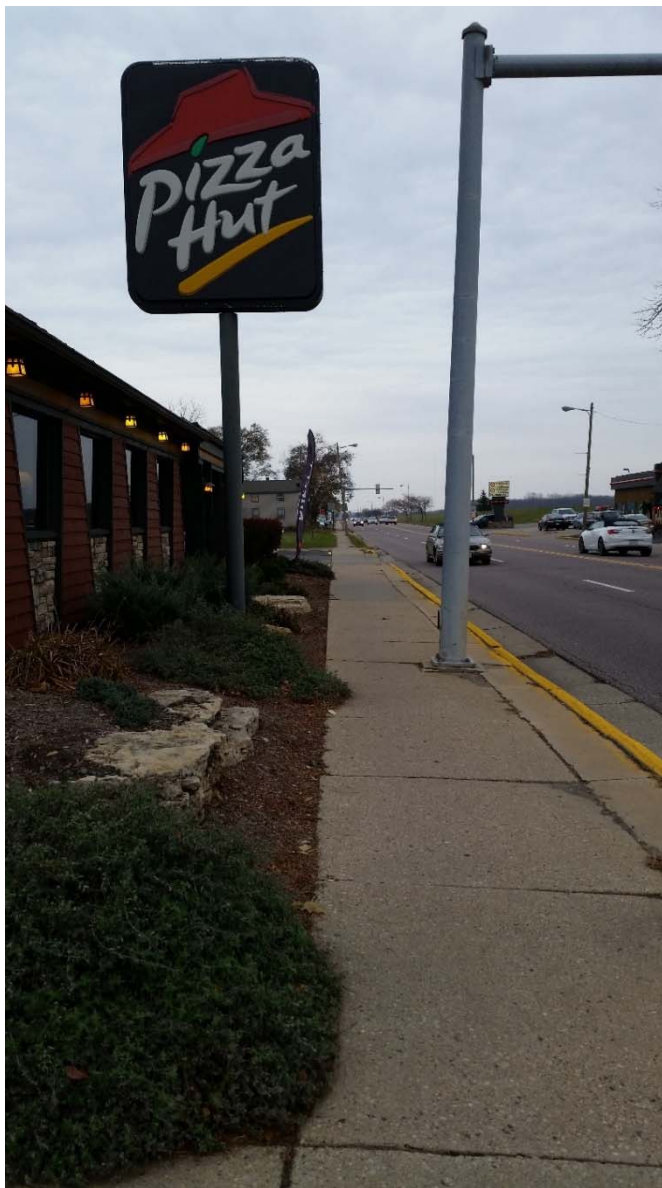
## SITE #6A

**Location:** STA 113+56 LT

**Encroachment Type:** Sign overhang

**Horizontal Encroachment into Existing R/W:** 2 ft

**Vertical Height above Surface:** 10 ft

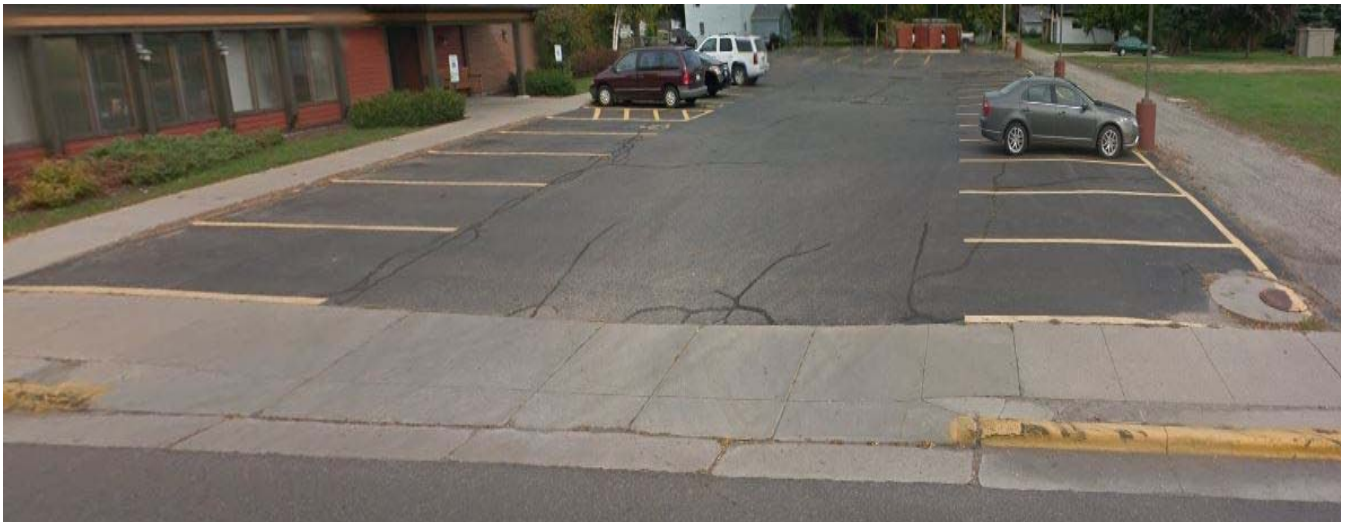
## SITE #6B

**Location:** STA 113+56 LT

**Encroachment Type:** Parking lot

**Horizontal Encroachment into Existing R/W:** 1.25 to 6.7 ft

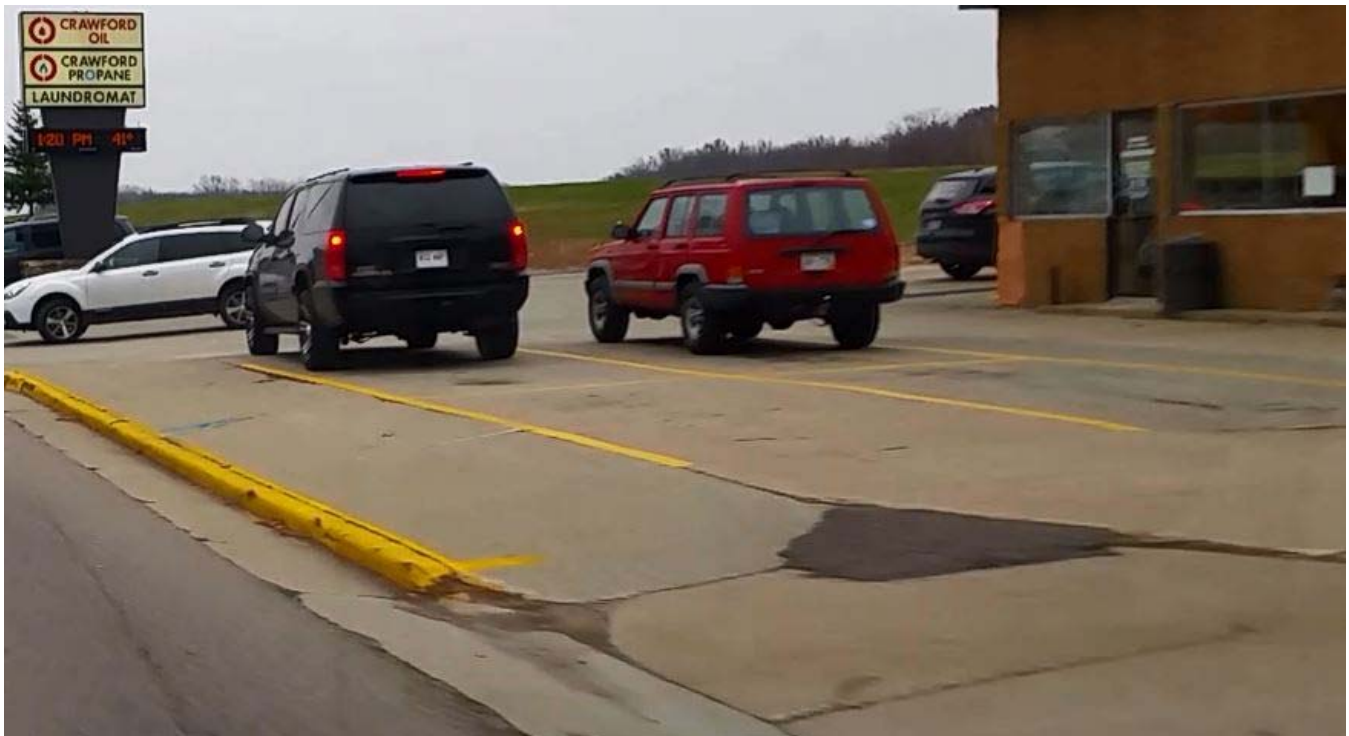
Vertical Height above Surface: N/A

Accident Record: None

| Encroachment Site No. | Station | Encroachment Description | Existing R/W Width from R/L | Encroachment Distance | Owner/ Address | Proposed Action | Construction Conflict |
|---|---|---|---|---|---|---|---|
| 6A | 113+56 LT | Sign | 35' | 2' | 401 East Wisconsin Street Portage WI LLC<br>(Physical) 401 E. Wisconsin St<br>Portage, WI 53901<br>(Mailing) 434 S. Yellowstone Dr.<br>Madison, WI 53719 | To Remain | None |

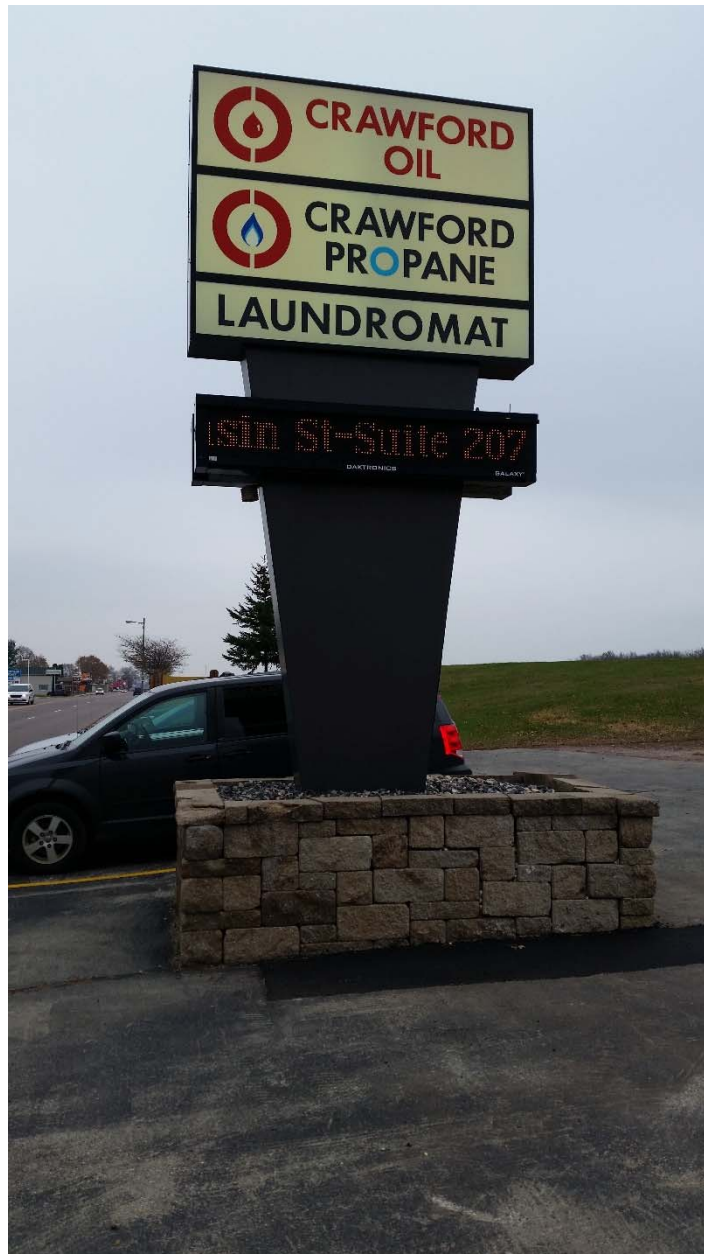
## SITE #7B

Location: STA 117+13 RT

Vertical Height above Surface: 2.5 ft (Planter) 8 – 15 ft (Sign)

Accident Record: None

| Encroachment Site No. | Station | Encroachment Description | Existing R/W Width from R/L | Encroachment Distance | Owner/ Address | Proposed Action | Construction Conflict |
|---|---|---|---|---|---|---|---|
| 7B | 117+13 RT | Sign and Planter | 31' | 1.6' | JHK Inc<br>(Physical) 516 E. Wisconsin St<br>Portage, WI 53901<br>(Mailing) PO Box 115<br>Portage, WI 53901 | To Remain | None, but within slope intercept |

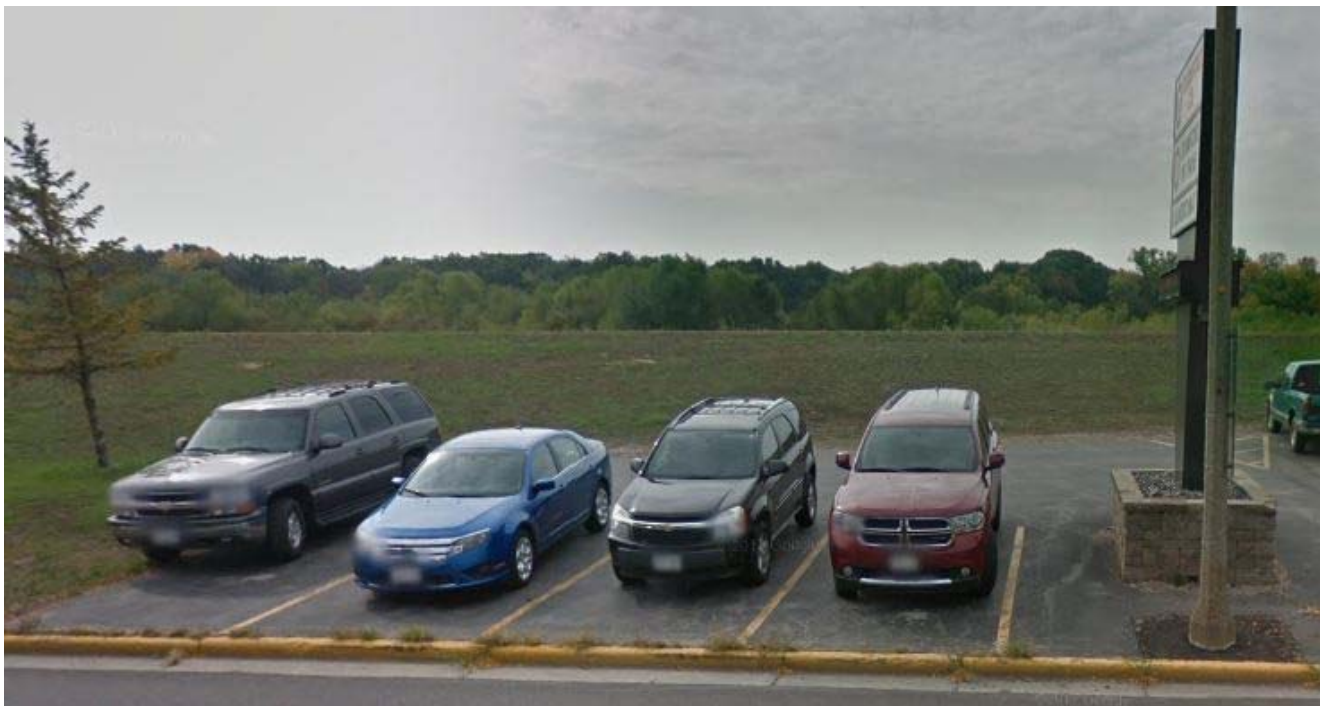
## SITE #7C

**Location:** STA 117+40 RT

**Vertical Height above Surface:** N/A

**Accident Record:** None

| Encroachment Site No. | Station | Encroachment Description | Existing R/W Width from R/L | Encroachment Distance | Owner/ Address | Proposed Action | Construction Conflict |
|---|---|---|---|---|---|---|---|
| 7C | 117+40 RT | Parking Lot | 31' | 9.5' | JHK Inc<br>(Physical) 516 E. Wisconsin St<br>Portage, WI 53901<br>(Mailing) PO Box 115<br>Portage, WI 53901 | Removal by Project | Yes, within slope intercept |

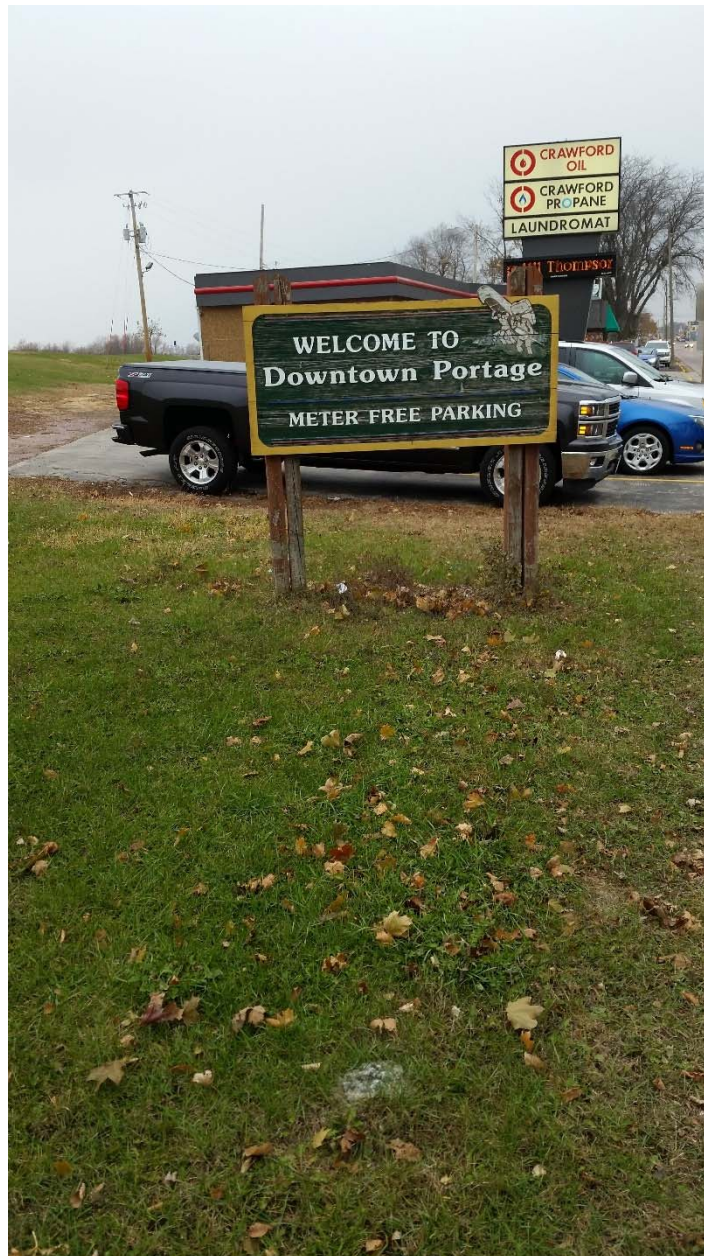
## SITE #8

Location: STA 117+75 RT

Vertical Height above Surface: 0 - 6 ft

Accident Record: None

| Encroachment Site No. | Station | Encroachment Description | Existing R/W Width from R/L | Encroachment Distance | Owner/ Address | Proposed Action | Construction Conflict |
|---|---|---|---|---|---|---|---|
| 8 | 117+75 RT | Sign | 31' | 2.5' | City of Portage<br>115 W. Pleasant St.<br>Portage, WI 53901 | Removal by Owner | Yes, within slope intercept |

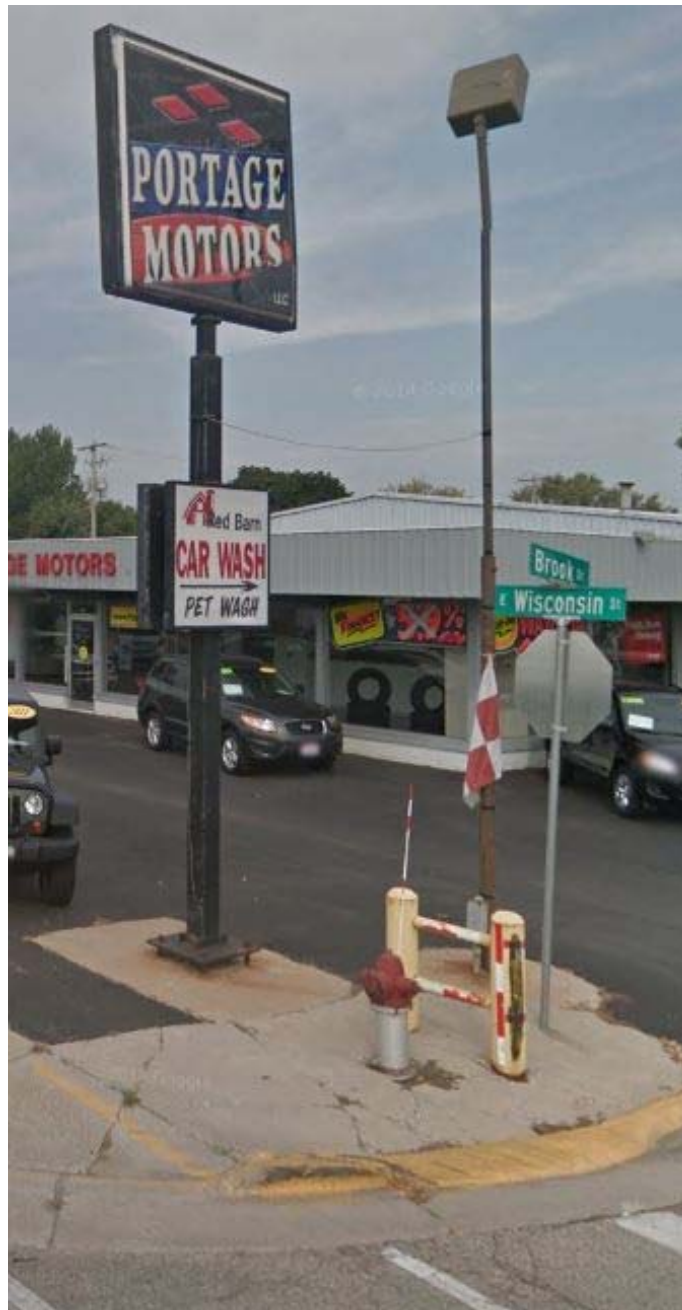
## SITE #9

Location: STA 120+50 LT

Vertical Height above Surface: 10 ft

Accident Record: None

| Encroachment Site No. | Station | Encroachment Description | Existing R/W Width from R/L | Encroachment Distance | Owner/ Address | Proposed Action | Construction Conflict |
|---|---|---|---|---|---|---|---|
| 9 | 120+50 LT | Sign & Light Pole | 35' USH 51<br>31.5' Brooks St. | 6' Brooks | Joseph S Janas<br>515 E. Wisconsin St<br>Portage, WI 53901 | To Remain | None |

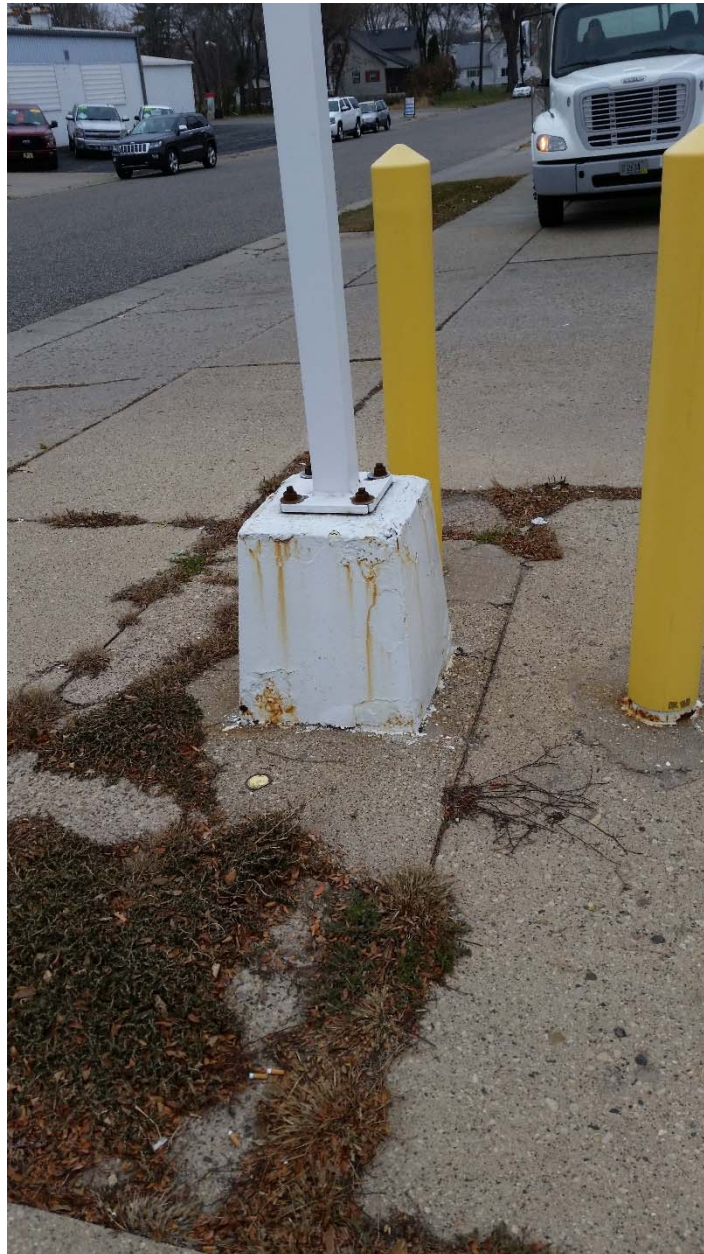
## SITE #10

Location: STA 121+08 LT

Vertical Height above Surface: N/A

Accident Record: None

| Encroachment Site No. | Station | Encroachment Description | Existing R/W Width from R/L | Encroachment Distance | Owner/ Address | Proposed Action | Construction Conflict |
|---|---|---|---|---|---|---|---|
| 10 | 121+08 LT | Light Pole & Bollard | 35' USH 51<br>34.5' Brooks St. | ½ Light Base Width | Liberty Kwik Stop, LLC<br>(Physical) 601 E. Wisconsin St<br>Portage, WI 53901<br>(Mailing) 3050 Saddle Brook Trail<br>Sun Prairie, WI 53590 | To Remain | None |

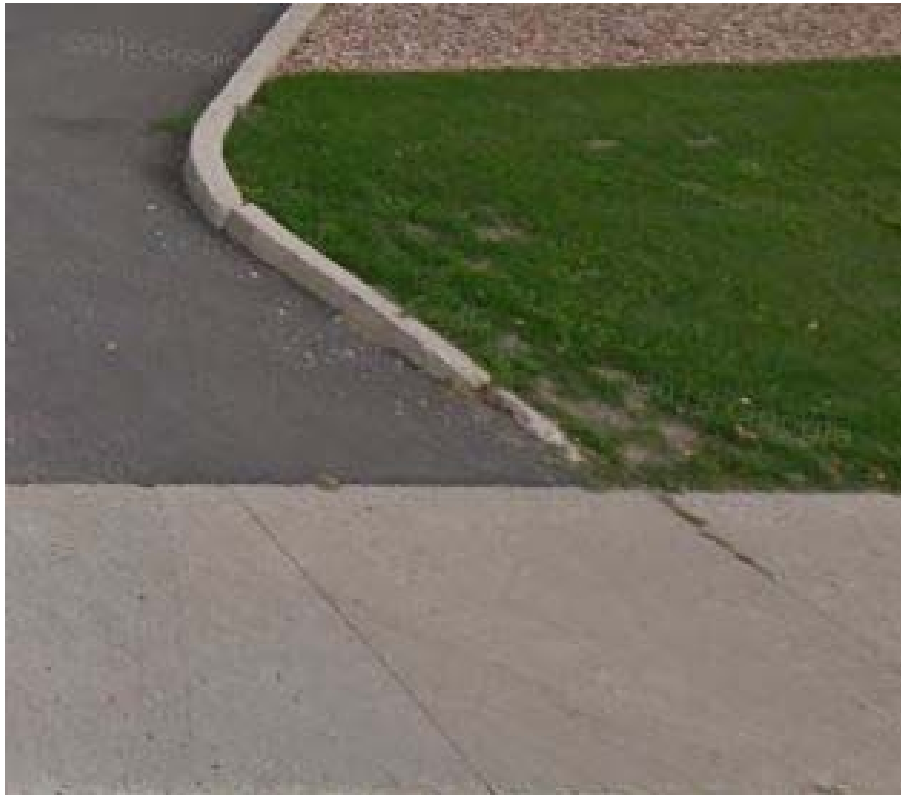
## SITE #11A

**Location:** STA 122+83 LT

**Encroachment Type:** Concrete curb

**Horizontal Encroachment into Existing R/W:** 1 – 2.5 ft

**Vertical Height above Surface:** 0.5 ft

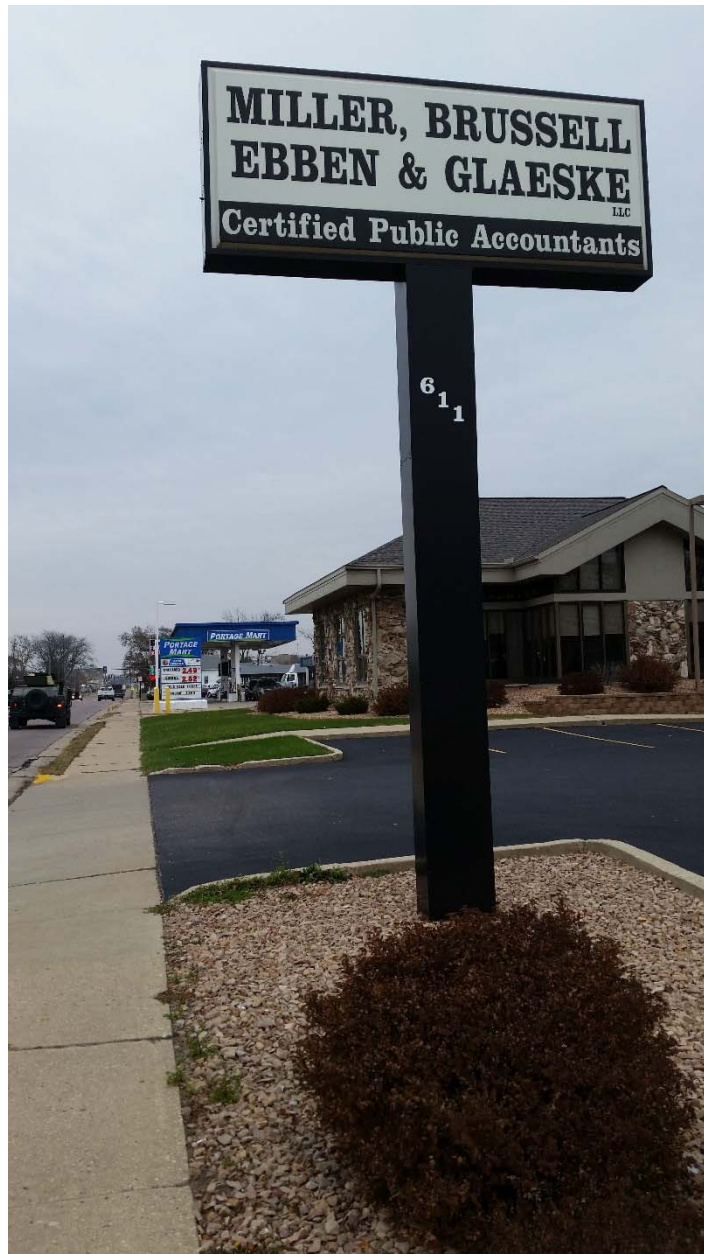
**Vertical Height above Surface:** 15 - 20 ft (Sign)

**Accident Record:** None

| Encroachment Site No. | Station | Encroachment Description | Existing R/W Width from R/L | Encroachment Distance | Owner/ Address | Proposed Action | Construction Conflict |
|---|---|---|---|---|---|---|---|
| 11A | 122+83 LT | Concrete Curb | 25' Alley | 2.5' Alley | Miller, Brussell, Ebben & Glaeske LLC<br>611 E. Wisconsin St<br>Portage, WI 53901 | Removal by Project | Yes, within slope intercept |

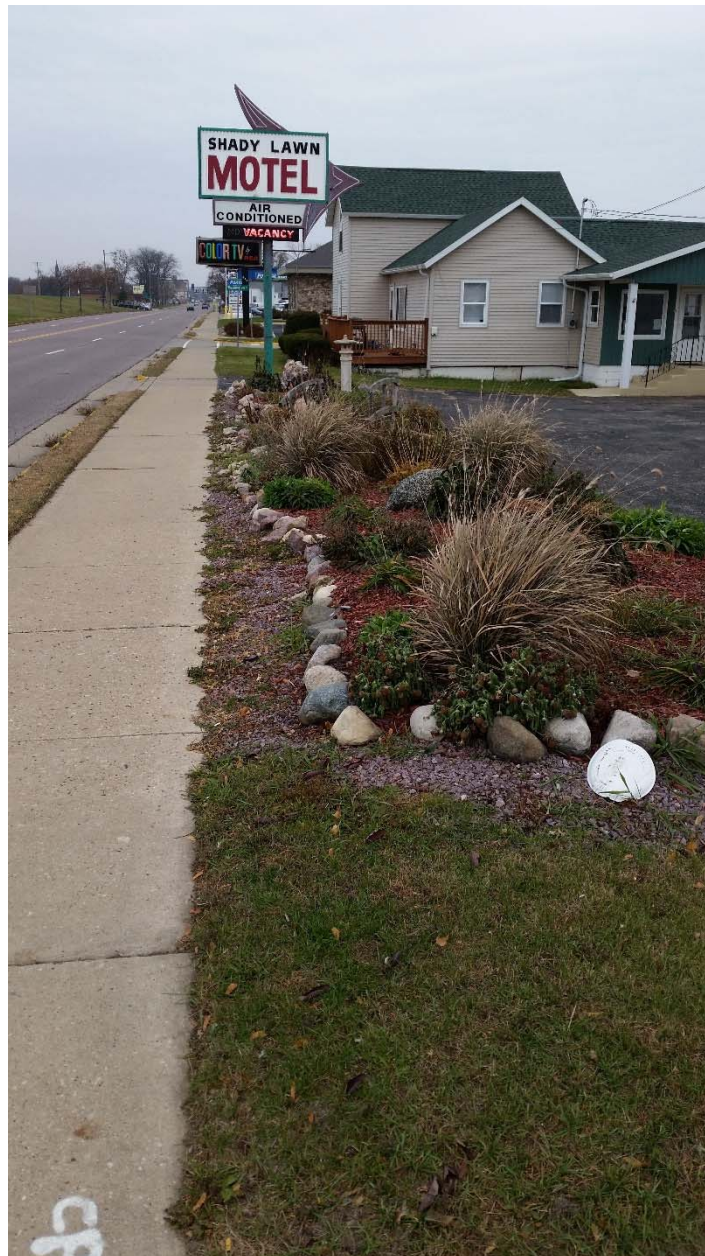
## SITE #12

**Location:** STA 125+87 LT

**Vertical Height above Surface:** 7 – 10 ft

**Accident Record:** None

| Encroachment Site No. | Station | Encroachment Description | Existing R/W Width from R/L | Encroachment Distance | Owner/ Address | Proposed Action | Construction Conflict |
|---|---|---|---|---|---|---|---|
| 12 | 125+87 LT | Sign | 35' | 2.25' Overhang of sign | Shady Lawn Motel of Portage, LLC<br>(Physical) 703 E. Wisconsin St<br>Portage, WI 53901<br>(Mailing) 619 W. Decker St.<br>Viroqua, WI 54665 | To Remain | None, but within slope intercept |

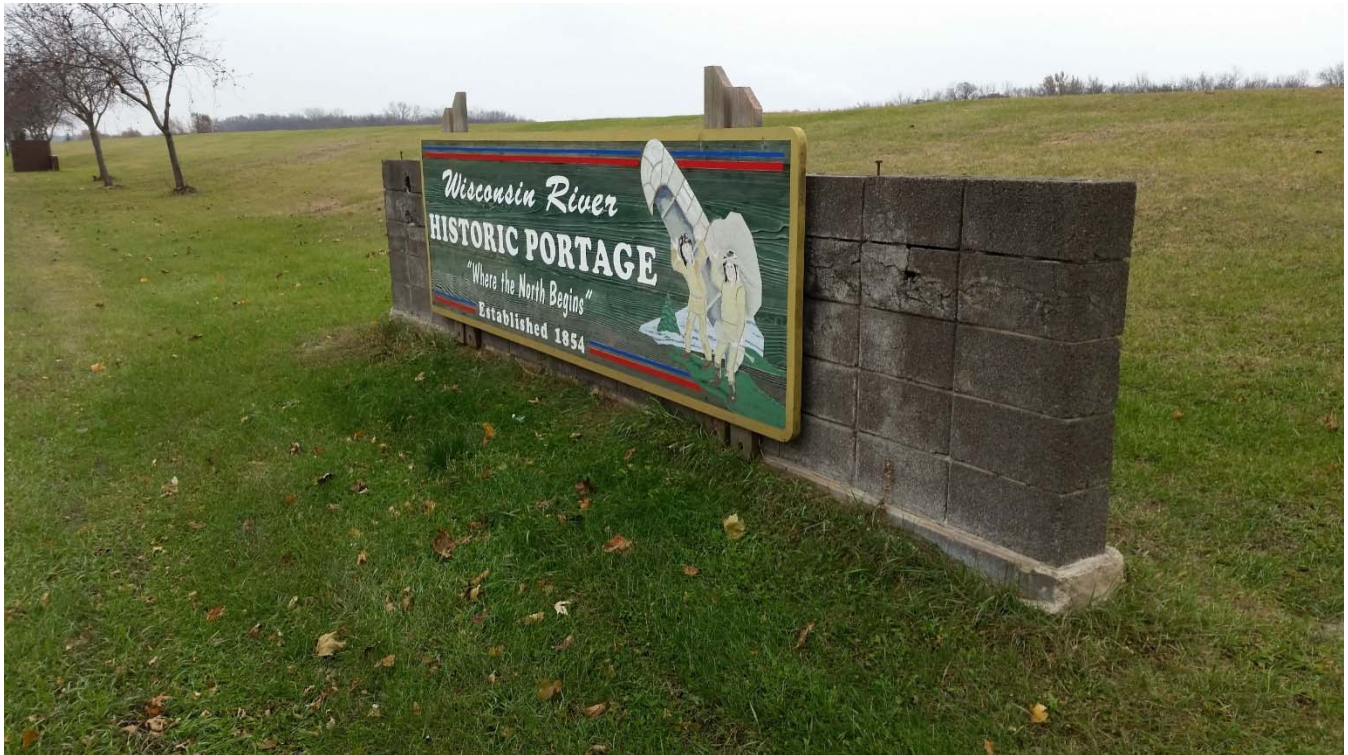
## SITE #13

**Location:** STA 126+65 RT

**Vertical Height above Surface:** 0 – 3.5 ft

**Accident Record:** None

| Encroachment Site No. | Station | Encroachment Description | Existing R/W Width from R/L | Encroachment Distance | Owner/ Address | Proposed Action | Construction Conflict |
|---|---|---|---|---|---|---|---|
| 13 | 126+65 RT | Concrete Wall & Sign | 31' | 1' | City of Portage<br>(Mailing) 115 W. Pleasant St.<br>Portage, WI 53901 | Removal by Owner | Yes, within slope intercept |

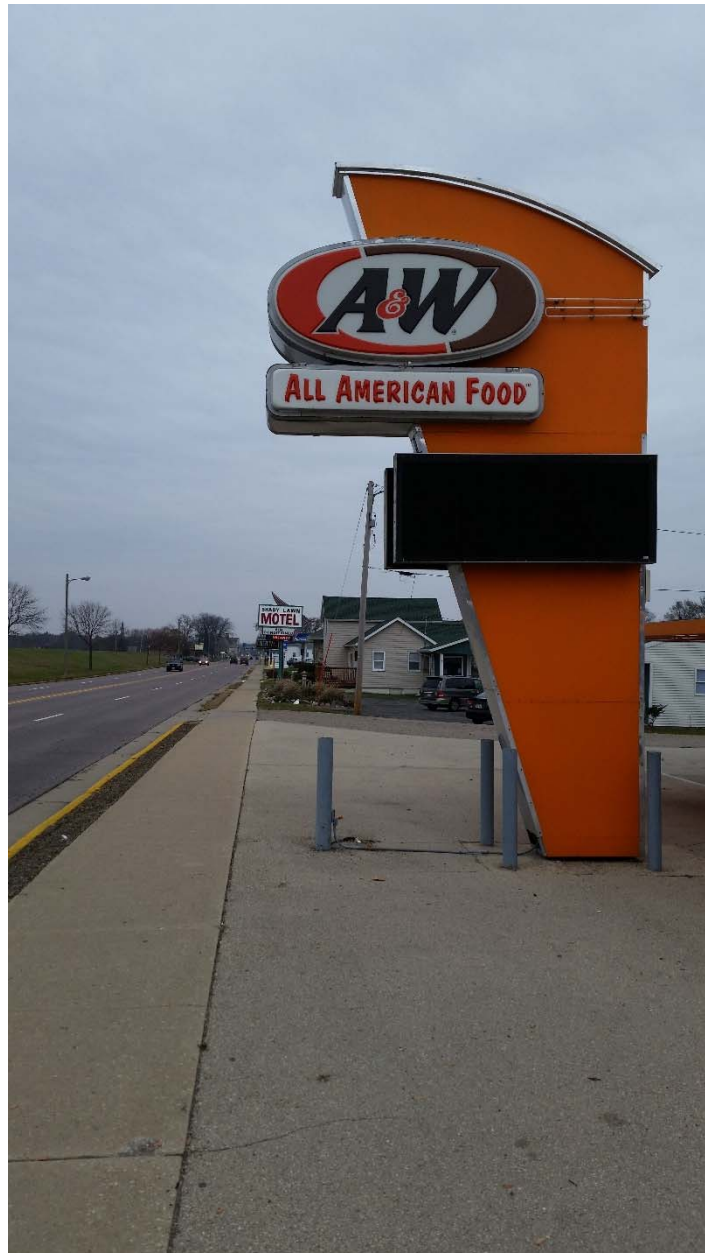
## SITE #14

Location: STA 127+42 LT

Vertical Height above Surface: 10 - 15 ft

Accident Record: None

| Encroachment Site No. | Station | Encroachment Description | Existing R/W Width from R/L | Encroachment Distance | Owner/ Address | Proposed Action | Construction Conflict |
|---|---|---|---|---|---|---|---|
| 14 | 127+42 LT | Sign | 35' | 1' | MRP Properties LLC<br>(Physical) 717 E. Wisconsin St<br>Portage, WI 53901<br>(Mailing) 2611 Pine Ridge Court<br>Portage, WI 53901 | To Remain | None |

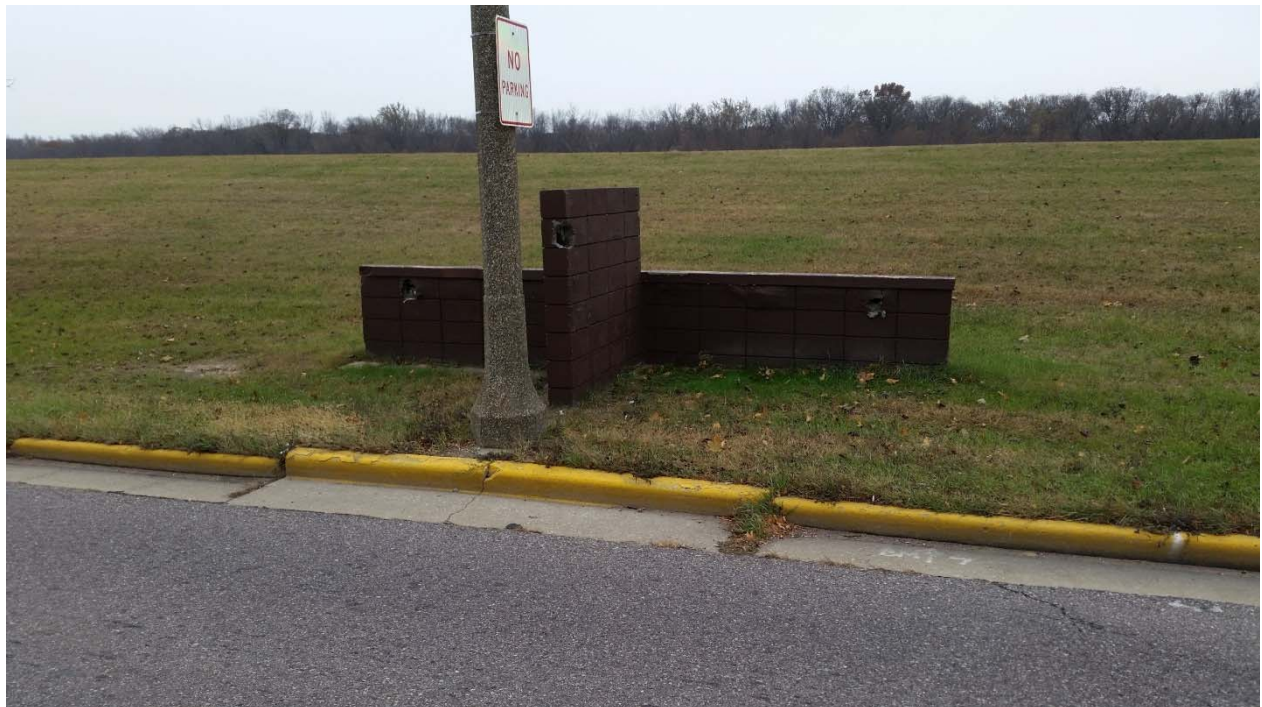
## SITE #15

**Location:** STA 128+60 RT

**Vertical Height above Surface:** 0 - 4 ft

**Accident Record:** None

| Encroachment Site No. | Station | Encroachment Description | Existing R/W Width from R/L | Encroachment Distance | Owner/ Address | Proposed Action | Construction Conflict |
|---|---|---|---|---|---|---|---|
| 15 | 128+60 RT | Wall | 31' | 4.8' | City of Portage<br>(Mailing) 115 W. Pleasant St.<br>Portage, WI 53901 | Removal by Project | Yes, within slope intercept |

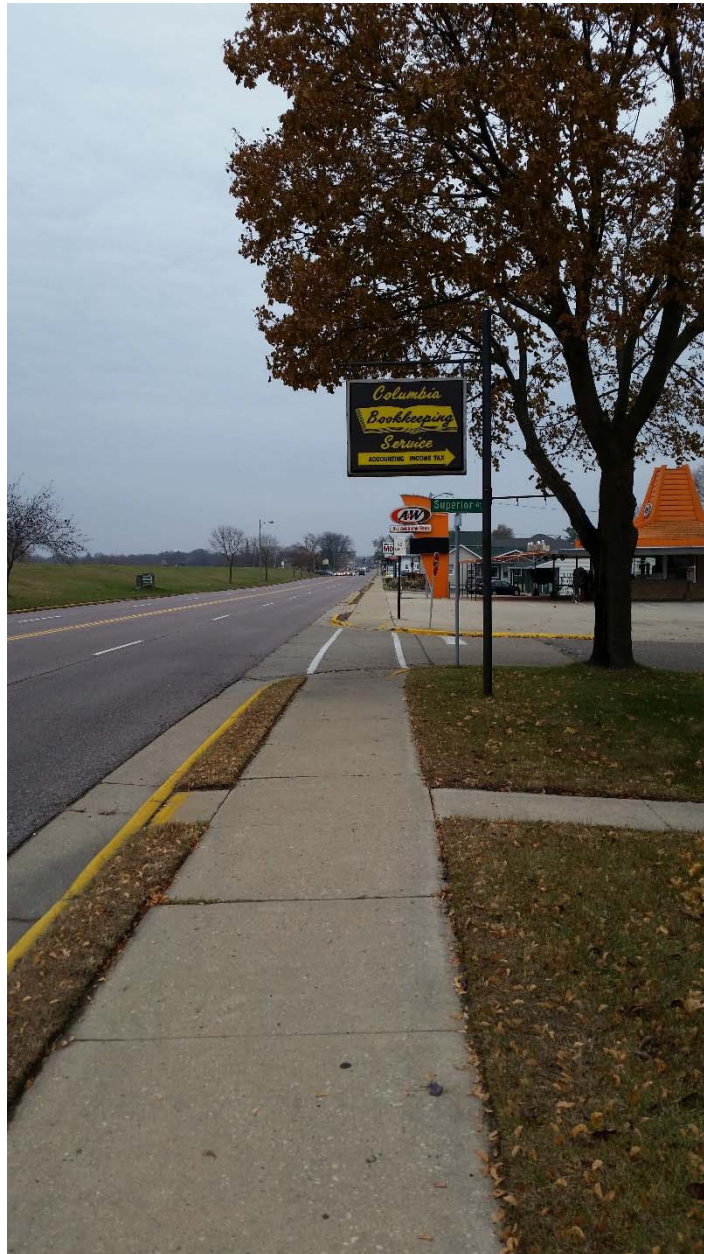
## SITE #16

**Location:** 128+97 LT

**Vertical Height above Surface:** 8.5 – 12.5 ft

**Accident Record:** None

| Encroachment Site No. | Station | Encroachment Description | Existing R/W Width from R/L | Encroachment Distance | Owner/ Address | Proposed Action | Construction Conflict |
|---|---|---|---|---|---|---|---|
| 16 | 128+97 LT | Sign | 35' | 3.5' | Sign Location: Daniel F Kuper<br>801 E. Wisconsin St.<br>Portage, WI 53901<br>Business: Doris J Domstrich Rev Trust<br>(Physical) 110 Superior St.<br>Portage, WI 53901<br>(Mailing) W8562 Thompson Rd.<br>Poynette, WI 53955 | Removal by Owner | None |

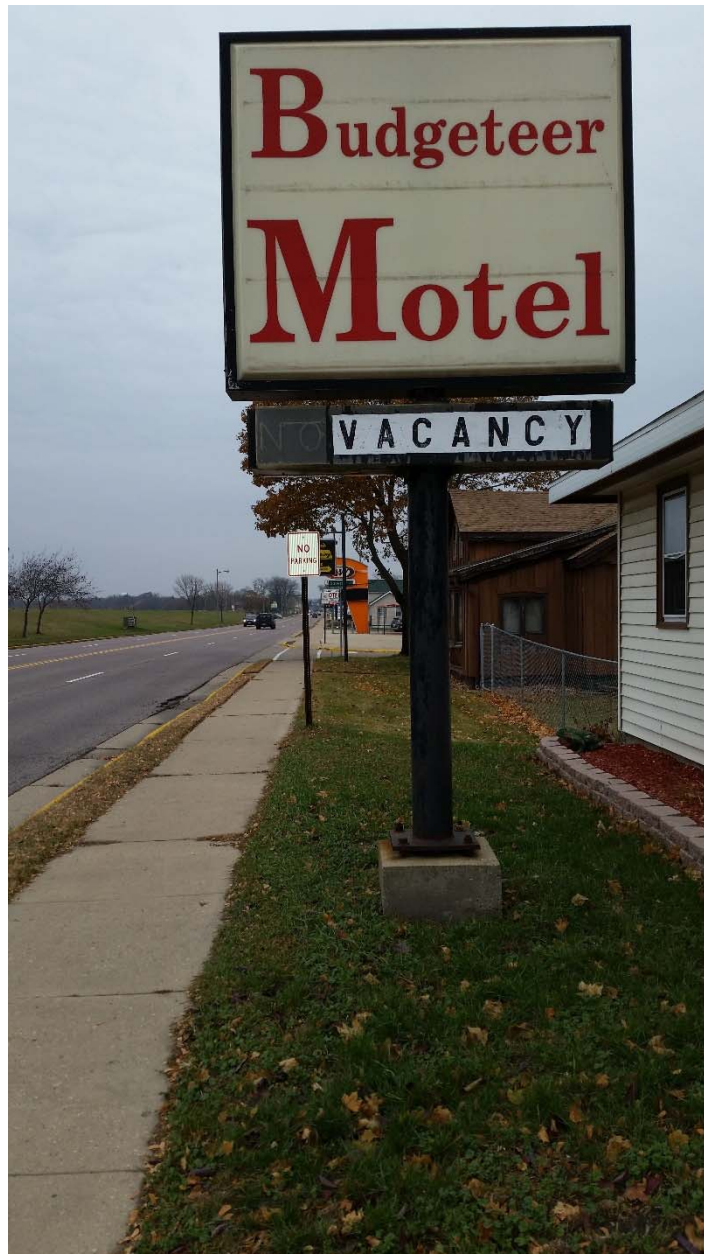
## SITE #17

Location: STA 129+91 LT

Vertical Height above Surface: 8 - 15 ft

Accident Record: None

| Encroachment Site No. | Station | Encroachment Description | Existing R/W Width from R/L | Encroachment Distance | Owner/ Address | Proposed Action | Construction Conflict |
|---|---|---|---|---|---|---|---|
| 17 | 129+91 LT | Sign | 35' | 1.15' | Joanne Klome<br>(Physical) 811 E. Wisconsin St<br>Portage, WI 53901<br>(Mailing) 619 W. Decker St.<br>Viroqua, WI 54665 | To Remain | None |
