## MEMORANDUM

**Subject:** Encroachment Report for:

Project I.D. 6918-01-02  
City of Portage, Wisconsin & Dewitt Street  
(Ontario Street - East Pleasant Street)  
USH 51  
Columbia County

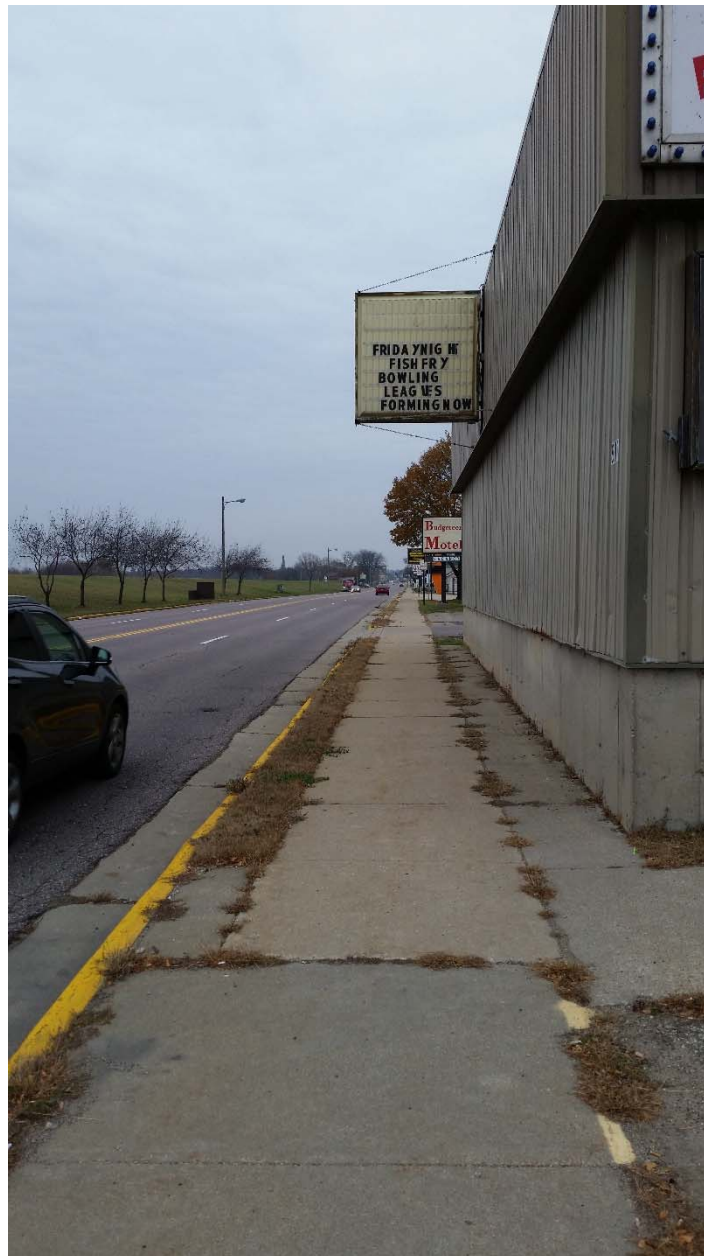
## SITE #18

**Location:** STA 131+10 LT

**Vertical Height above Surface:** 10 - 15 ft

**Accident Record:** None

| Encroachment Site No. | Station | Encroachment Description | Existing R/W Width from R/L | Encroachment Distance | Owner/ Address | Proposed Action | Construction Conflict |
|---|---|---|---|---|---|---|---|
| 18 | 131+10 LT | Sign | 35' | 7' | Brian R Tollison LLC<br>817 E. Wisconsin St<br>Portage, WI 53901 | To Remain | None |

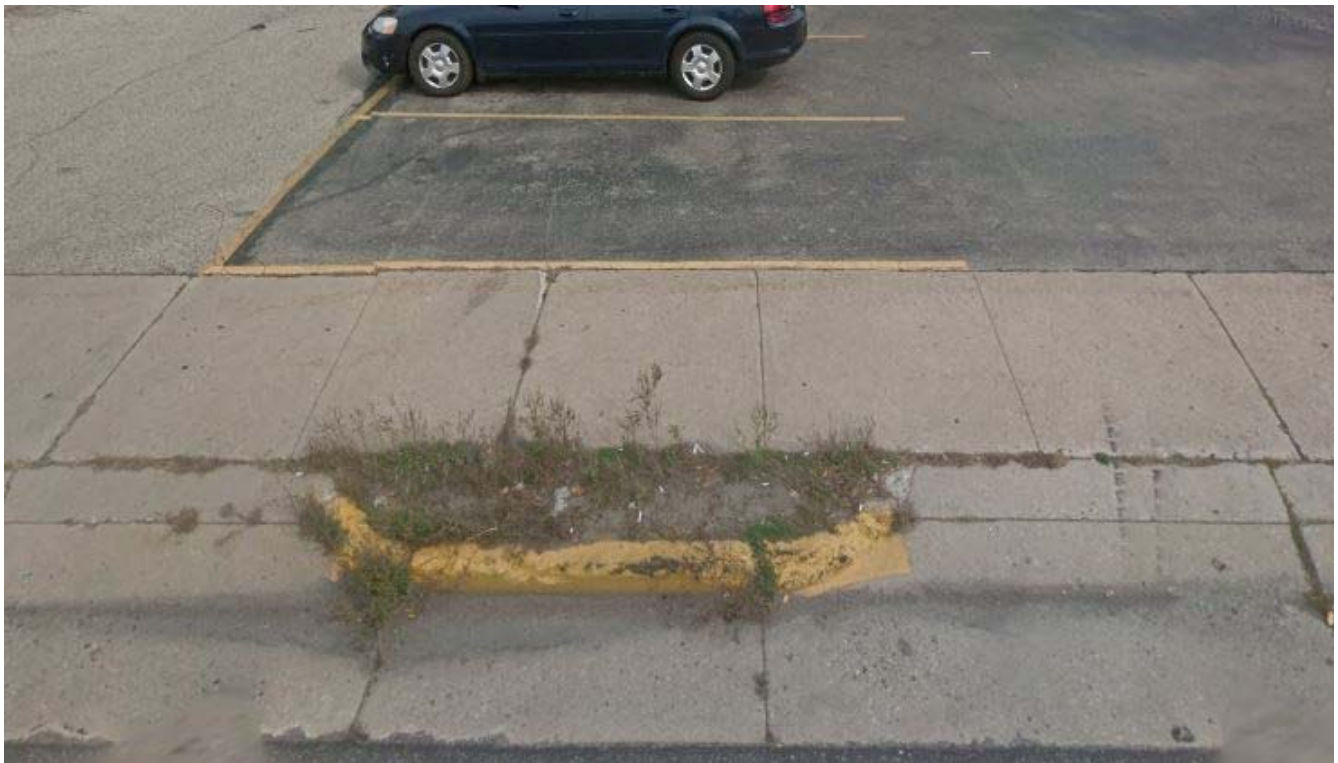
## SITE #19A

**Location:** STA 134+60 LT

**Vertical Height above Surface:** N/A

**Accident Record:** None

| Encroachment Site No. | Station | Encroachment Description | Existing R/W Width from R/L | Encroachment Distance | Owner/ Address | Proposed Action | Construction Conflict |
|---|---|---|---|---|---|---|---|
| 19A | 134+60 LT | Parking Lot | 35' USH 51<br>25' Alley | 1.2' USH 51<br>4.75' Alley | Lois M Rethard Living Trust<br>(Physical) 929 E. Wisconsin St<br>Portage, WI 53901<br>(Mailing) N6941 Karen Ann Dr.<br>Pardeeville, WI 53954 | Removal by Project | Yes, within slope intercept |

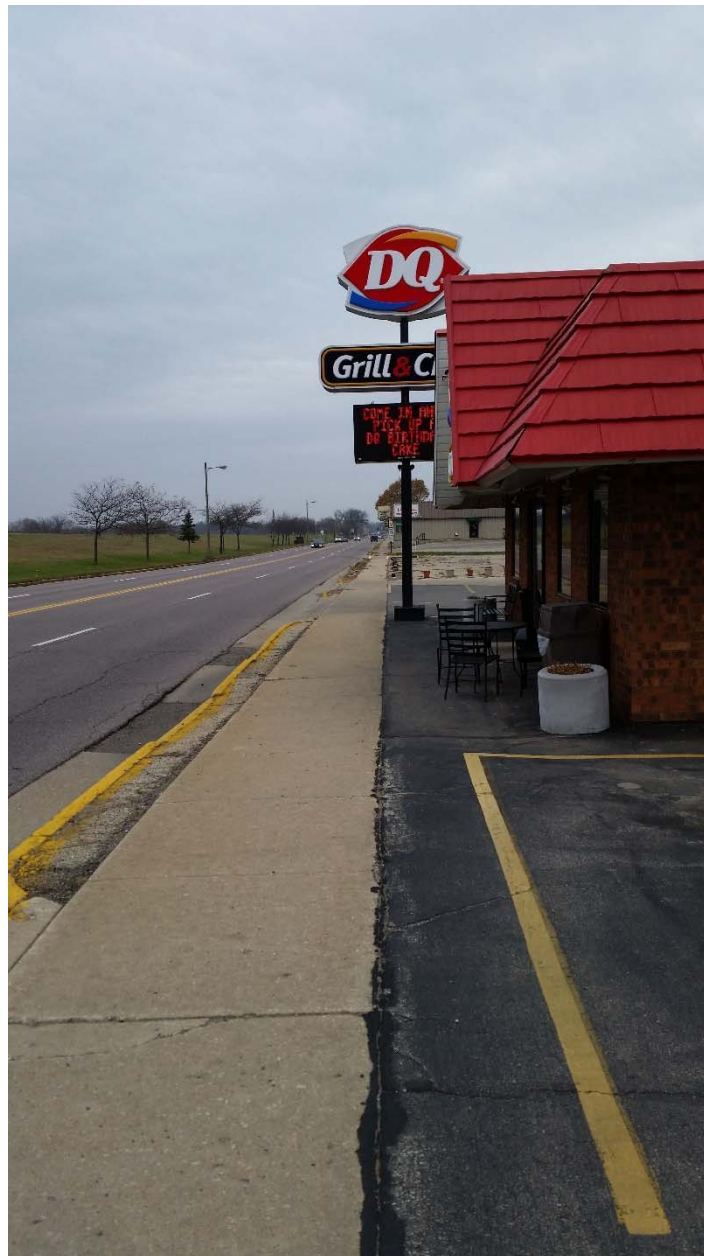
## SITE #19B

**Location:** STA 135+06 LT

**Vertical Height above Surface:** 8 - 20 ft

**Accident Record:** None

| Encroachment Site No. | Station | Encroachment Description | Existing R/W Width from R/L | Encroachment Distance | Owner/ Address | Proposed Action | Construction Conflict |
|---|---|---|---|---|---|---|---|
| 19B | 135+06 LT | Sign | 35' | 5' | Lois M Rethard Living Trust<br>(Physical) 929 E. Wisconsin St<br>Portage, WI 53901<br>(Mailing) N6941 Karen Ann Dr.<br>Pardeeville, WI 53954 | To Remain | None, but within slope intercept |

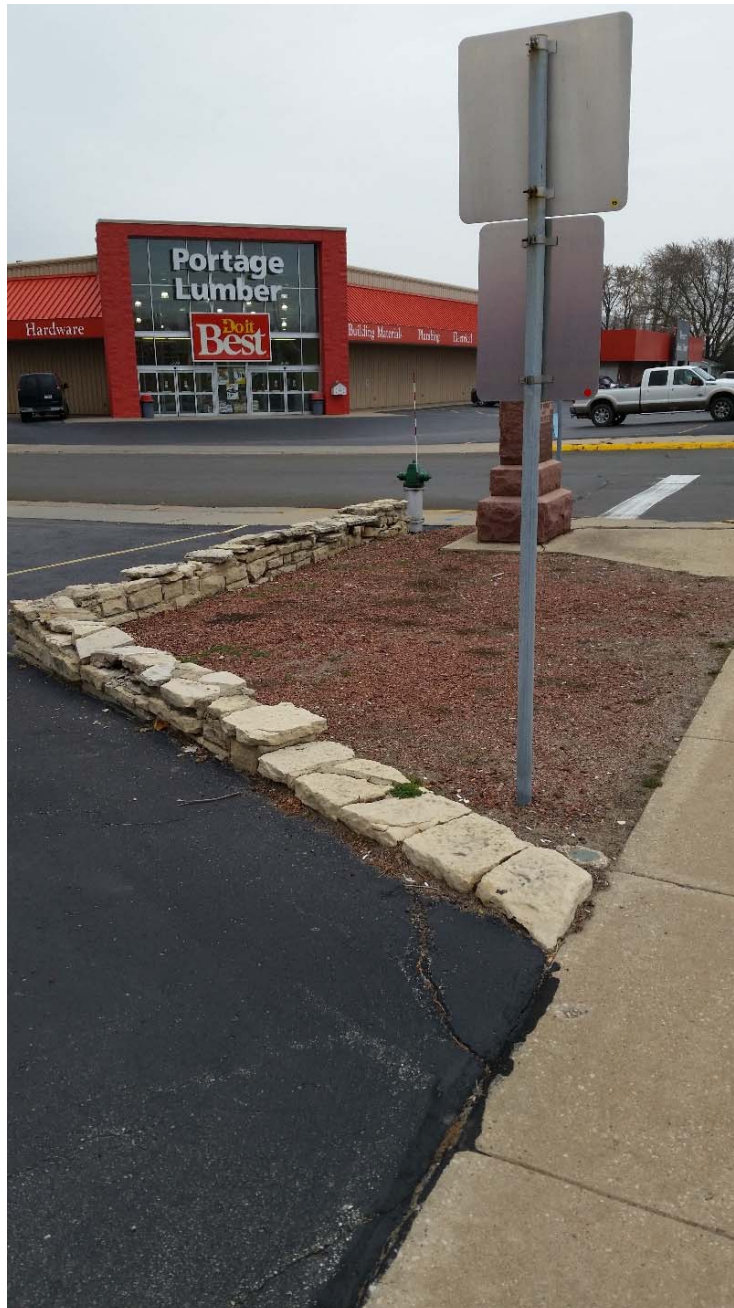
## SITE #19C

**Location:** STA 136+25 LT

**Vertical Height above Surface:** 0 to 5 ft

**Accident Record:** None

| Encroachment Site No. | Station | Encroachment Description | Existing R/W Width from R/L | Encroachment Distance | Owner/ Address | Proposed Action | Construction Conflict |
|---|---|---|---|---|---|---|---|
| 19C | 136+25 LT | Rock Wall | 35' USH 51<br>50' Wauna | 1.2' USH 51<br>20' Wauna | Lois M Rethard Living Trust<br>(Physical) 929 E. Wisconsin St<br>Portage, WI 53901<br>(Mailing) N6941 Karen Ann Dr.<br>Pardeeville, WI 53954 | Removal by Project | Yes, within slope intercept |

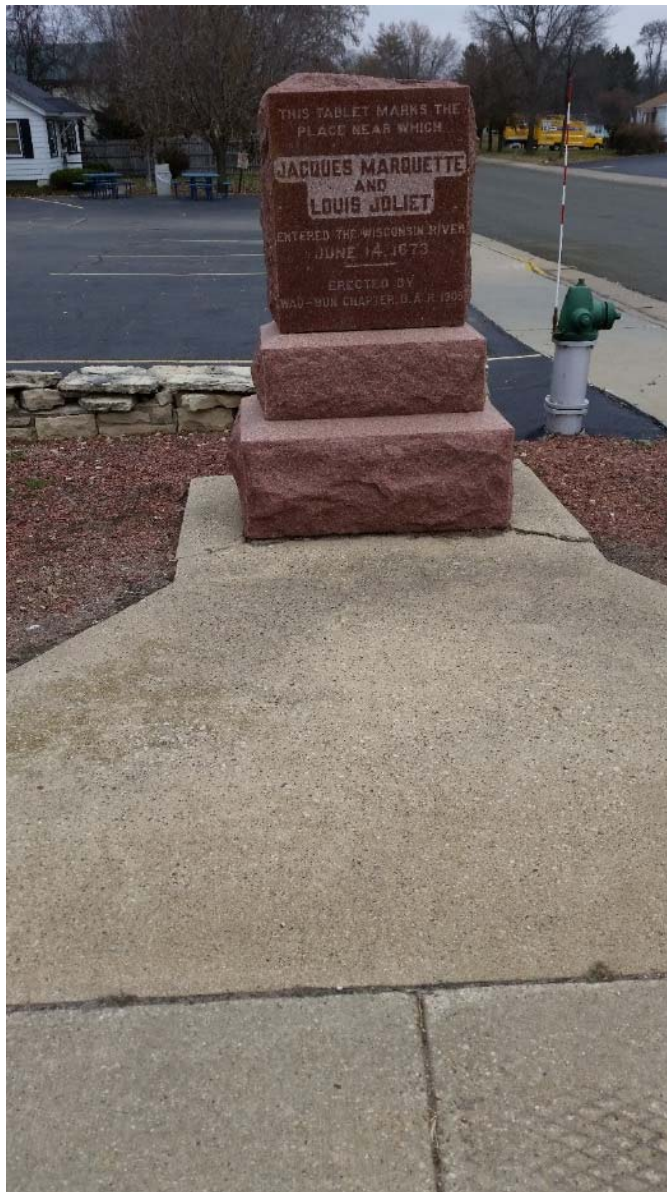
**Vertical Height above Surface:** 0 to 5 ft

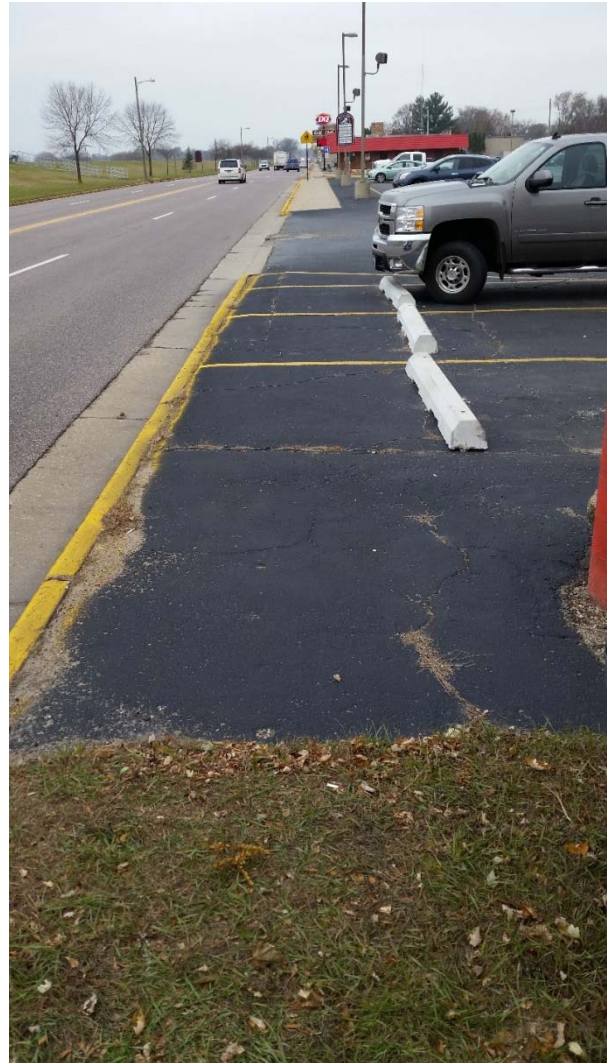
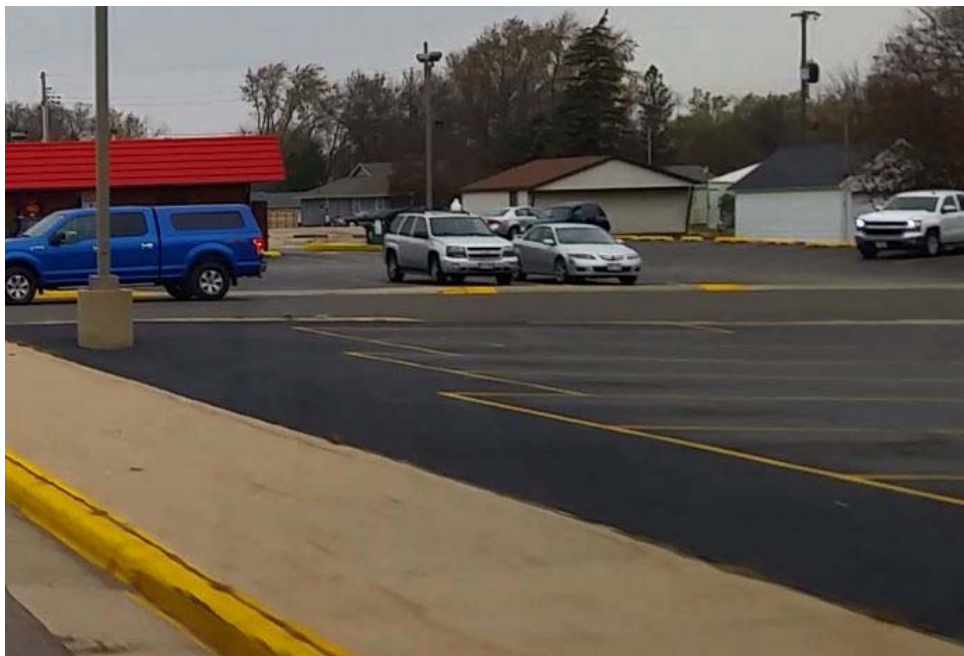
## SITE #21A

**Location:** STA 137+00 – 139+50 LT

**Vertical Height above Surface:** N/A

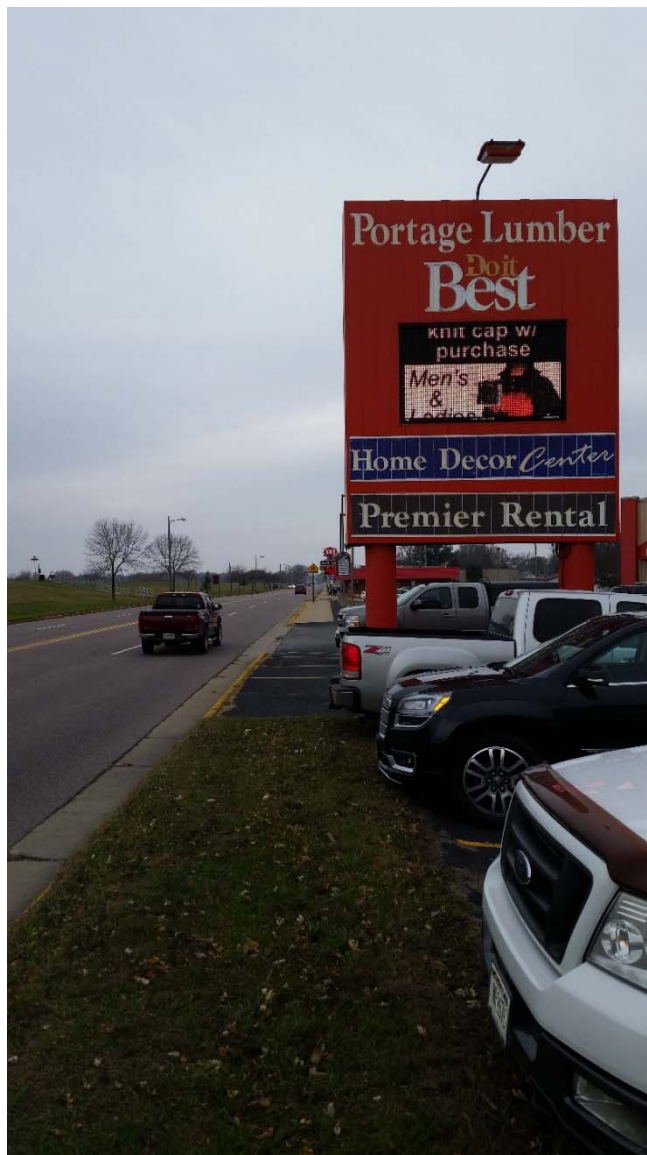
## SITE #21B

Location: STA 139+52 LT

Vertical Height above Surface: 0 – 32 ft

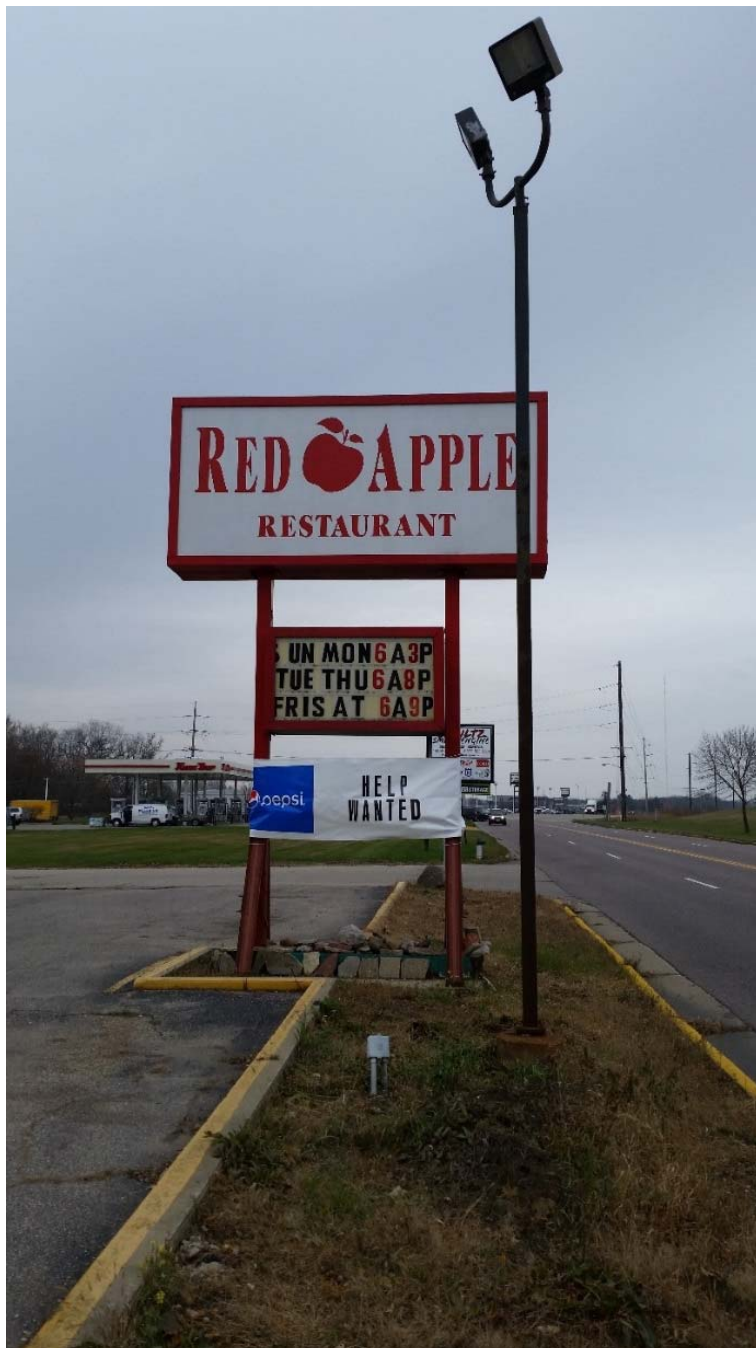
## SITE #22

**Location:** STA 143+42 – 144+40 LT

**Vertical Height above Surface:** 0 - 15 ft

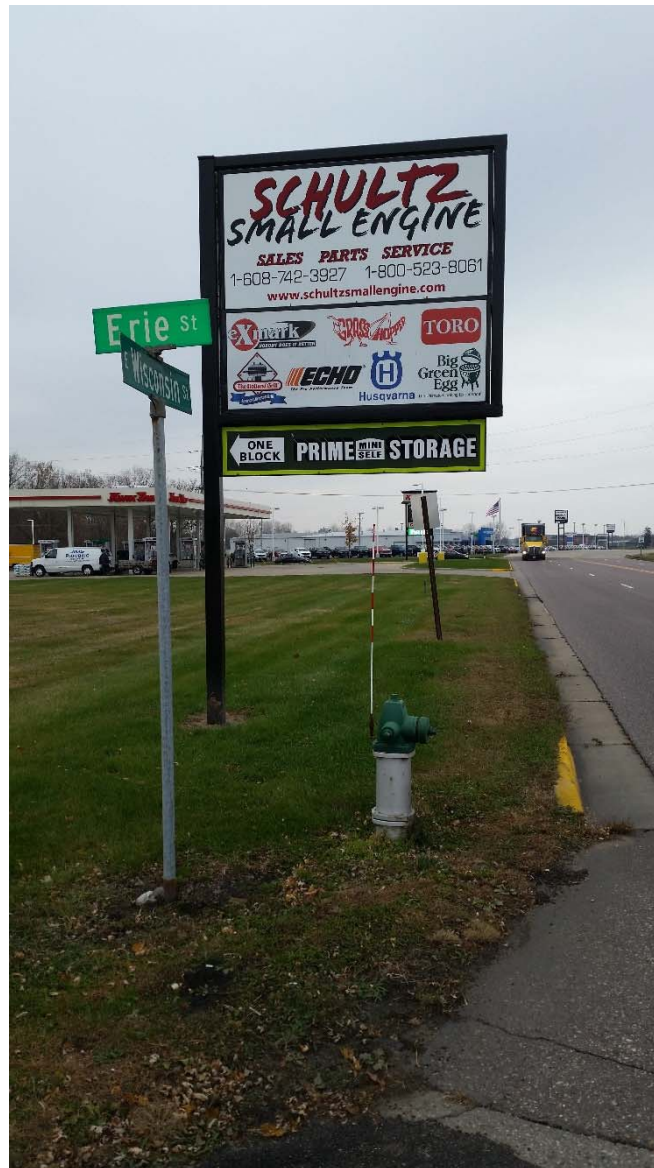
## SITE #23

Location: STA 145+00 LT

Vertical Height above Surface: 15 ft

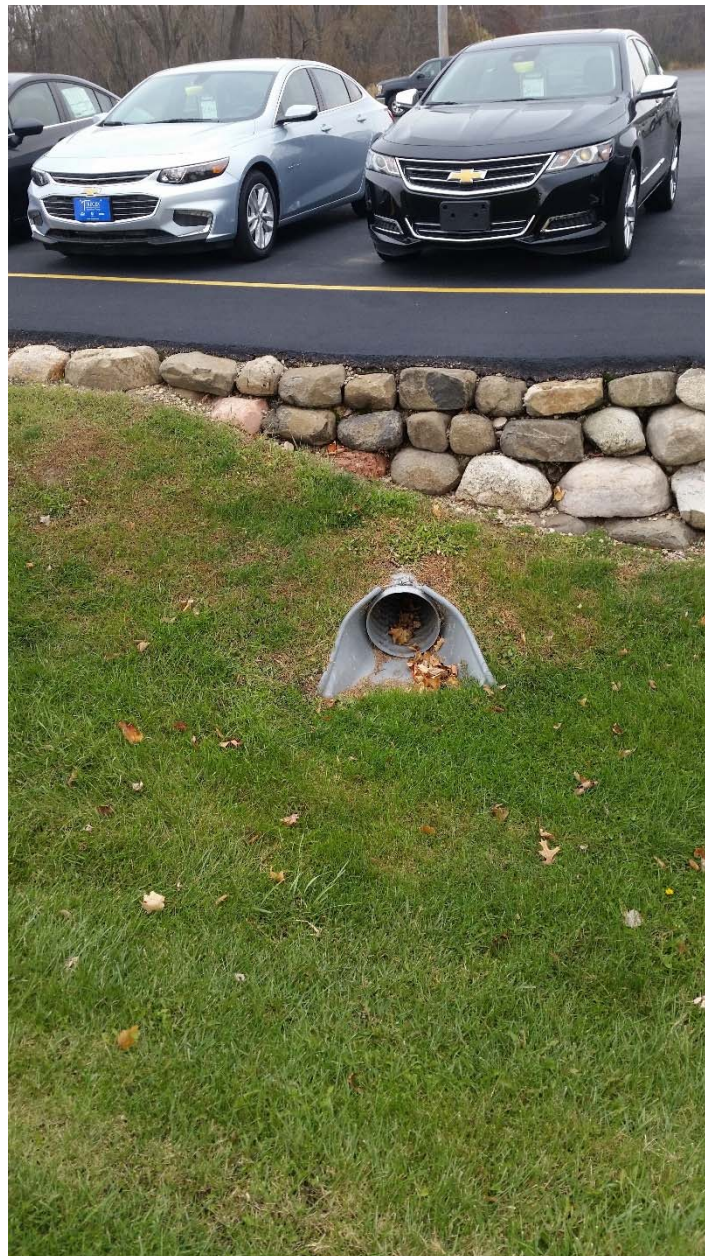
## SITE #24A

**Location:** STA 152+10 LT

**Vertical Height above Surface:** N/A

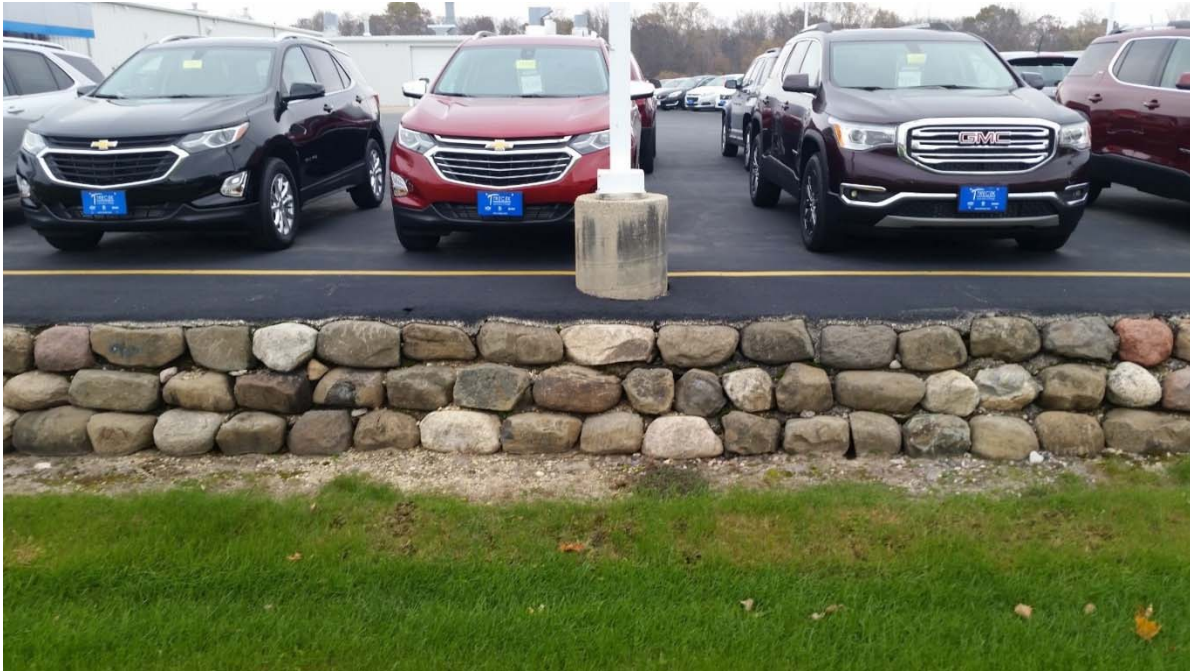
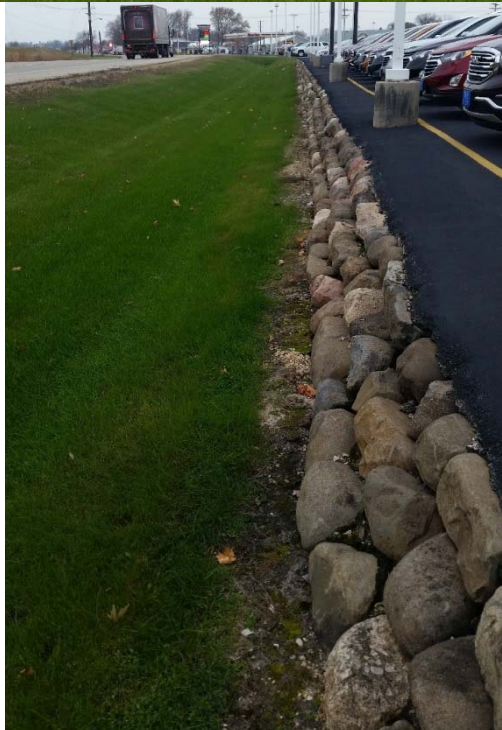
## SITE #24B

**Location:** STA 152+00 – 155+20 LT

**Vertical Height above Surface:** 3 ft

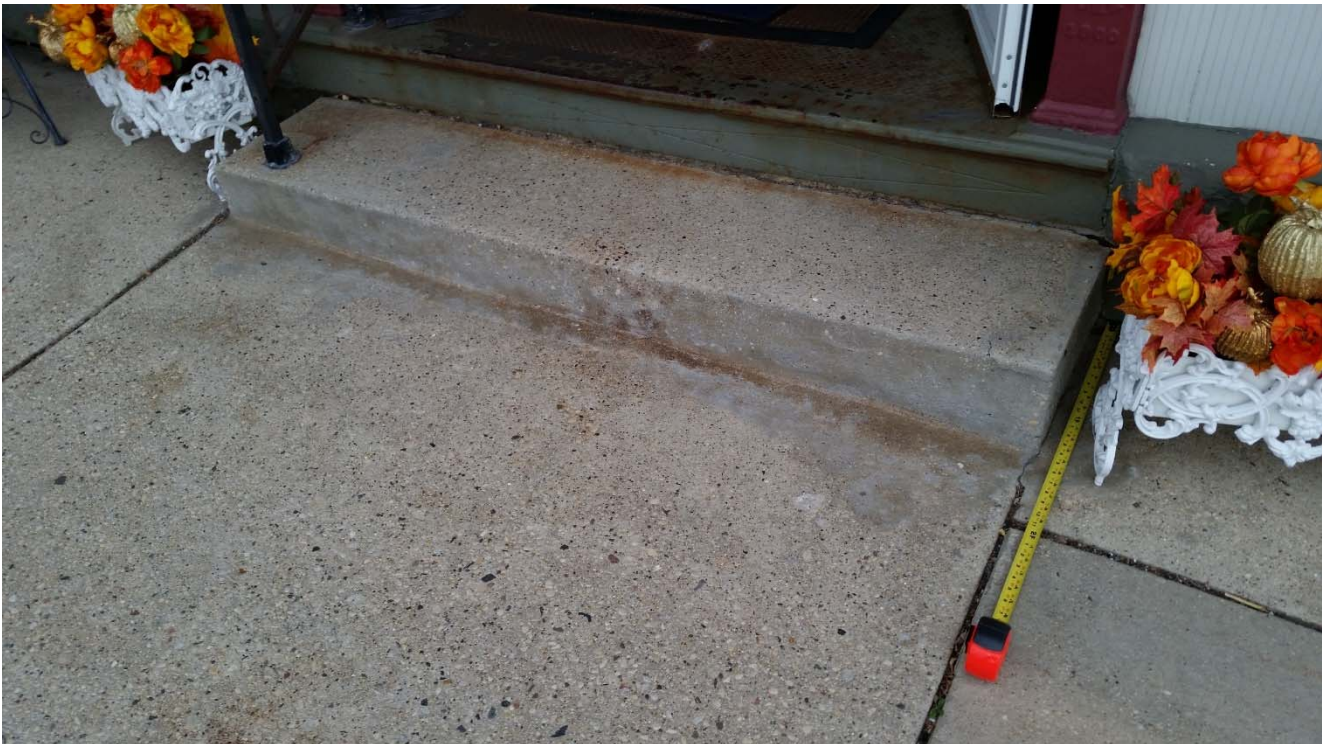
## SITE #100A

**Location:** STA 540+10 RT

**Vertical Height above Surface:** 0.5 – 3.0 ft

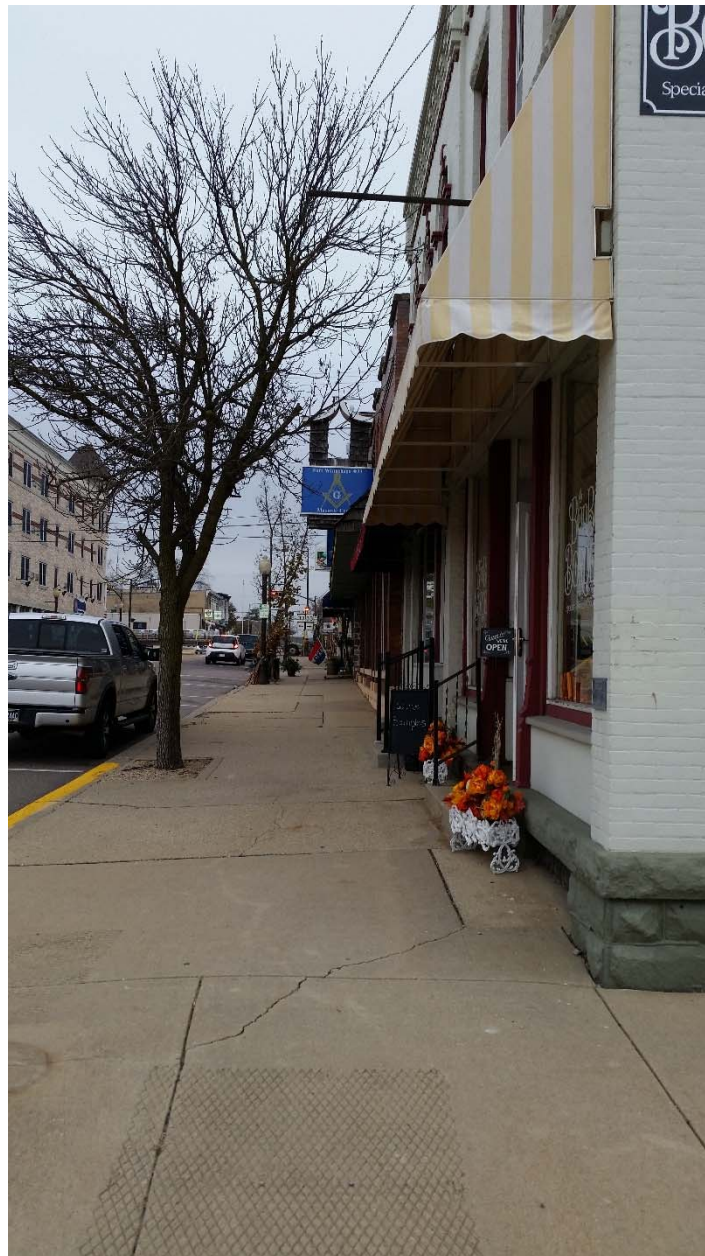
## SITE #100B

**Location:** STA 540+10 Rt

**Vertical Height above Surface:** 10 - 15 ft

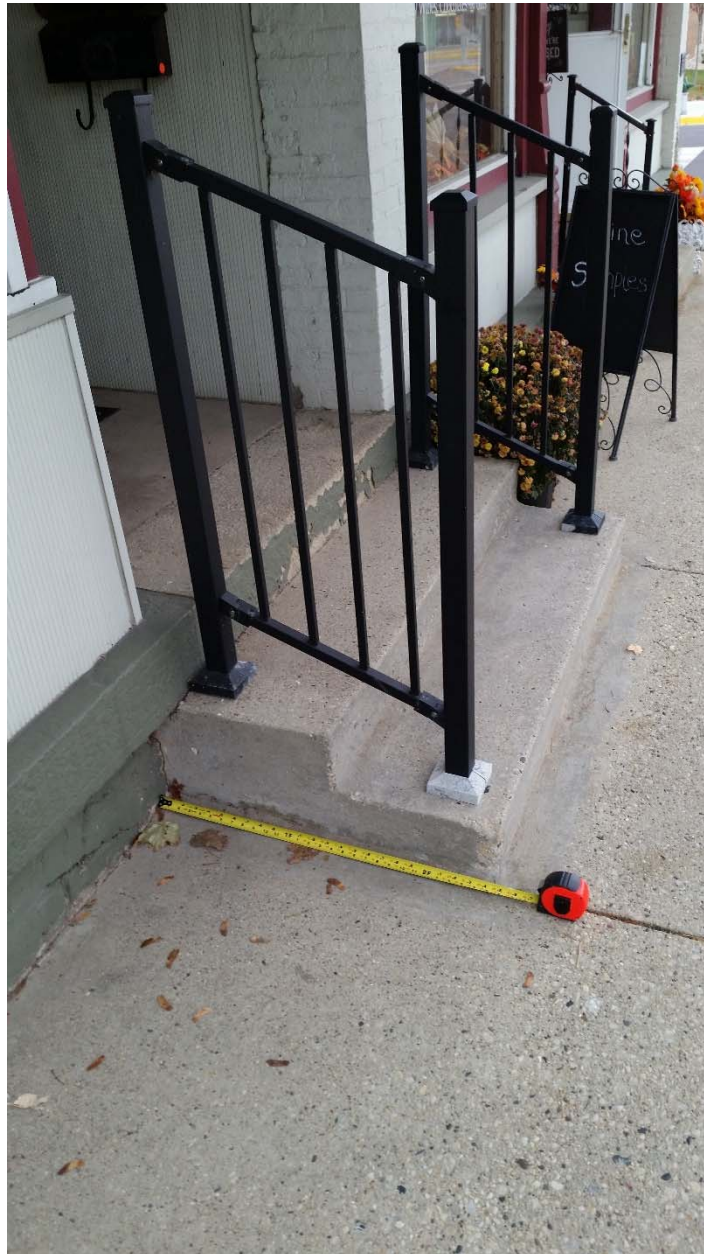
## SITE #101A

**Location:** STA 540+15 RT

**Vertical Height above Surface:** 0.5 - 5 ft

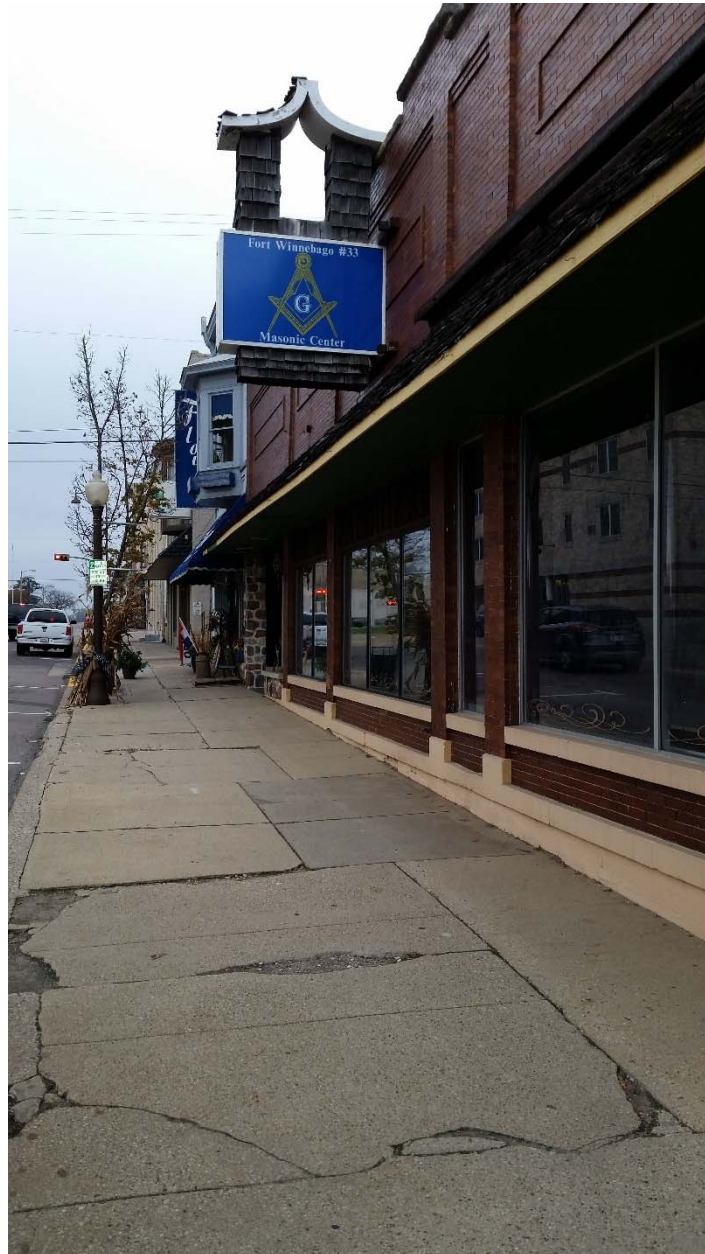
## SITE #102

**Location:** STA 540+50 RT

**Encroachment Type:** Sign and canopy overhang

**Horizontal Encroachment into Existing R/W:** 5 ft

**Vertical Height above Surface:** 10 - 20 ft

**Accident Record:** None

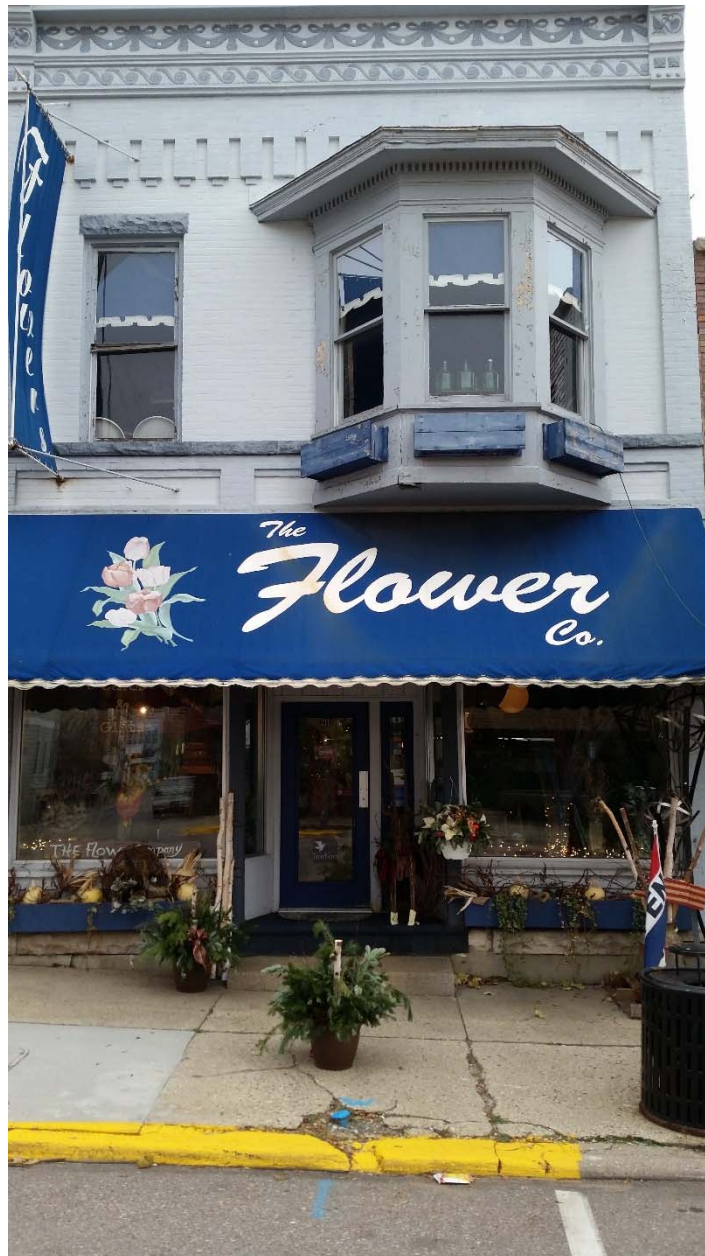
## SITE #103A

Location: STA 540+00 RT

Encroachment Type: Sign and canopy overhang

Horizontal Encroachment into Existing R/W: 5 ft

Vertical Height above Surface: 10 - 20 ft

Accident Record: None

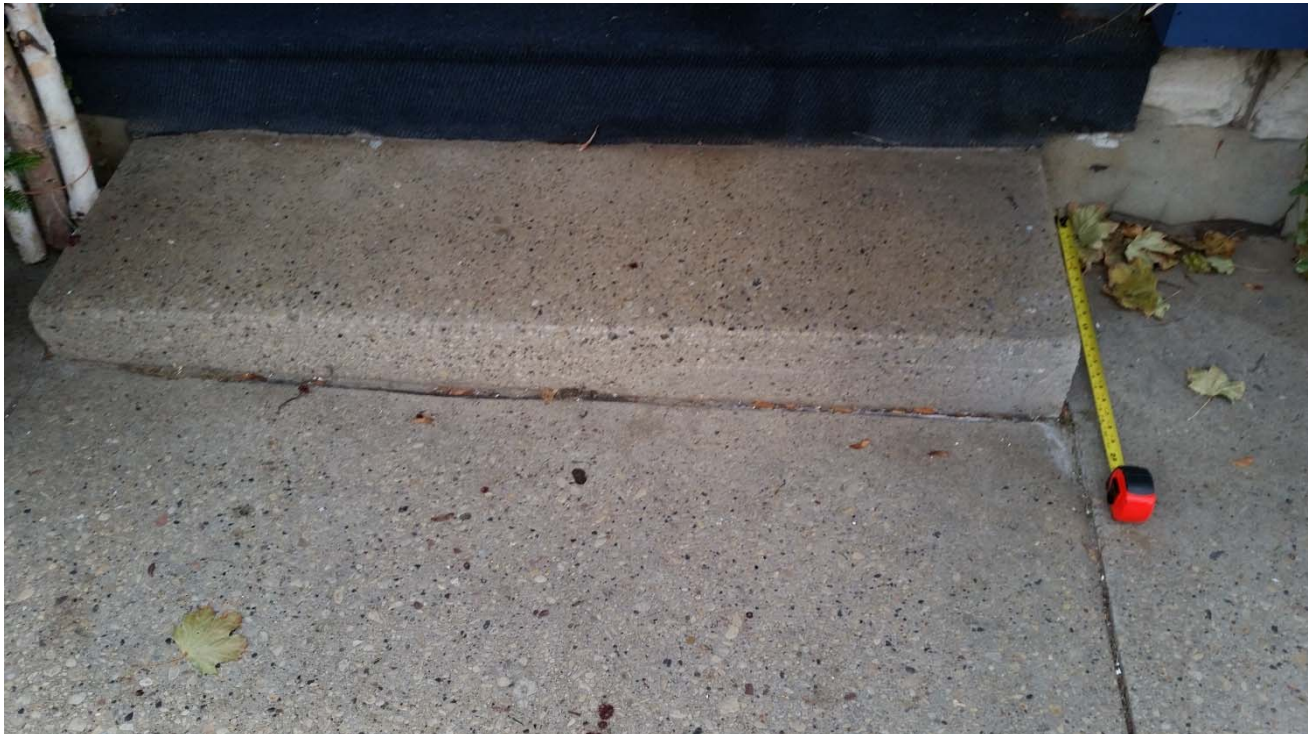
## SITE #103B

Location: STA 541+00

Encroachment Type: Step

Horizontal Encroachment into Existing R/W: 1.5 ft

Vertical Height above Surface: 0.5 ft

Accident Record: None

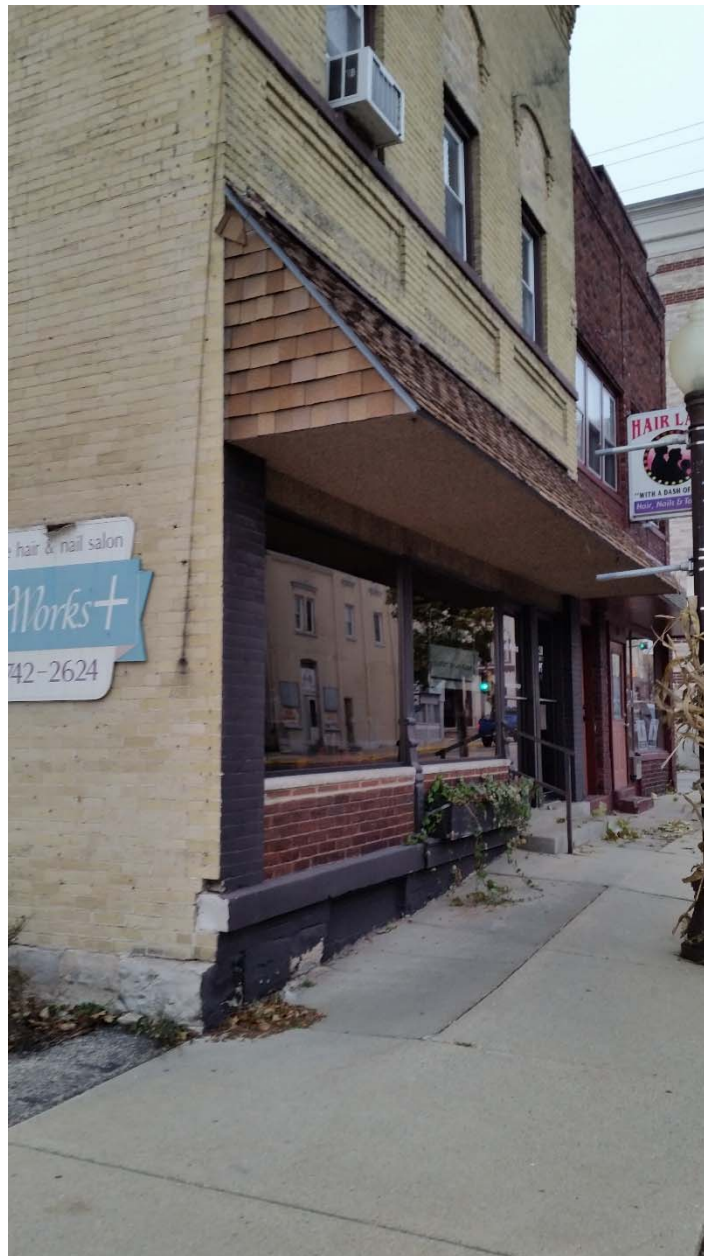
## SITE #104A

**Location:** STA 540+85 LT

**Encroachment Type:** Canopy overhang

**Horizontal Encroachment into Existing R/W:** 4 ft

**Vertical Height above Surface:** 10 - 15 ft

**Accident Record:** None

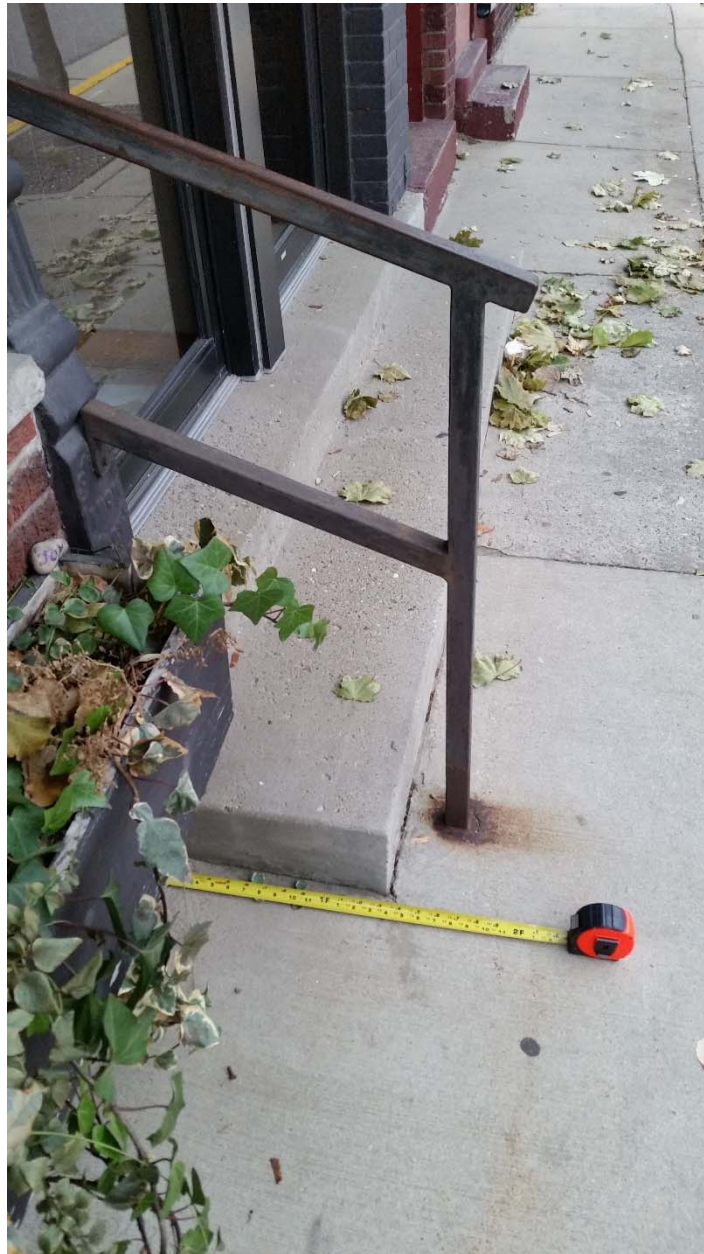
## SITE #104B

Location: STA 540+95 LT

Encroachment Type: Steps and railing

Horizontal Encroachment into Existing R/W: 1.5 ft

Vertical Height above Surface: 0.5 - 4 ft

Accident Record: None

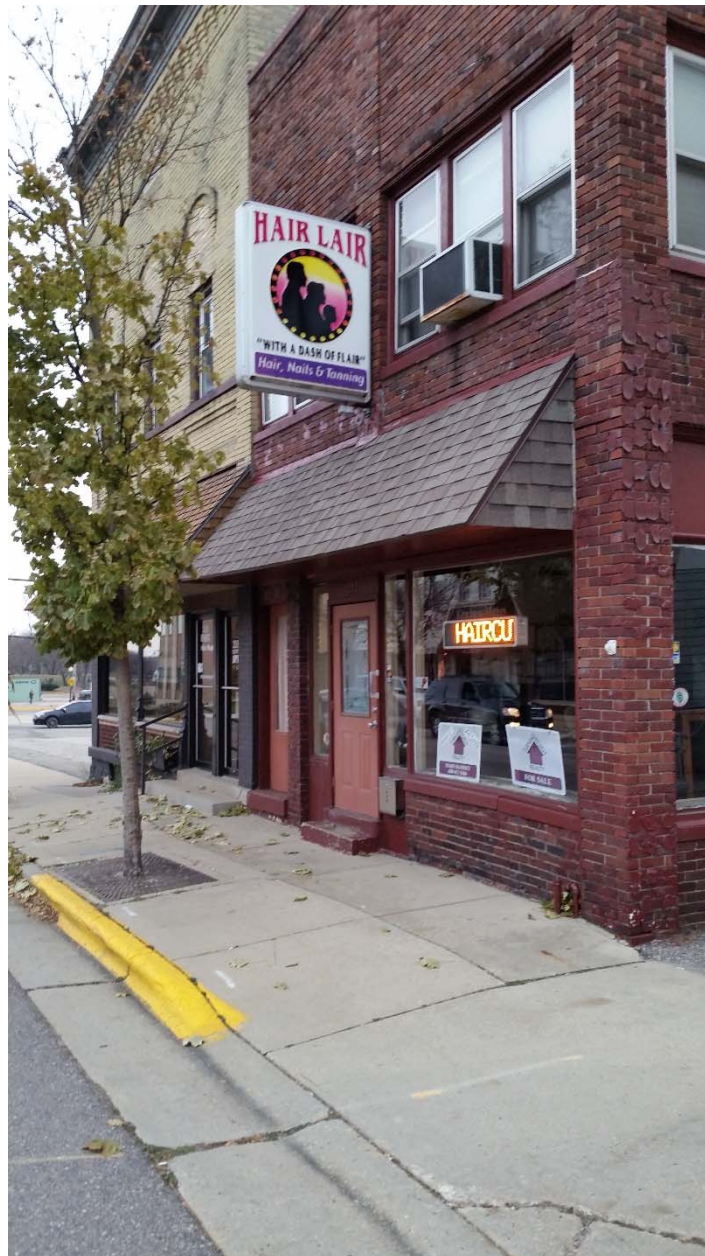
## SITE #105A

Location: STA 541+10 LT

Encroachment Type: Sign and canopy overhang

Horizontal Encroachment into Existing R/W: 4 ft

Vertical Height above Surface: 10 - 18 ft

Accident Record: None

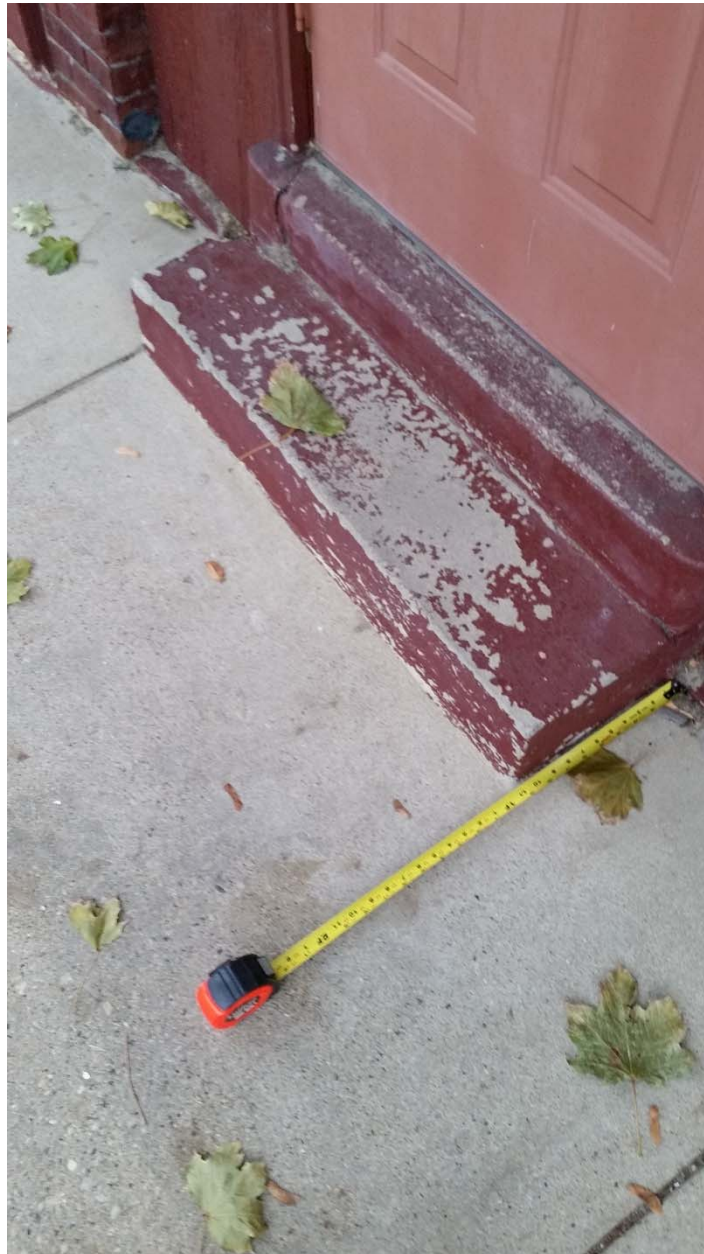
## SITE #105B

Location: STA 541+10 LT

Encroachment Type: Step

Horizontal Encroachment into Existing R/W: 1 ft

Vertical Height above Surface: 0.5 ft

Accident Record: None

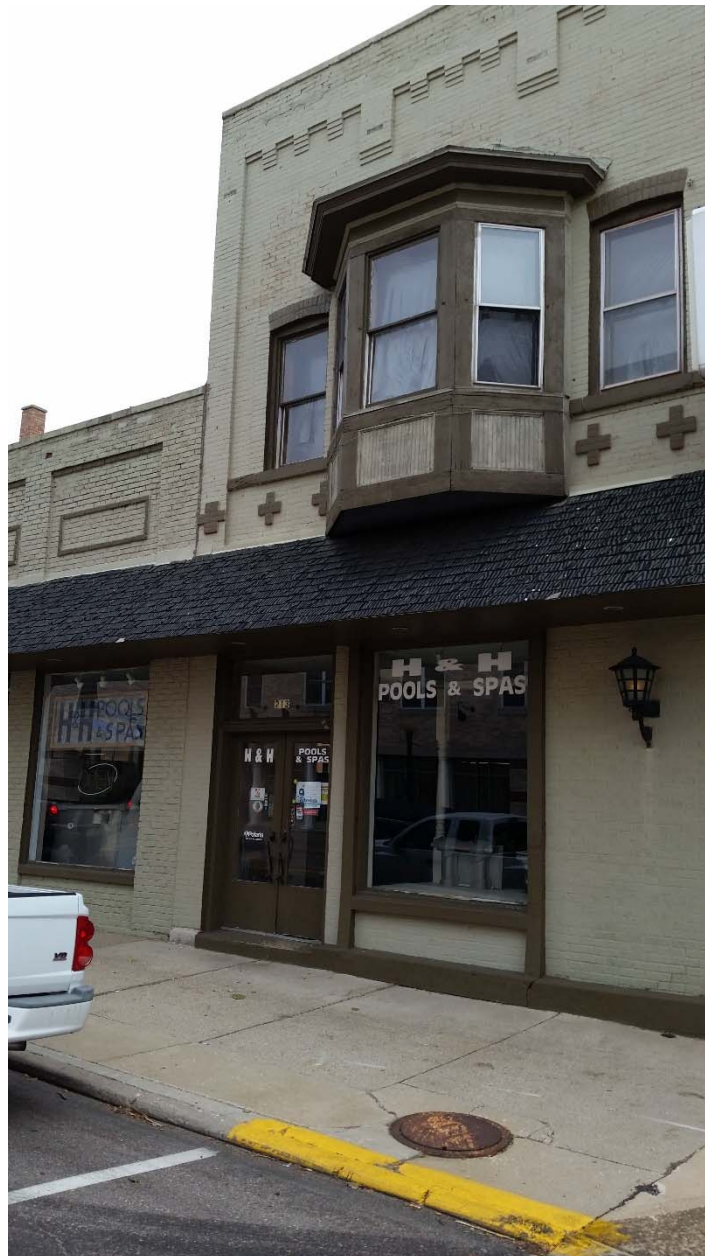
## SITE #106

**Location:** STA 541+50 RT

**Encroachment Type:** Canopy & dormer

**Horizontal Encroachment into Existing R/W:** 4 ft

**Vertical Height above Surface:** 10 - 20 ft

**Accident Record:** None

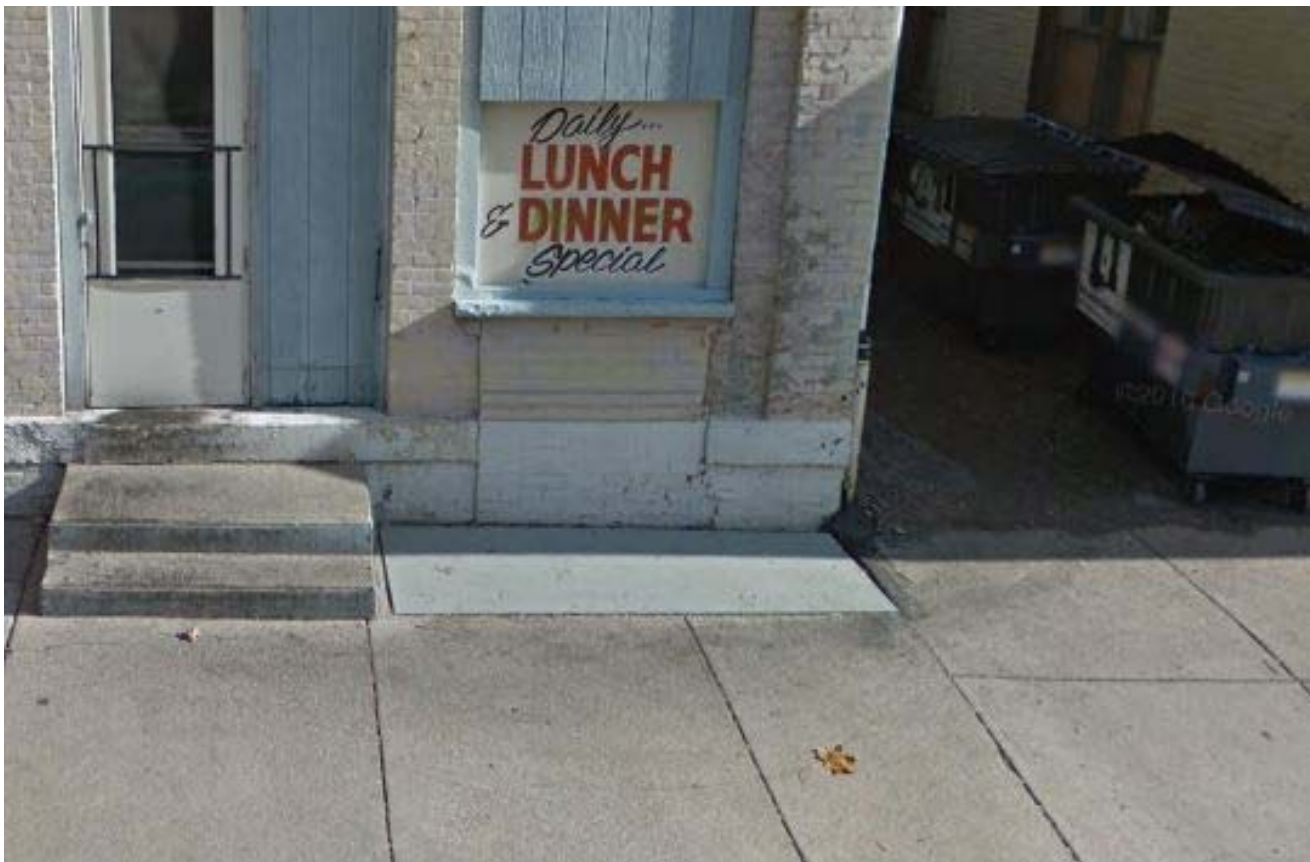
## SITE #107A

Location: STA 542+00 RT

Encroachment Type: Vault

Horizontal Encroachment into Existing R/W: 3.5 ft

Vertical Height above Surface: 1 ft

Accident Record: None
