## MEMORANDUM

**Subject:** Encroachment Report for:

Project I.D. 6918-01-02  
City of Portage, Wisconsin & Dewitt Street  
(Ontario Street - East Pleasant Street)  
USH 51  
Columbia County

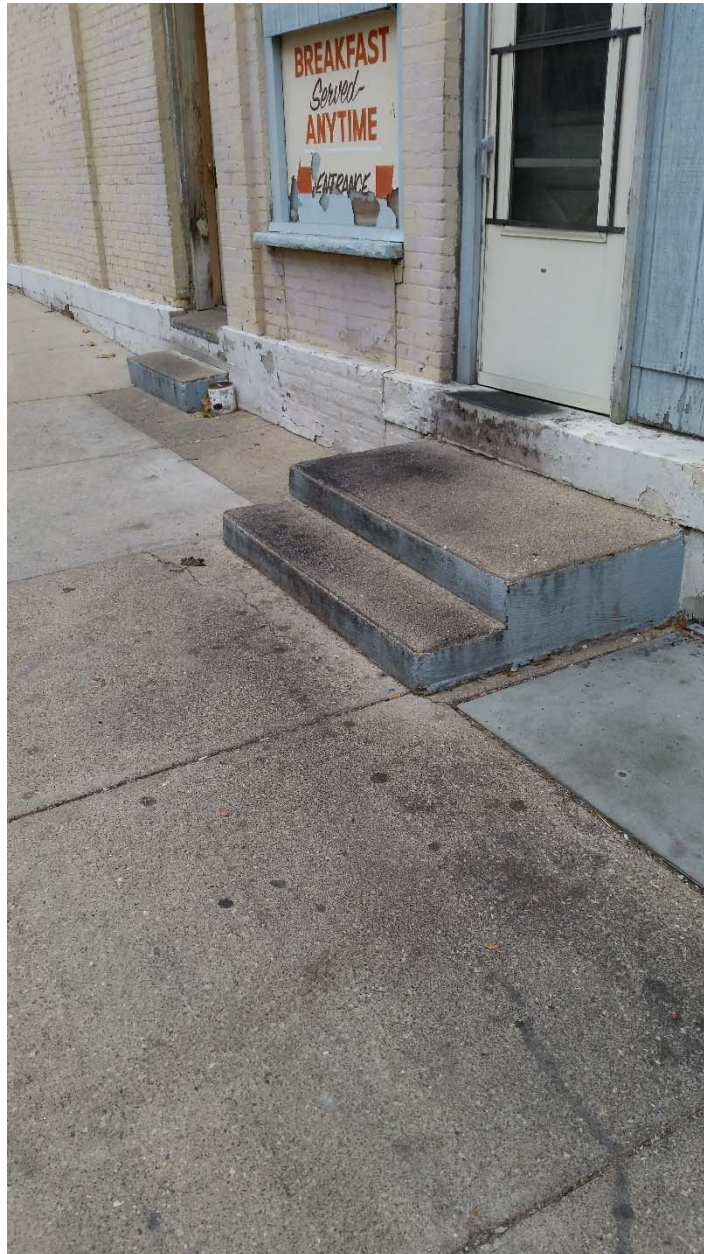
## SITE #107B

Location: STA 542+00 RT

Encroachment Type: Steps

Horizontal Encroachment into Existing R/W: 3.5 ft

Vertical Height above Surface: 1 ft

Accident Record: None

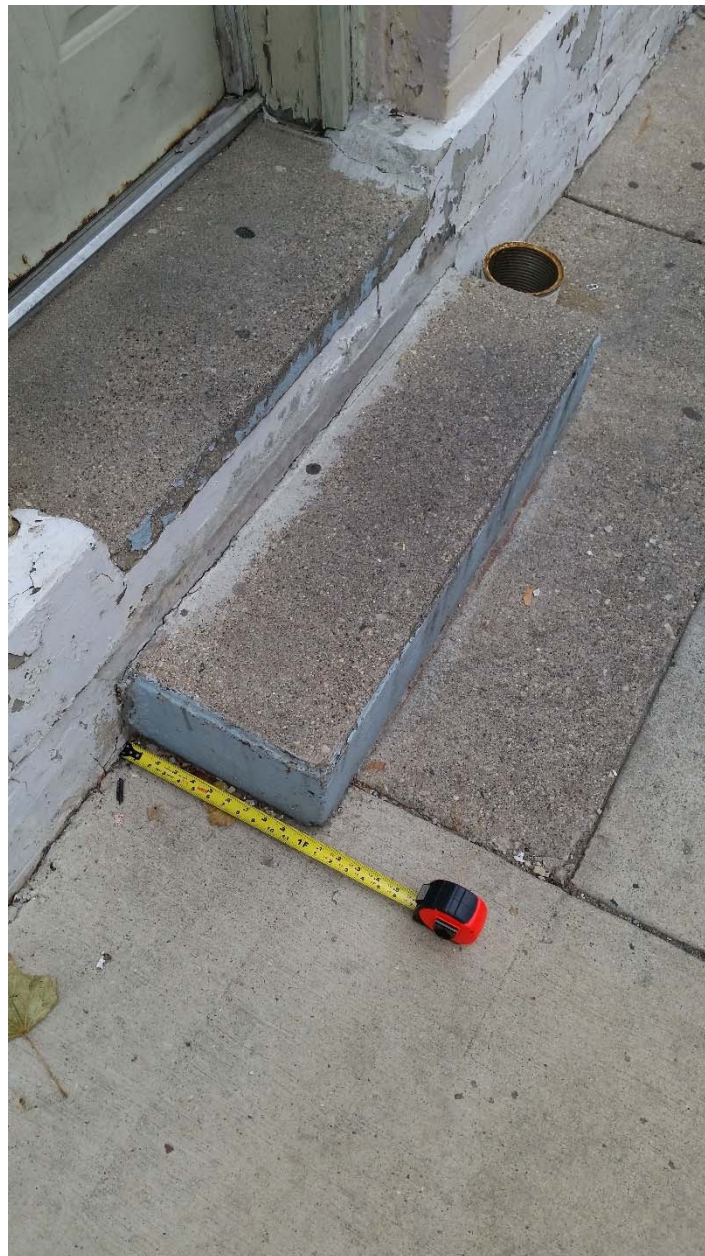
## SITE #107C

Location: STA 542+10 RT

Encroachment Type: Step

Horizontal Encroachment into Existing R/W: 1 ft

Vertical Height above Surface: 0.5 ft

Accident Record: None

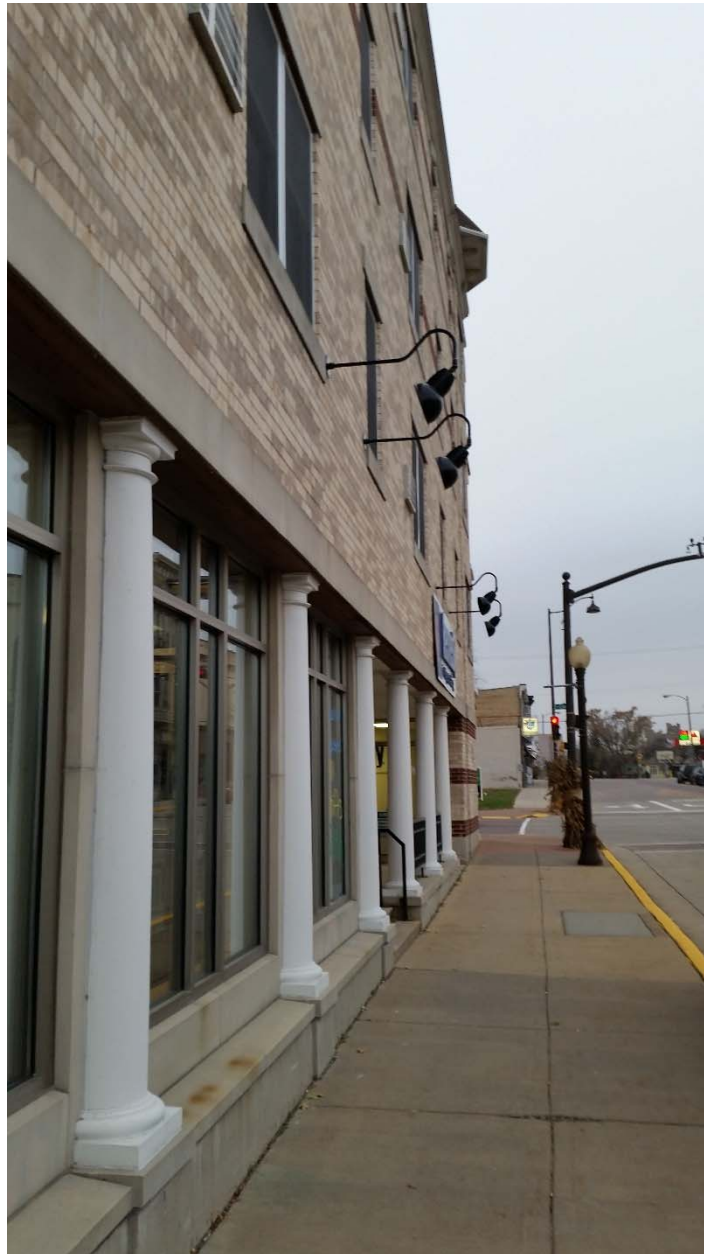
## SITE #108

**Location:** STA 542+00 LT

**Encroachment Type:** Building lights

**Horizontal Encroachment into Existing R/W:** 3.5 ft

**Vertical Height above Surface:** 15 – 20 ft

**Accident Record:** None

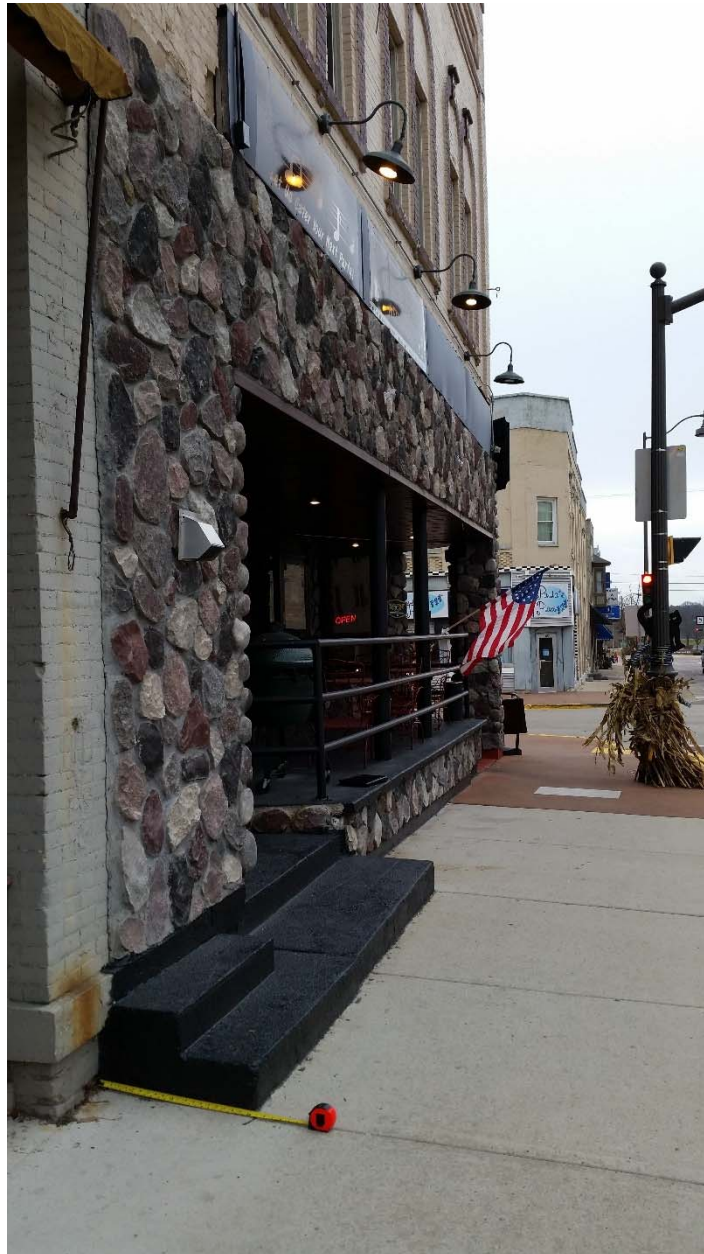
## SITE #109

**Location:** STA 543+65 RT

**Encroachment Type:** Steps

**Horizontal Encroachment into Existing R/W:** 2 ft

**Vertical Height above Surface:** 1 ft

**Accident Record:** None

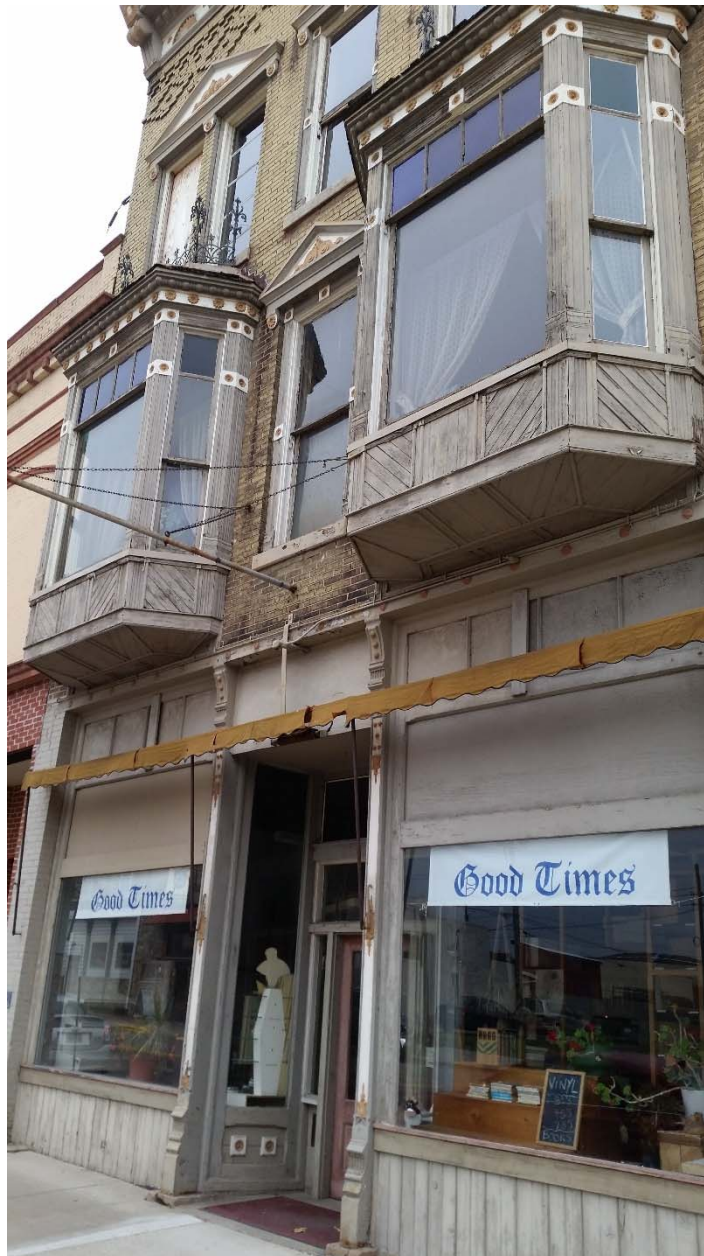
## SITE #110

**Location:** STA 543+85 RT

**Encroachment Type:** Canopy, dormers, and sign overhang

**Horizontal Encroachment into Existing R/W:** 5 ft

**Vertical Height above Surface:** 10 - 20 ft

**Accident Record:** None

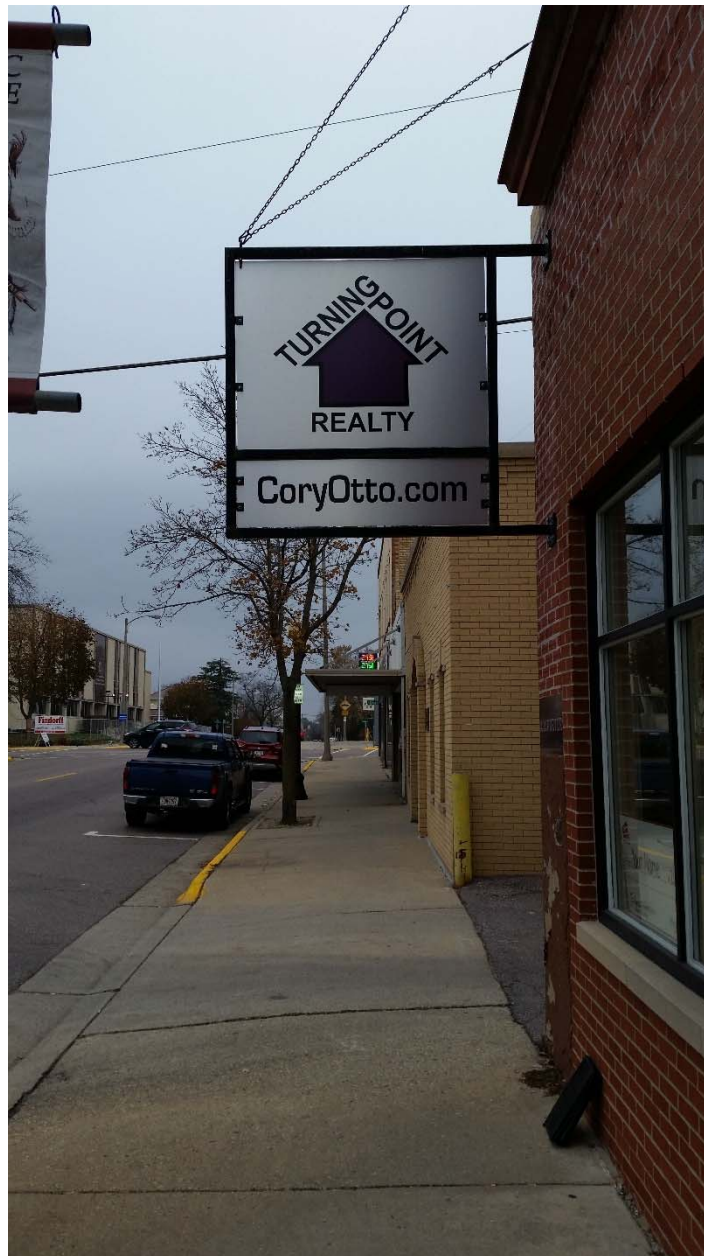
## SITE #111

Location: STA 544+38 RT

Encroachment Type: Sign overhang

Horizontal Encroachment into Existing R/W: 5 ft

Vertical Height above Surface: 10 - 15 ft

Accident Record: None

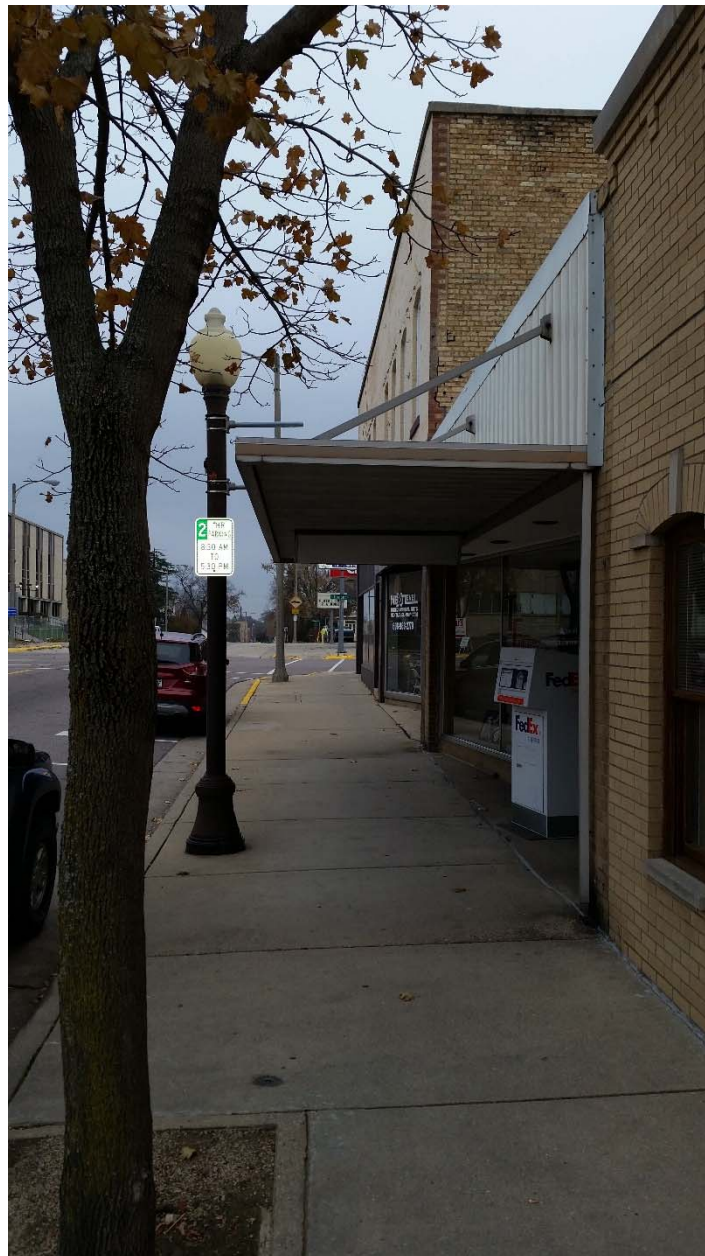
## SITE #112

Location: STA 545+00 RT

Encroachment Type: Canopy overhang

Horizontal Encroachment into Existing R/W: 6 ft

Vertical Height above Surface: 10 – 15 ft

Accident Record: None

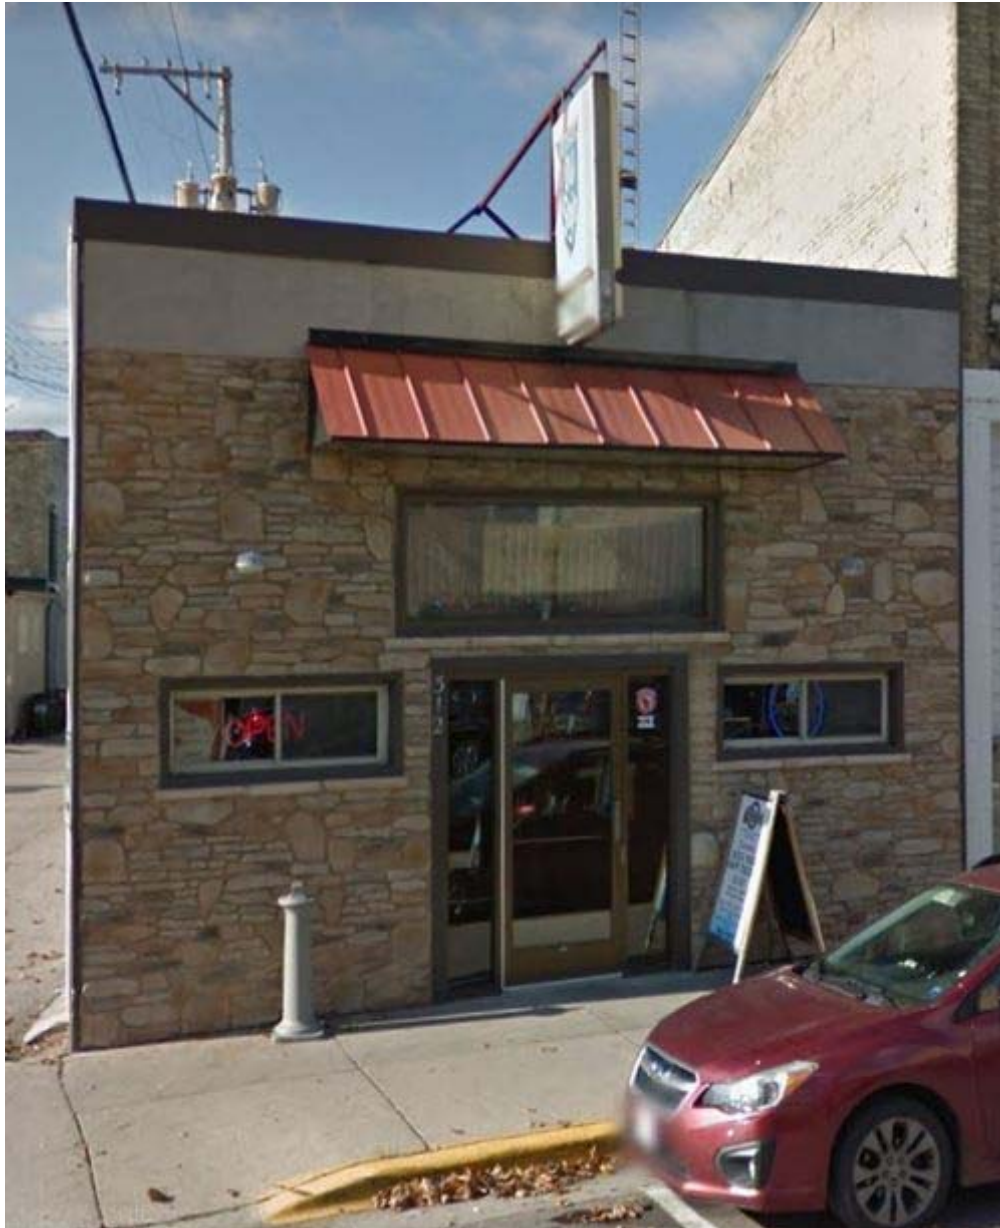
## SITE #113

**Location:** STA 544+80 LT

**Encroachment Type:** Sign and canopy overhang

**Horizontal Encroachment into Existing R/W:** 4 ft

**Vertical Height above Surface:** 10 - 18 ft

**Accident Record:** None

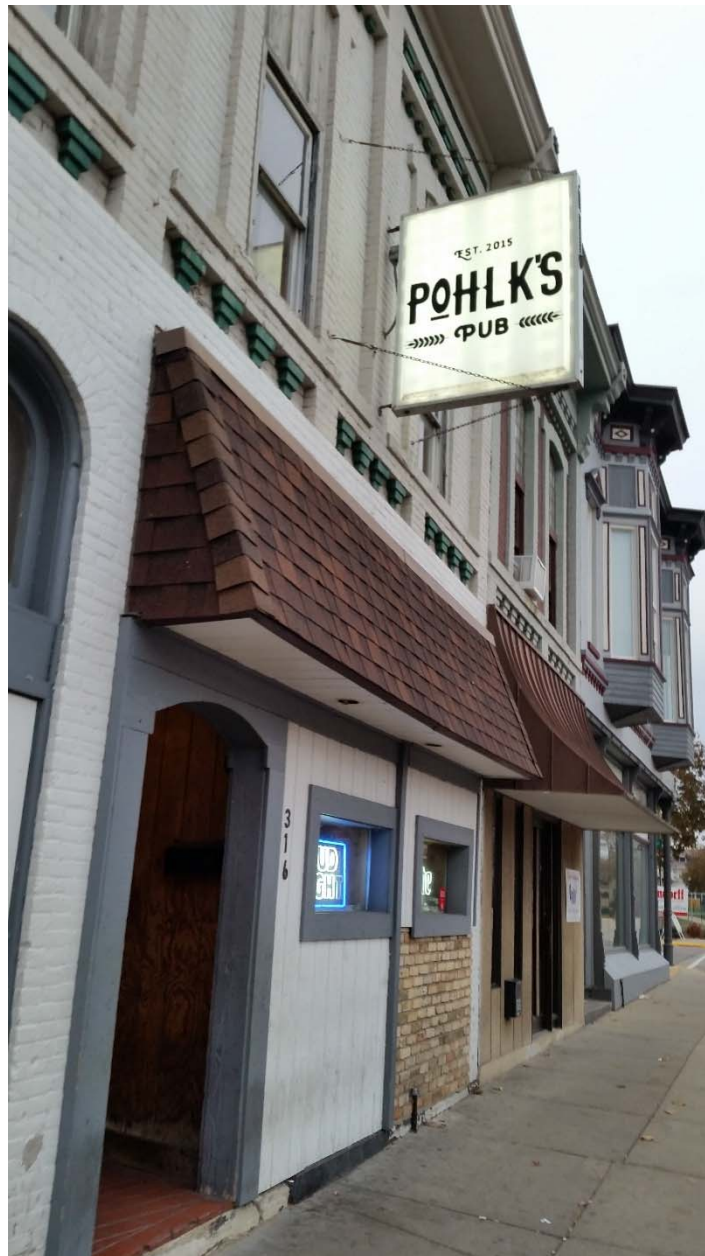
## SITE #114

Location: STA 545+10 LT

Encroachment Type: Sign and canopy overhang

Horizontal Encroachment into Existing R/W: 4 ft

Vertical Height above Surface: 8 - 20 ft

Accident Record: None

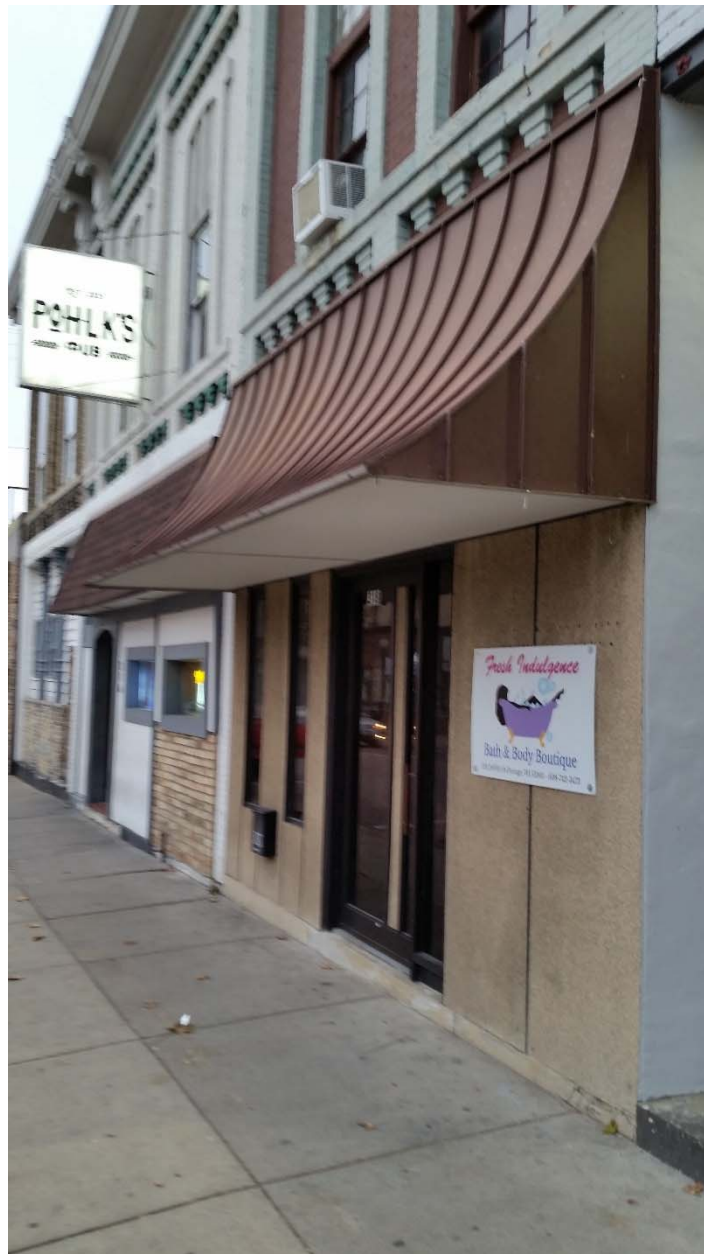
## SITE #115

**Location:** STA 545+40 LT

**Encroachment Type:** Canopy overhang

**Horizontal Encroachment into Existing R/W:** 4 ft

**Vertical Height above Surface:** 8 - 15 ft

**Accident Record:** None

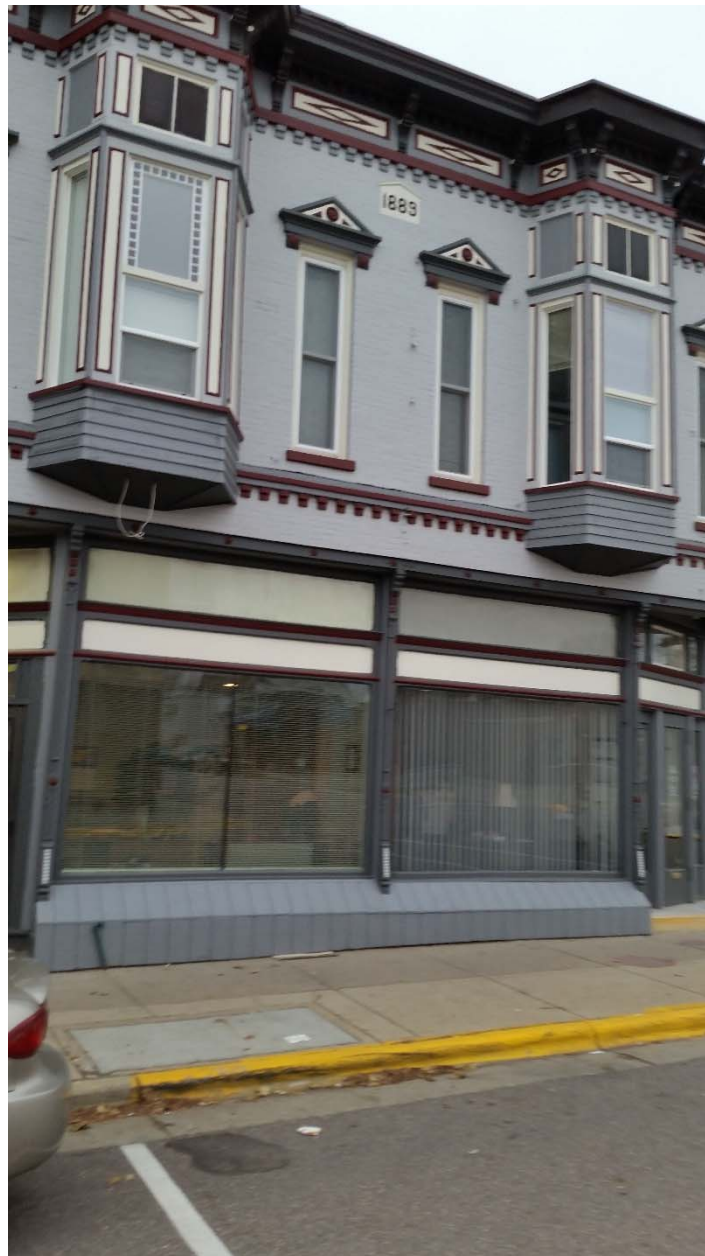
## SITE #116

**Location:** STA 545+70 LT

**Encroachment Type:** Building dormers overhang

**Horizontal Encroachment into Existing R/W:** 3 ft

**Vertical Height above Surface:** 10 - 25 ft

**Accident Record:** None

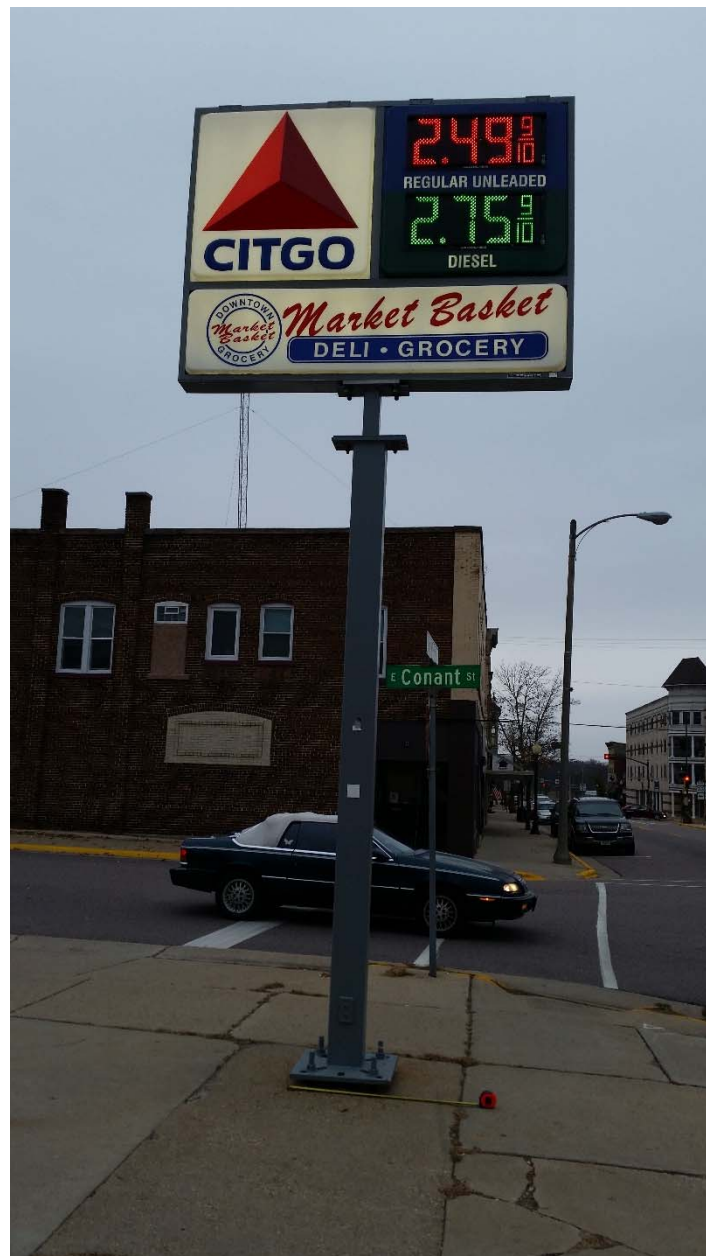
## SITE #117

Location: STA 546+41 RT

Encroachment Type: Sign

Horizontal Encroachment into Existing R/W: 5 ft

Vertical Height above Surface: 0 - 20 ft

Accident Record: None

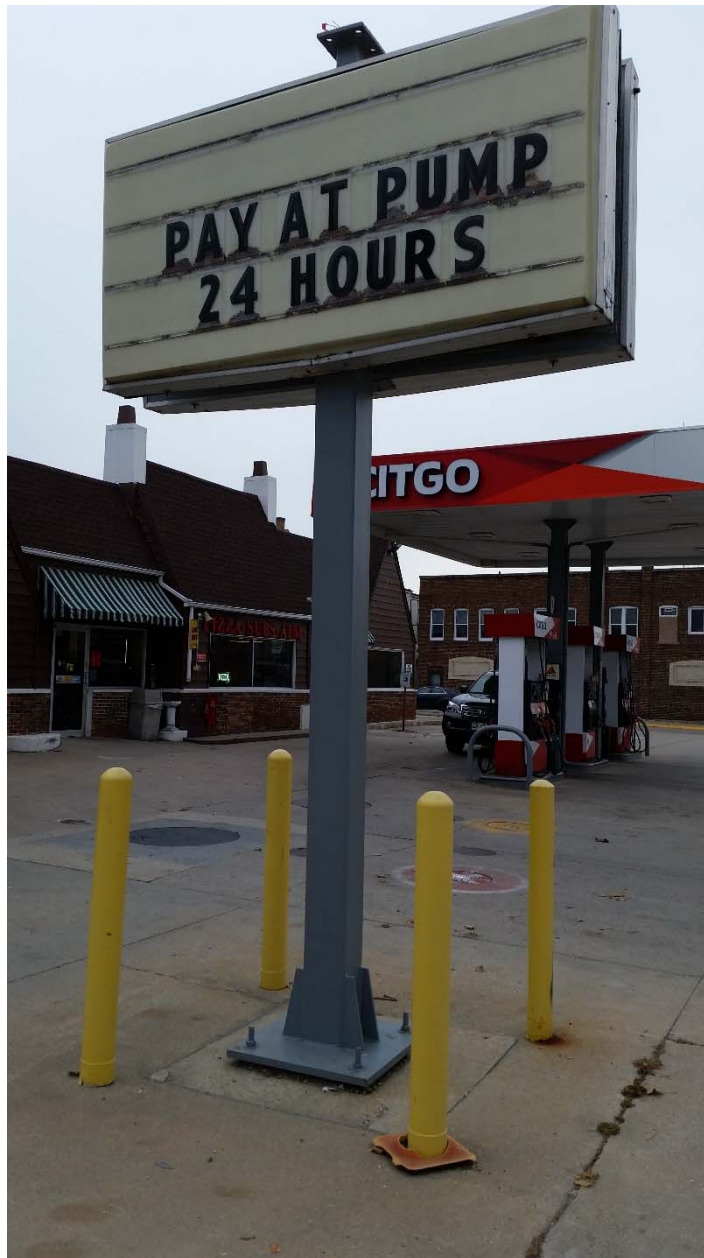
## SITE #118

**Location:** STA 547+48 RT

**Encroachment Type:** Sign and bollards

**Horizontal Encroachment into Existing R/W:** 3 ft

**Vertical Height above Surface:** 0 - 15 ft

**Accident Record:** None

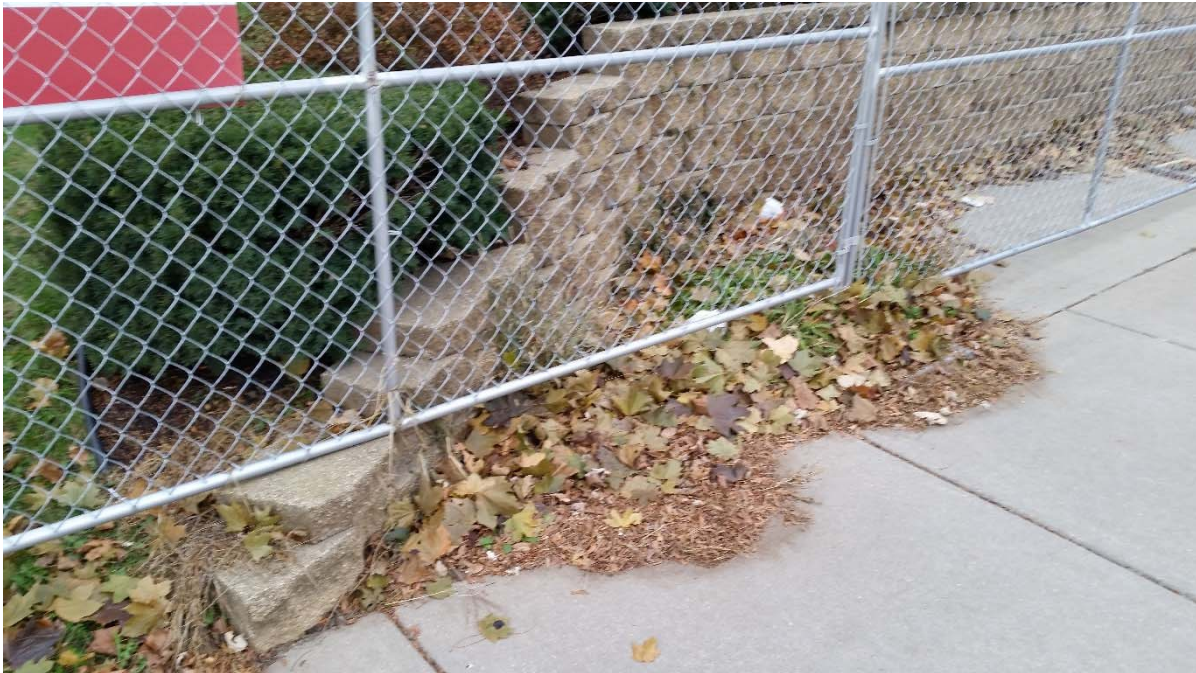
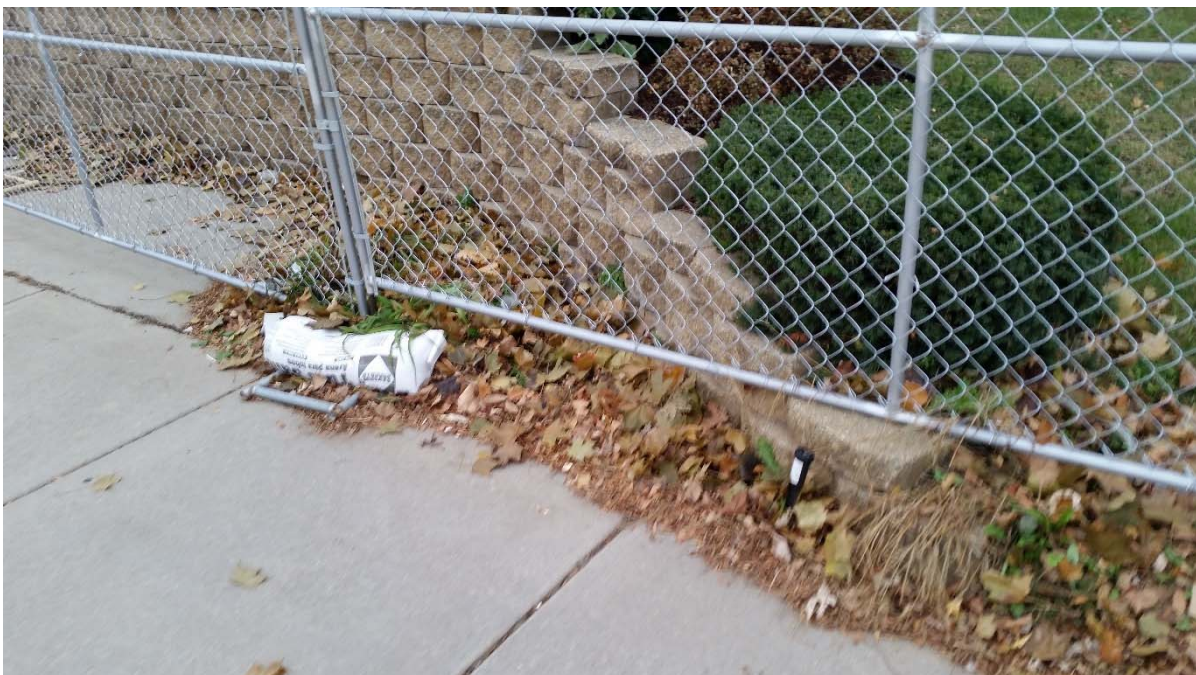
## SITE #119

Location: STA 548+00 LT

Encroachment Type: Wall

Horizontal Encroachment into Existing R/W: 4.75 ft

Vertical Height above Surface: 0 - 4 ft

Accident Record: None

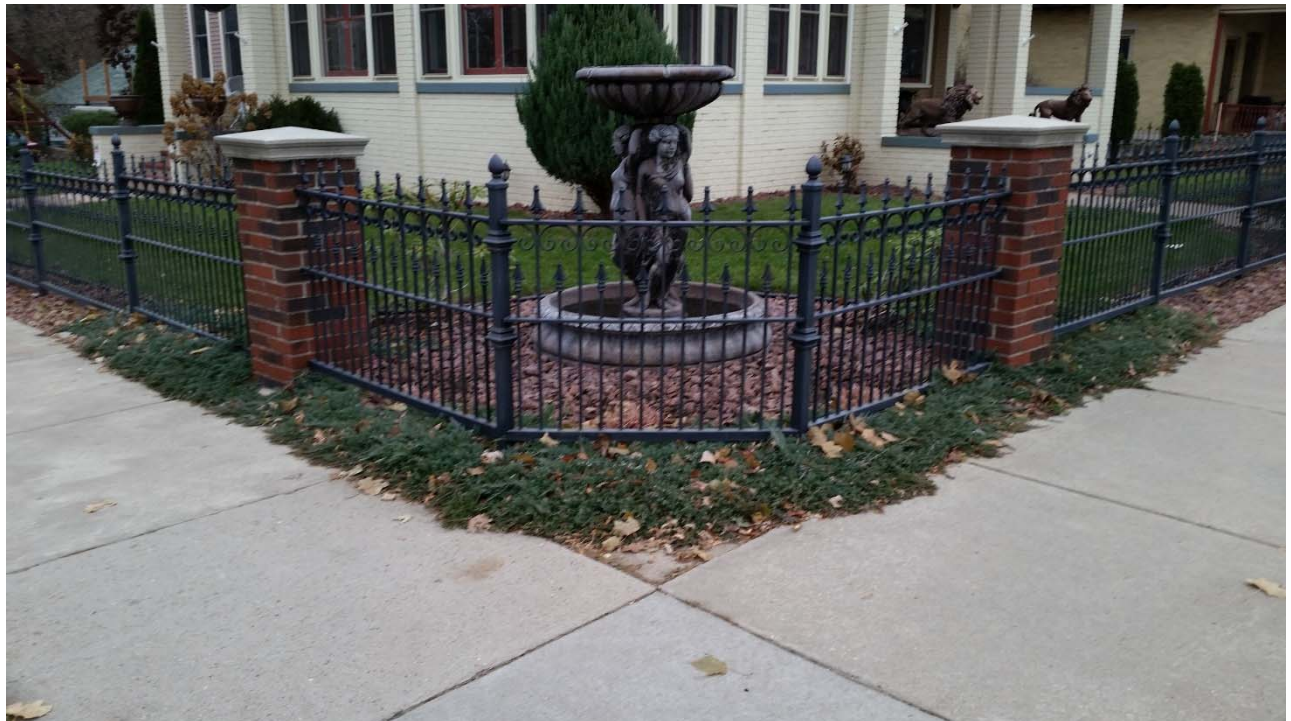
## SITE #120

**Location:** STA 549+53 RT

**Encroachment Type:** Iron Fencing

**Horizontal Encroachment into Existing R/W:** 0.5 ft

**Vertical Height above Surface:** 0 - 4 ft

**Accident Record:** None

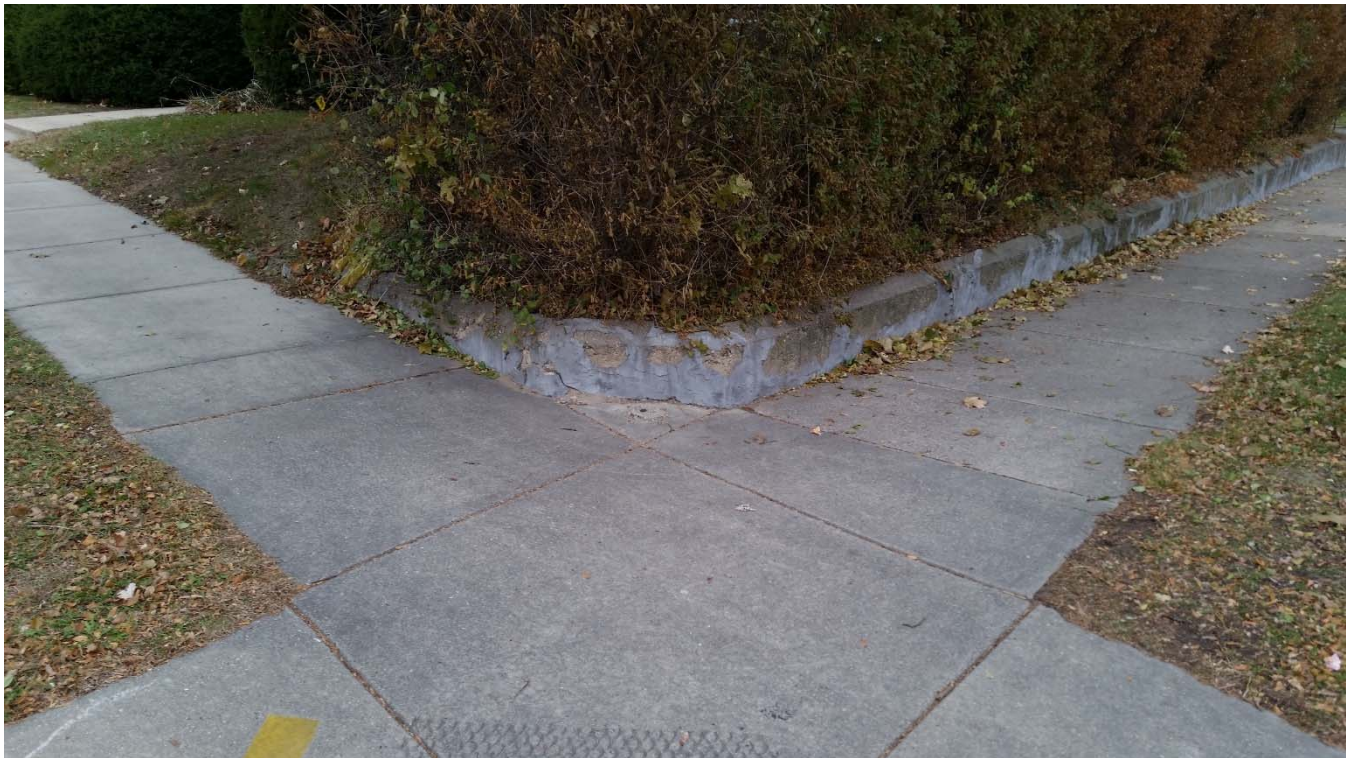
## SITE #121

**Location:** STA 49+68 LT

**Encroachment Type:** Concrete retaining wall

**Horizontal Encroachment into Existing R/W:** 0.5 ft

**Vertical Height above Surface:** N/A

**Accident Record:** None
