**STATE OF WISCONSIN
DEPARTMENT OF TRANSPORTATION**

**Inspection Report for
B-16-038-0003**

**USH 2 over BN Rail Road
Oct 19, 2015**

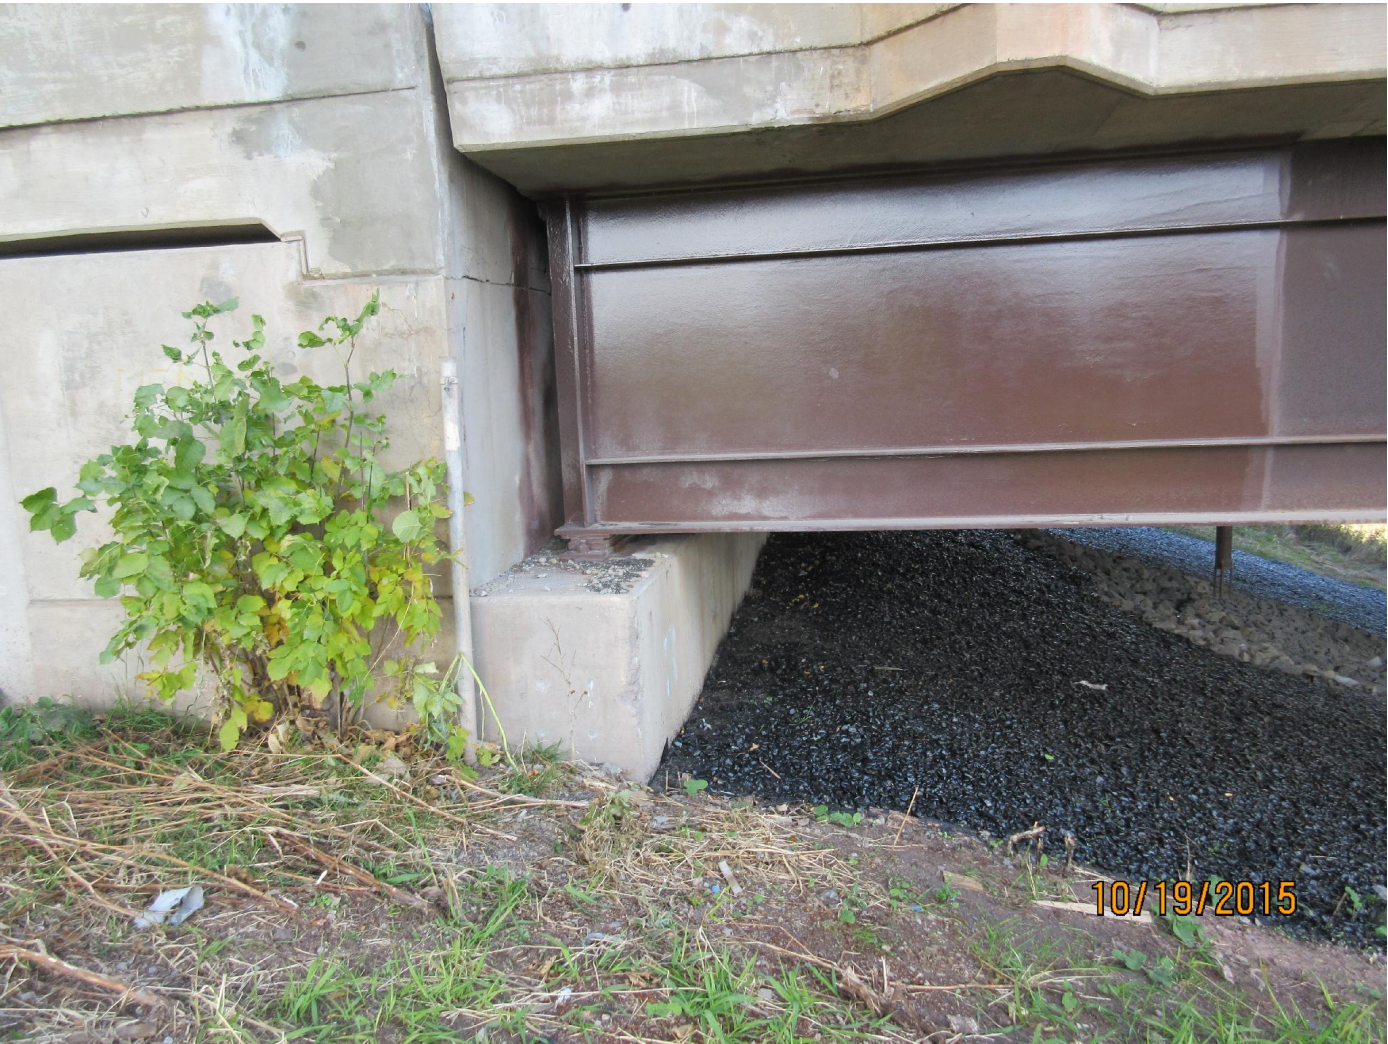
South fascia looking east from Pier 4.

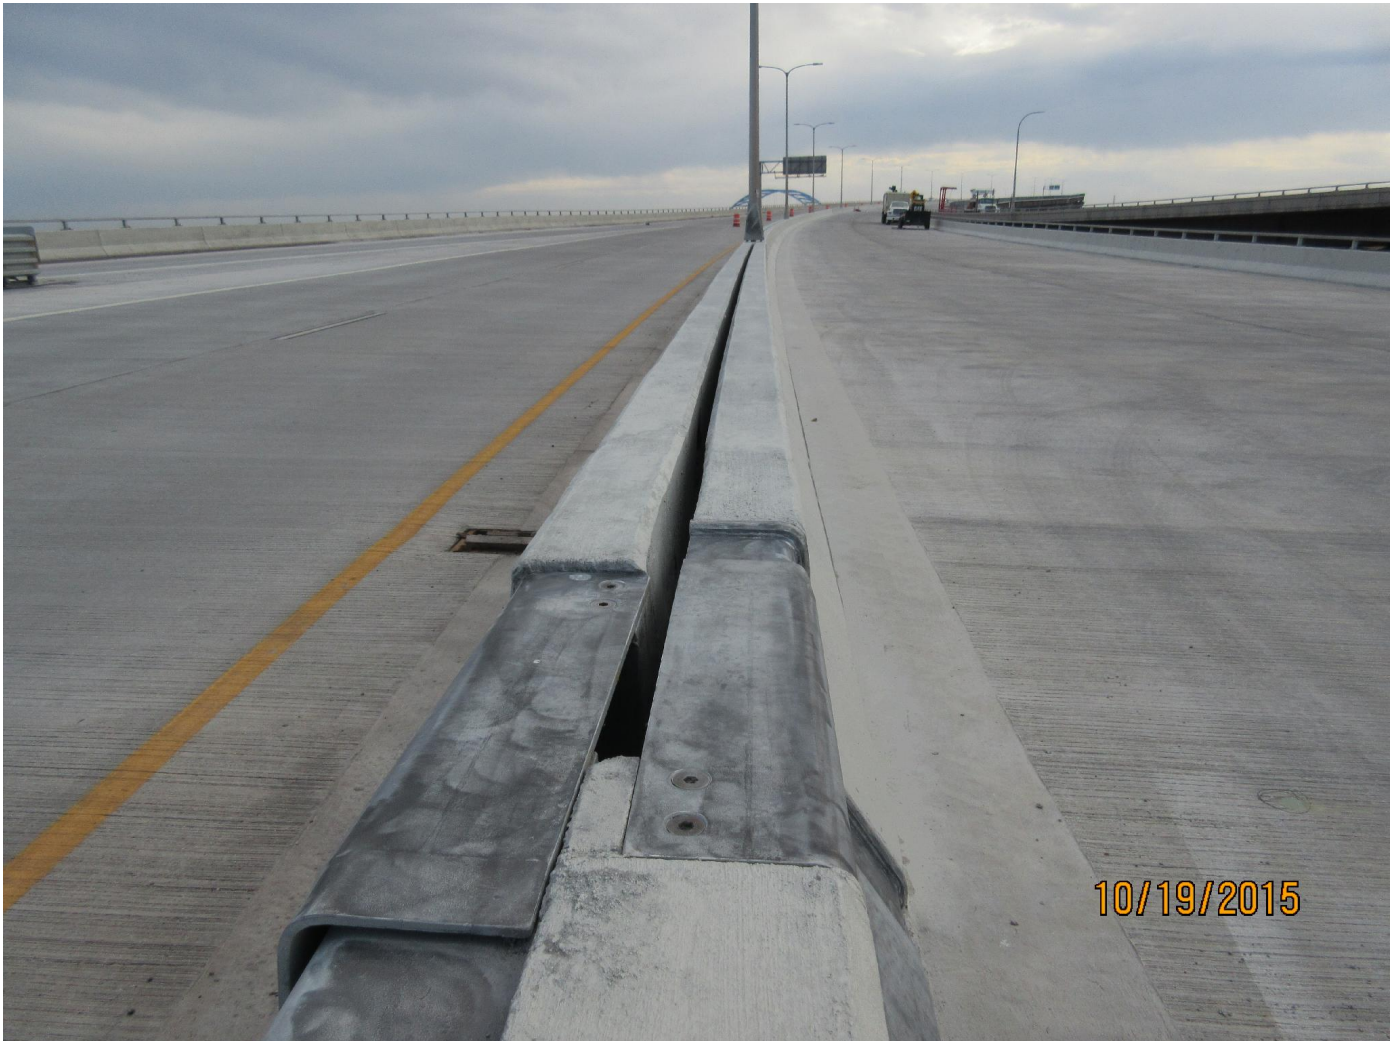
Finished at Jt 3-4.

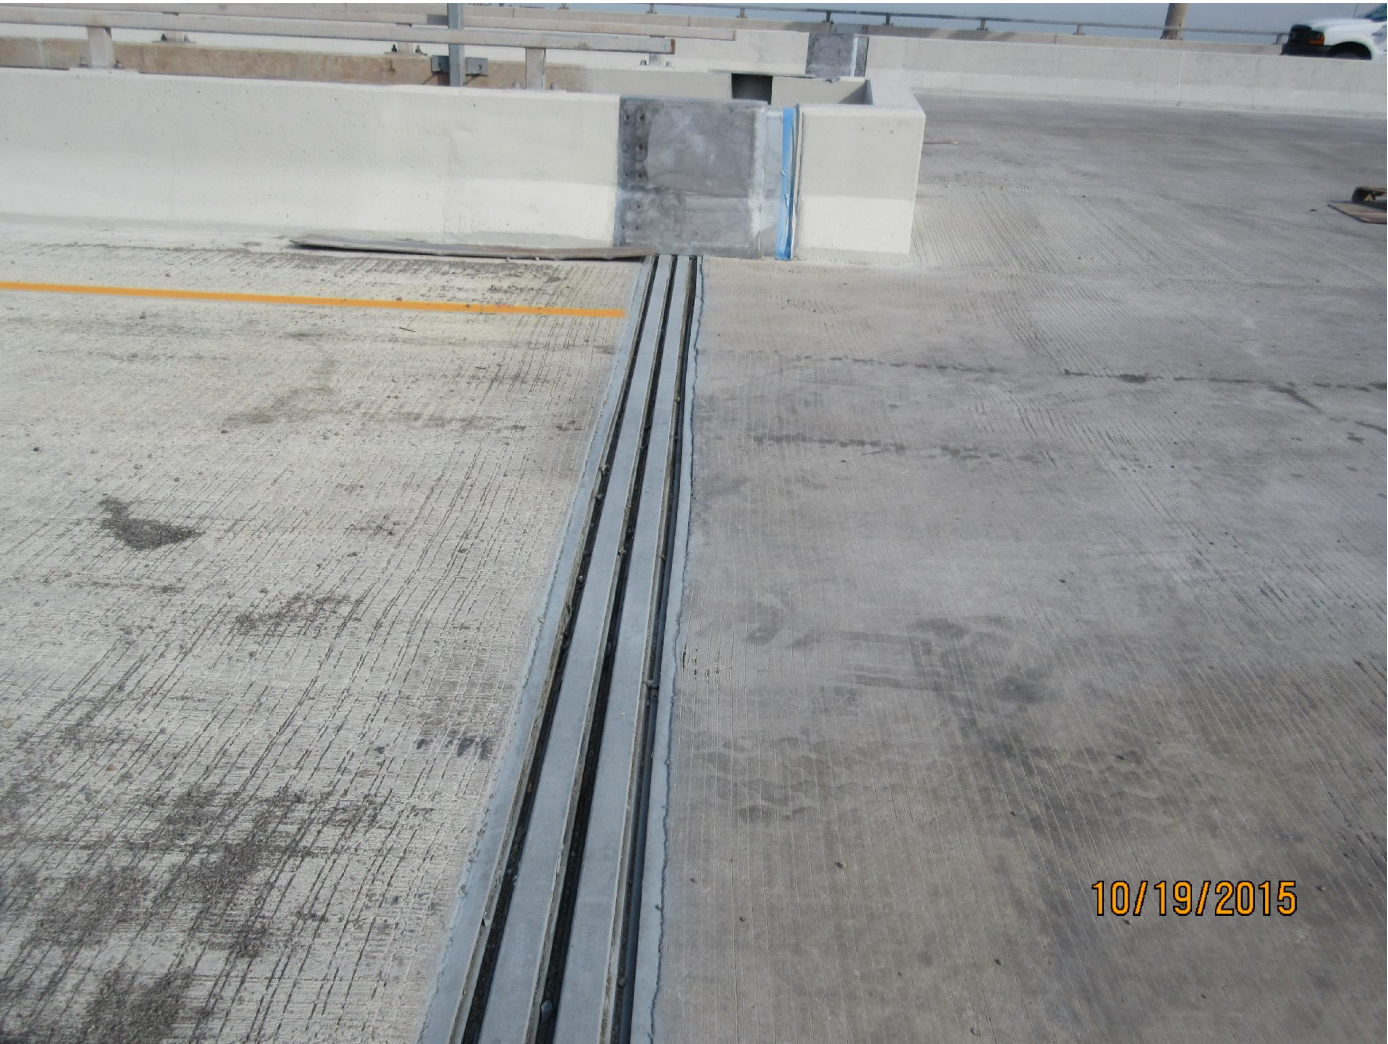
Note continued separated median.

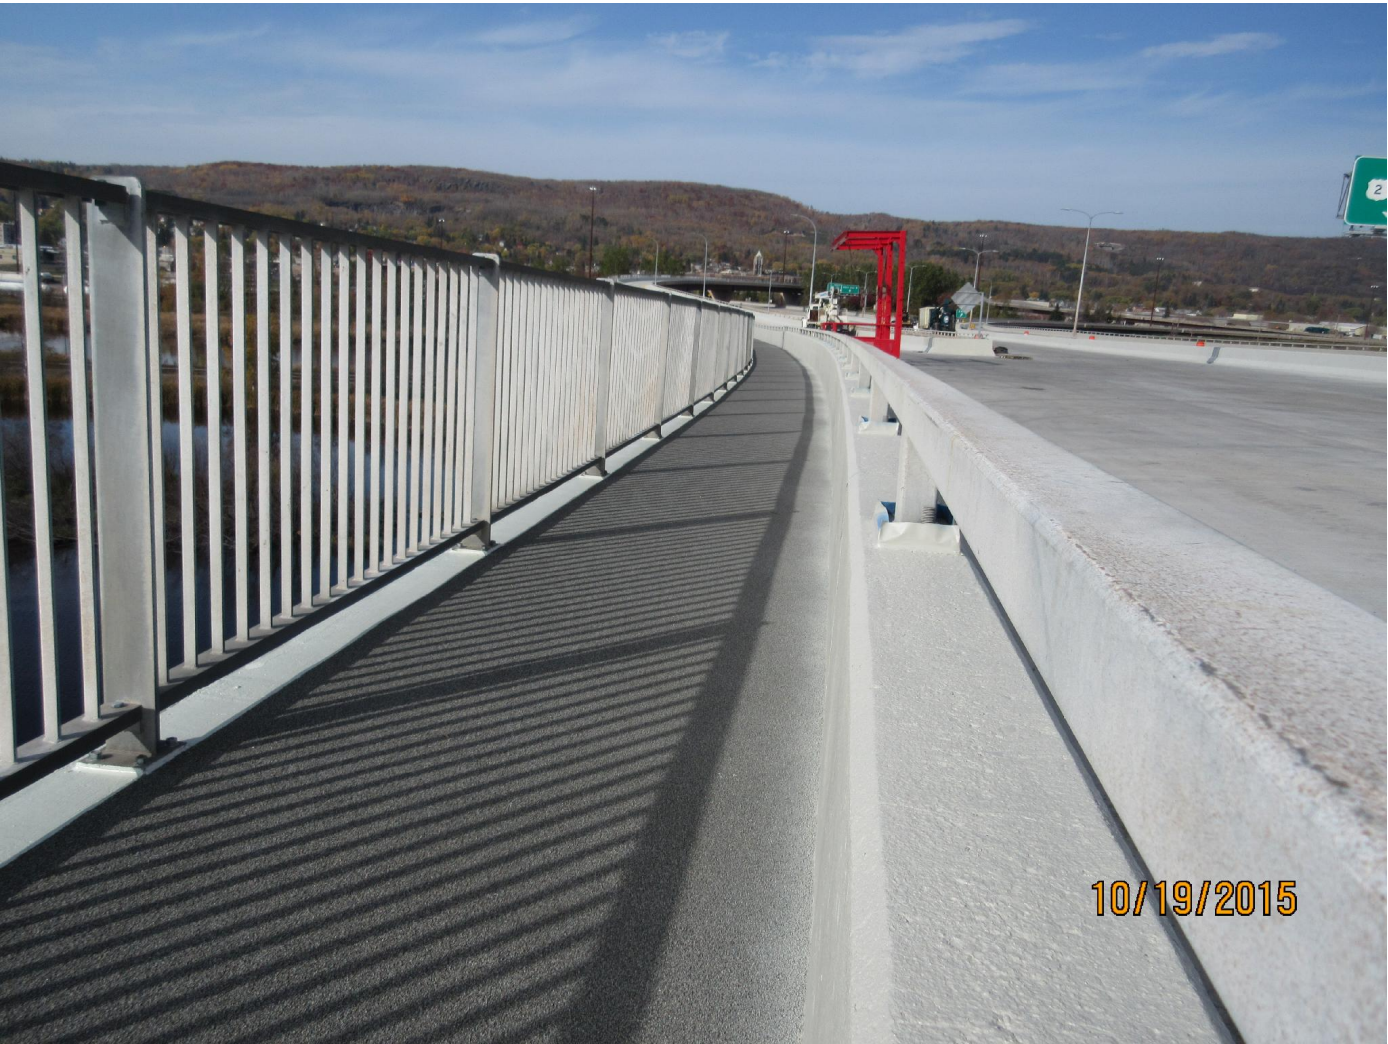
Typical work on sidewalk included adding a polymer overlay from parapet to base of rail, epoxy sealer from poly overlay to exterior girder, and caulking around rail base.

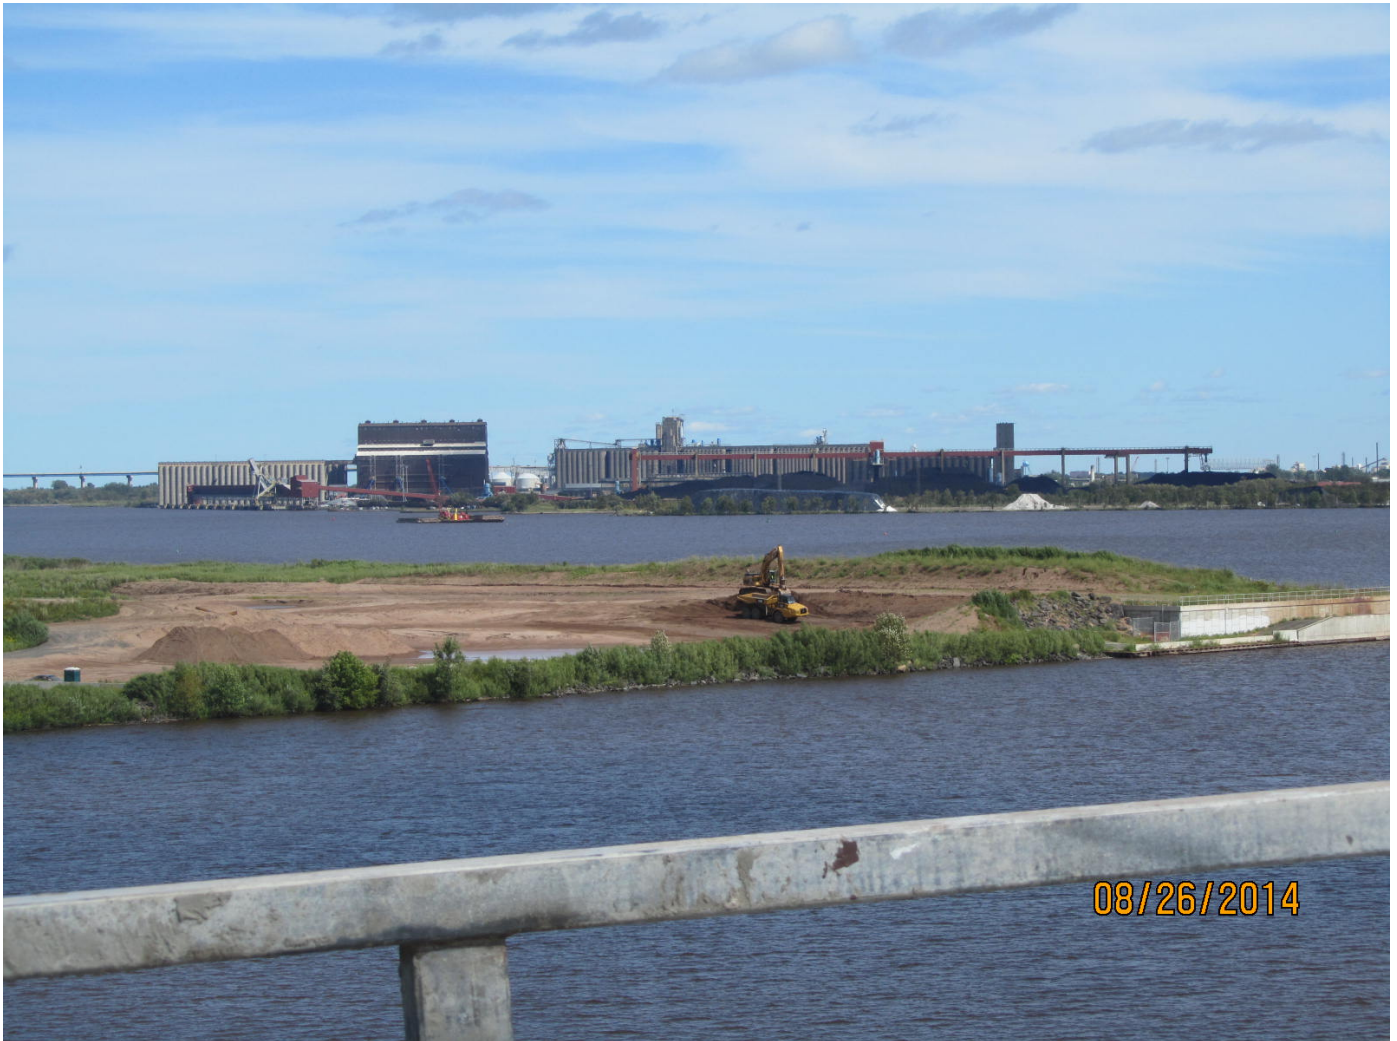
Routine
Document Comment/Description
scrapes along parapet rail

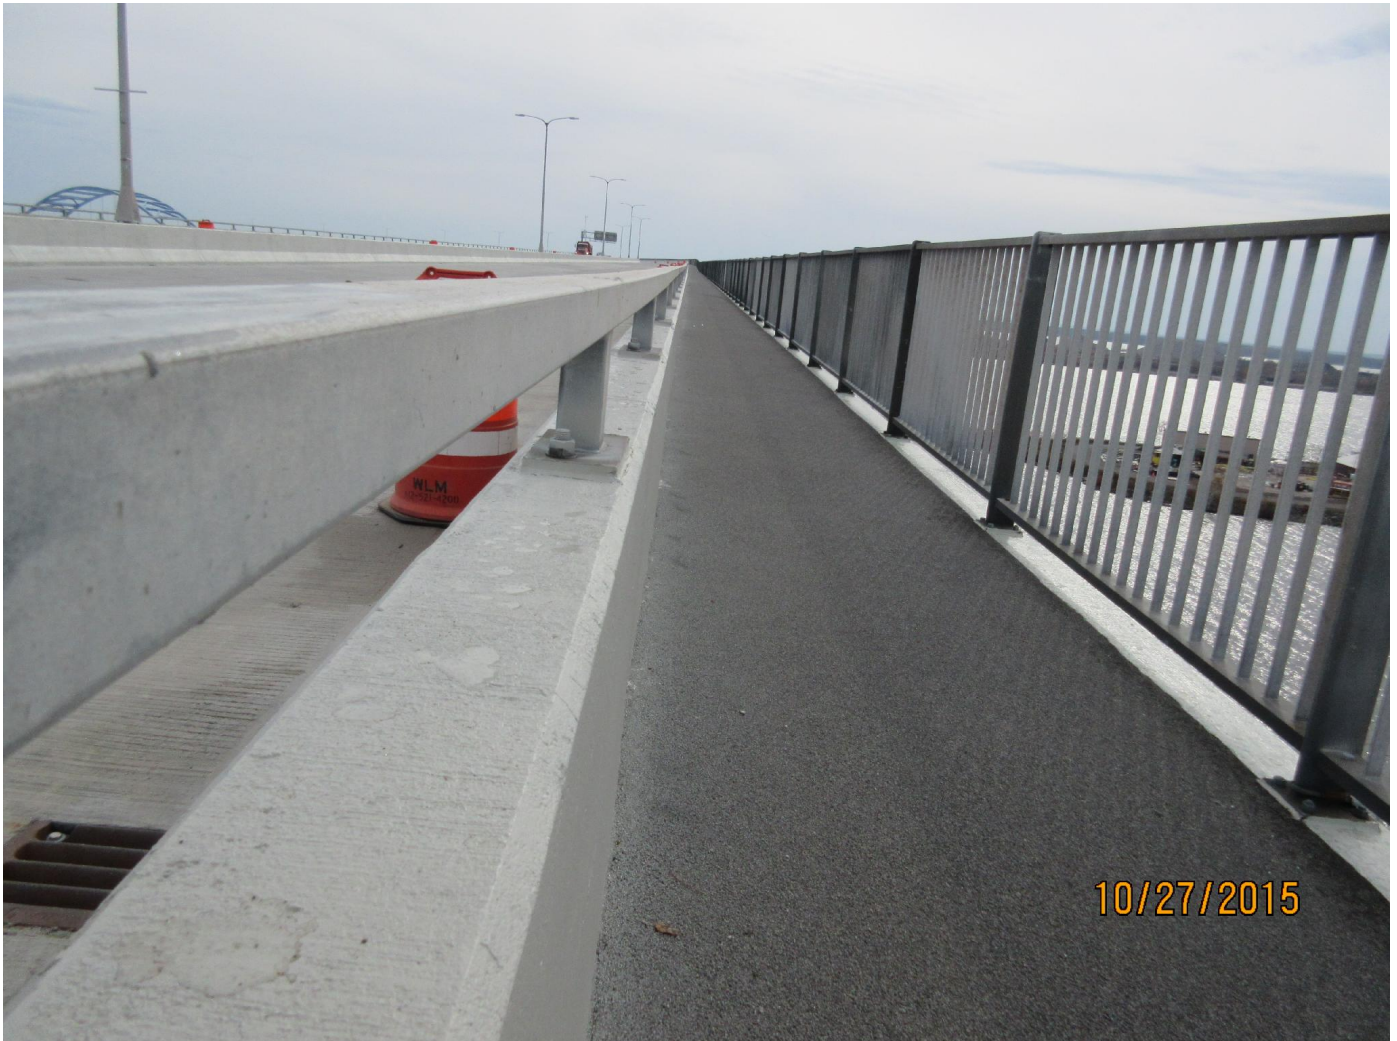
Typical work on sidewalk.

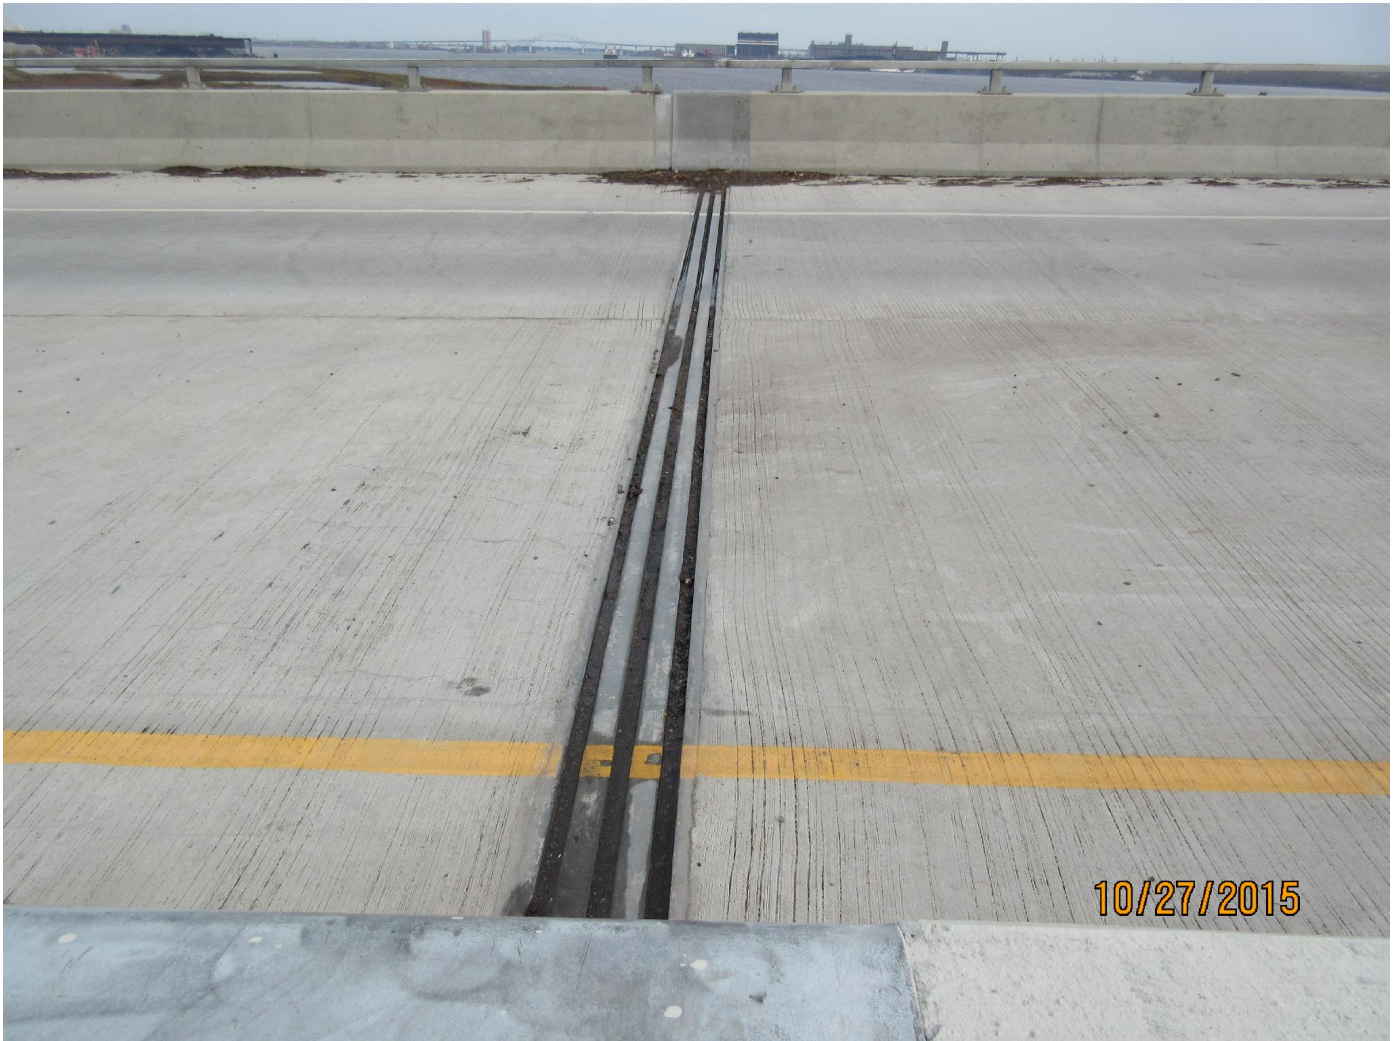
Typical overlay cracking.

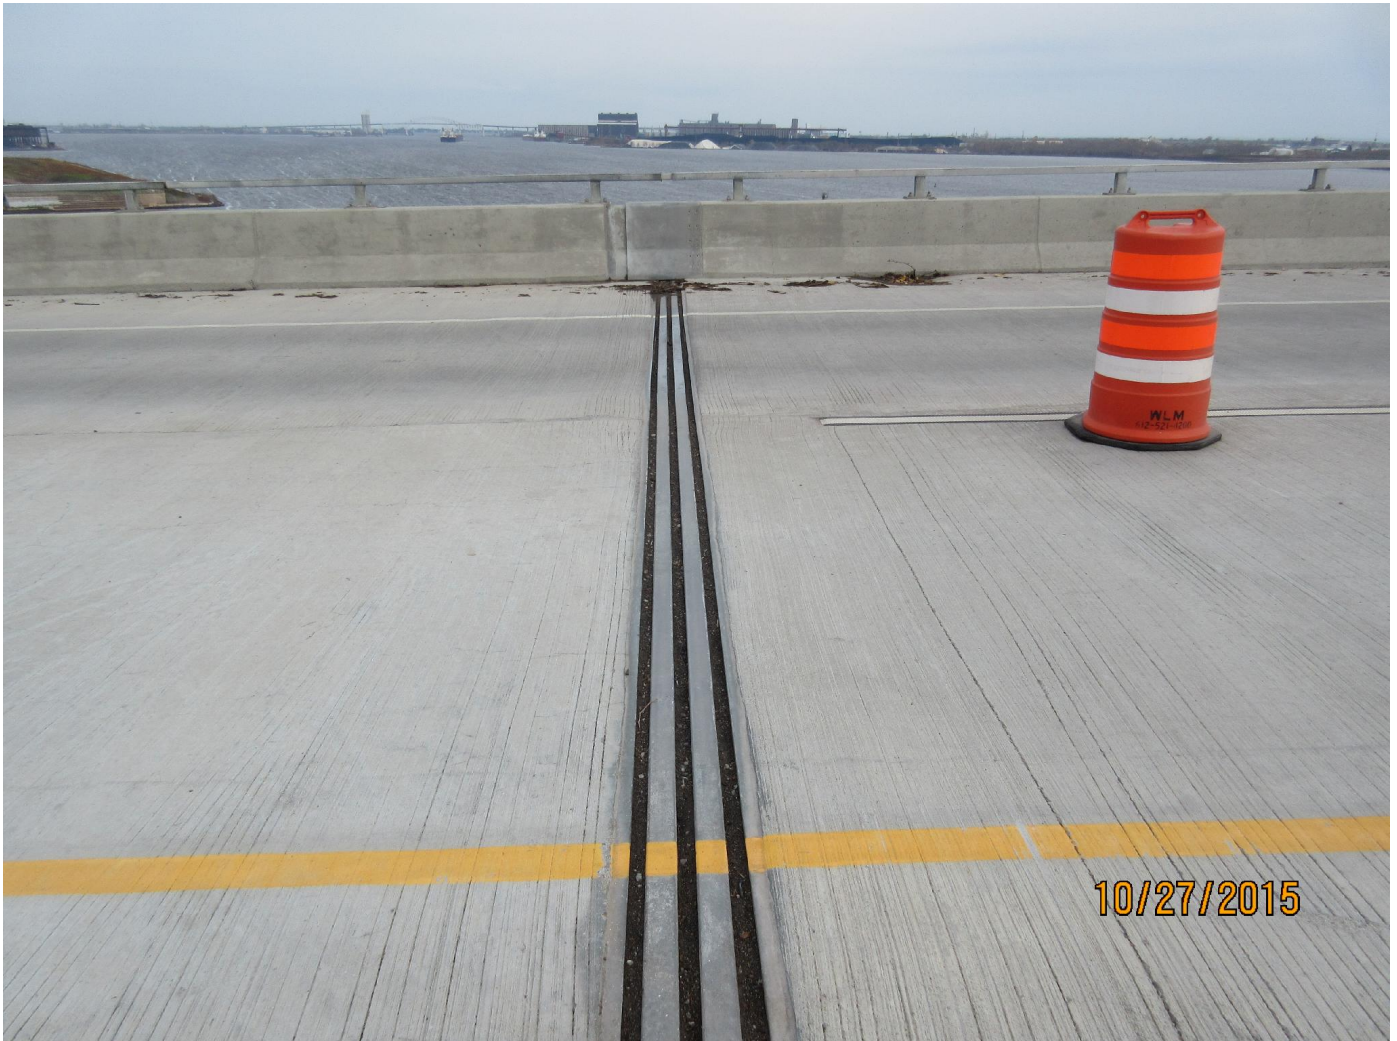
Typical cracking in overlay.

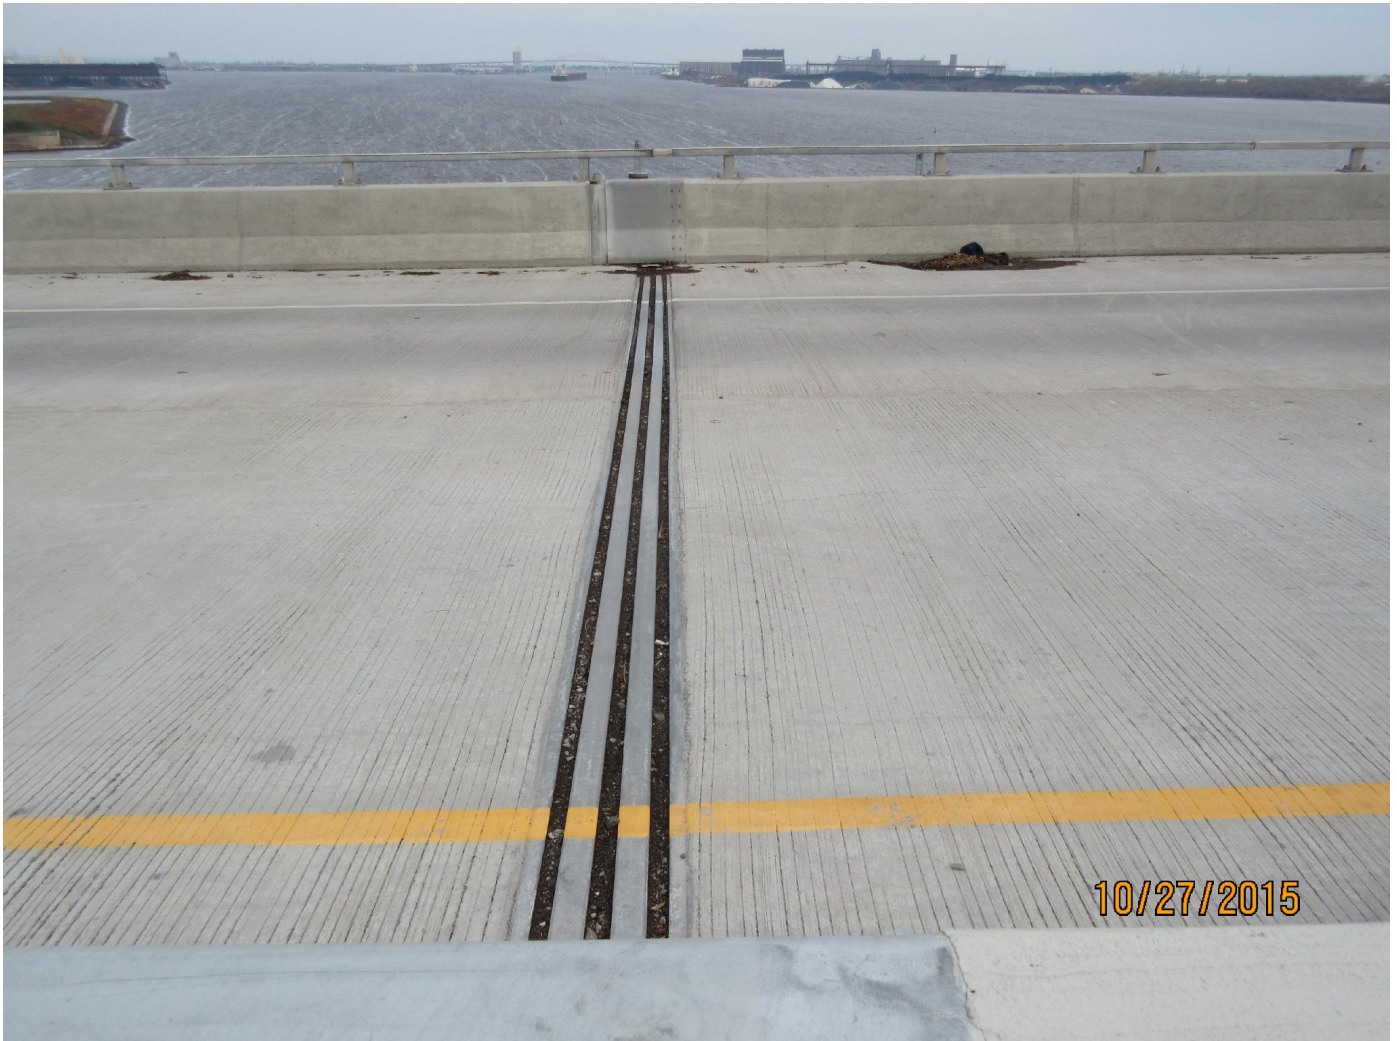
Typical cracking in overlay.

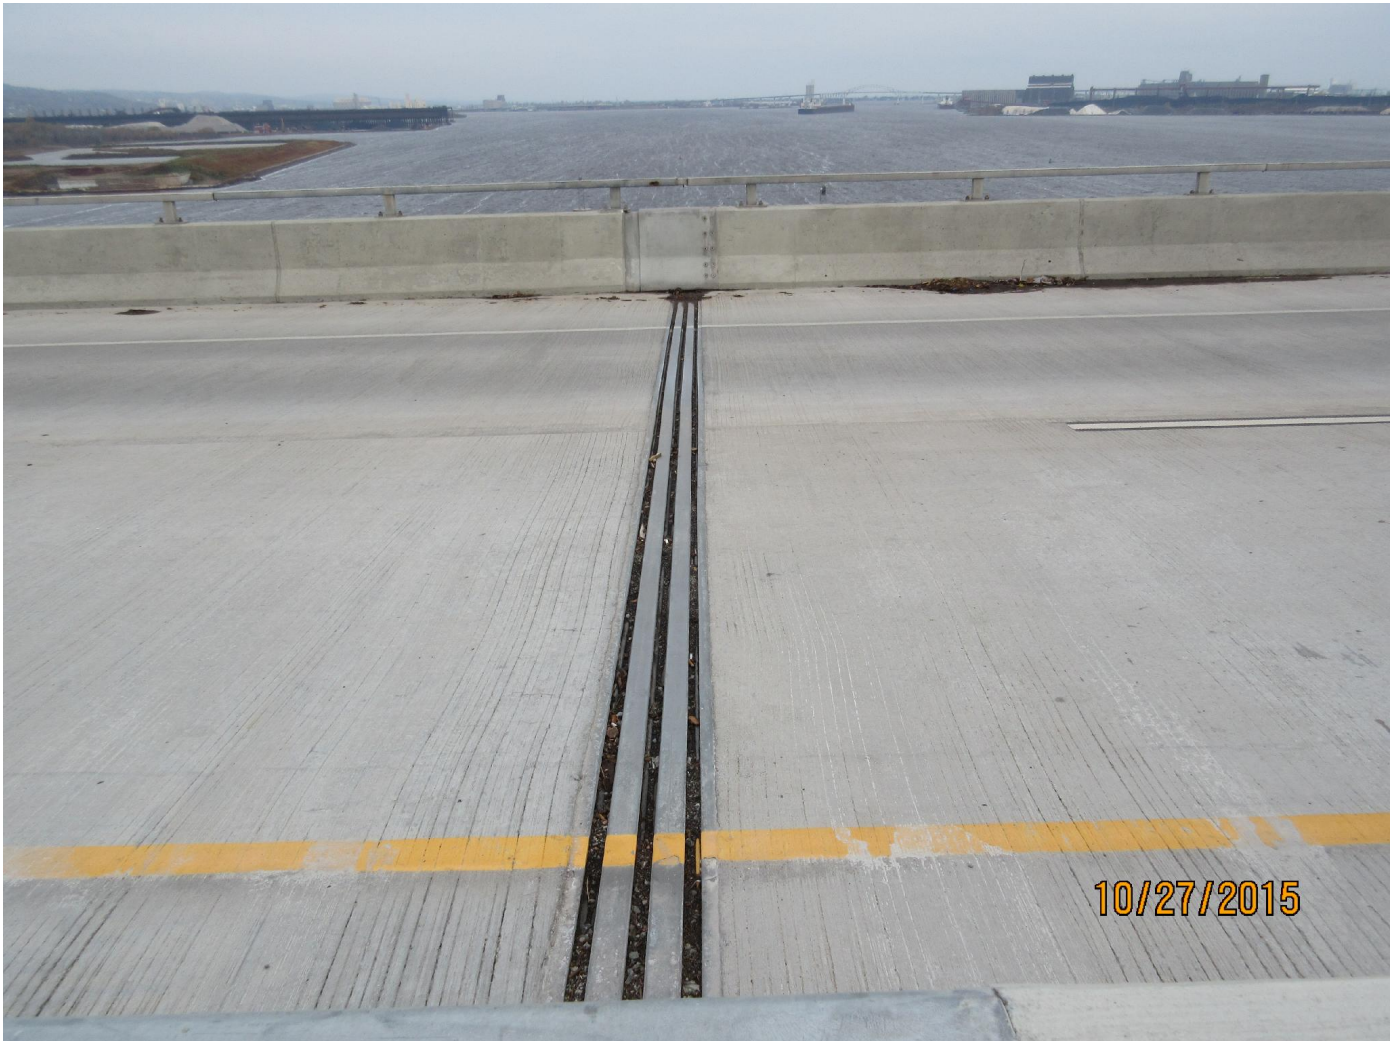
Typical cracking in overlay.

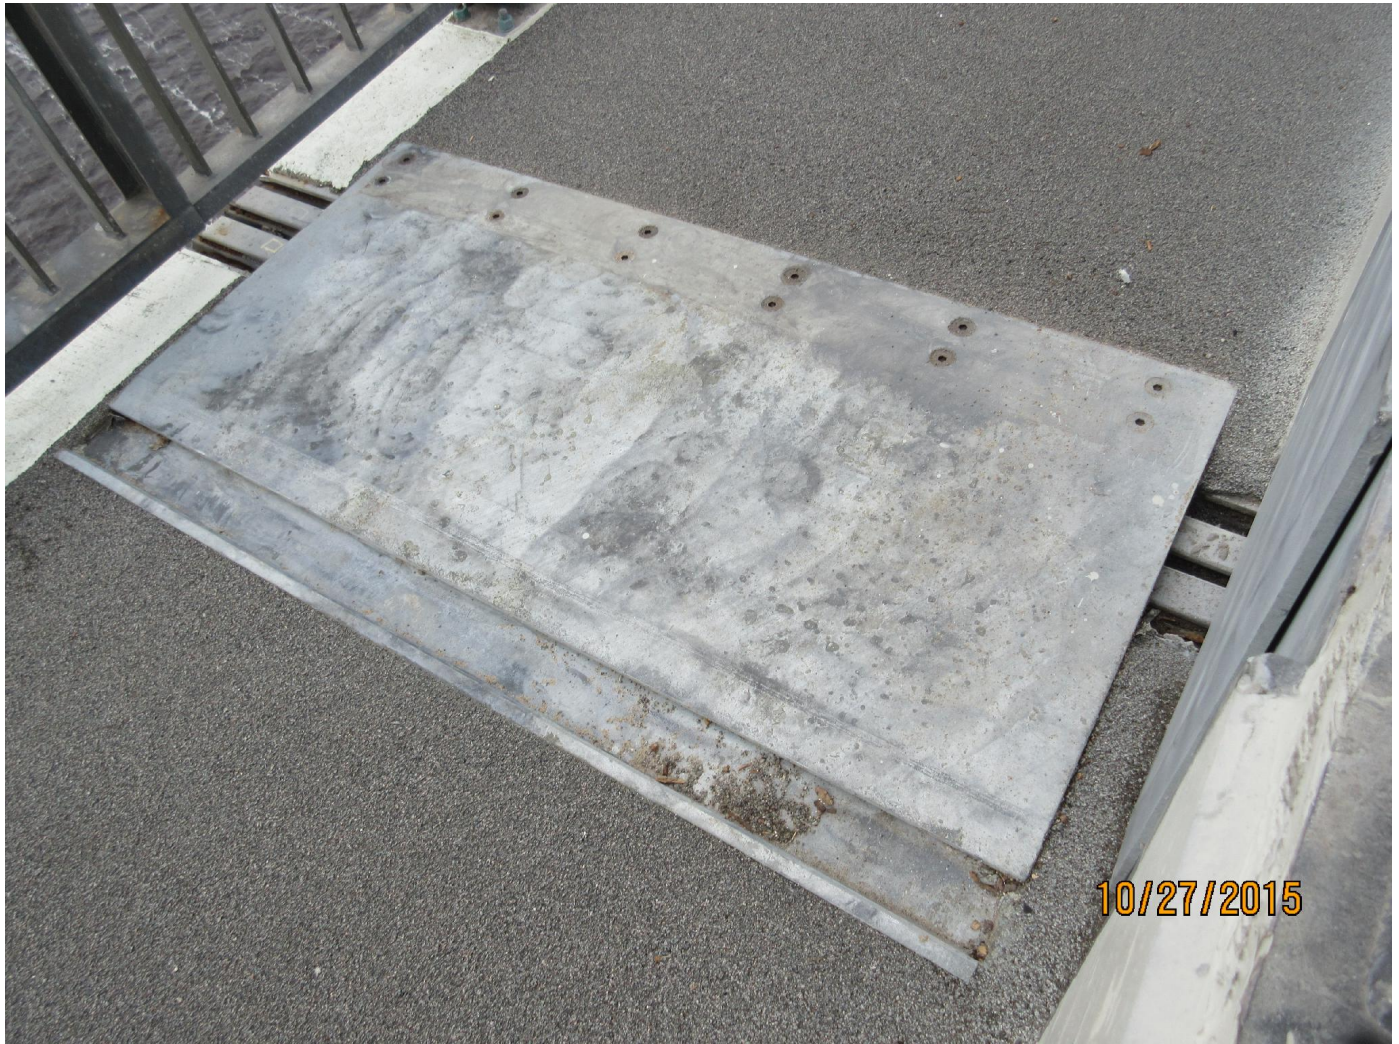
Typical sidewalk work.

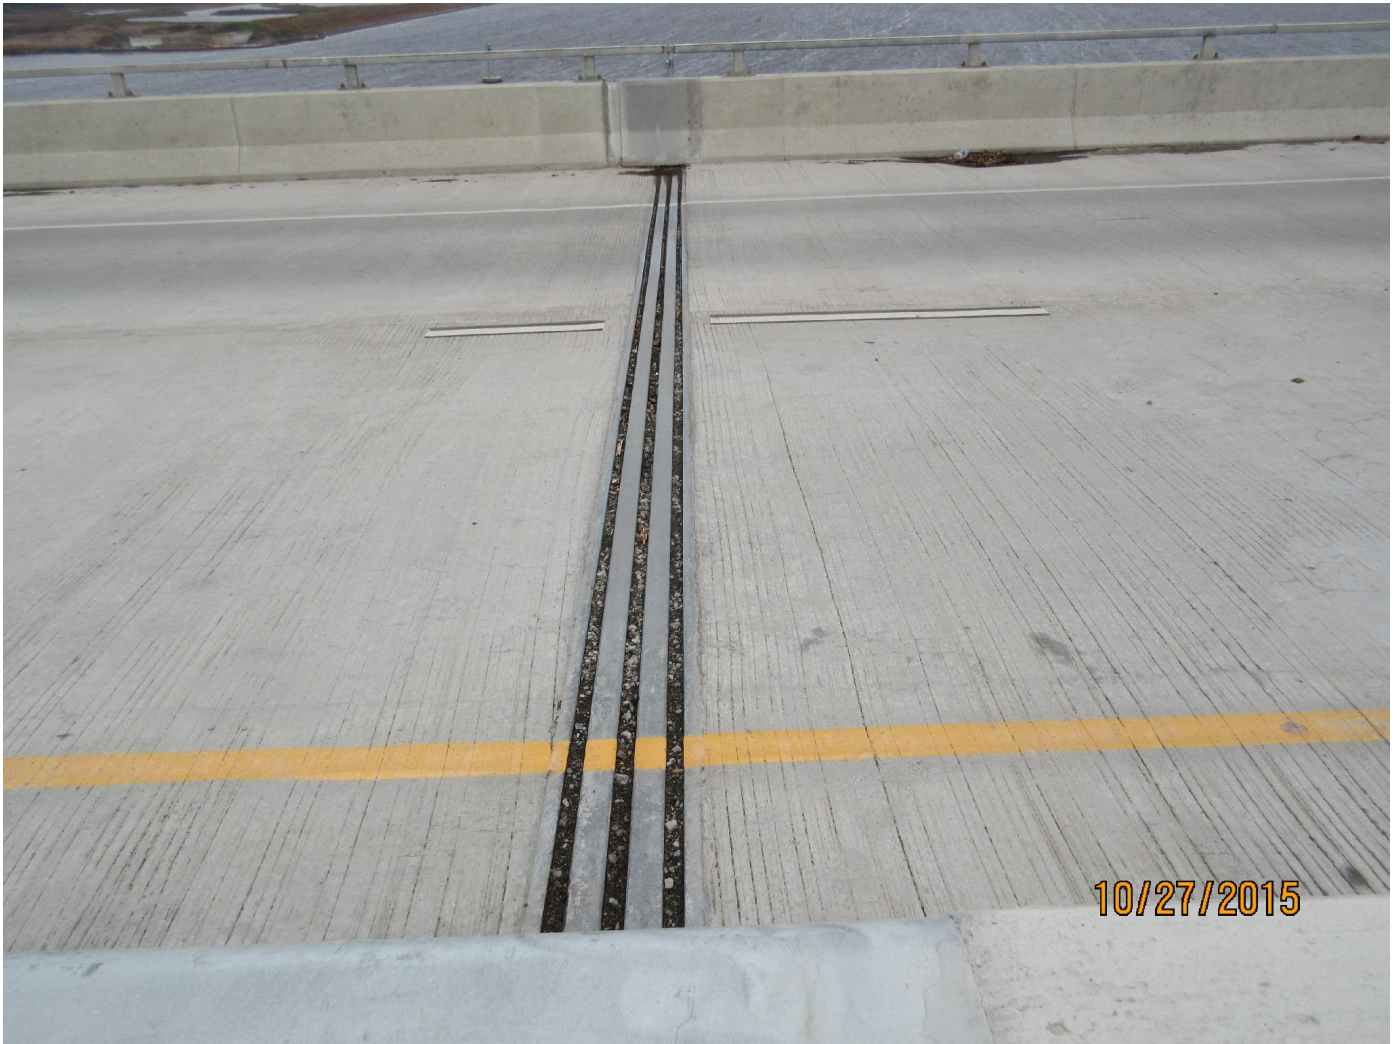
Typical cracking in overlay.

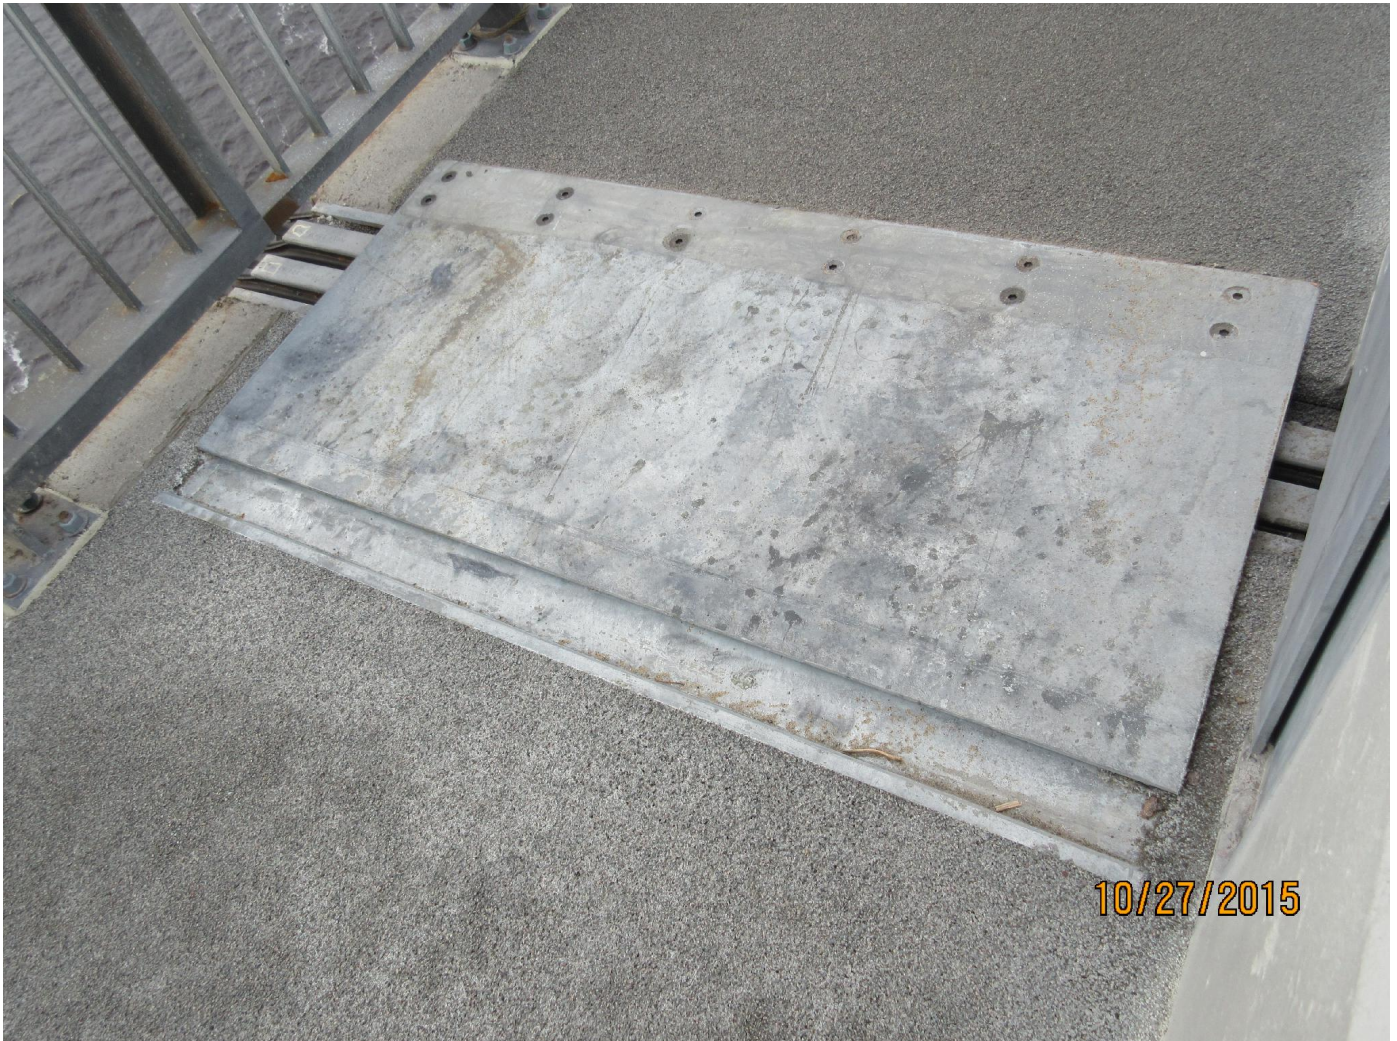
Typical sidewalk work.

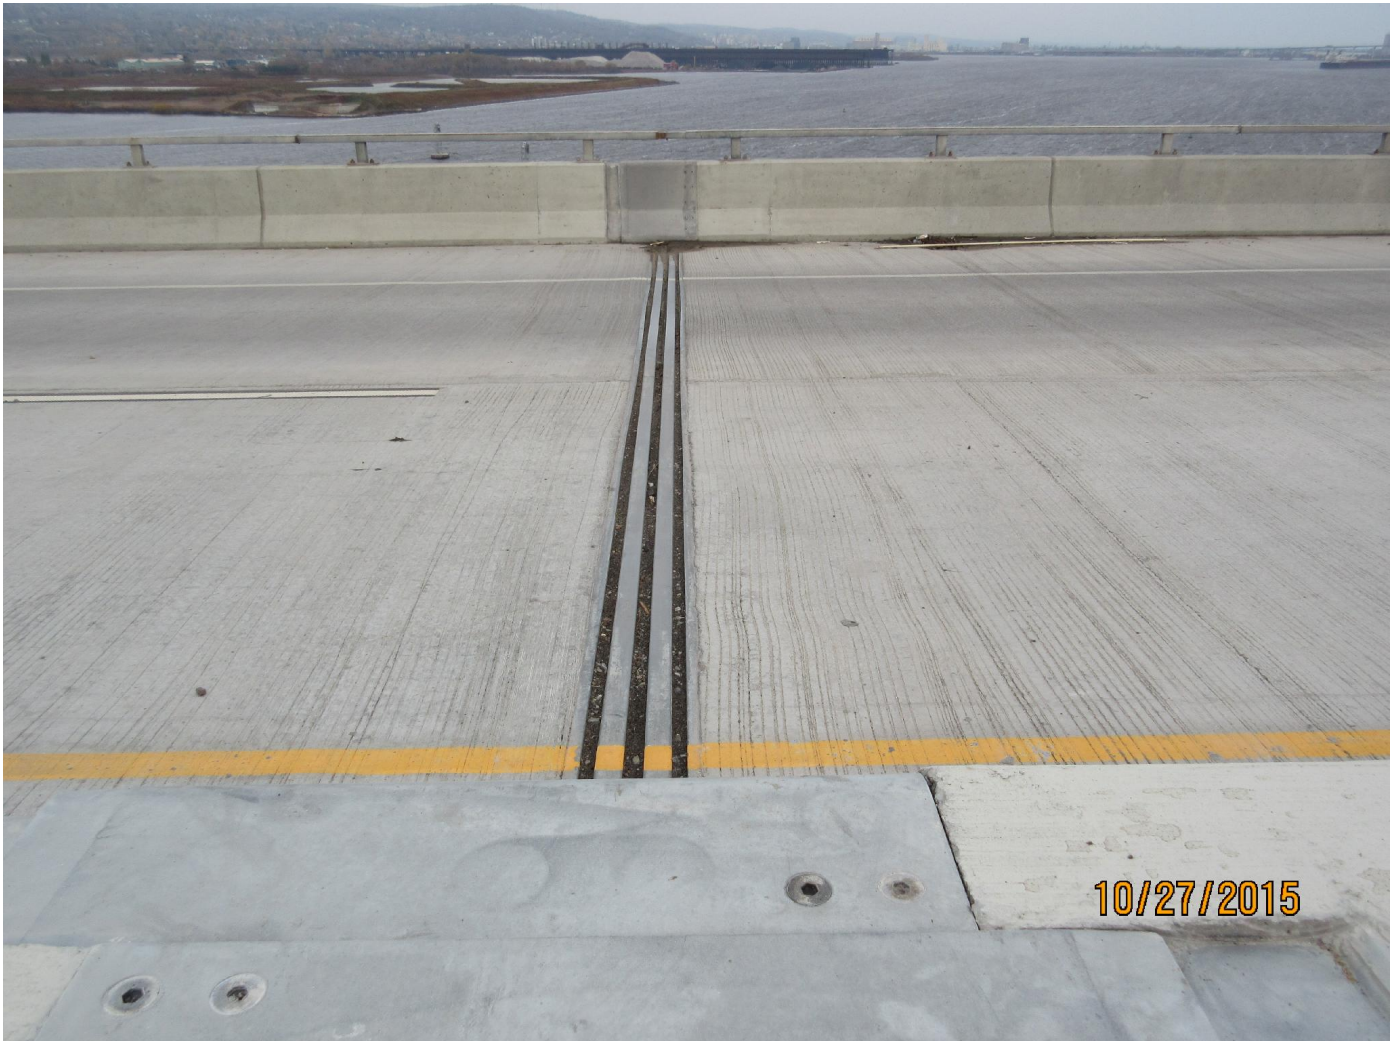
Typical cracking in overlay.

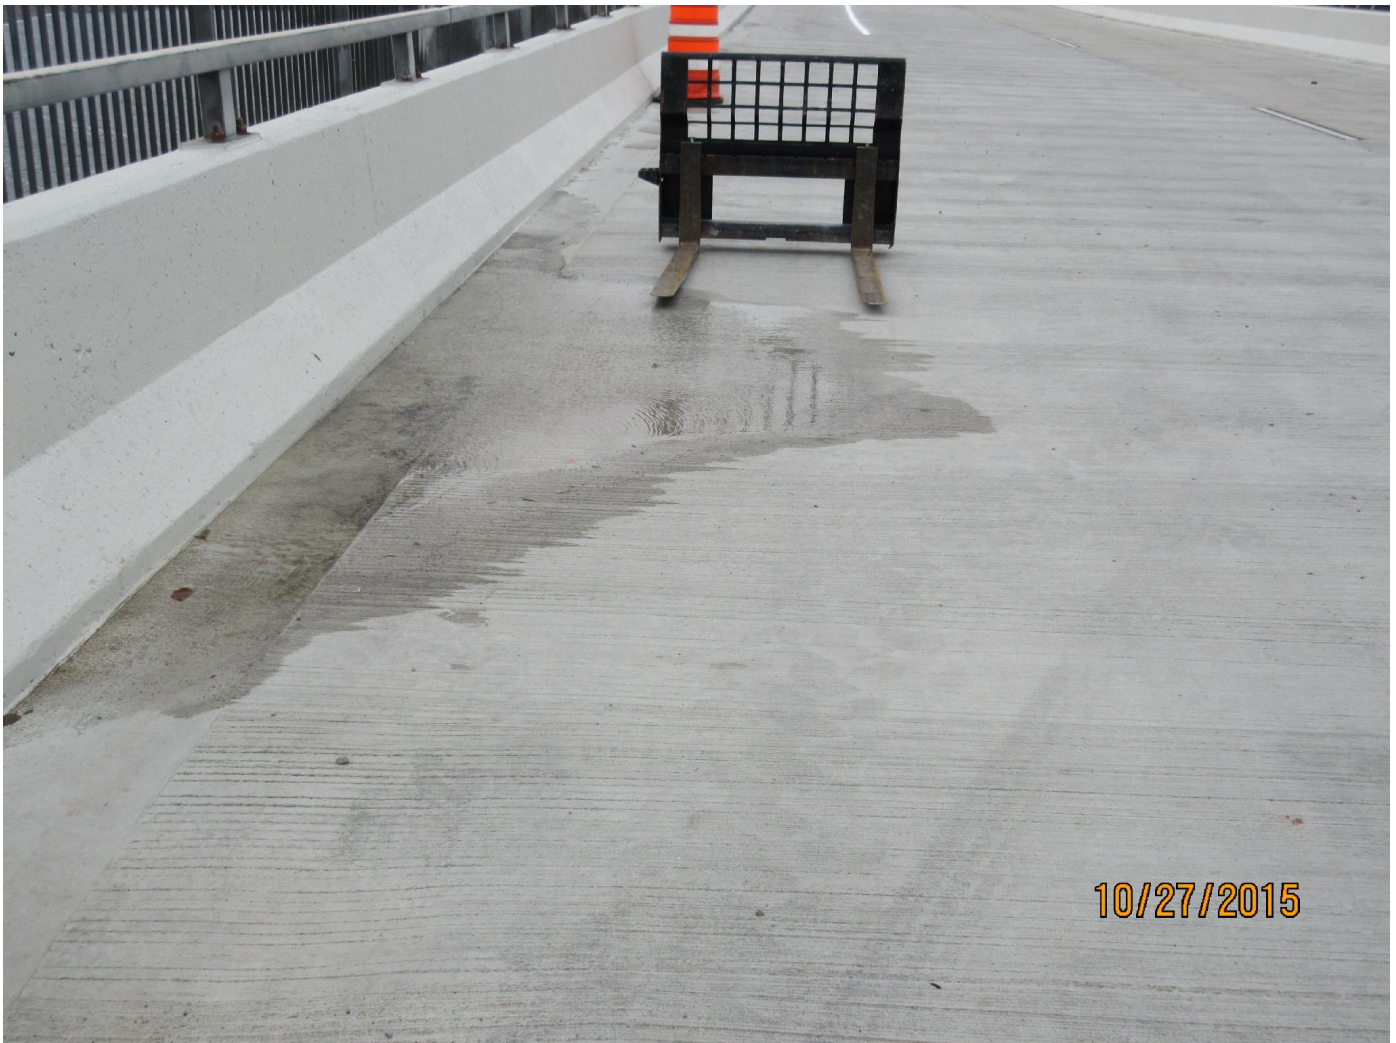
Ponding near joint 12-13 on EB shoulder.
