**STATE OF WISCONSIN
DEPARTMENT OF TRANSPORTATION**

**Inspection Report for
B-16-038-0003**

**USH 2 over BN Rail Road
Oct 19, 2015**

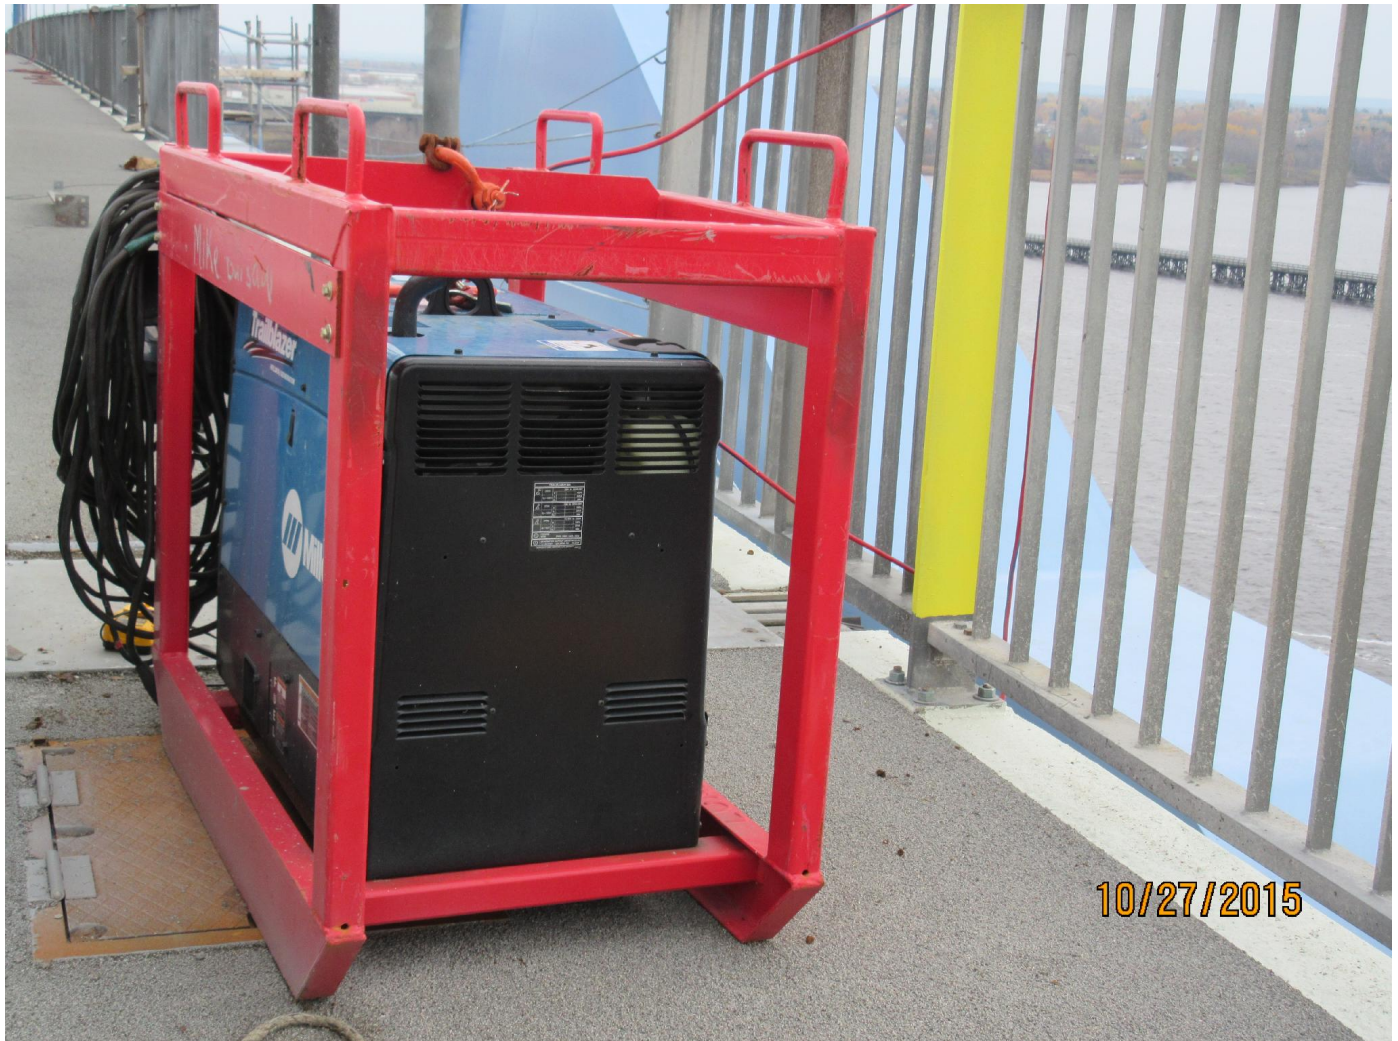
Sidewalk access hatch near joint 12-13. Note reflective tape on rail to indicate location of hatch for snow removal operations.

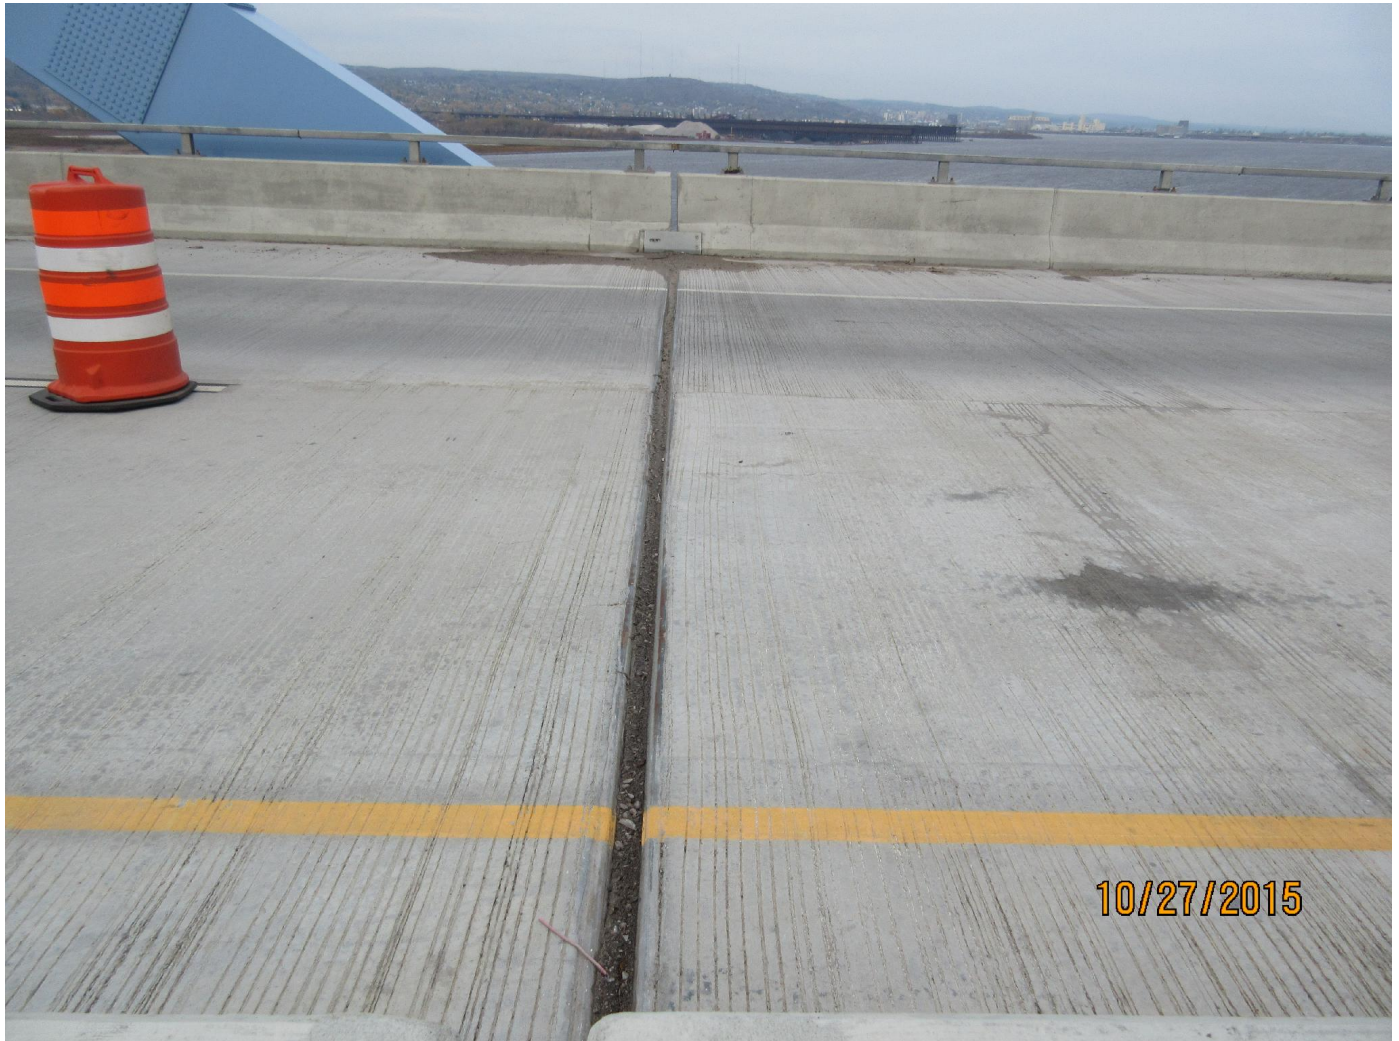
Typical sidewalk work.

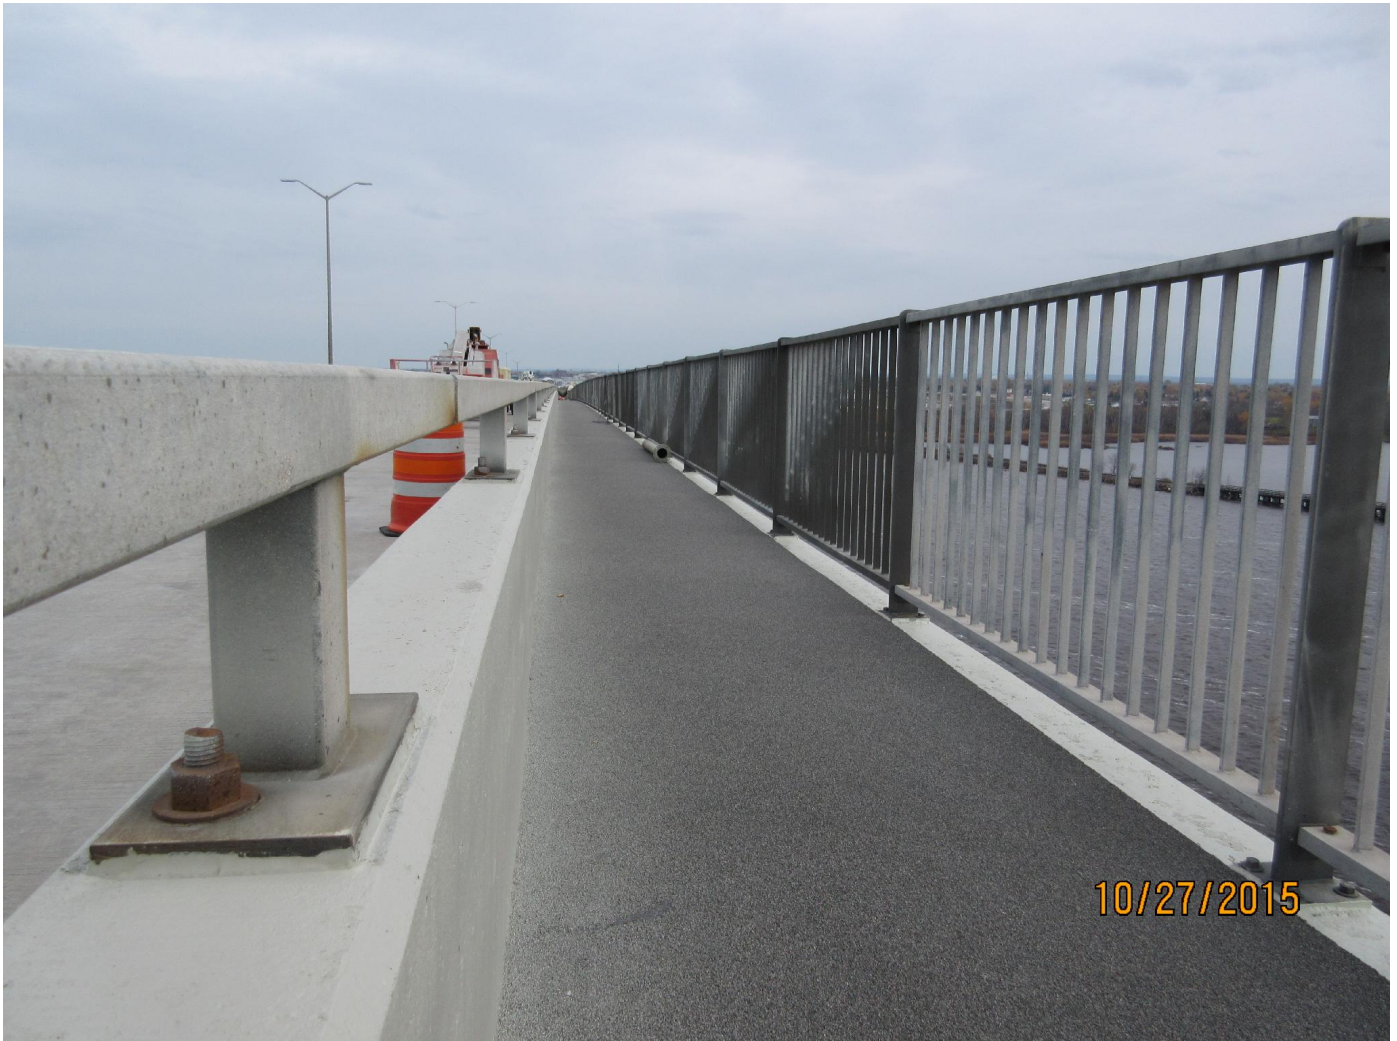
Typical cracking in overlay.

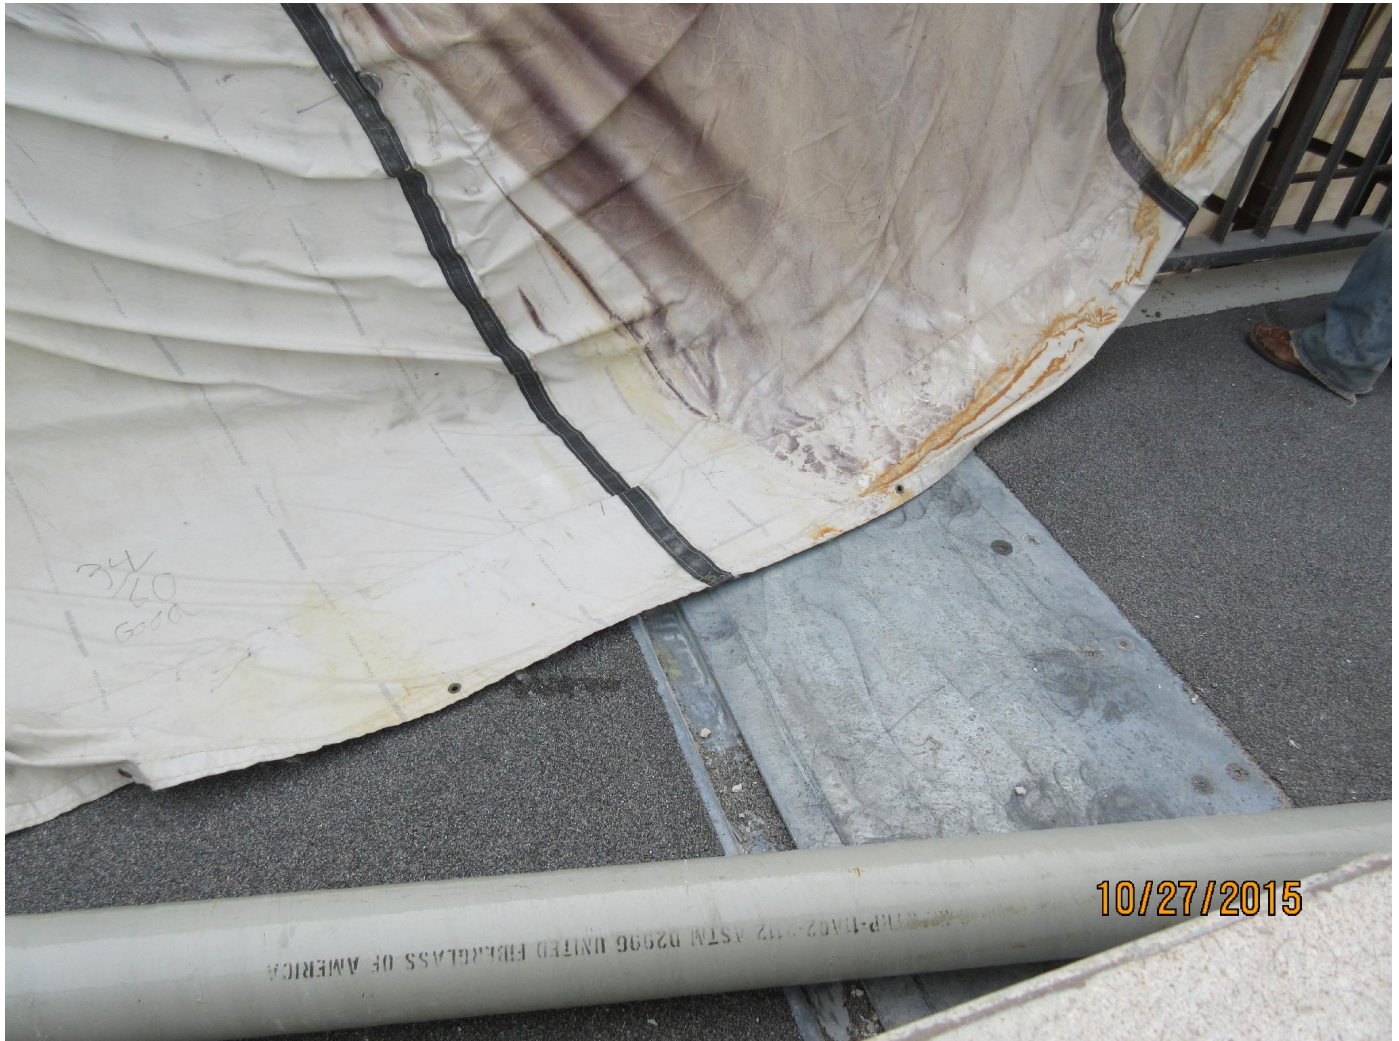
Typical work on sidewalk.

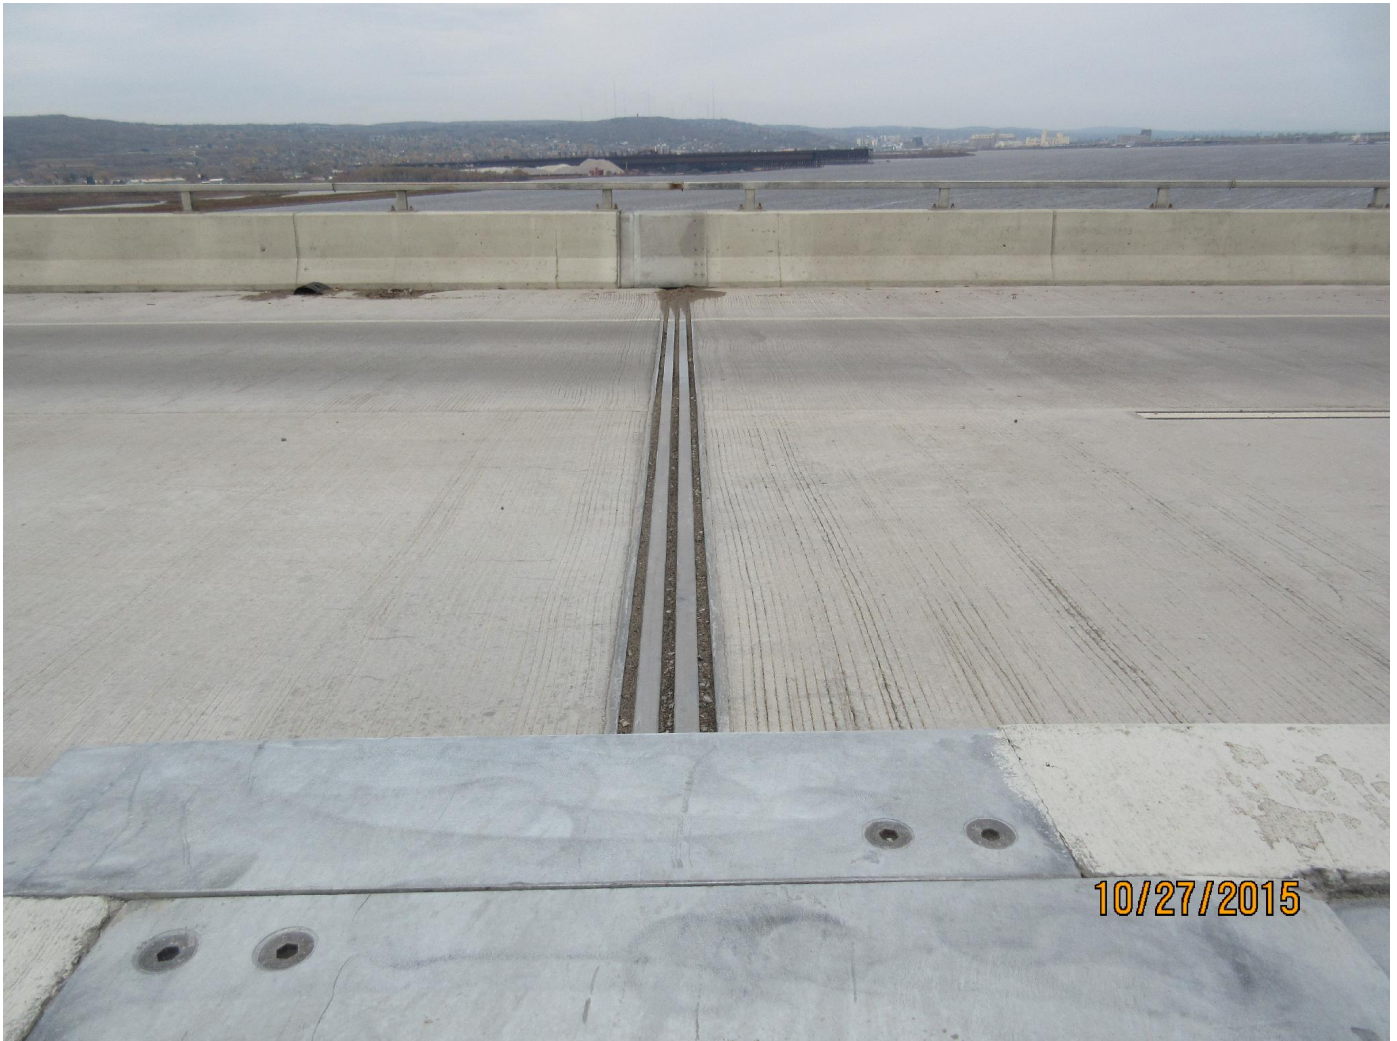
Typical cracking in overlay.

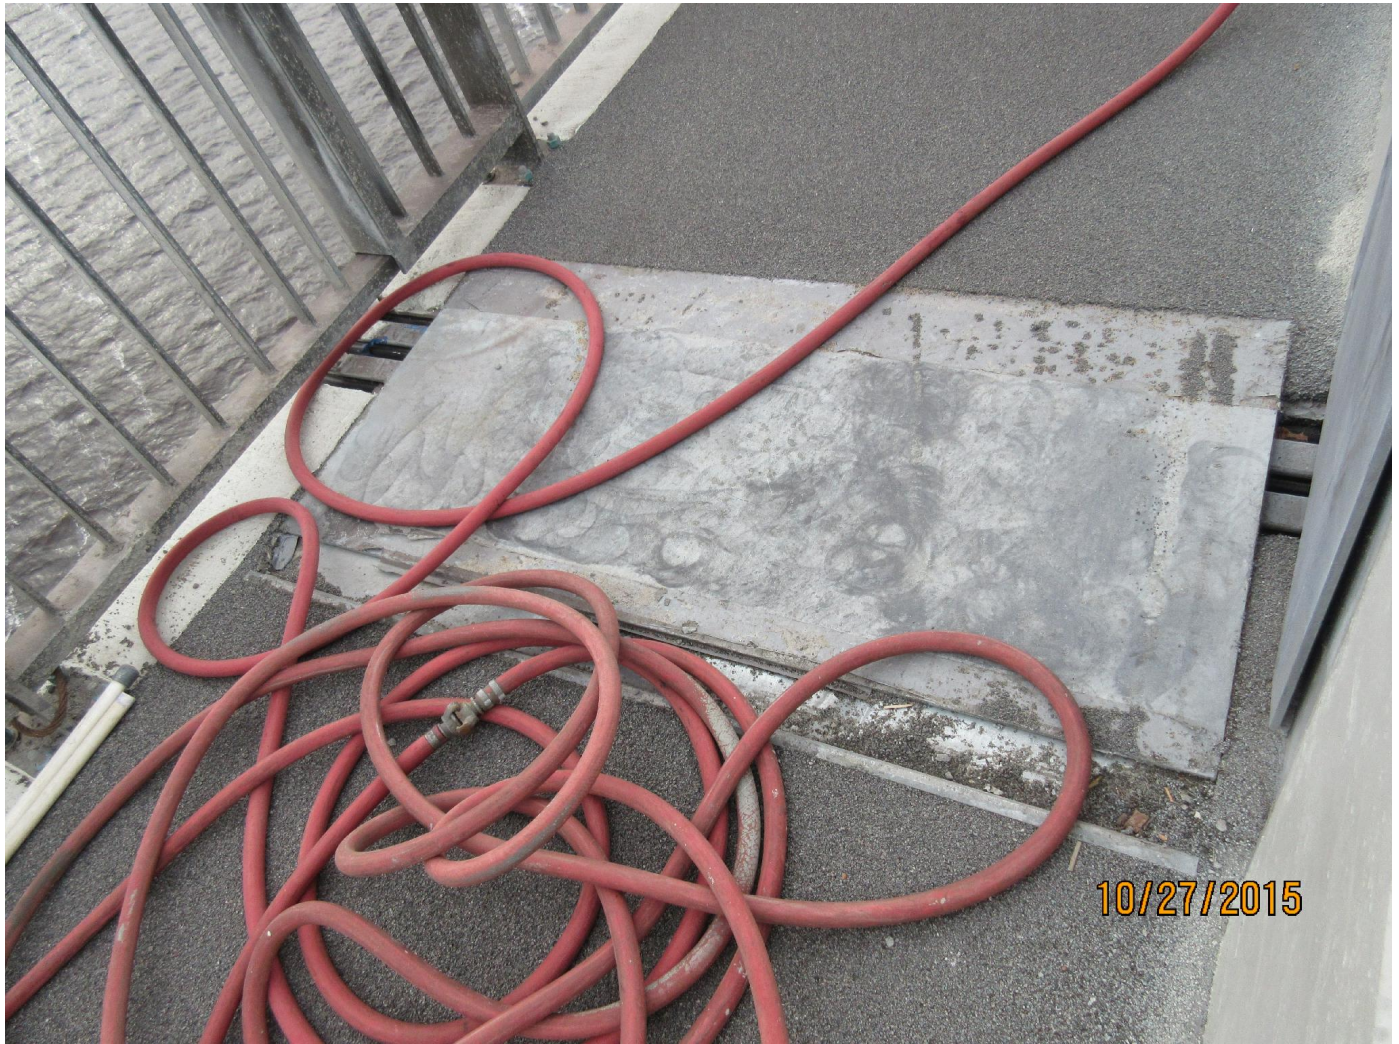
Typical sidewalk work.

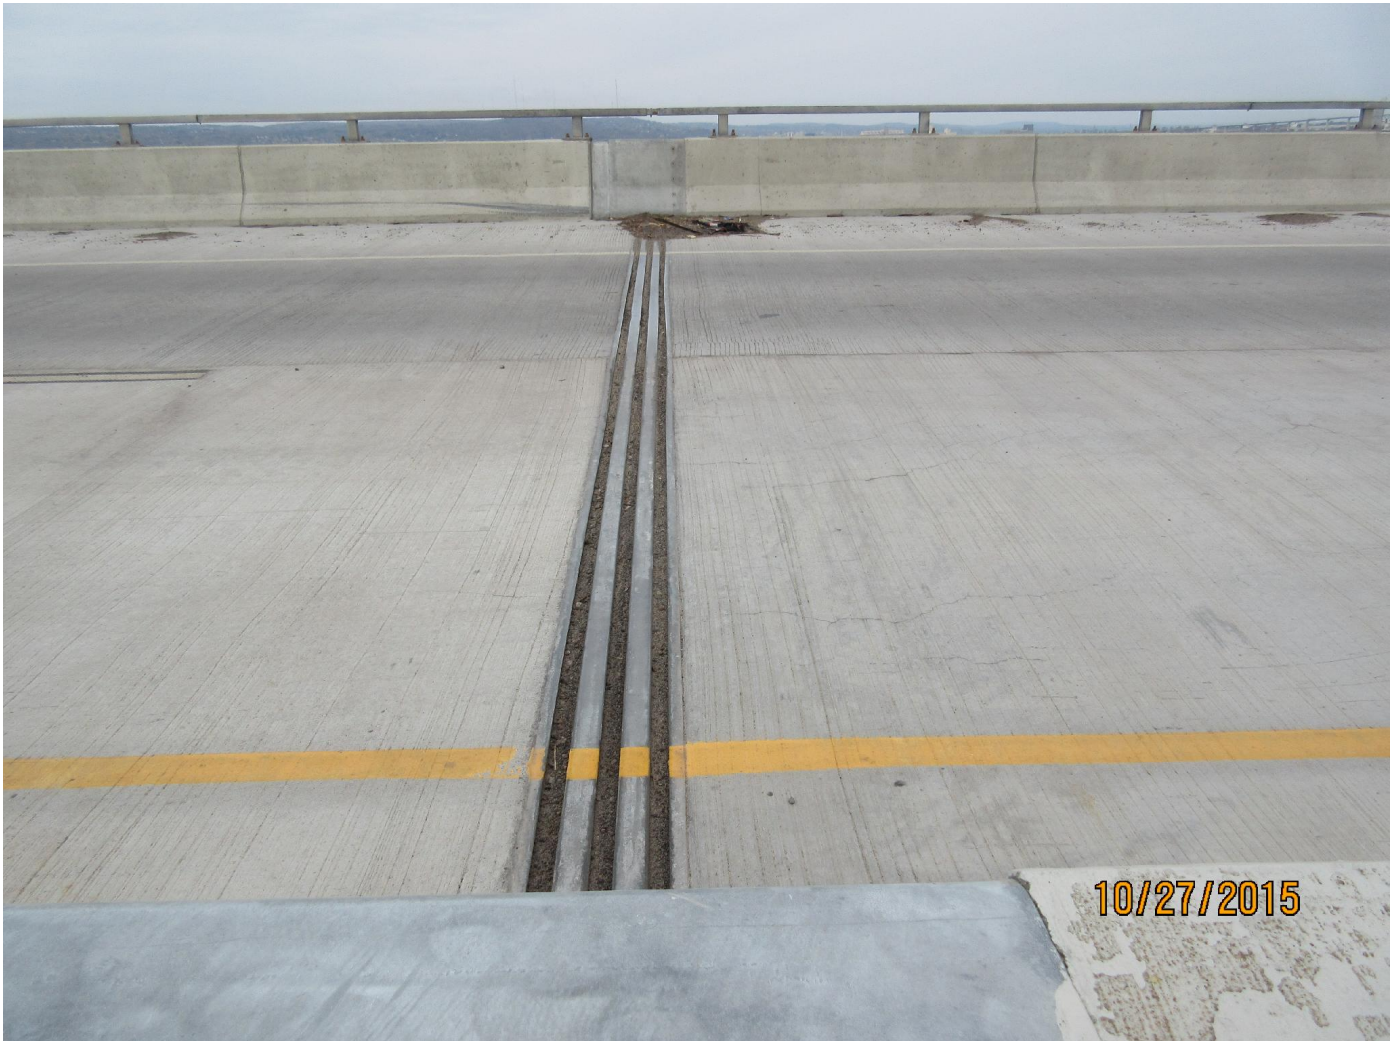
Typical cracking in overlay.

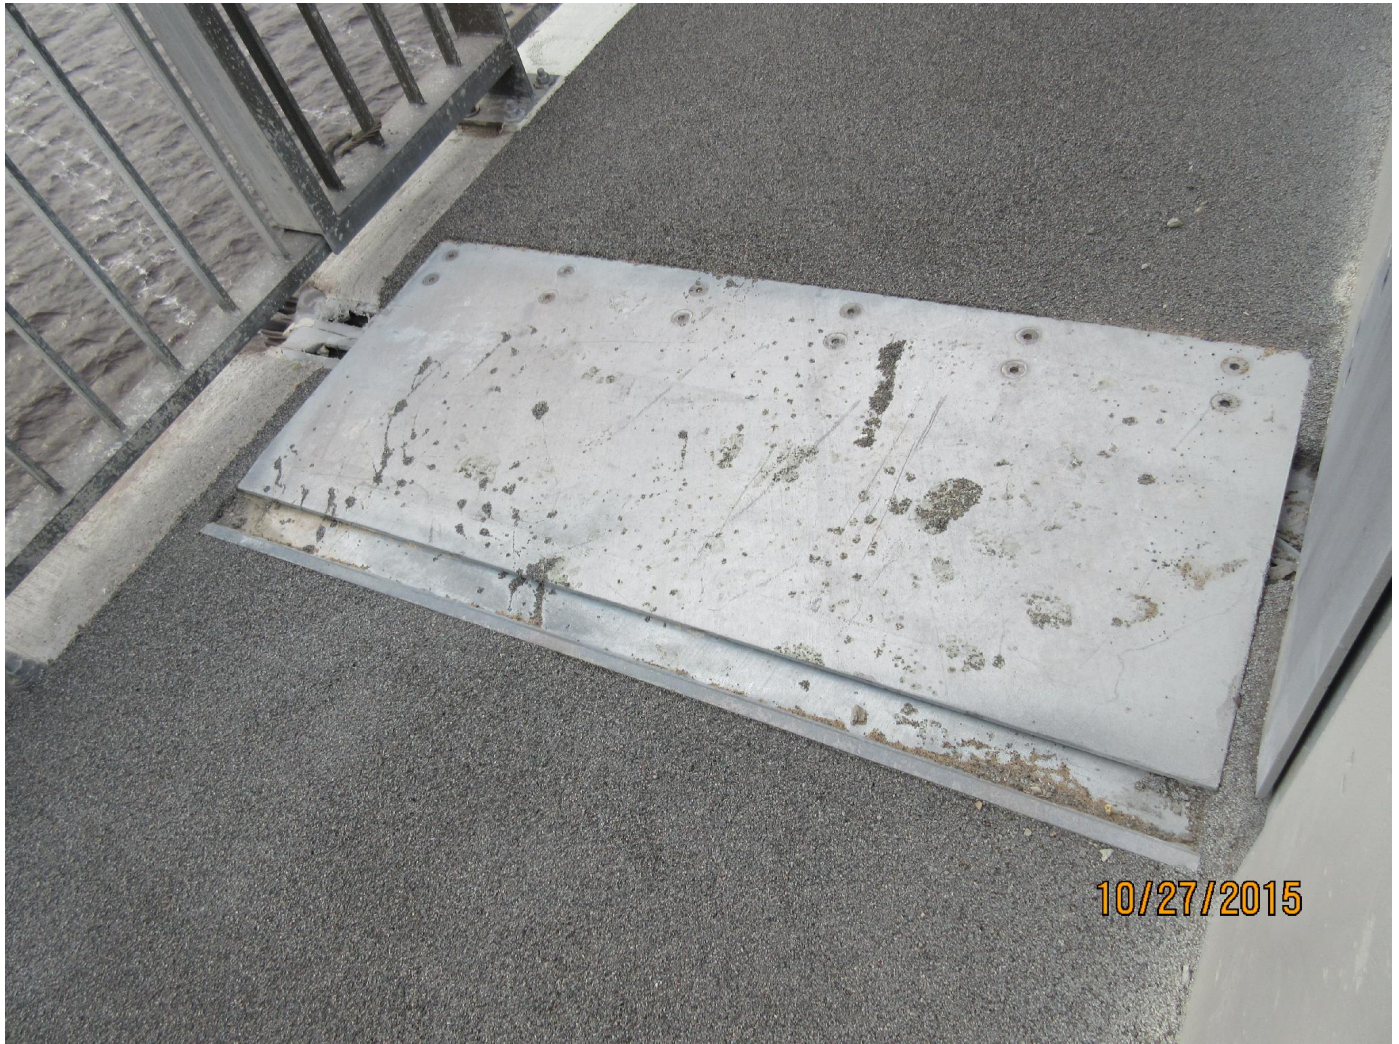
Typical sidewalk work.

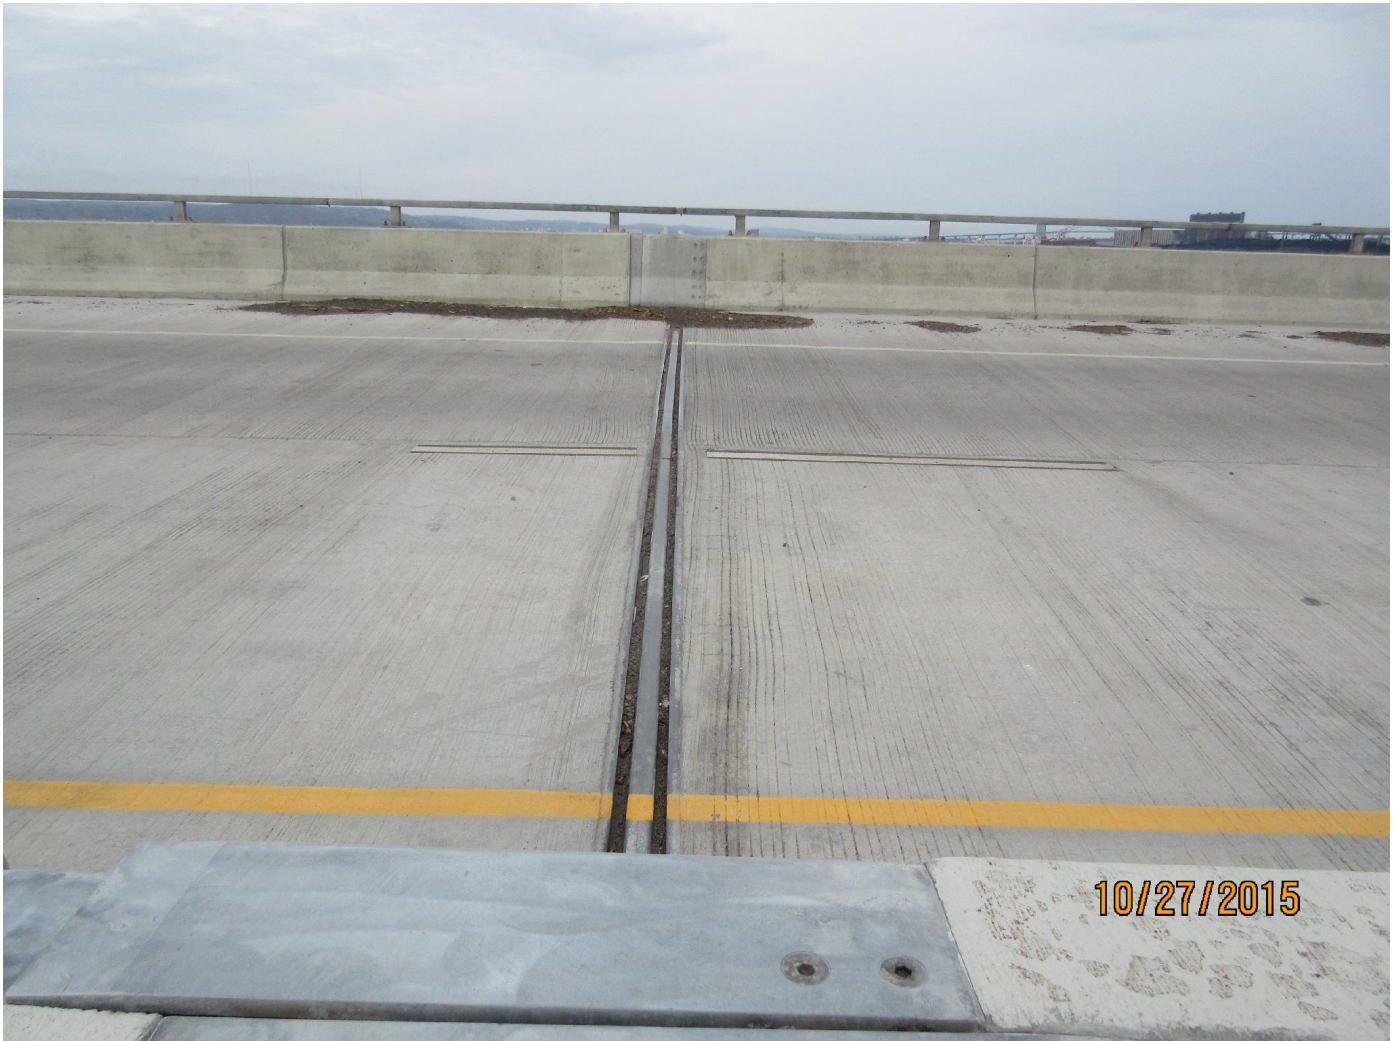
Typical cracking in overlay.

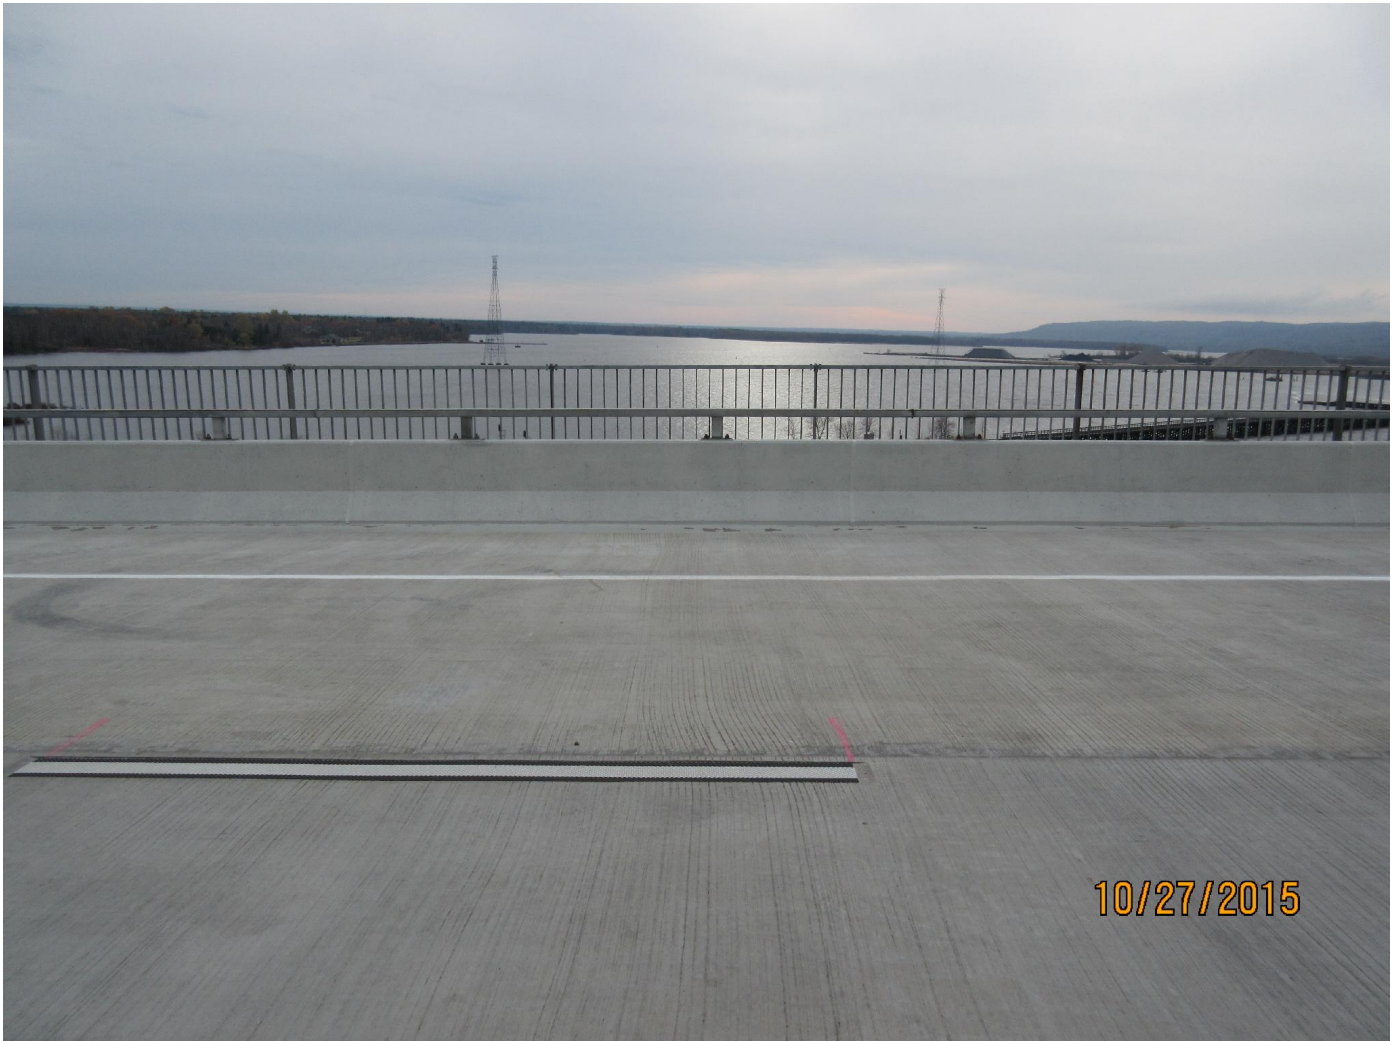
Upstream view.

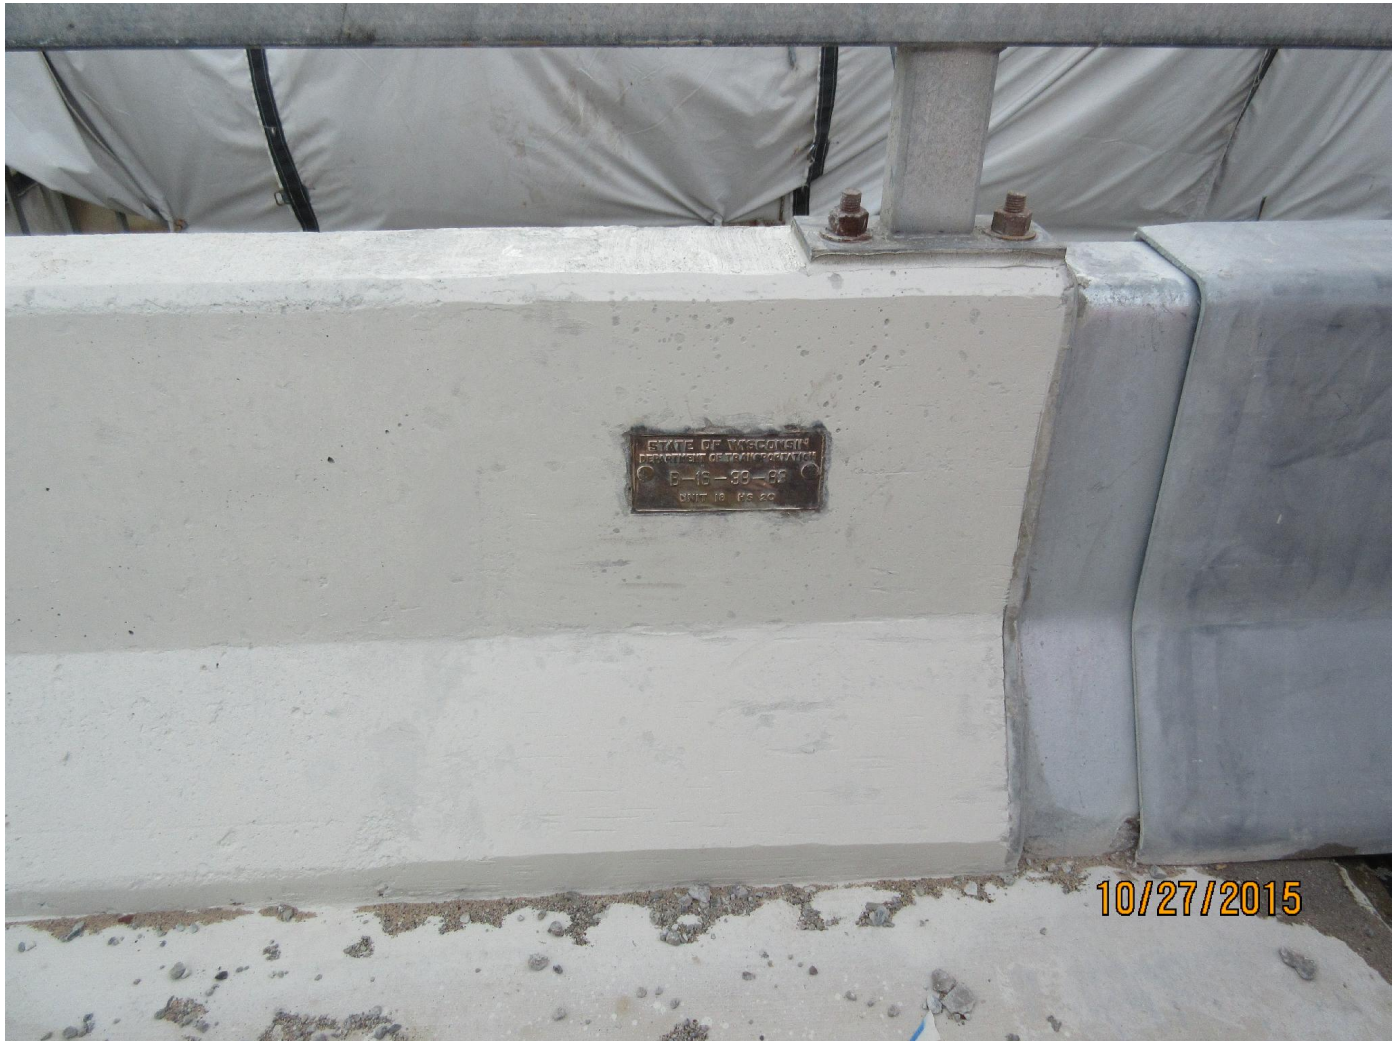
Nameplate.

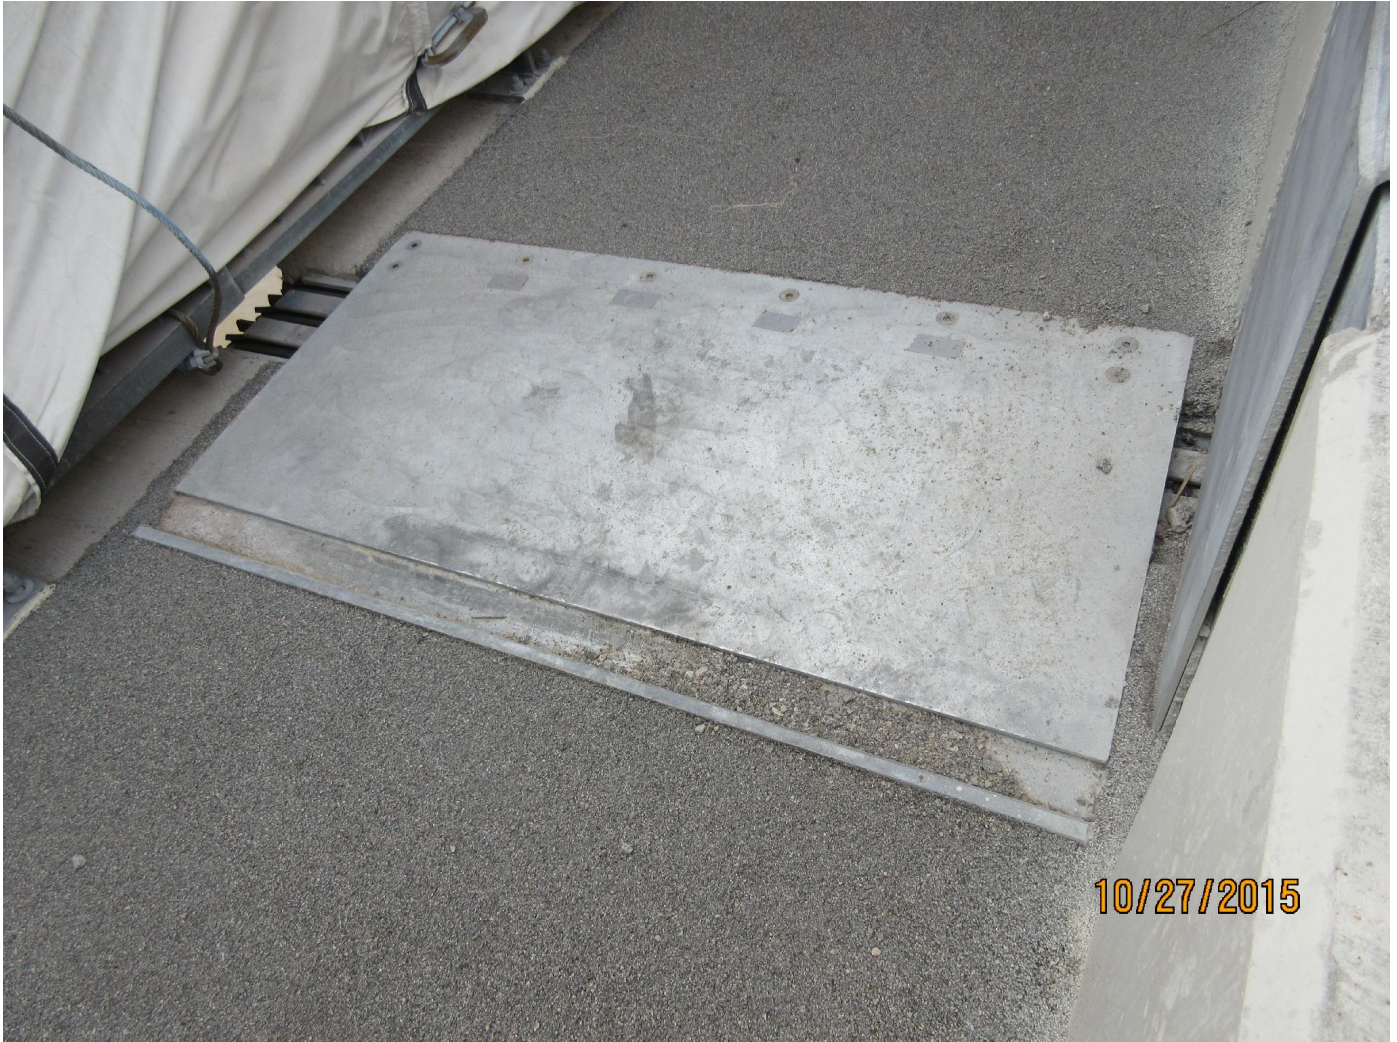
Sidewalk cover plate Joint 17-18.

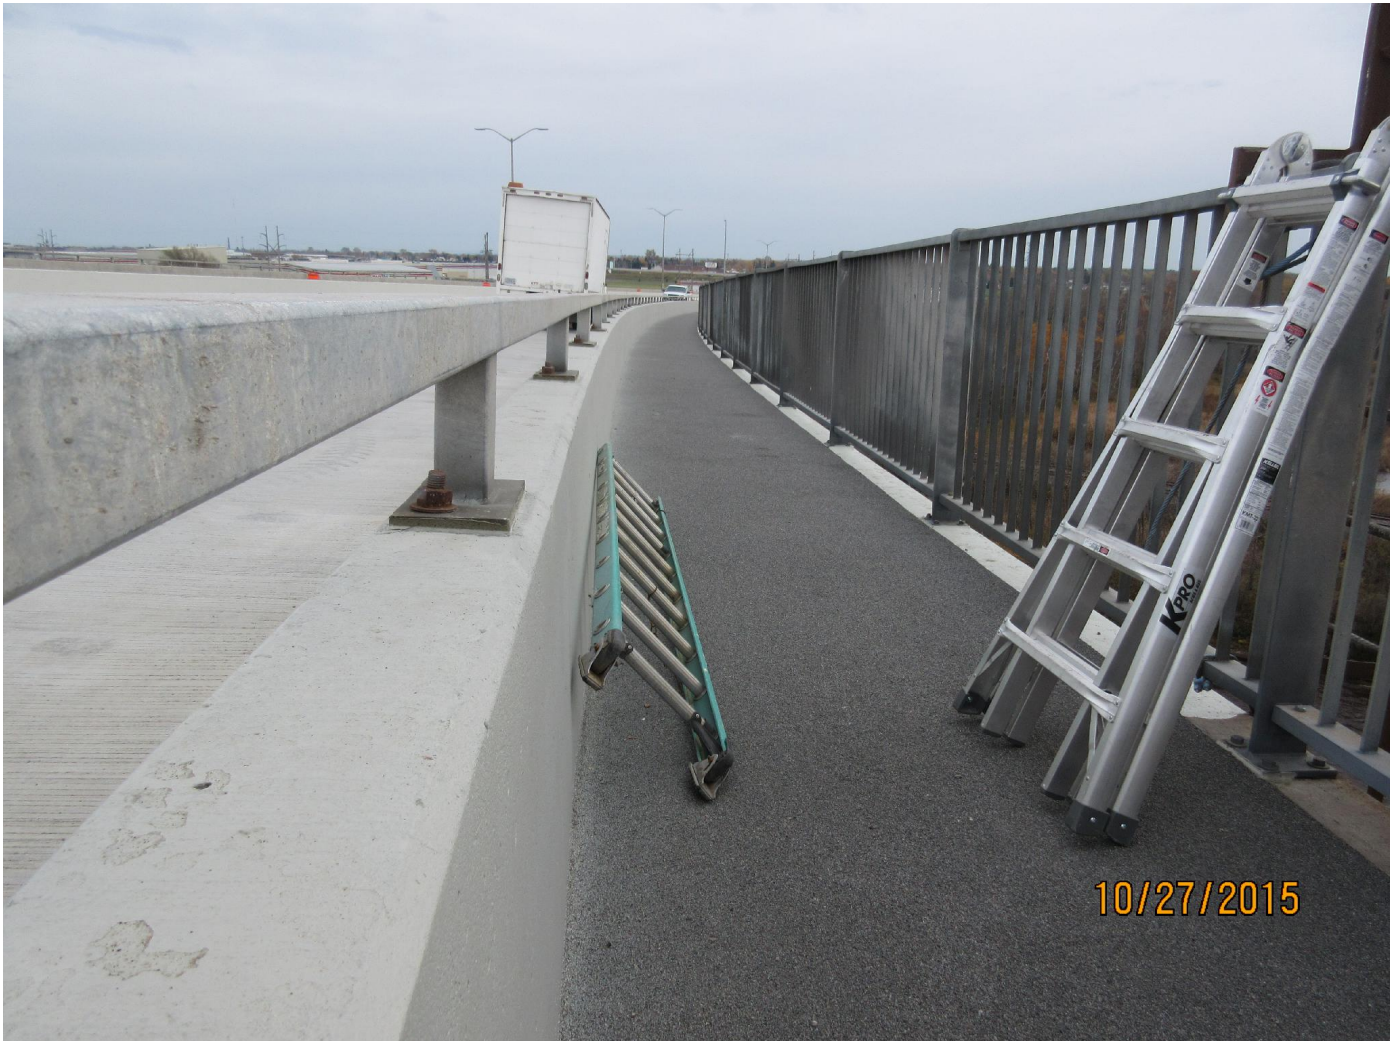
Typical sidewalk work.

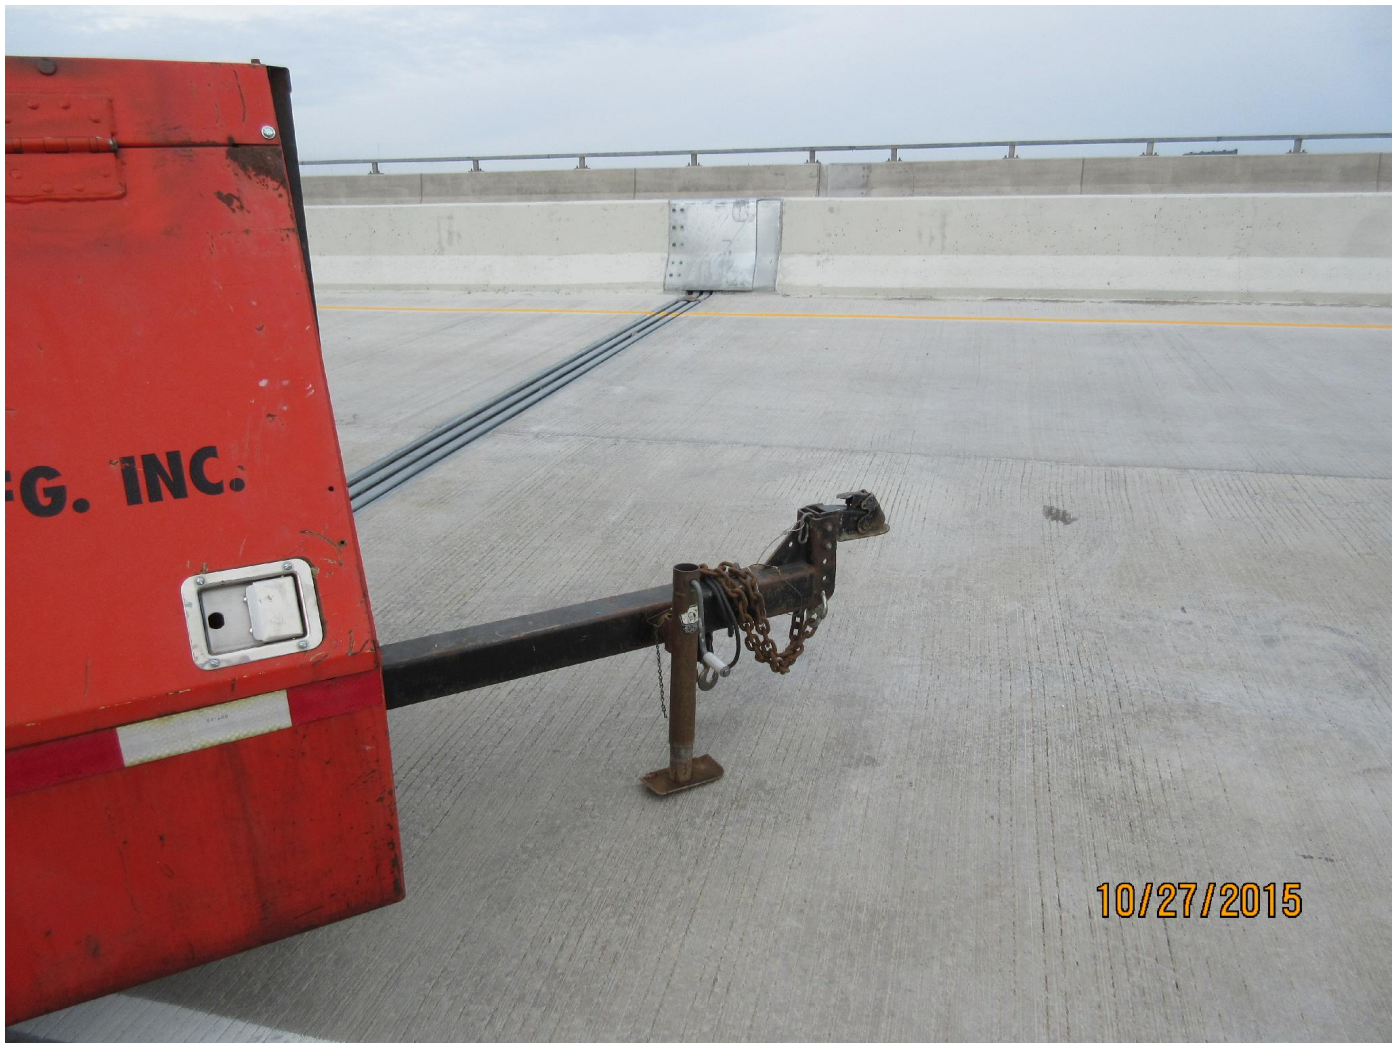
Joint 17-18 EB.

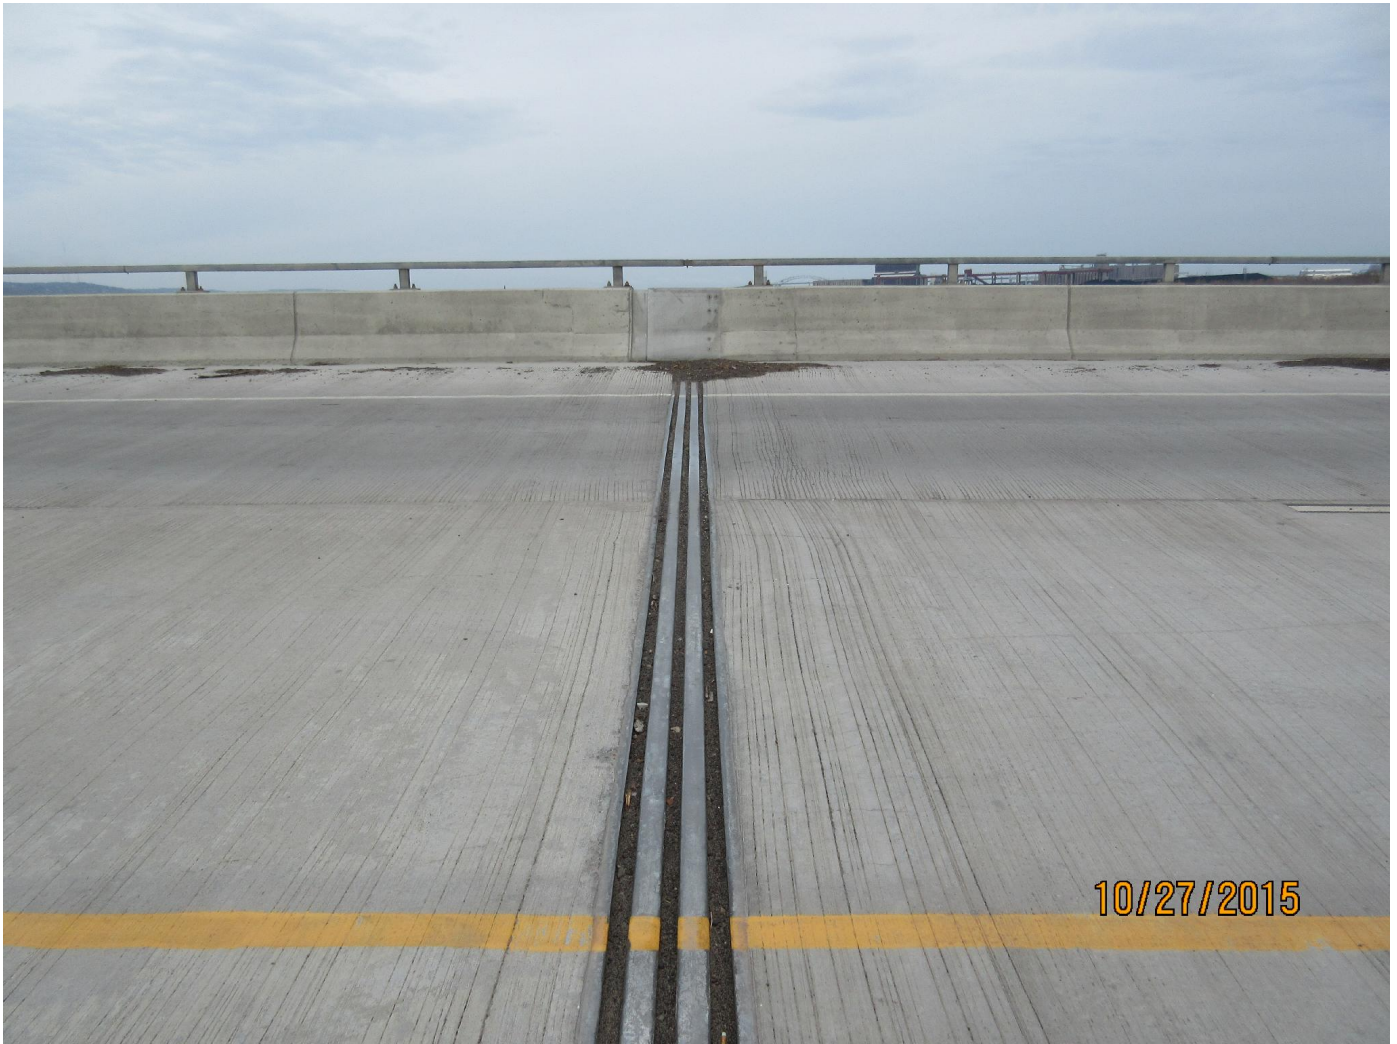
Joint 17-18 WB.

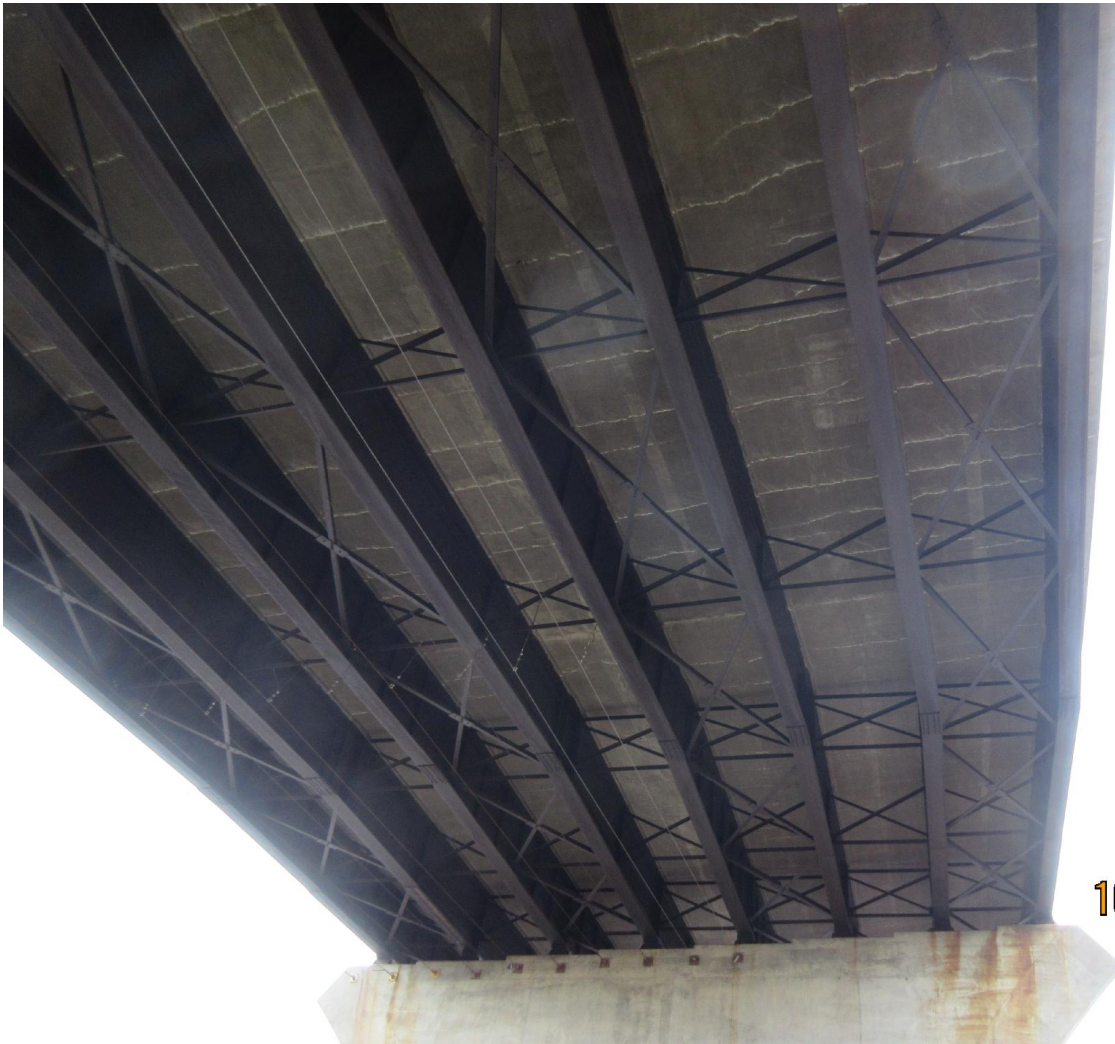
Typical underside of deck.
