**STATE OF WISCONSIN
DEPARTMENT OF TRANSPORTATION**

**Inspection Report for
B-16-038-0003**

**USH 2 over BN Rail Road
Oct 19, 2015**

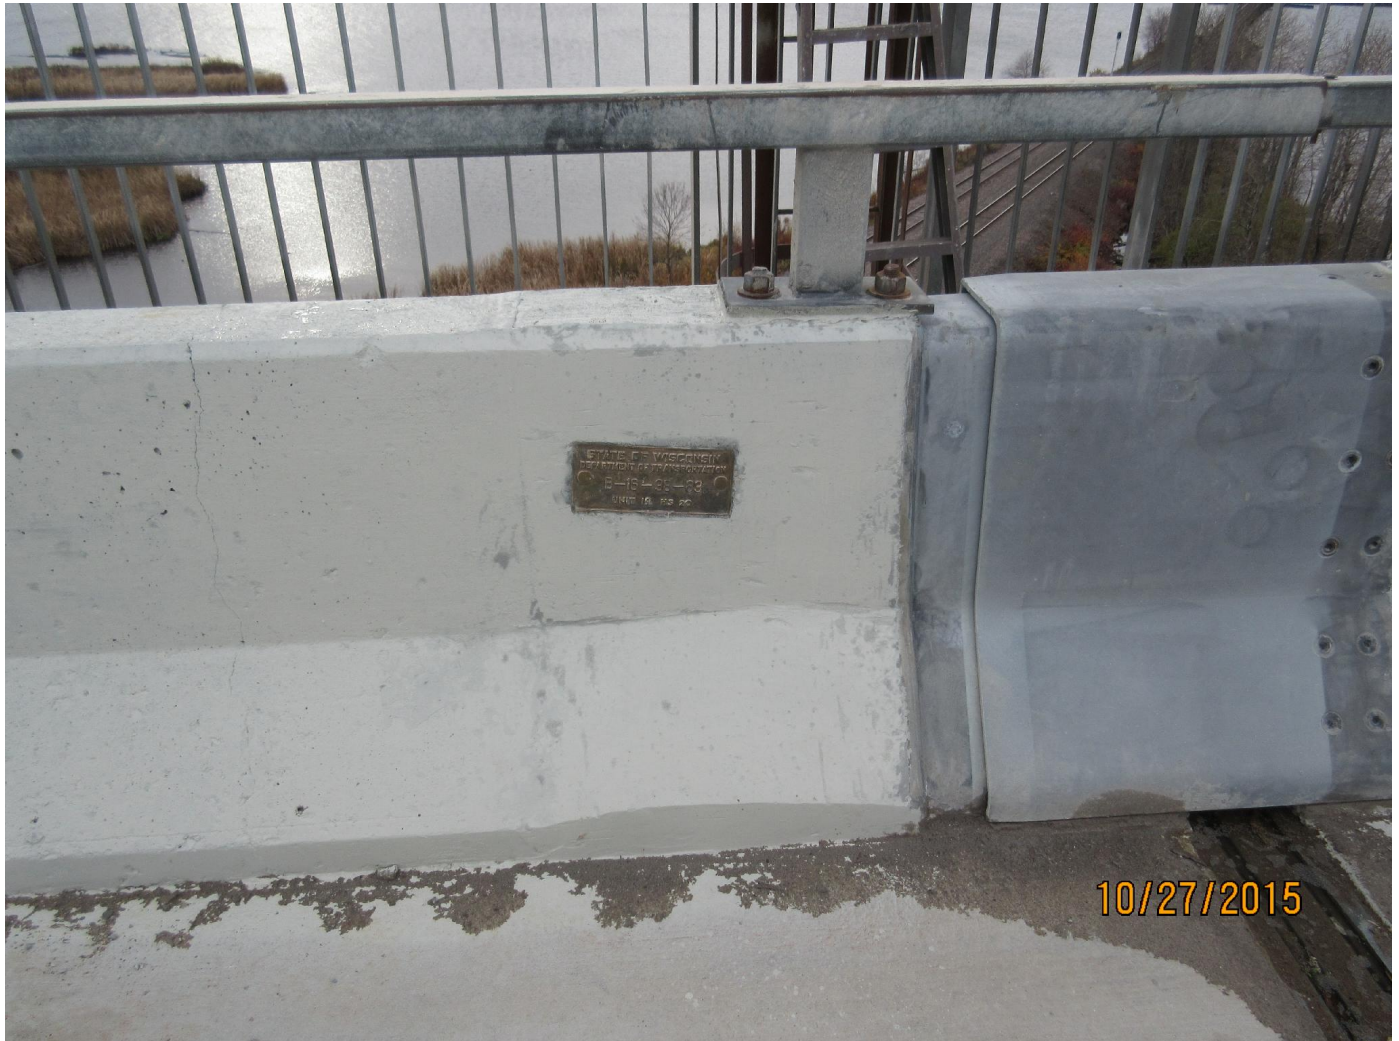
Nameplate.

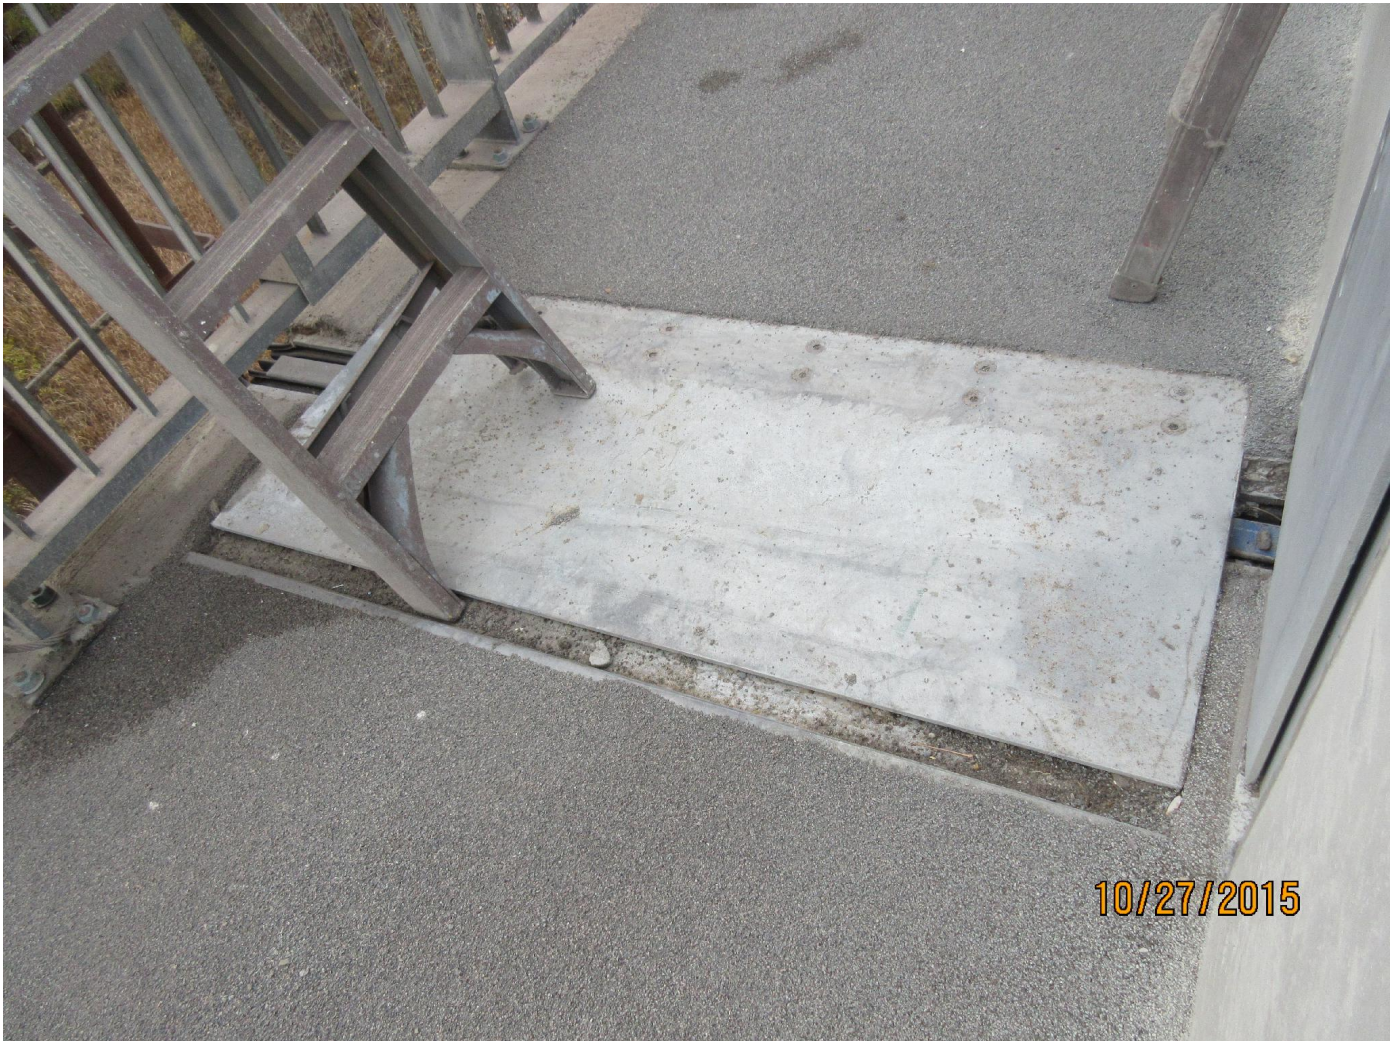
Sidewalk cover plate joint 18-19.

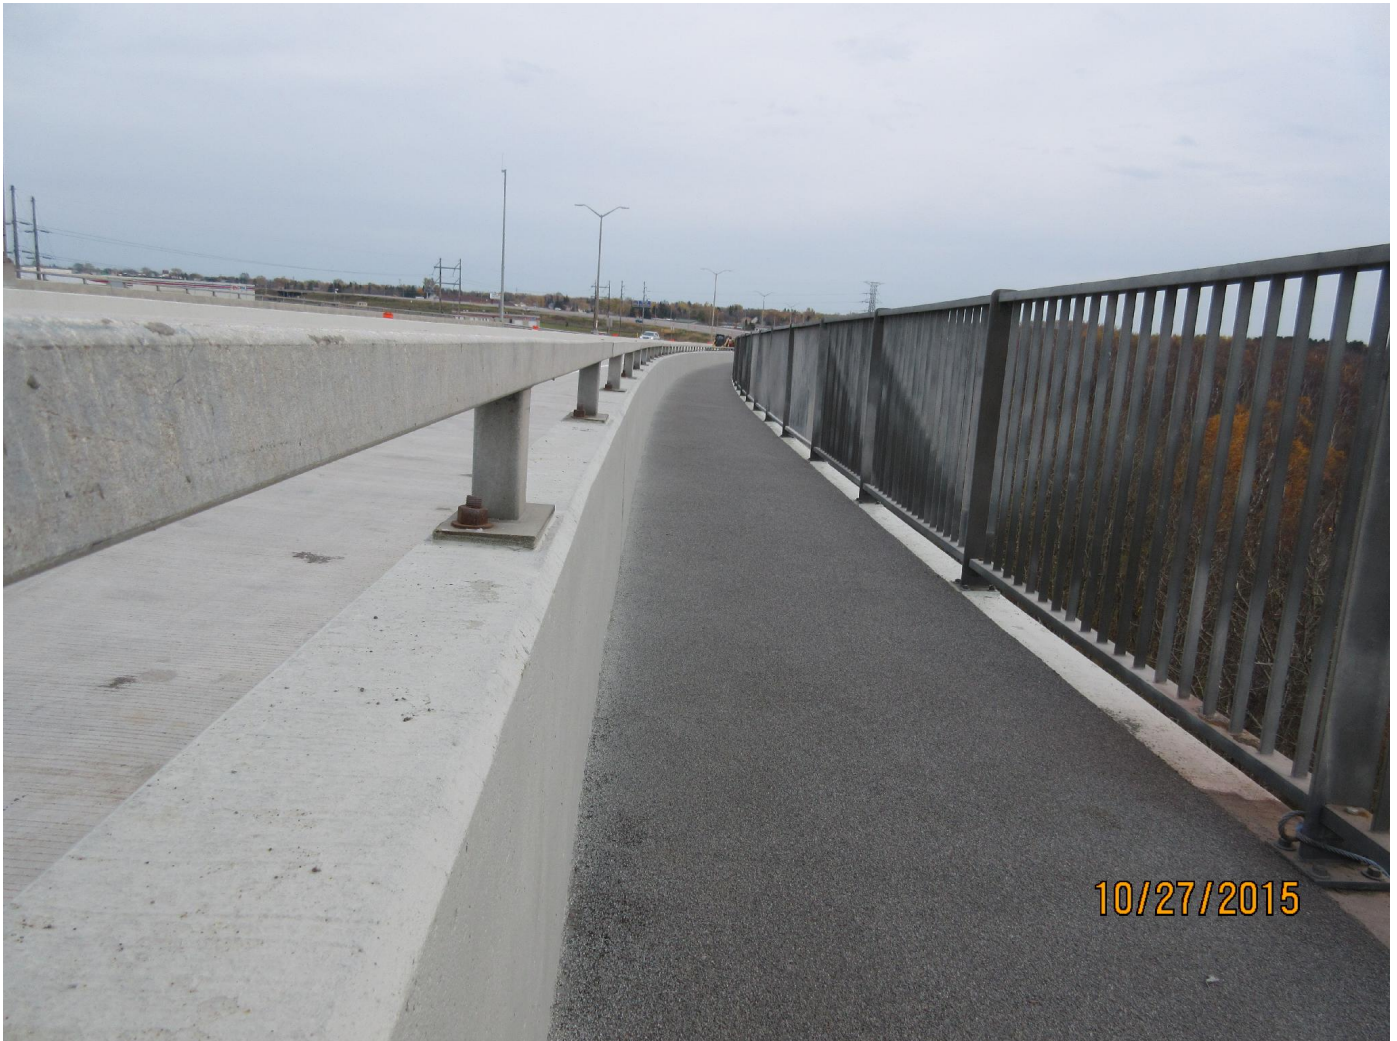
Typical sidewalk work.

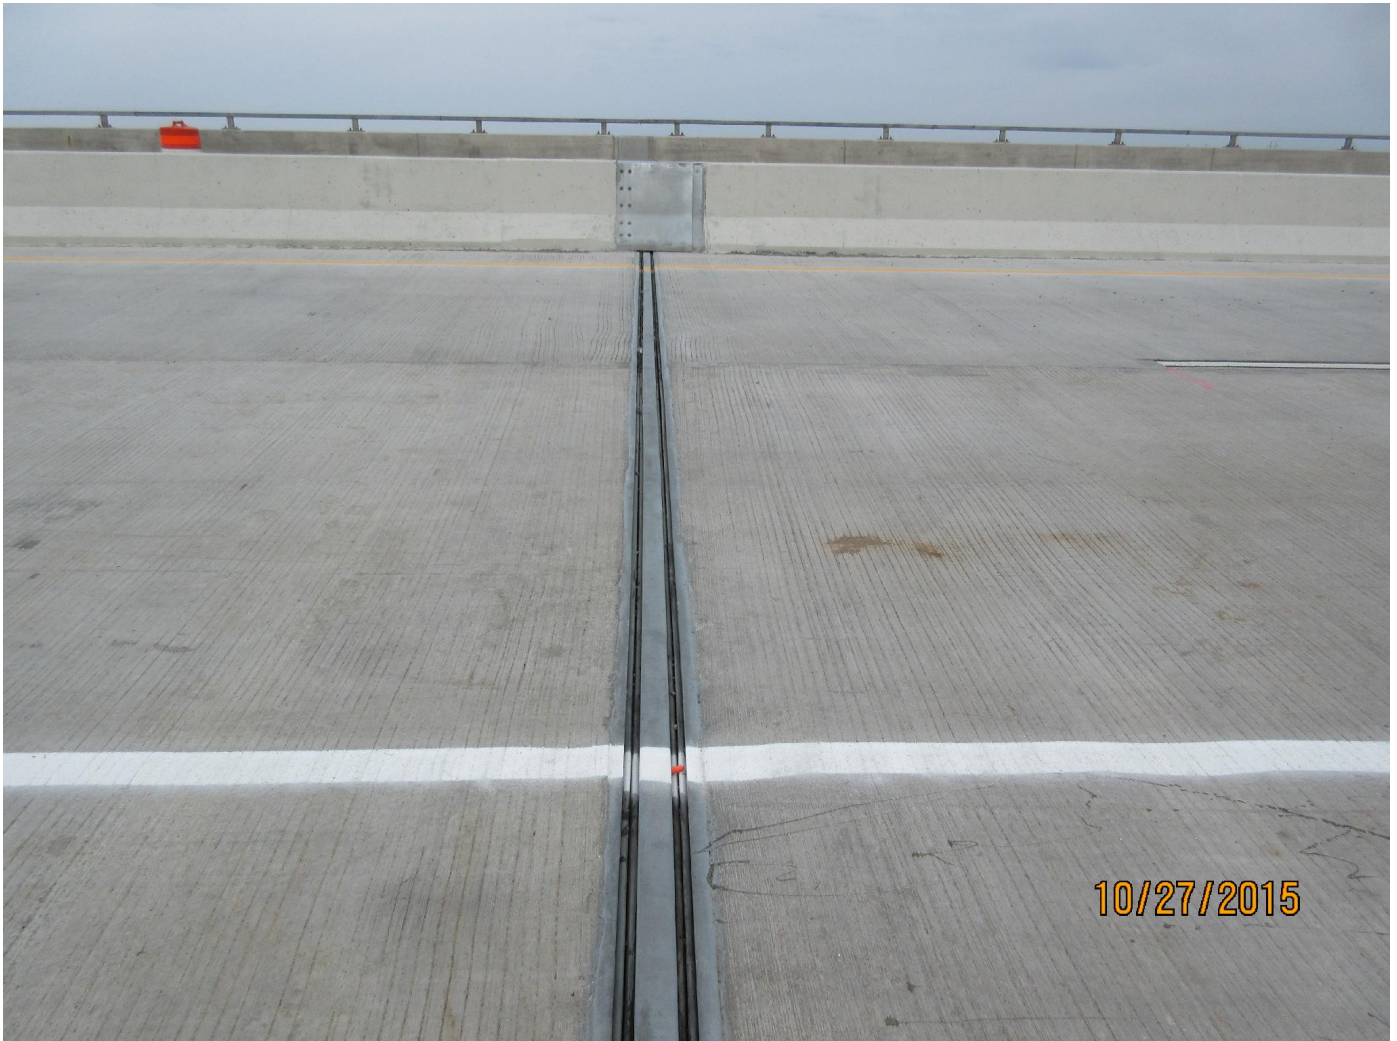
Joint 18-19 EB.

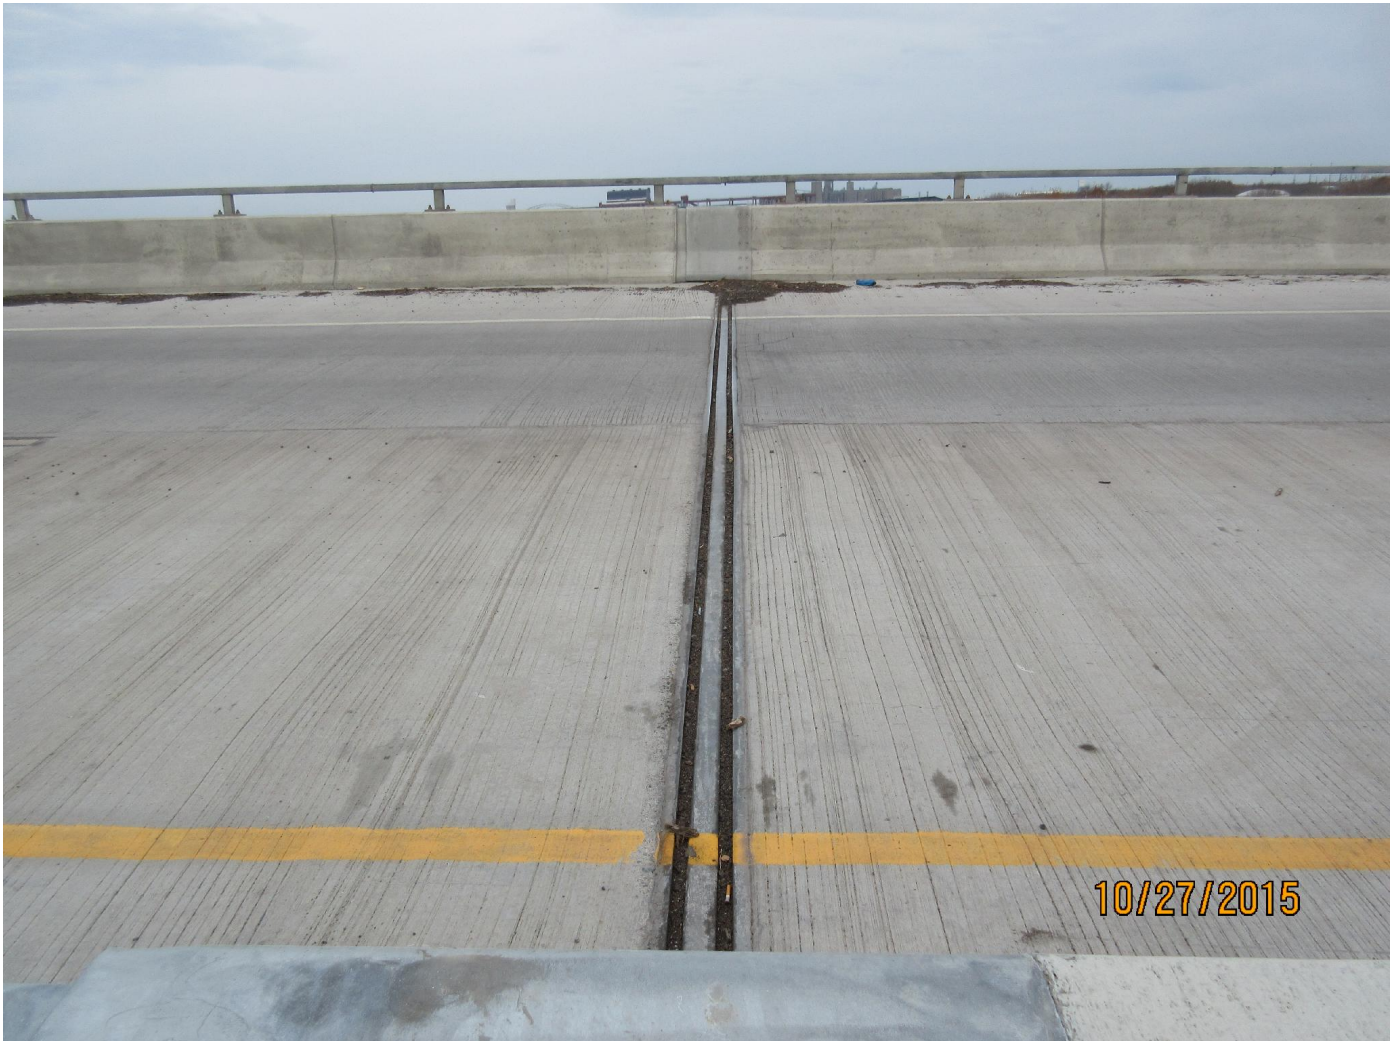
Joint 18-19 WB.

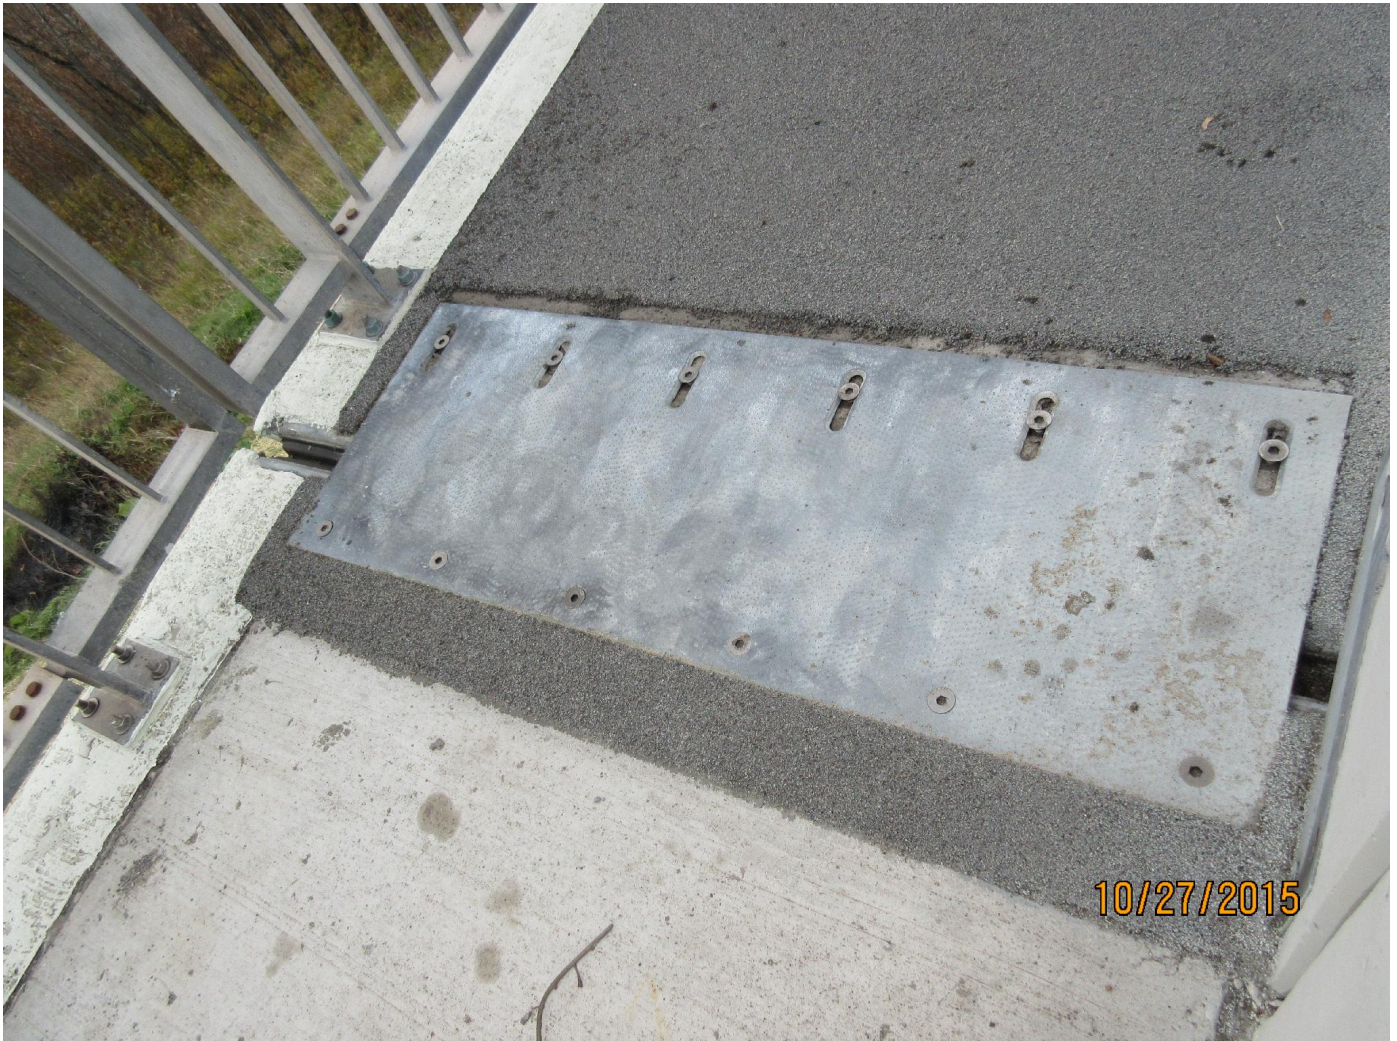
Sidewalk cover plate at east abutment.

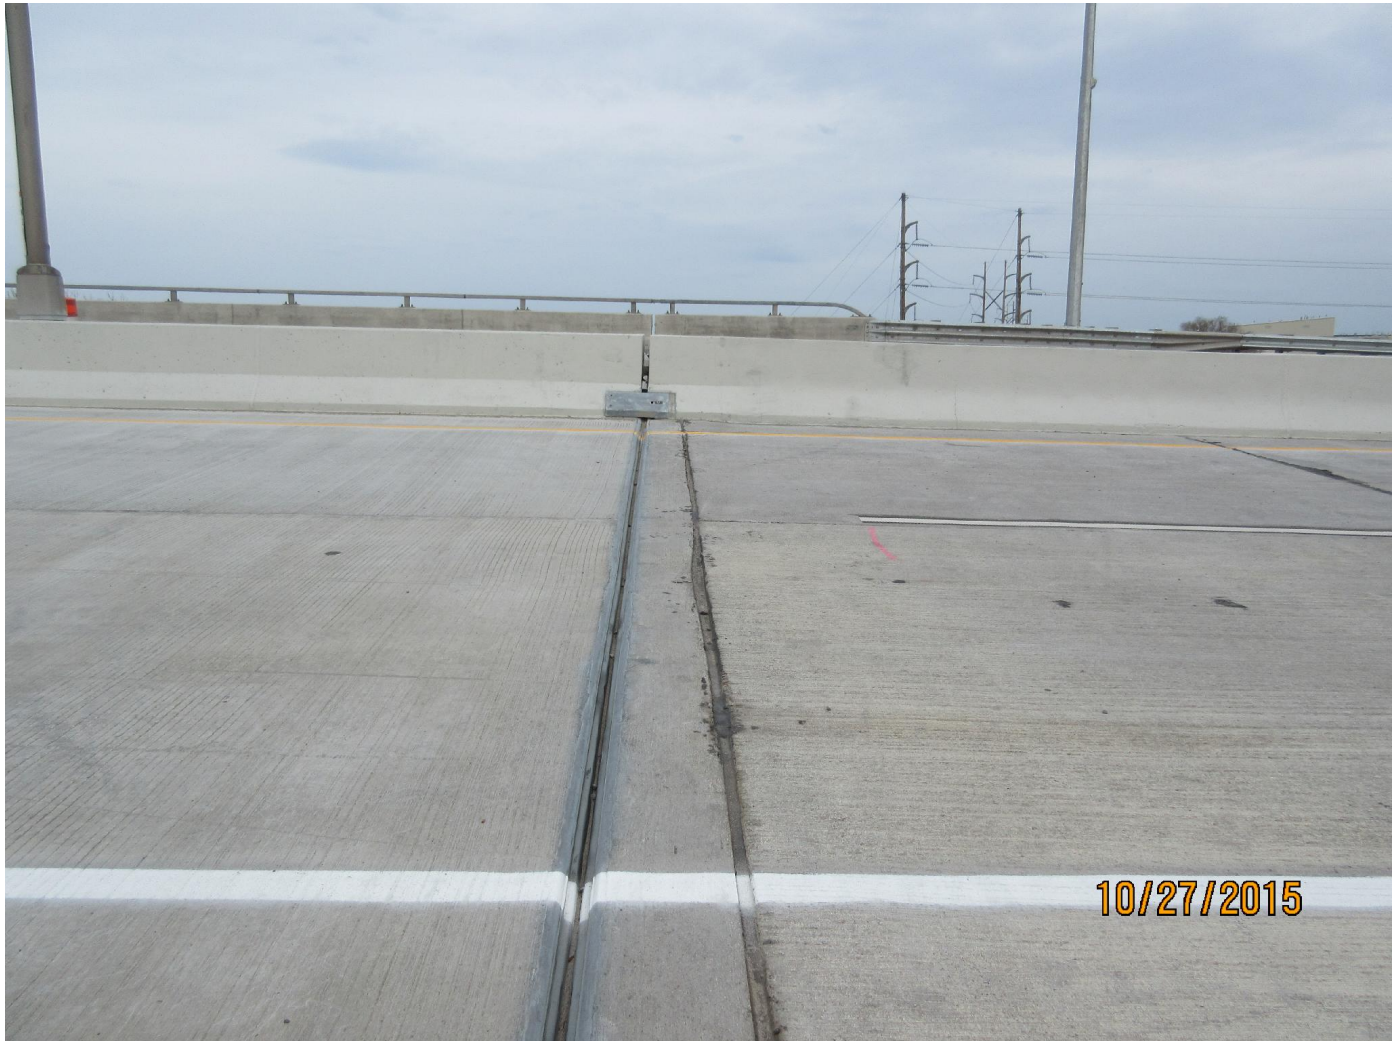
Joint East Abutment EB.

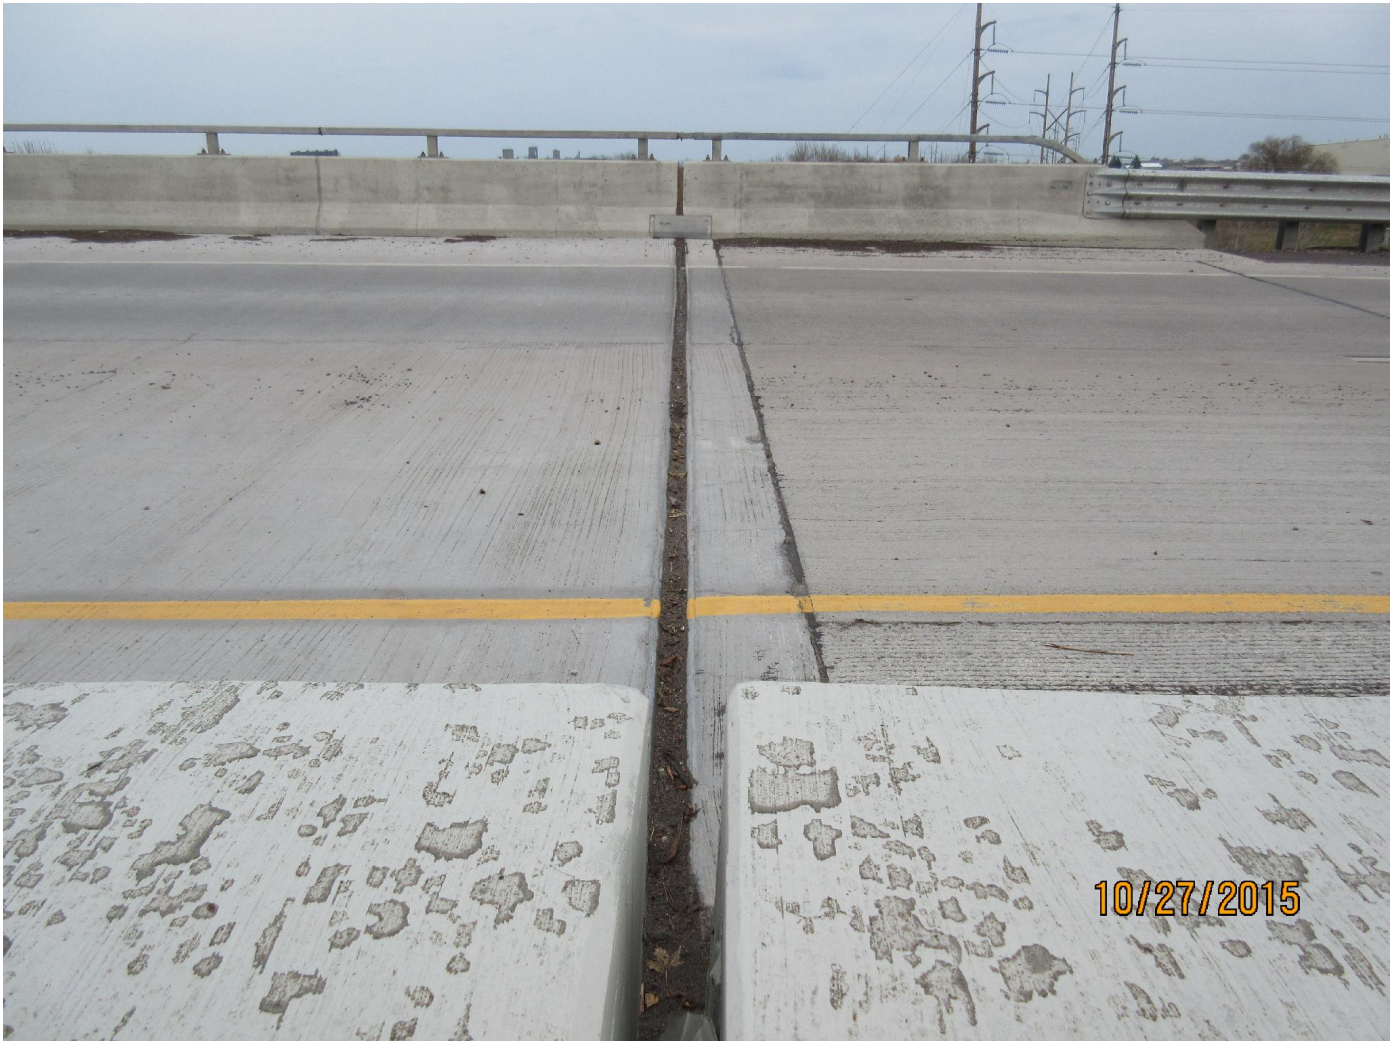
Joint East Abutment WB.
