# STRUCTURE INVENTORY REPORT

Project 2150-00-01 Date 4/24/2019 Crew WFF/SAS Point # 10738

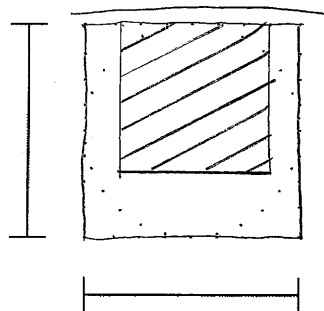
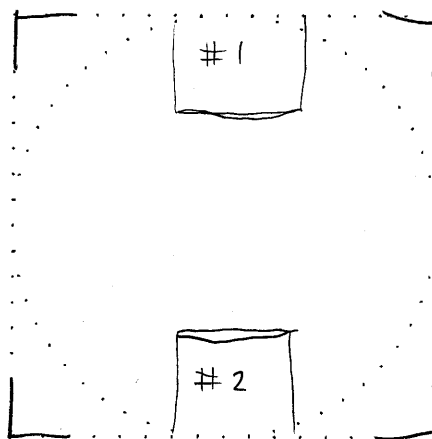
Condition / Notes Unable to remove cover.

Condition: ☒ Good ☐ Fair ☐ Poor

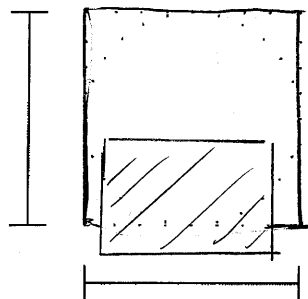
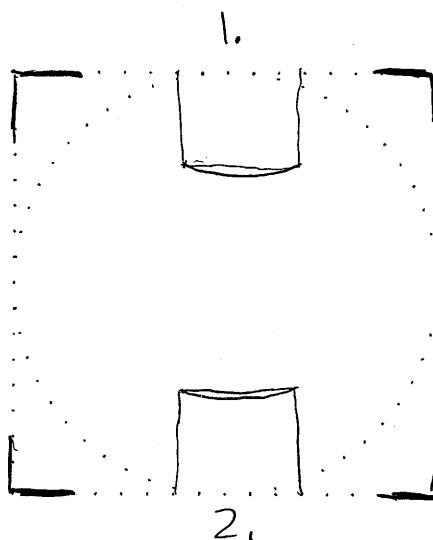
Condition: ☐ Good ☐ Fair ☒ Poor

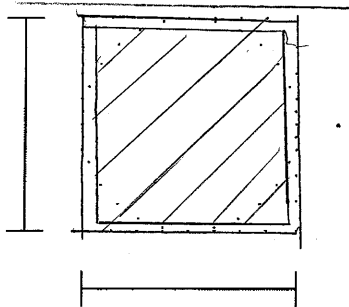
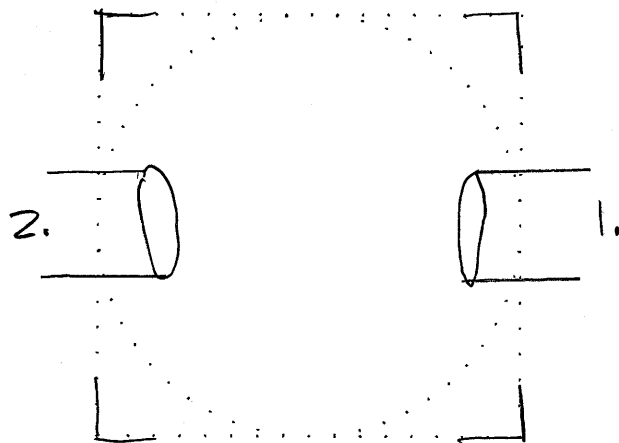
Condition: ☐ Good ☐ Fair ☒ Poor

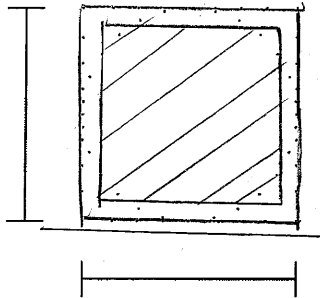
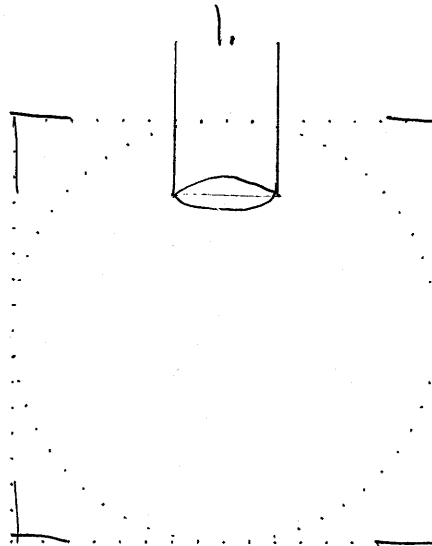
Condition / Notes unable to open

Condition: ☐ Good ☐ Fair ☒ Poor

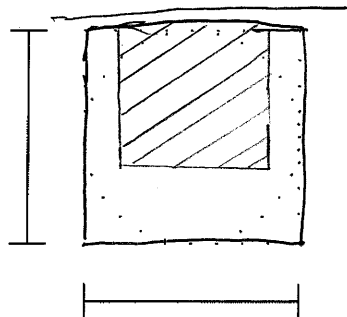
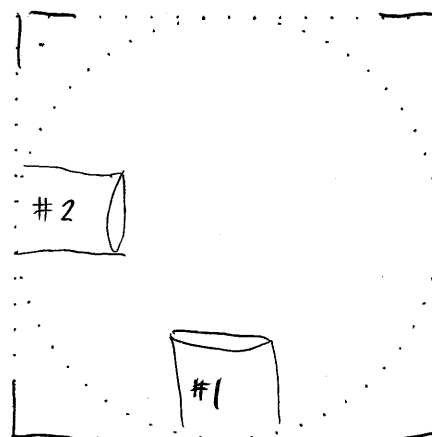
Condition / Notes unable to open.

Condition: ☒ Good ☐ Fair ☐ Poor

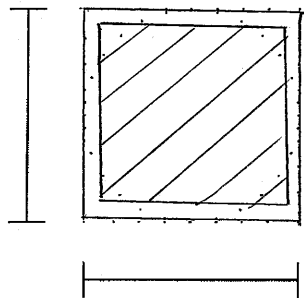
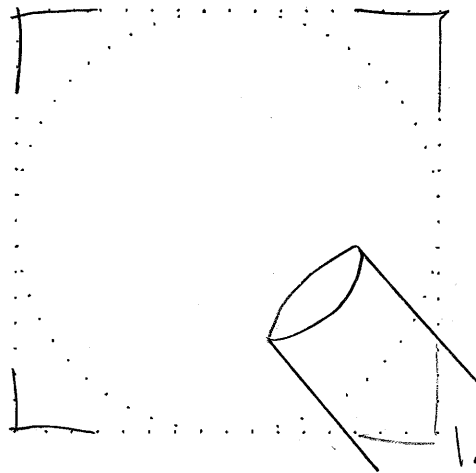
Condition: ☐ Good ☐ Fair ☒ Poor

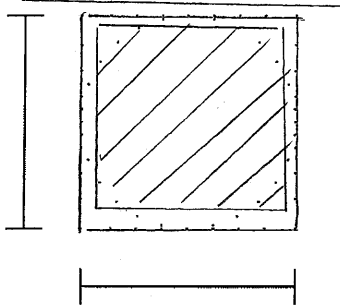
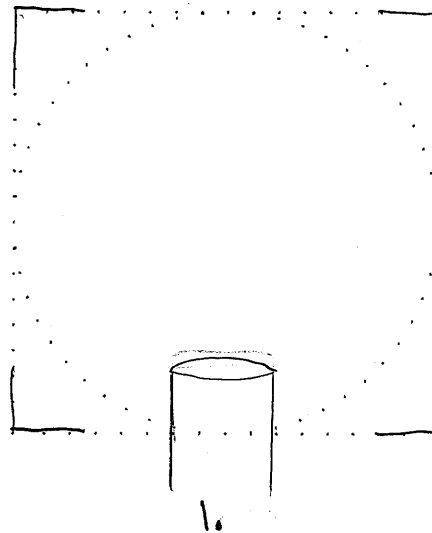
Condition: ☐ Good ☐ Fair ☒ Poor

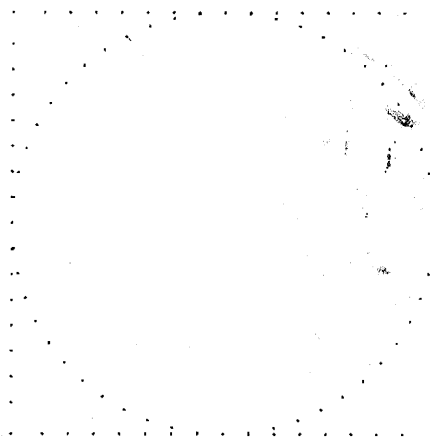
Condition / Notes unable to open.

Condition: ☒ Good ☐ Fair ☐ Poor
