ATTACHMENT 1
INSPECTION REPORT

Inspection Report for B-40-280

W GRANTOSA DR WB over STH 145-W FOND DU LAC AV
Jul 21,2018

B-40-280
W GRANTOSA DR WB over STH 145-W FOND DU LAC AV
North Elevation
7/21/2018

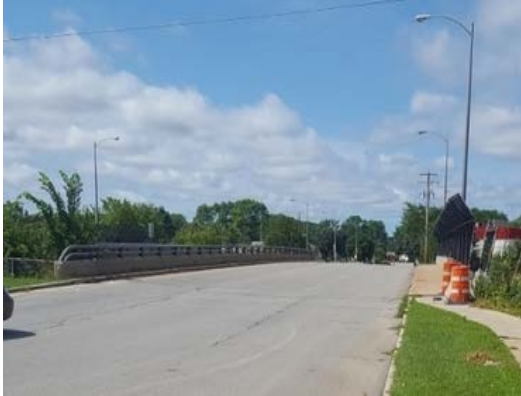
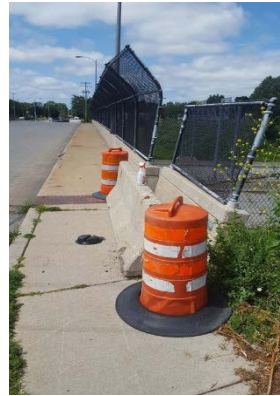
Black paint on pedestrian fence and railing

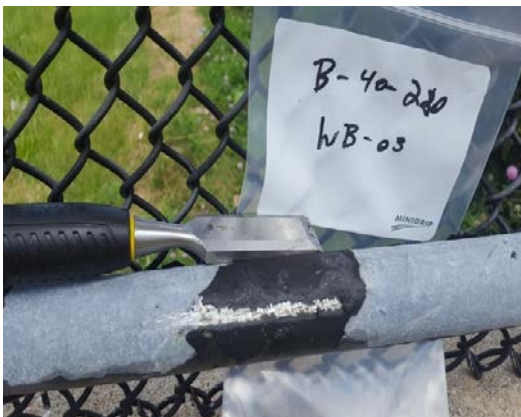
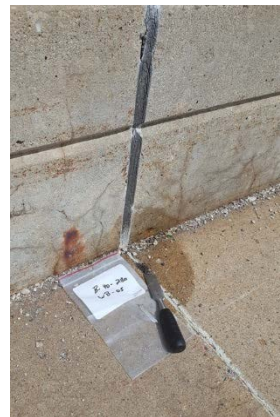
Caulk in parapet expansion joint and sidewalk joint

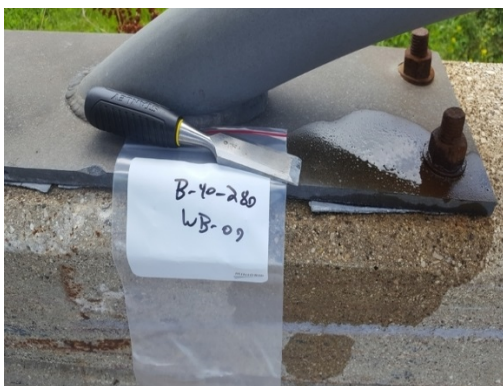
Gasket under railing attachment plate on parapet

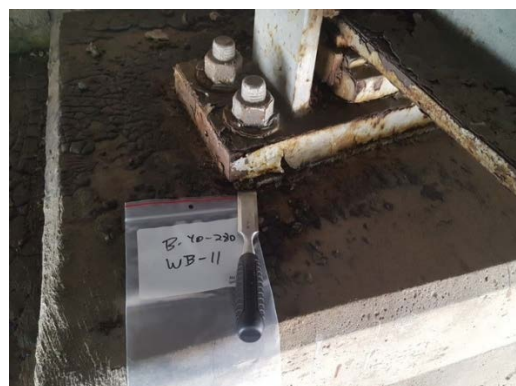
Tar on bridge bearing support piers

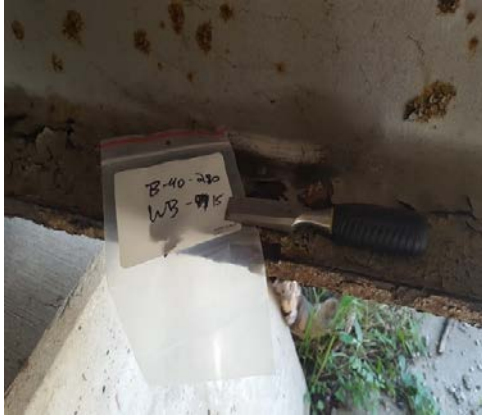
Silver paint on girder

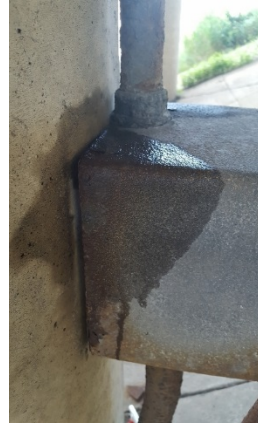
Silver paint on galvanized metal conduit

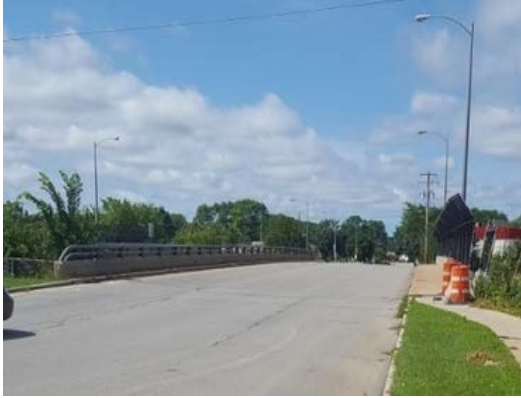
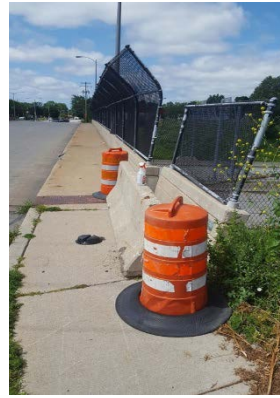
Black paint on pedestrian fence and railing

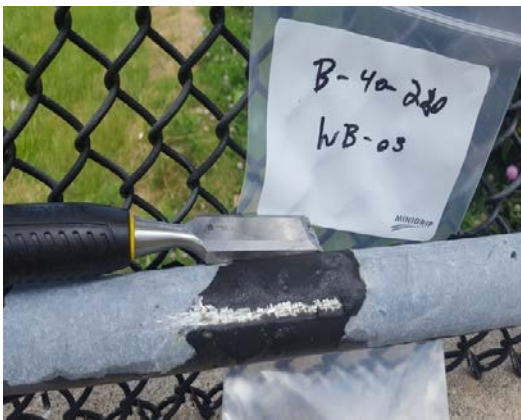
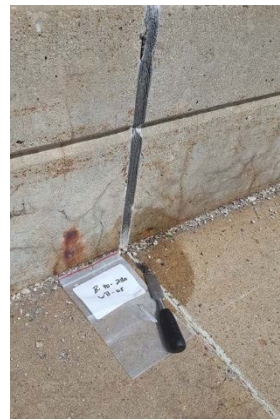
Caulk in parapet expansion joint and sidewalk joint
