ATTACHMENT 1
INSPECTION REPORT

Inspection Report for B-40-281

W GRANTOSA DR EB over STH 145-W FOND DU LAC AV
Jul 21, 2018

B-40-281
W GRANTOSA DR EB over STH 145-W
FOND DU LAC AV
South Elevation
7/21/2018

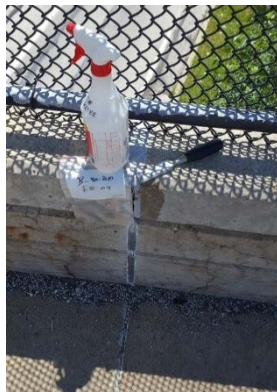
Caulk in parapet expansion joint and sidewalk joint

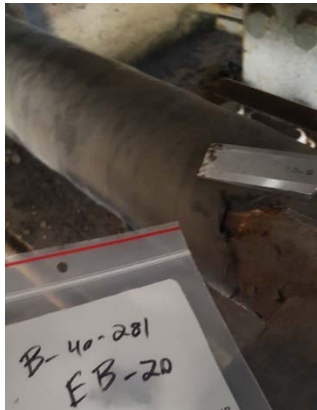
Pipe wrap on utility piping

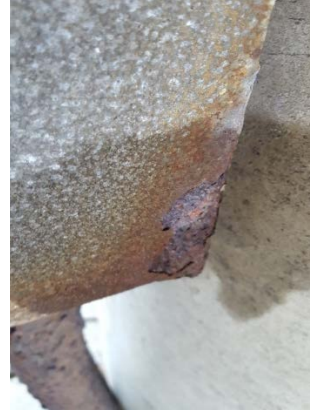
Paint on galvanized metal conduit
