From: [Parve, Lance - DOT](#)
To: [Mohammed H. Zaghloul, S.E., P.E.](#)
Subject: FW: For your Review and Comments from Consultant - 1090-05-02/72 and 1090-35-00/70 I-43 Rock Freeway Bridges: Rehab Items - feel free to further comment
Date: Monday, March 25, 2019 9:38:02 AM

WisDOT Project ID: 1090-05-02
Structure Number: B-40-0376
Structure Name: 124th Street over IH 43
City/County: City of Greenfield, Milwaukee County
Lat/Long Coordinates: 425726.39/ 880408.99
TRC Project Number: 258938.0000.0000
Date Inspected: June 21, 2016
Inspected By/License Number: John Roelke, All-119523

Inspection Report for B-40-376

S 124TH ST over IH 43
Mar 28, 2018

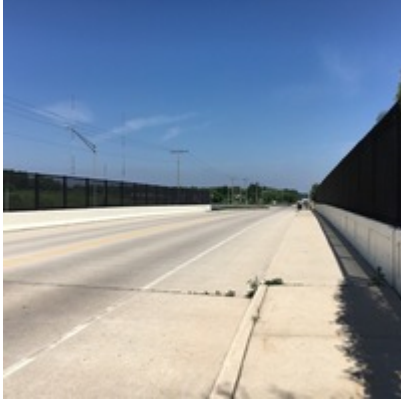
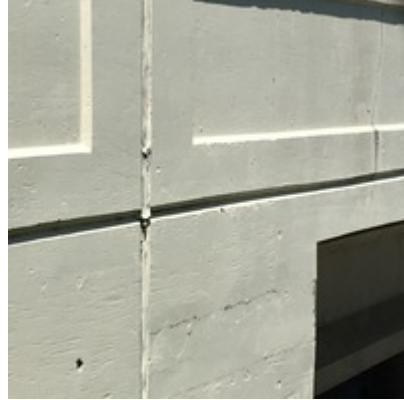
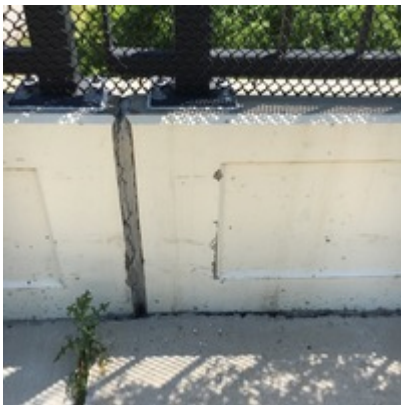
B-40-0376

Caulk in abutment joint

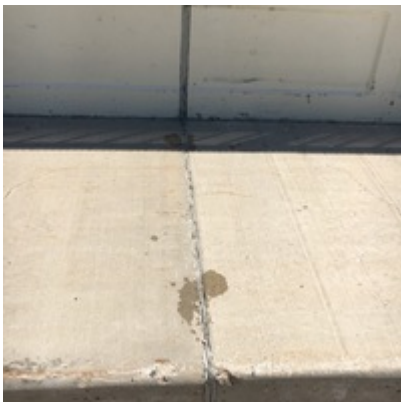
Caulk in parapet and sidewalk joints

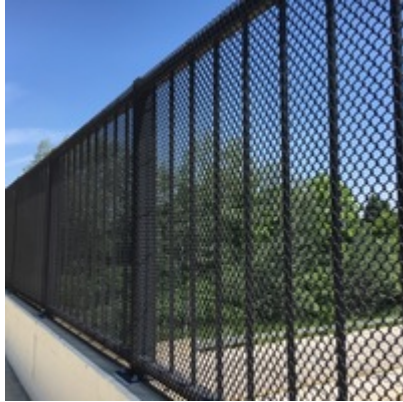
Black paint on pedestrian fence

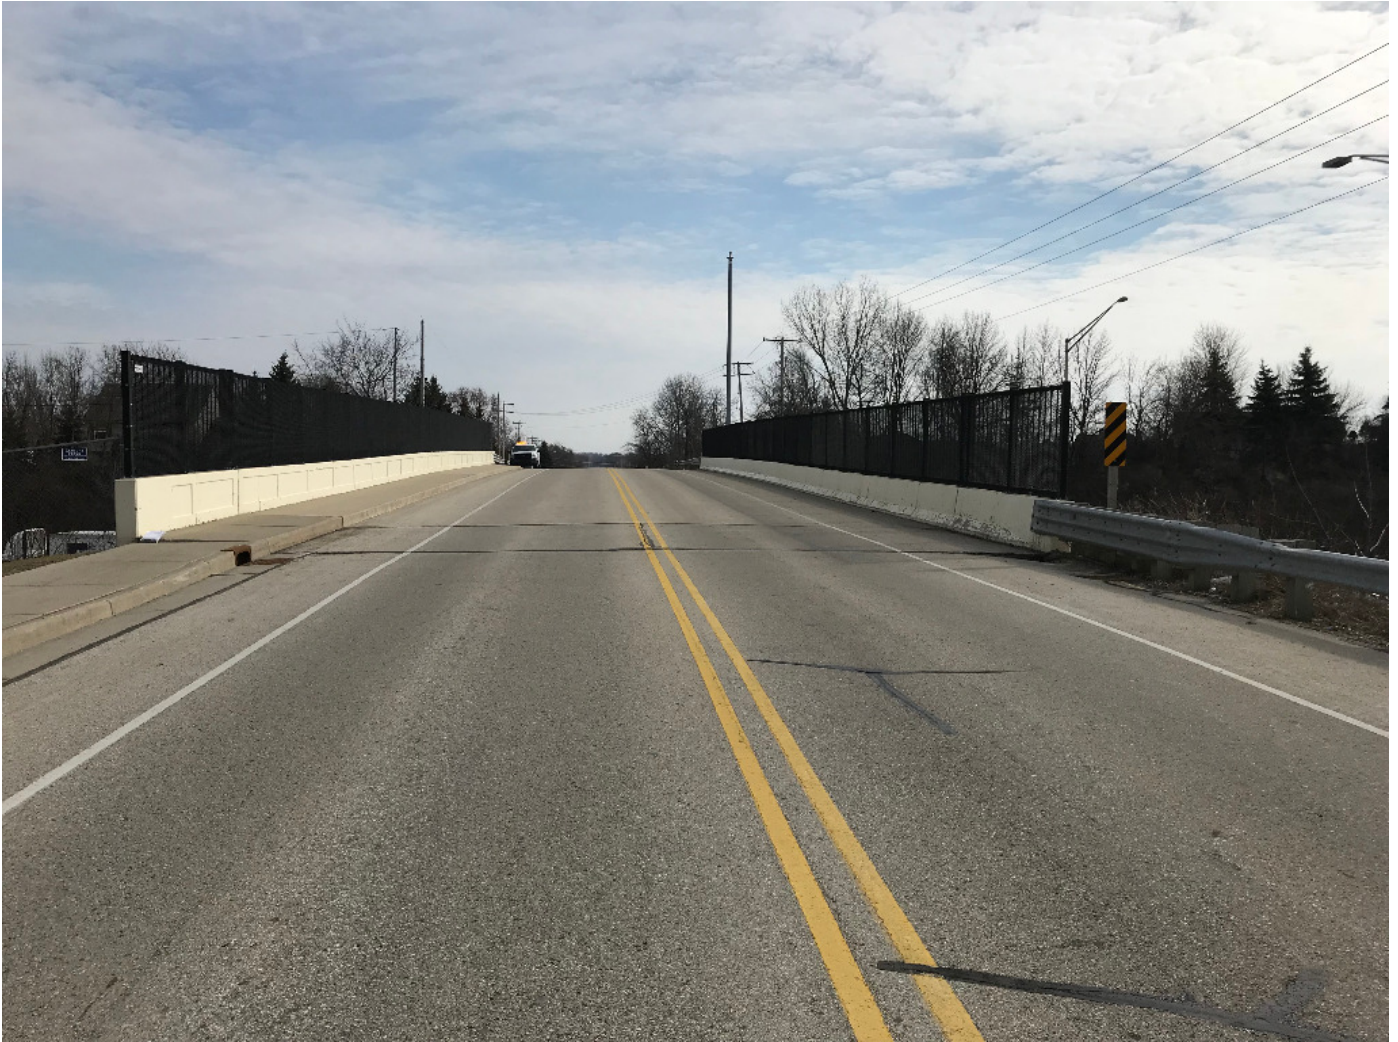
Roadway looking south.
